Proposed Road Improvement Works in West Kowloon Reclamation Development – Phase 1

Environmental Monitoring & Audit Report

01/02/2018 – 28/2/2018

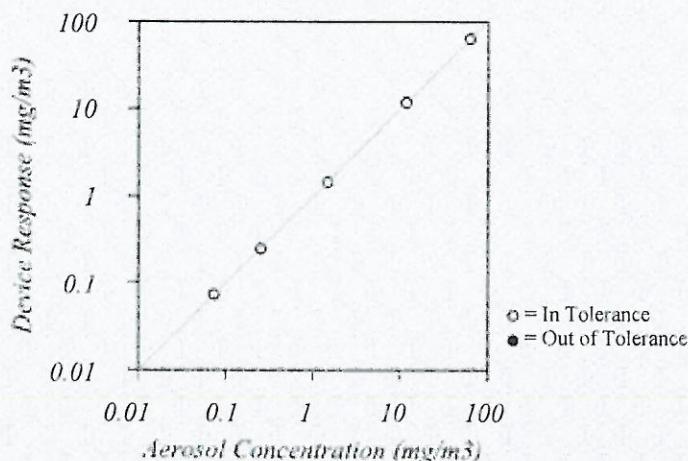
Concentration Linearity Plot

Environment Conditions			Model	AM520
Temperature	75.7 (24.3)	°F (°C)	Serial Number	5201750009
Relative Humidity	26	%RH		
Barometric Pressure	28.83 (976.3)	inHg (hPa)

☒ In Tolerance
☐ Out of Tolerance

CONCENTRATION				Unit: mg/m ³			
#	STANDARD	MEASURED	ALLOWABLE RANGE	#	STANDARD	MEASURED	ALLOWABLE RANGE
1	0.072	0.073	0.050~0.094	4	11.745	11.665	10.571~12.919
2	0.250	0.247	0.213~0.287	5	63.293	62.903	56.964~69.622
3	1.468	1.417	1.321~1.615

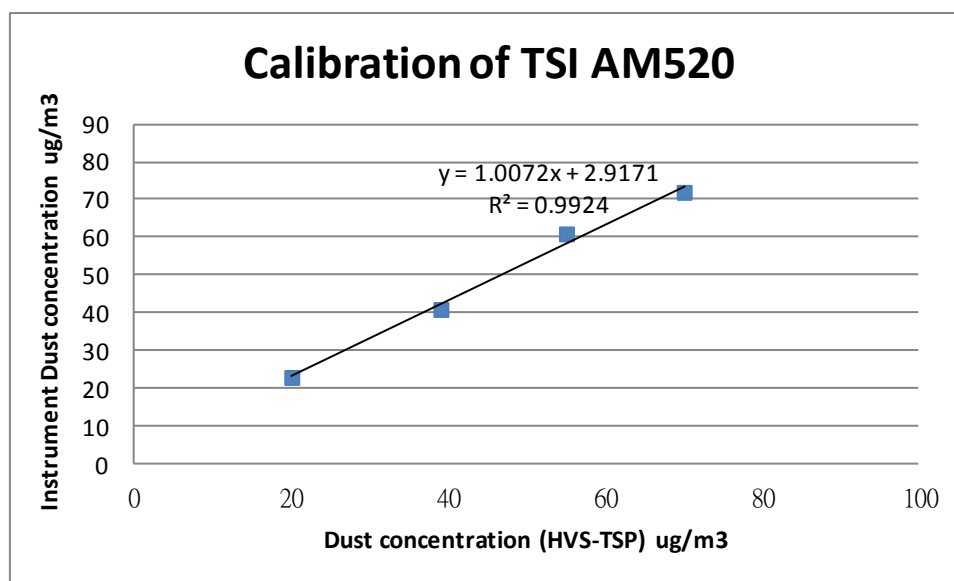
Calibration Record

HVS - TSP	20	39	55	70
TSI AM520	23	41	61	72

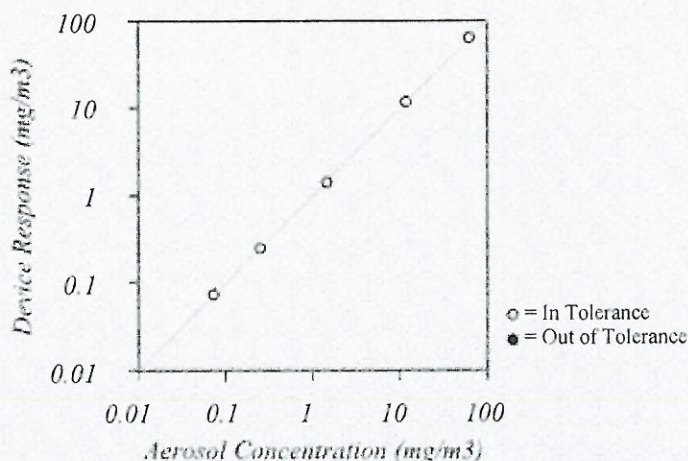
Concentration Linearity Plot

Environment Conditions			Model	AM520
Temperature	75.7 (24.3)	°F (°C)	Serial Number	5201750010
Relative Humidity	26	%RH		
Barometric Pressure	28.83 (976.3)	inHg (hPa)

☒ In Tolerance
☐ Out of Tolerance

CONCENTRATION				Unit: mg/m ³			
#	STANDARD	MEASURED	ALLOWABLE RANGE	#	STANDARD	MEASURED	ALLOWABLE RANGE
1	0.072	0.072	0.050~0.094	4	11.745	11.659	10.571~12.919
2	0.250	0.242	0.213~0.287	5	63.293	62.717	56.964~69.622
3	1.468	1.403	1.321~1.615

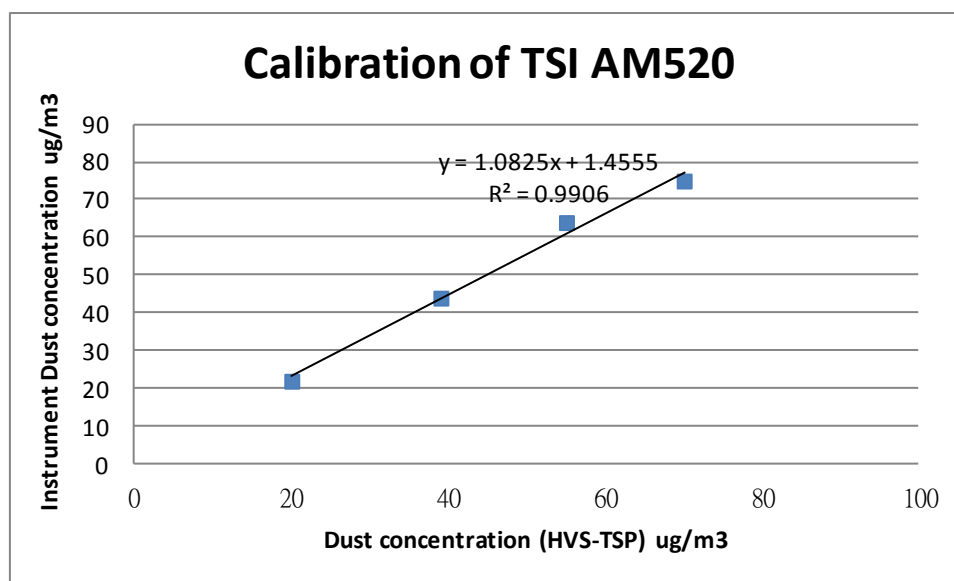
Calibration Record

HVS - TSP	20	39	55	70
TSI AM520	22	44	64	75

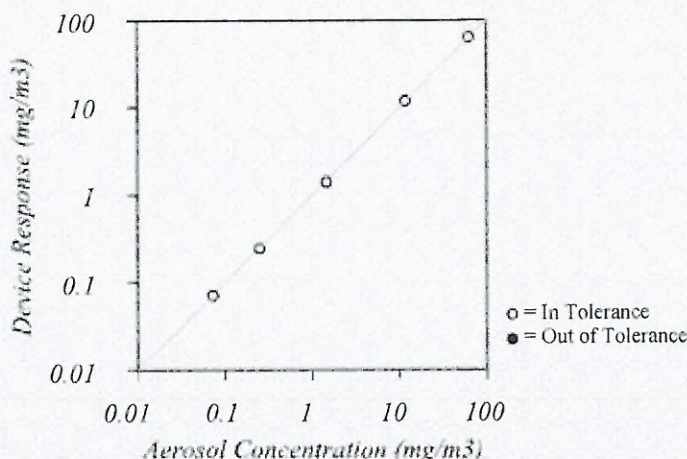
Concentration Linearity Plot

Environment Conditions			Model	AM520
Temperature	75.7 (24.3)	°F (°C)	Serial Number	5201750011
Relative Humidity	26	%RH		
Barometric Pressure	28.83 (976.3)	inHg (hPa)

☒ In Tolerance
☐ Out of Tolerance

CONCENTRATION				Unit: mg/m ³			
#	STANDARD	MEASURED	ALLOWABLE RANGE	#	STANDARD	MEASURED	ALLOWABLE RANGE
1	0.072	0.071	0.050~0.094	4	11.745	11.649	10.571~12.919
2	0.250	0.245	0.213~0.287	5	63.293	62.844	56.964~69.622
3	1.468	1.402	1.321~1.615

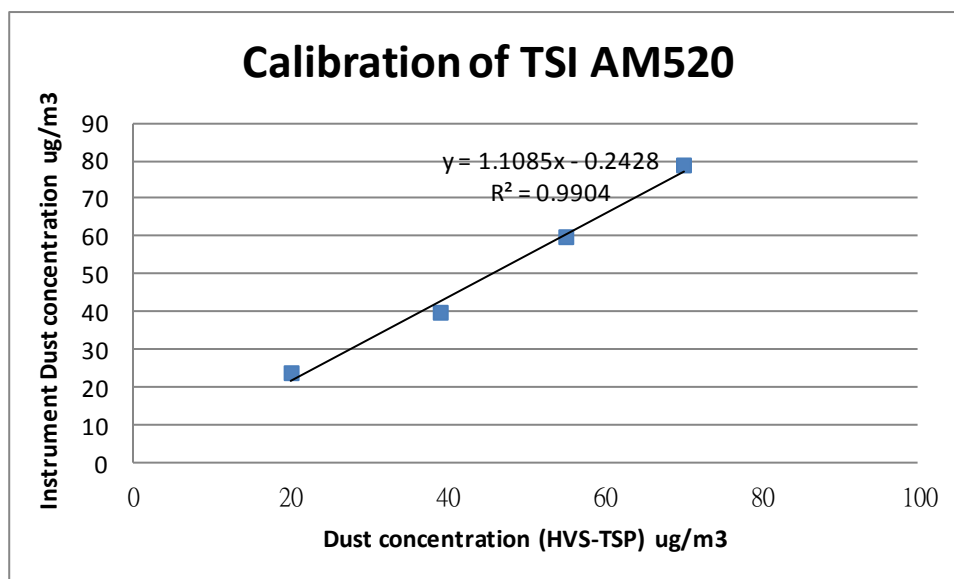
Calibration Record

HVS - TSP	20	39	55	70
TSI AM520	24	40	60	79

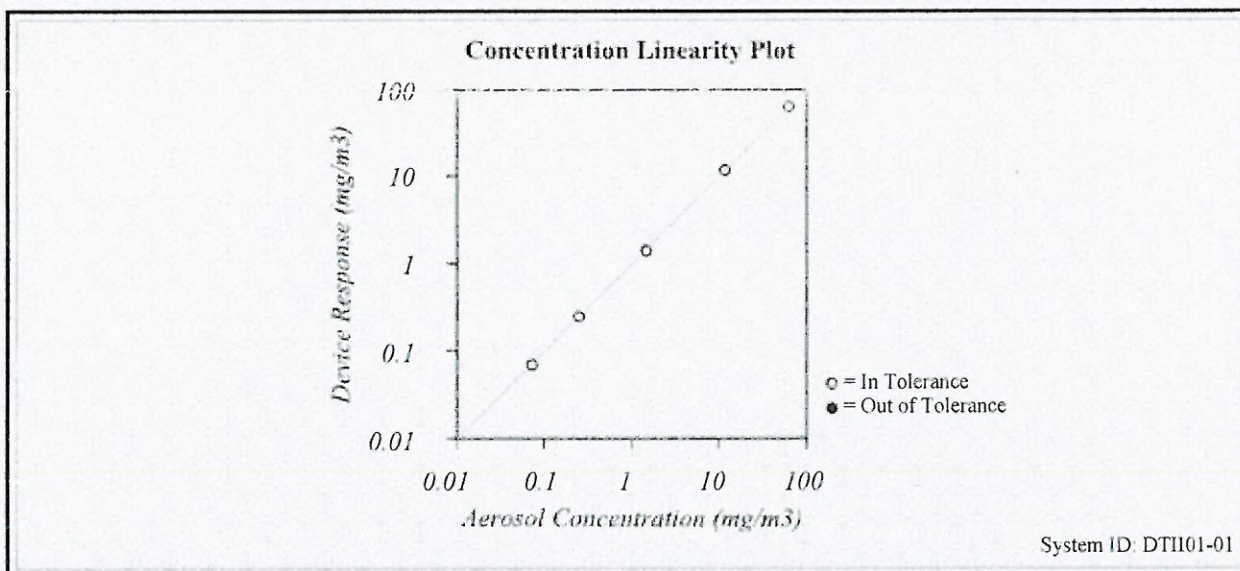
Environment Conditions			Model	AM520
Temperature	75.7 (24.3)	°F (°C)	Serial Number	5201750012
Relative Humidity	26	%RH		
Barometric Pressure	28.83 (976.3)	inHg (hPa)

☒ As Left ☒ In Tolerance
☐ As Found ☐ Out of Tolerance

CONCENTRATION				Unit: mg/m ³			
#	STANDARD	MEASURED	ALLOWABLE RANGE	#	STANDARD	MEASURED	ALLOWABLE RANGE
1	0.072	0.070	0.050~0.094	4	11.745	11.612	10.571~12.919
2	0.250	0.246	0.213~0.287	5	63.293	63.376	56.964~69.622
3	1.468	1.403	1.321~1.615

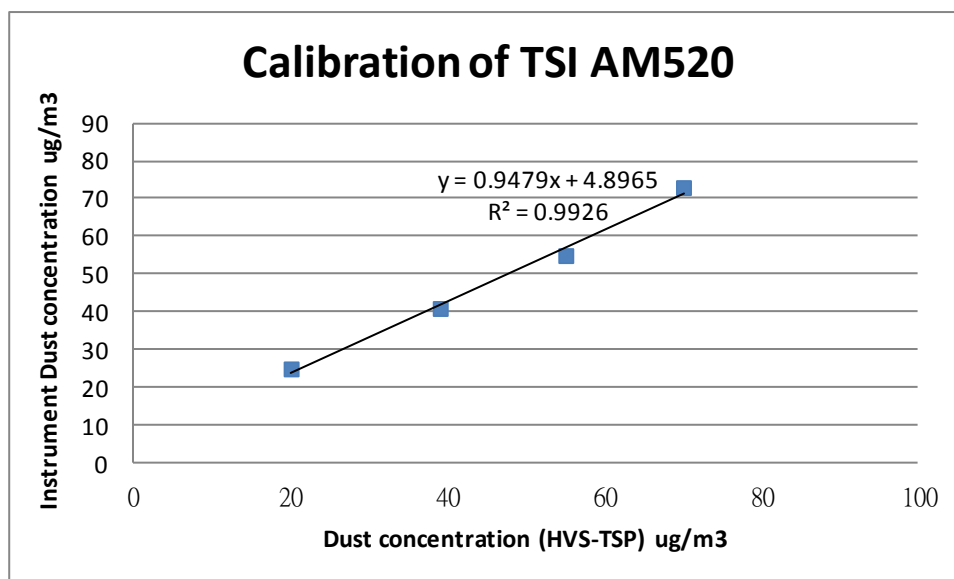
Calibration Record

HVS - TSP	20	39	55	70
TSI AM520	25	41	55	73

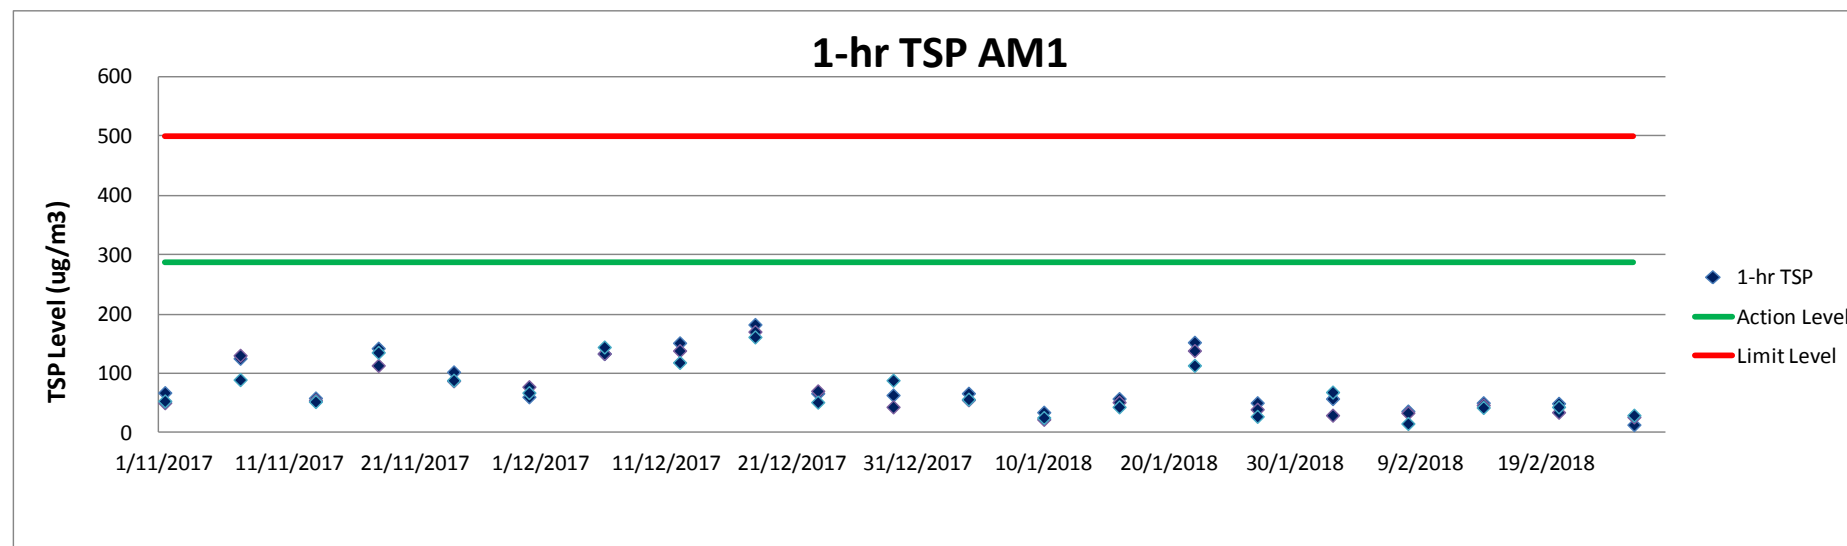
Date	Weather	Temperature (°C) *	Wind Direction *	Wind Speed (m/s) *	Sampling Time			Reading (µg/m ³)			
					1	2	3	1	2	3	Average
2/2/2018	Overcast	9.0 - 11.5	SE	<5m/s	10:25	11:26	12:27	58	30	69	52
8/2/2018	Sunny	10.8 - 17.0	SE	<5m/s	12:40	13:41	14:42	37	34	16	29
14/2/2018	Sunny	14.1 - 19.0	E	<5m/s	10:13	11:14	12:15	51	47	43	47
20/2/2018	Sunny	18.9 - 24.2	NE	<5m/s	10:54	11:55	12:56	50	35	44	43
26/2/2018	Overcast	15.9 - 18.1	SE	<5m/s	10:13	11:14	12:15	14	27	30	24

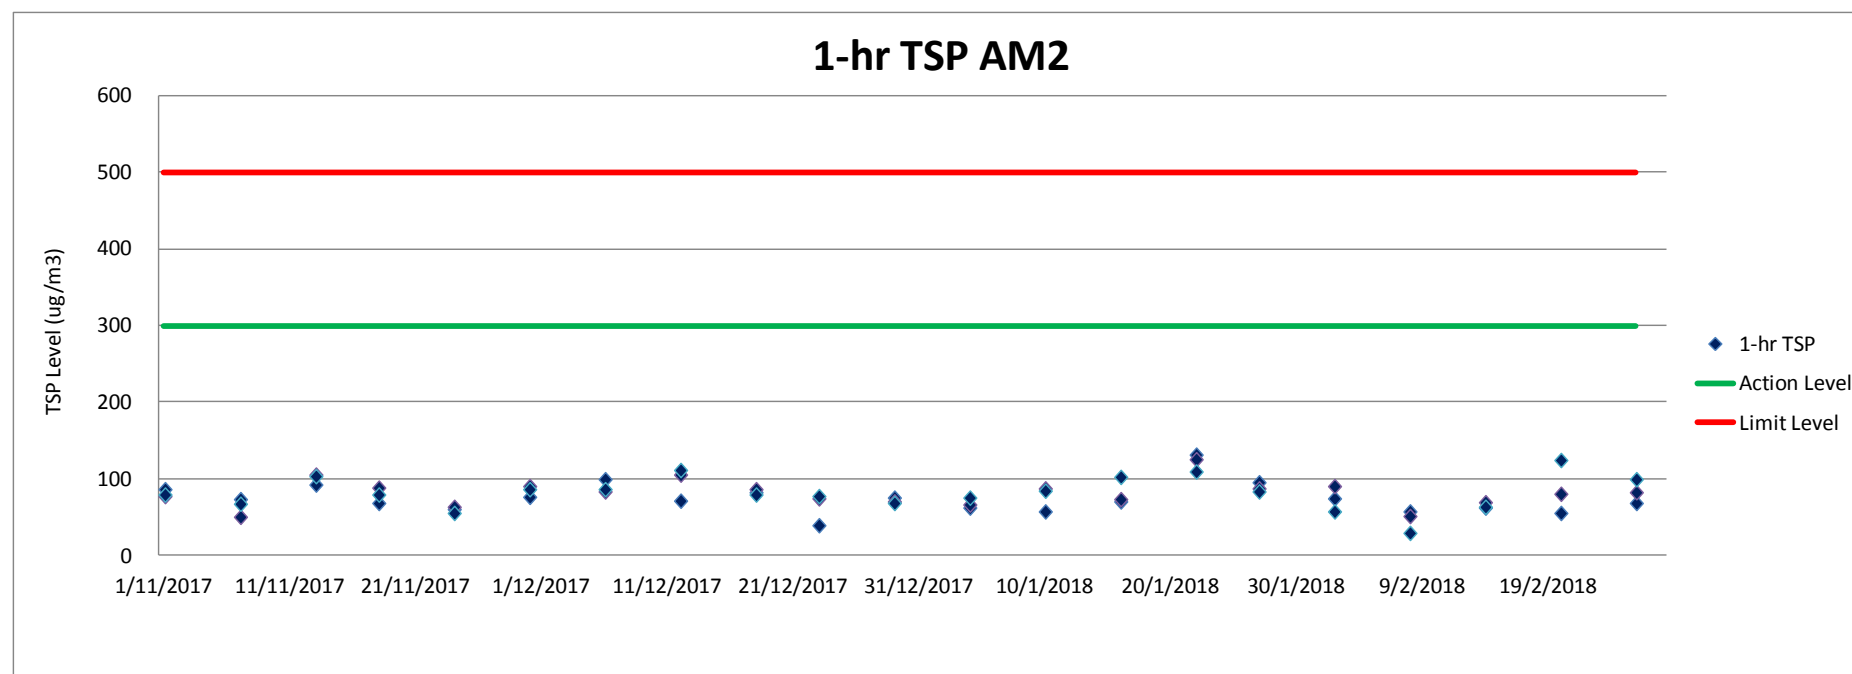
1-hr TSP Monitoring Result for AM2

Date	Weather	Temperature (°C) *	Wind Direction *	Wind Speed (m/s) *	Sampling Time			Reading (µg/m ³)			
					1	2	3	1	2	3	Average
2/2/2018	Overcast	9.0 - 11.5	SE	<5m/s	13:05	14:06	15:07	74	90	57	74
8/2/2018	Sunny	10.8 - 17.0	SE	<5m/s	13:05	14:06	15:07	57	51	29	46
14/2/2018	Sunny	14.1 - 19.0	E	<5m/s	13:05	14:06	15:07	62	69	63	65
20/2/2018	Sunny	18.9 - 24.2	NE	<5m/s	13:05	14:06	15:07	55	80	124	86
26/2/2018	Overcast	15.9 - 18.1	SE	<5m/s	13:05	14:06	15:07	68	82	99	83

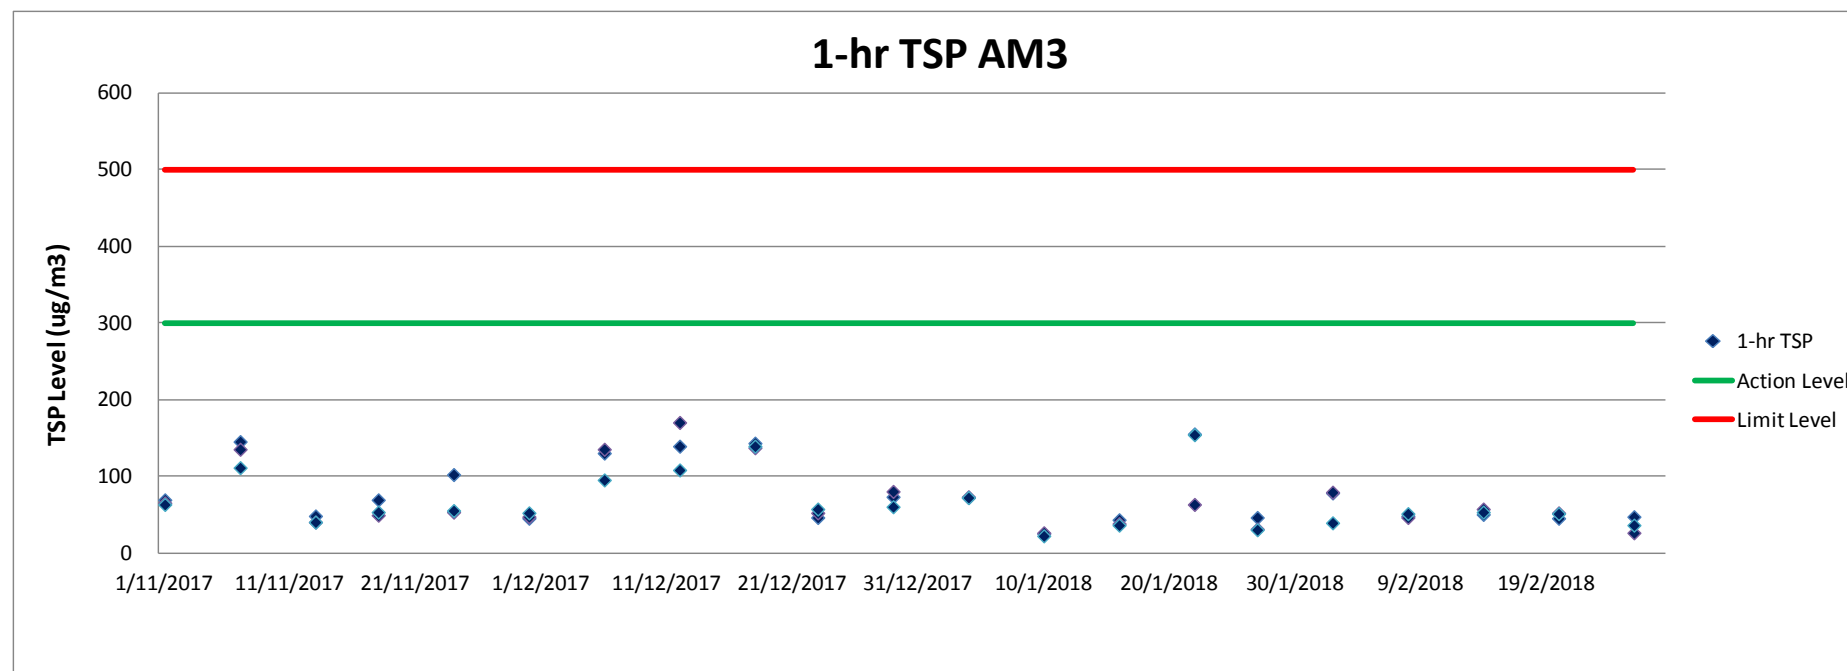
1-hr TSP Monitoring Result for AM3

Date	Weather	Temperature (°C) *	Wind Direction *	Wind Speed (m/s) *	Sampling Time			Reading (µg/m ³)			
					1	2	3	1	2	3	Average
2/2/2018	Overcast	9.0 - 11.5	SE	<5m/s	9:32	10:33	11:34	79	80	40	66
8/2/2018	Sunny	10.8 - 17.0	SE	<5m/s	11:28	12:29	13:30	49	47	52	49
14/2/2018	Sunny	14.1 - 19.0	E	<5m/s	9:35	10:36	11:37	51	58	54	54
20/2/2018	Sunny	18.9 - 24.2	NE	<5m/s	10:15	11:16	12:17	46	53	52	50
26/2/2018	Overcast	15.9 - 18.1	SE	<5m/s	9:01	10:02	11:03	48	27	37	37

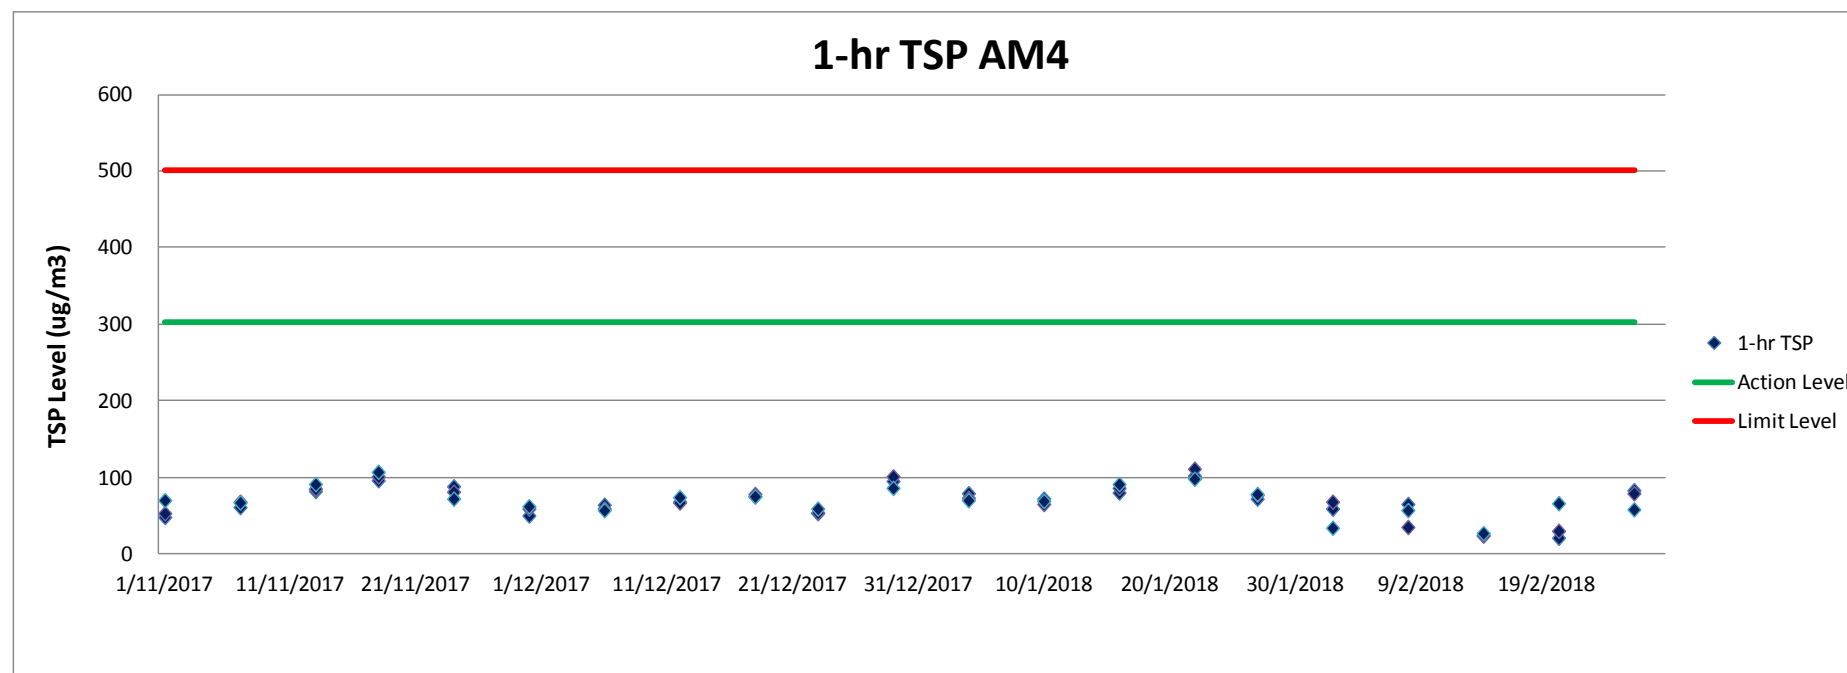
1-hr TSP Monitoring Result for AM4

Date	Weather	Temperature (°C) *	Wind Direction *	Wind Speed (m/s) *	Sampling Time			Reading (µg/m ³)			
					1	2	3	1	2	3	Average
2/2/2018	Overcast	9.0 - 11.5	SE	<5m/s	13:09	14:10	15:11	59	68	34	54
8/2/2018	Sunny	10.8 - 17.0	SE	<5m/s	13:12	14:13	15:14	65	35	57	52
14/2/2018	Sunny	14.1 - 19.0	E	<5m/s	13:42	14:43	15:44	24	24	27	25
20/2/2018	Sunny	18.9 - 24.2	NE	<5m/s	13:06	14:07	15:08	21	30	66	39
26/2/2018	Overcast	15.9 - 18.1	SE	<5m/s	13:10	14:11	15:12	83	79	58	73

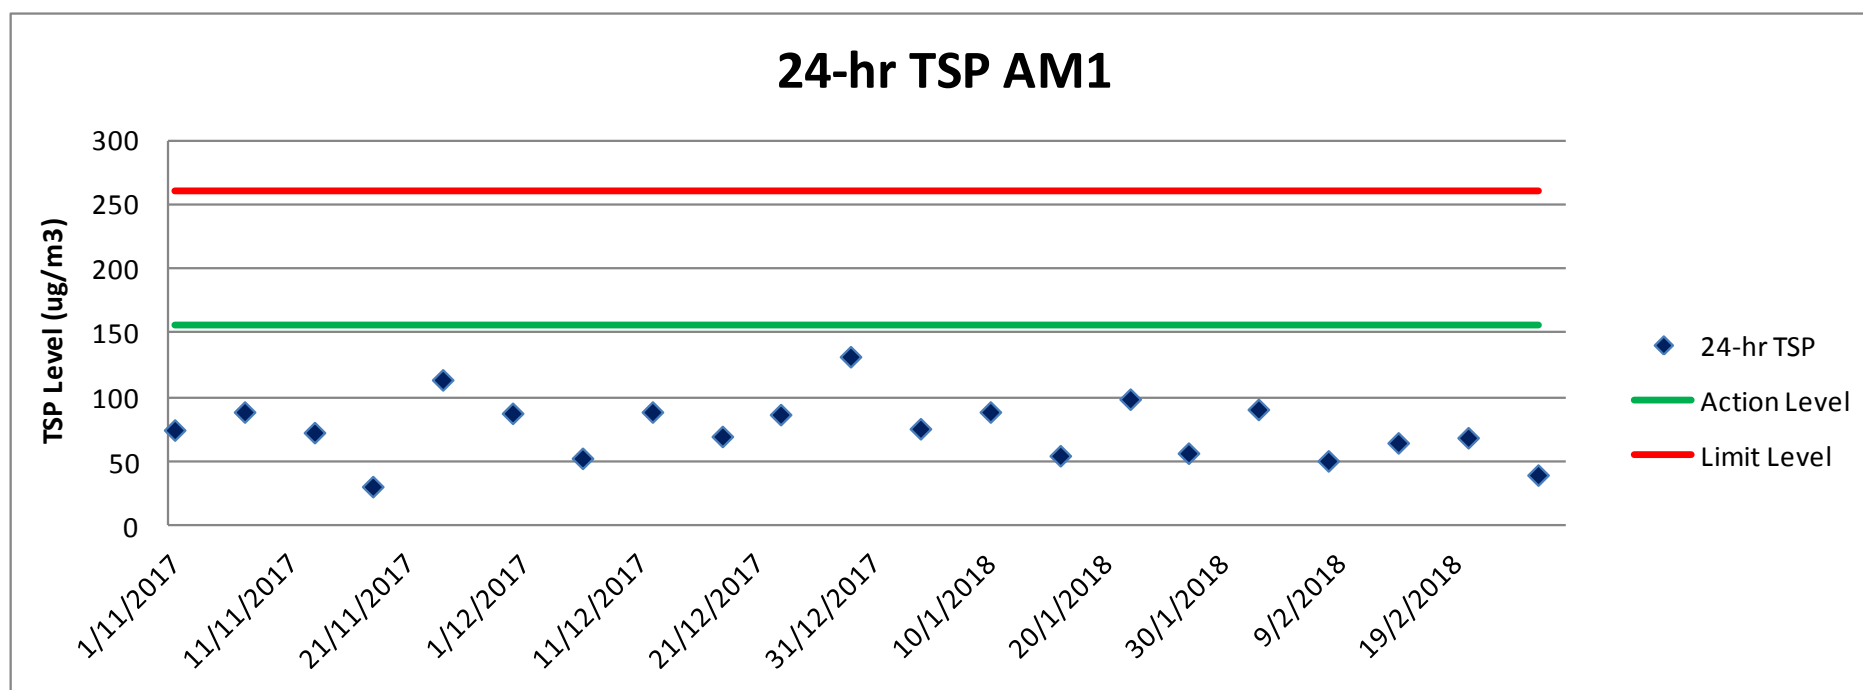
24-hr TSP Monitoring Result for AM1

Sampling ID & Paper No.	Temperature (°C) * ¹	Wind Direction * ¹	Wind Speed (m/s) * ¹	Sampling Date	Wt. of paper (g)			Flow Rate (CFM)	Total Volume * ² (m ³)	TSP Concentration (µg/m ³)
					Initial Wt.	Final Wt.	Wt. of dust			
AM10202 204474	9.0 - 11.5	SE	<5m/s	2/2/2018	2.6584	2.9169	0.2585	58.0	2835.92	91
AM10208 204464	10.8 - 17.0	SE	<5m/s	8/2/2018	2.6624	2.8082	0.1458	58.0	2835.92	51
AM10214 204470	14.1 - 19.0	E	<5m/s	14/2/2018	2.6441	2.8278	0.1837	58.0	2835.92	65
AM10220 204471	18.9 - 24.2	NE	<5m/s	20/2/2018	2.6218	2.8175	0.1957	58.0	2835.92	69
AM10127 204462	15.9 - 18.1	SE	<5m/s	26/2/2018	2.6362	2.7483	0.1121	58.0	2835.92	40

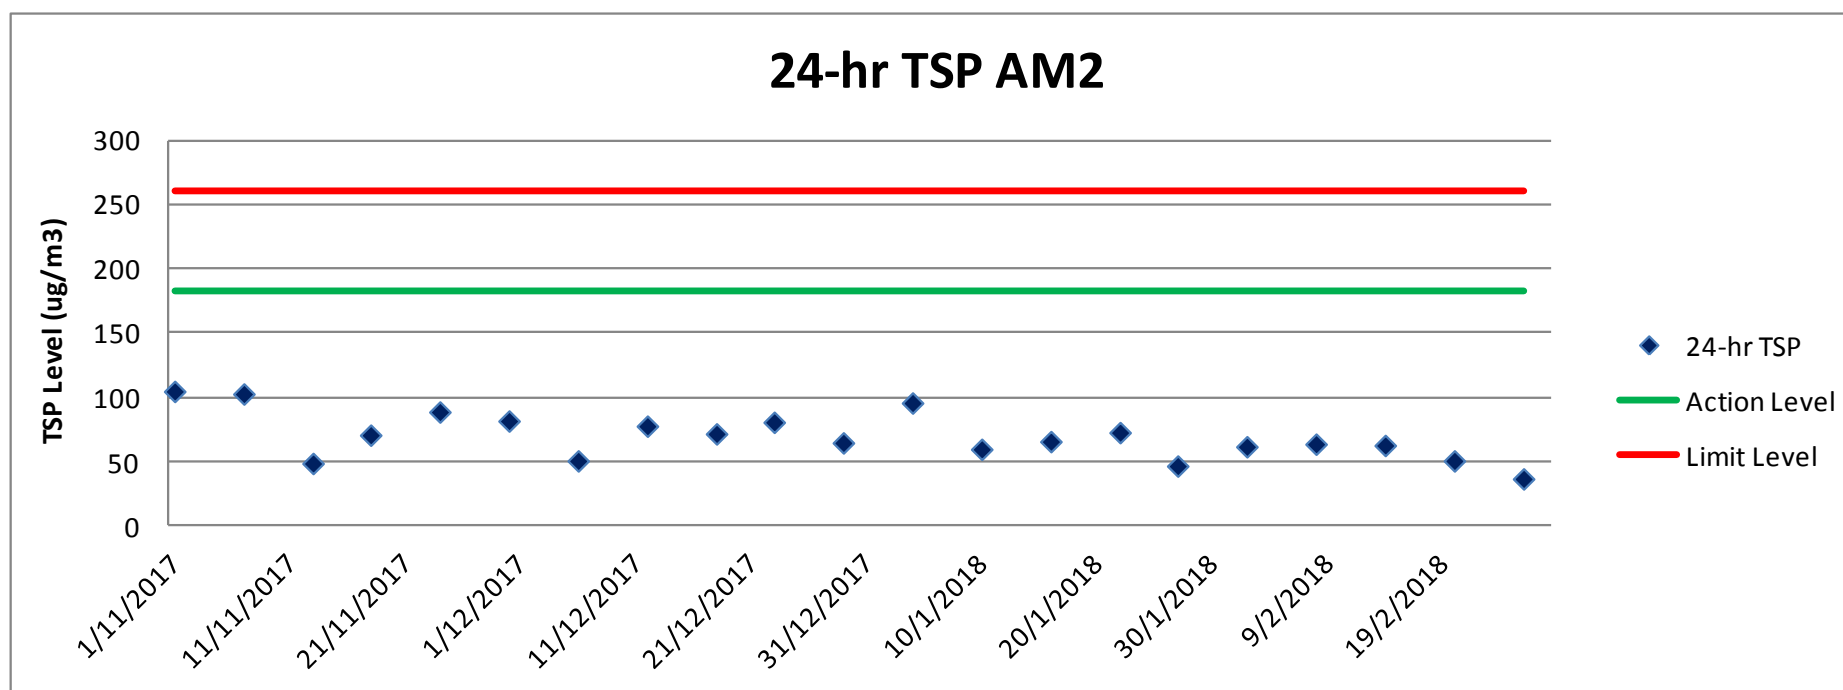
24-hr TSP Monitoring Result for AM2

Sampling ID & Paper No.	Temperature (°C) * ¹	Wind Direction * ¹	Wind Speed (m/s) * ¹	Sampling Date	Wt. of paper (g)			Flow Rate (CFM)	Total Volume * ² (m ³)	TSP Concentration (µg/m ³)
					Initial Wt.	Final Wt.	Wt. of dust			
AM20202 202652	9.0 - 11.5	SE	<5m/s	2/2/2018	2.8405	3.0027	0.1622	56.0	2604.33	62
AM20208 204485	10.8 - 17.0	SE	<5m/s	8/2/2018	2.6441	2.8116	0.1675	56.0	2604.33	64
AM20214 204484	14.1 - 19.0	E	<5m/s	14/2/2018	2.6415	2.8053	0.1638	56.0	2604.33	63
AM20220 204486	18.9 - 24.2	NE	<5m/s	20/2/2018	2.6340	2.7661	0.1321	56.0	2604.33	51
AM20226 204461	15.9 - 18.1	SE	<5m/s	26/2/2018	2.6456	2.7427	0.0971	56.0	2604.33	37

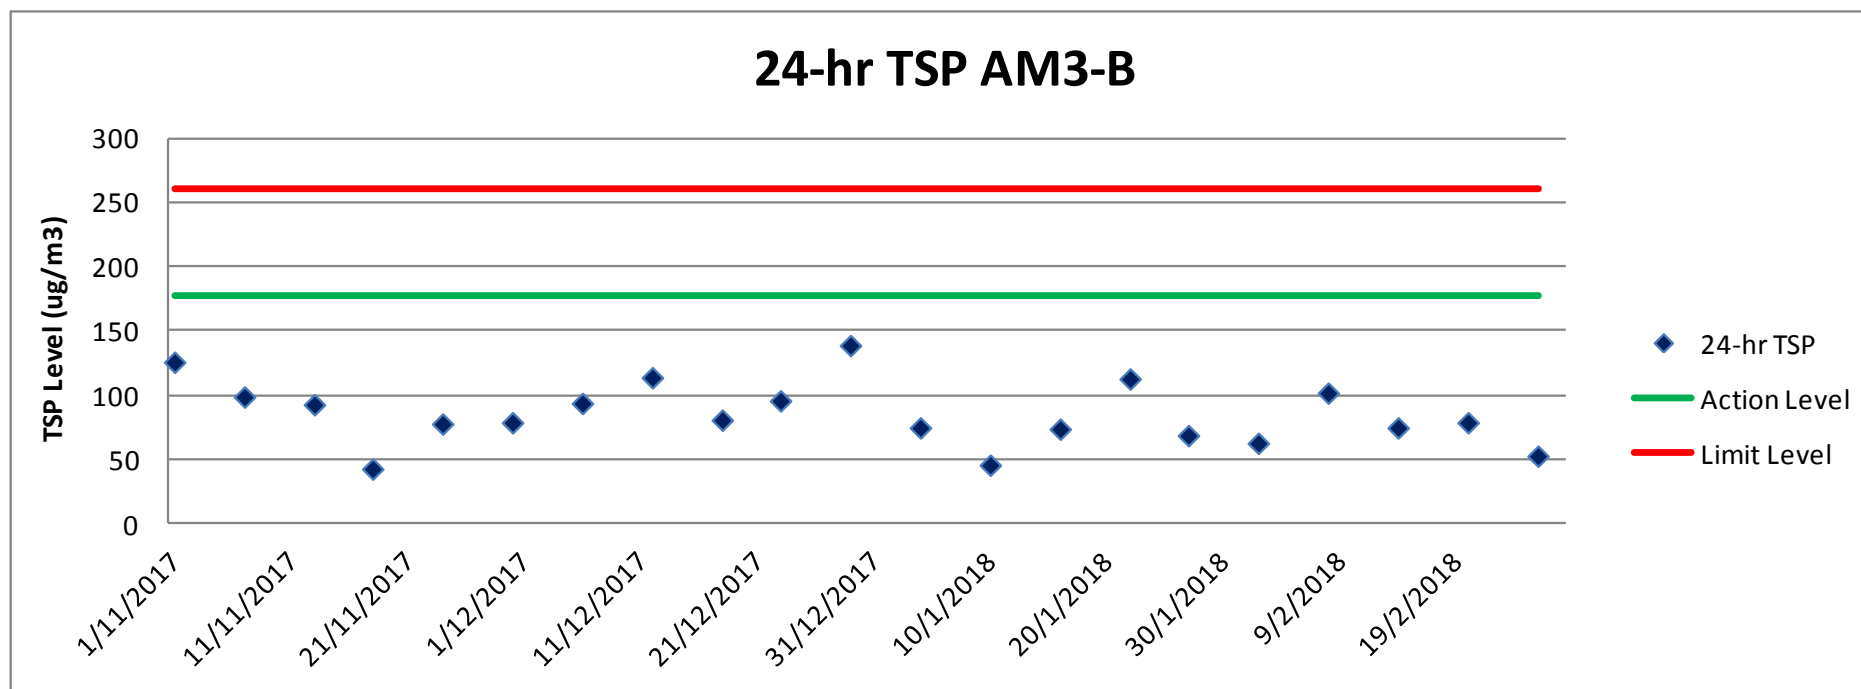
24-hr TSP Monitoring Result for AM3-B

Sampling ID & Paper No.	Temperature (°C) * ¹	Wind Direction * ¹	Wind Speed (m/s) * ¹	Sampling Date	Wt. of paper (g)			Flow Rate (CFM)	Total Volume * ² (m ³)	TSP Concentration (µg/m ³)
					Initial Wt.	Final Wt.	Wt. of dust			
AM3-B0202 204476	9.0 - 11.5	SE	<5m/s	2/2/2018	2.6247	2.7840	0.1593	58.0	2514.86	63
AM3-B0208 204475	10.8 - 17.0	SE	<5m/s	8/2/2018	2.6230	2.8788	0.2558	58.0	2514.86	102
AM3-B0214 204473	14.1 - 19.0	E	<5m/s	14/2/2018	2.6119	2.7997	0.1878	58.0	2514.86	75
AM3-B0220 204482	18.9 - 24.2	NE	<5m/s	20/2/2018	2.6323	2.8311	0.1988	58.0	2514.86	79
AM3-B0226 204490	15.9 - 18.1	SE	<5m/s	26/2/2018	2.6296	2.7635	0.1339	58.0	2514.86	53

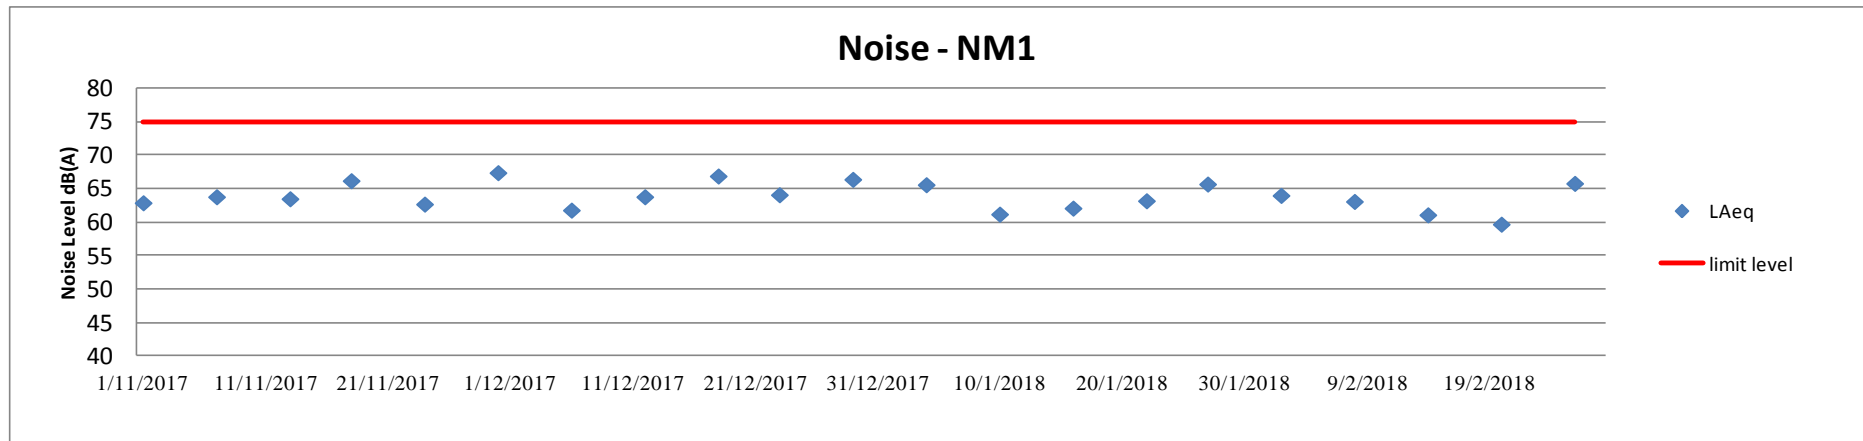
Noise Monitoring Result for NM1

Location	NM1				
Date	2/2/2018	8/2/2018	14/2/2018	20/2/2018	26/2/2018
Weather Condition	Overcast	Sunny	Sunny	Sunny	Overcast
Start Time	10:00	10:00	10:00	10:00	10:00
Measurement Period	30min	30min	30min	30min	30min
Baseline Level	75.1				
L _{Aeq}	64.0	63.1	61.1	59.7	65.8
L ₁₀	66.0	64.7	62.1	61.4	67.7
L ₉₀	60.6	61.0	59.7	57.3	63.2

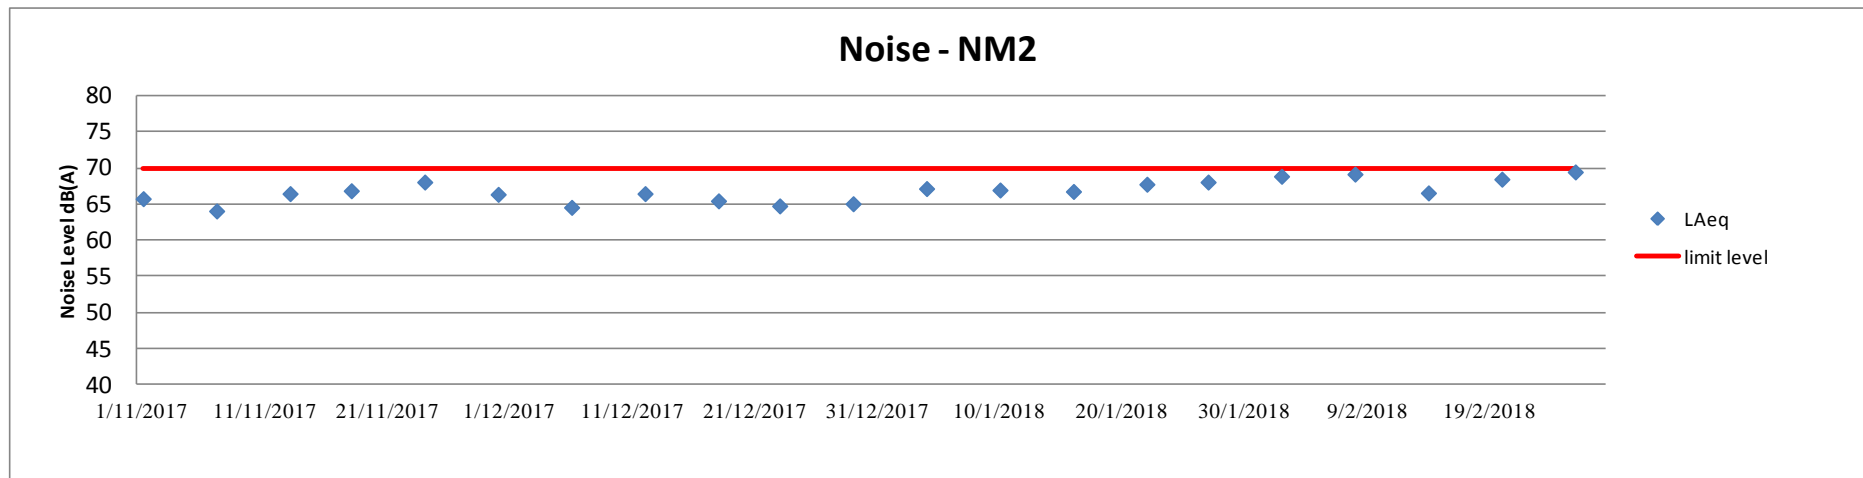
Noise Monitoring Result for NM2

Location	NM2				
Date	2/2/2018	8/2/2018	14/2/2018	20/2/2018	26/2/2018
Weather Condition	Overcast	Sunny	Sunny	Sunny	Overcast
Start Time	9:00	9:00	9:00	9:00	9:00
Measurement Period	30min	30min	30min	30min	30min
Baseline Level	66.5				
L _{Aeq}	68.9	69.2	66.6	68.5	69.5
L ₁₀	70.2	71.3	68.5	71.8	71.1
L ₉₀	63.6	64.8	61.4	62.3	60.9

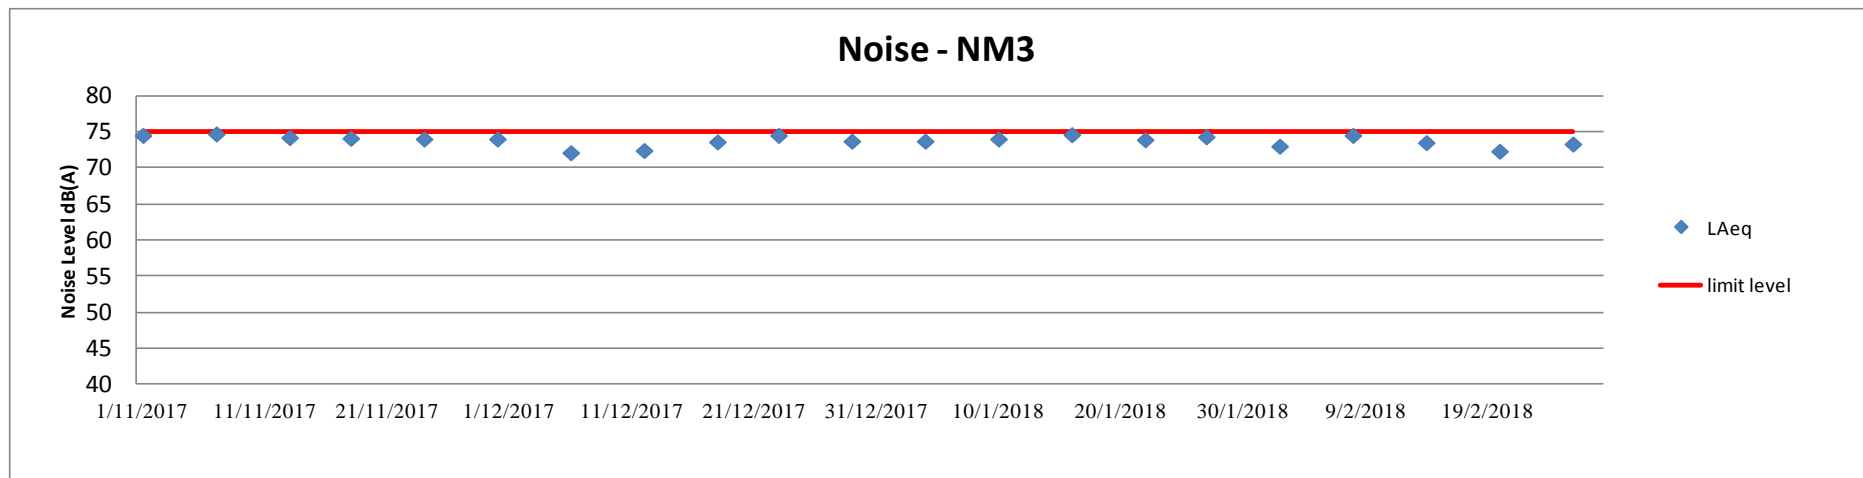
Noise Monitoring Result for NM3

Location	NM3				
Date	2/2/2018	8/2/2018	14/2/2018	20/2/2018	26/2/2018
Weather Condition	Overcast	Sunny	Sunny	Sunny	Overcast
Start Time	11:00	11:00	11:00	11:00	11:00
Measurement Period	30min	30min	30min	30min	30min
Baseline Level	74.5				
L _{Aeq}	73.1	74.6	73.6	72.4	73.4
L ₁₀	75.6	77.7	76.3	74.9	75.9
L ₉₀	69.3	70.6	68.7	68.8	69.7

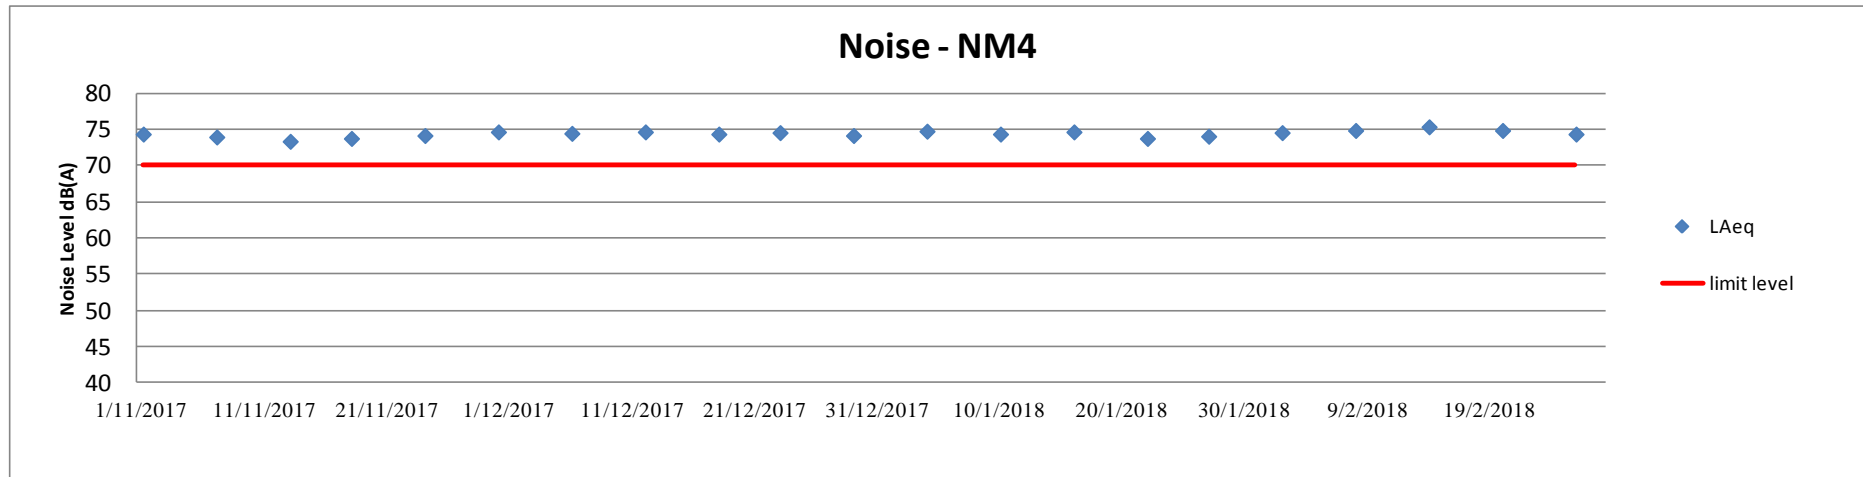
Noise Monitoring Result for NM4

The noise source for causing exceedances at NM4 was from the traffic of Canton Road. The NM4 was directly affected by the noise generated from the traffic. The recorded monitoring results at the NM4 were near the baseline noise level. The exceedances were not caused by the construction works of this project.

Location	NM4					NM4 (Re-measurement) *				
Date	2/2/2018	8/2/2018	14/2/2018	20/2/2018	26/2/2018	2/2/2018	8/2/2018	14/2/2018	20/2/2018	26/2/2018
Weather Condition	Overcast	Sunny	Sunny	Sunny	Overcast	Overcast	Sunny	Sunny	Sunny	Overcast
Start Time	13:00	13:00	13:00	13:00	13:00	13:31	13:31	13:31	13:31	13:31
Measurement Period	30min	30min	30min	30min	30min	30min	30min	30min	30min	30min
Baseline Level	73.3					73.3				
L _{Aeq}	74.7	75.0	75.5	75.0	74.5	75.2	75.5	74.9	74.9	74.8
L ₁₀	77.5	77.9	79.3	78.7	78.5	79.1	79.6	79.0	78.7	79.5
L ₉₀	68.9	69.1	69.3	68.7	69.0	69.5	69.1	69.0	70.0	68.7

* Repeat noise measurement when exceedance is recorded. The result is used to confirm the findings and it would not be showed on the graph plot

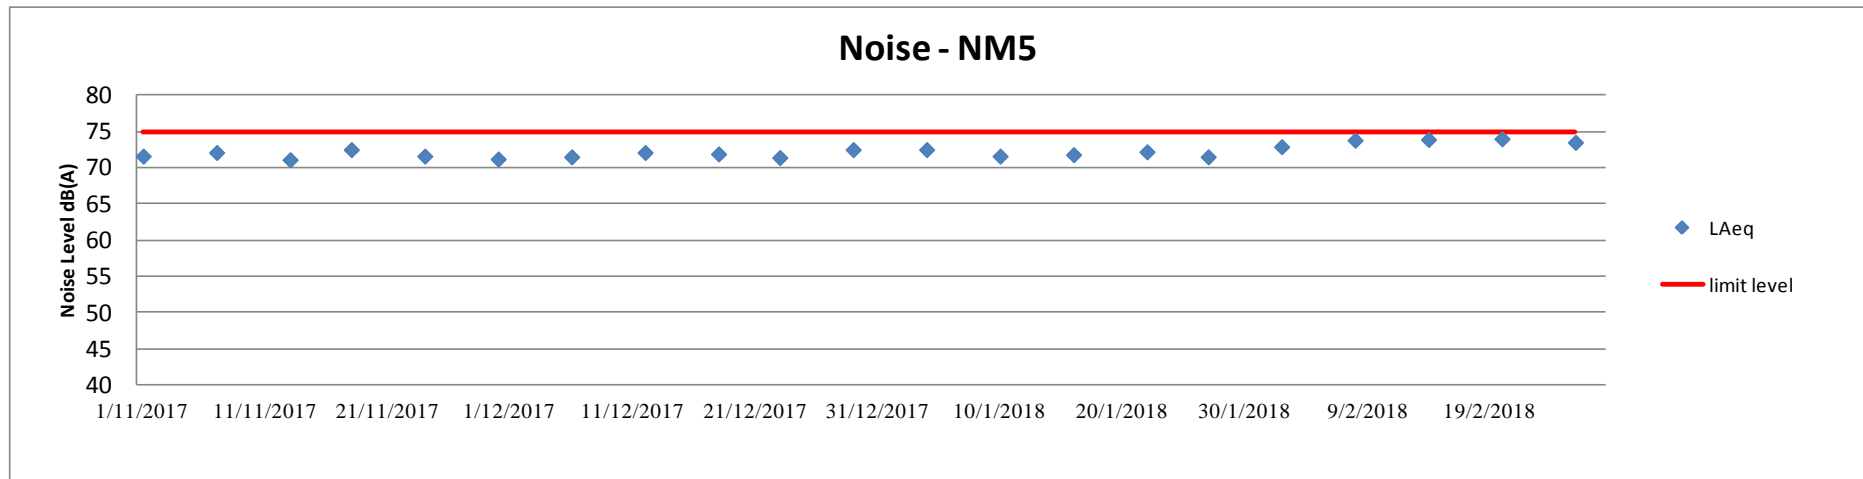
Noise Monitoring Result for NM5

Location	NM5				
Date	2/2/2018	8/2/2018	14/2/2018	20/2/2018	26/2/2018
Weather Condition	Overcast	Sunny	Sunny	Sunny	Overcast
Start Time	14:45	16:55	14:27	13:57	14:45
Measurement Period	30min	30min	30min	30min	30min
Baseline Level	71.8				
L _{Aeq}	72.9	73.8	73.9	74.0	73.5
L ₁₀	76.8	77.0	77.0	76.6	76.8
L ₉₀	67.5	67.2	67.5	69.1	68.5
