# **Proposed Road Improvement Works in West Kowloon Reclamation Development – Phase 1**

## **Environmental Monitoring & Audit Report**

**01/03/2018 – 31/3/2018**

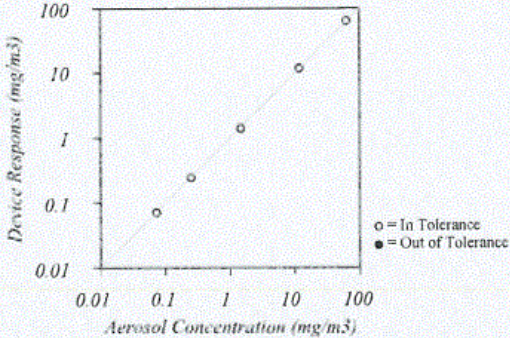
Concentration Linearity Plot

Environment Conditions			Model	AM520
Temperature	75.7 (24.3)	°F (°C)	Serial Number	5201750011
Relative Humidity	26	%RH		
Barometric Pressure	28.83 (976.3)	inHg (hPa)

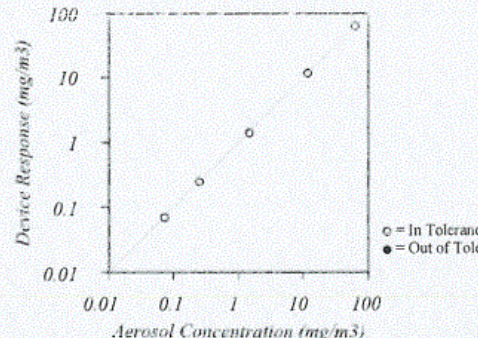
### Concentration Linearity Plot

CONCENTRATION				Unit: mg/m³			
#	STANDARD	MEASURED	ALLOWABLE RANGE	#	STANDARD	MEASURED	ALLOWABLE RANGE
1	0.072	0.070	0.050-0.094	4	11.745	11.612	10.571-12.919
2	0.250	0.246	0.213-0.287	5	63.293	63.376	56.964-69.622
3	1.468	1.403	1.321-1.615

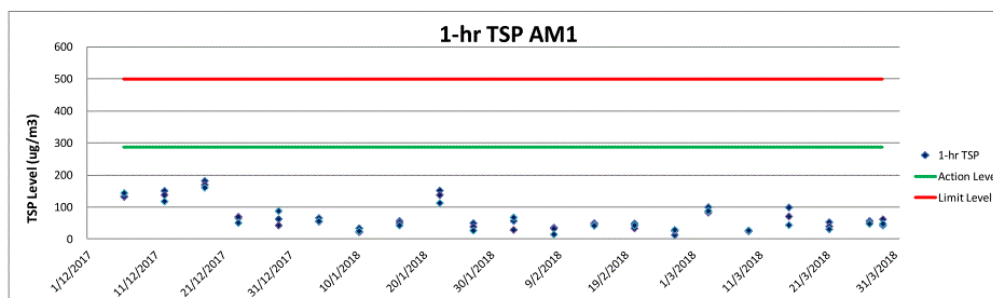
Date	Weather	Temperature (°C) *	Wind Direction *	Wind Speed (m/s) *	Sampling Time			Reading (µg/m³)			
					1	2	3	1	2	3	Average
3/3/2018	Overcast	20.8 - 24.0	SE	<5m/s	11:25	12:26	13:27	101	84	89	91
9/3/2018	Sunny	10.3 - 19.0	NE	<5m/s	13:49	14:50	15:51	26	27	28	27
15/3/2018	Sunny	20.3 - 25.3	SE	<5m/s	11:16	12:17	13:18	100	72	45	72
21/3/2018	Sunny	13.3 - 22.9	NE	<5m/s	13:04	14:05	15:06	54	41	32	42
27/3/2018	Sunny	20.3 - 26.0	SE	<5m/s	13:59	15:00	16:01	58	52	49	53
29/3/2018	Overcast	20.3 - 25.3	NE	<5m/s	14:17	15:18	16:19	44	63	49	52

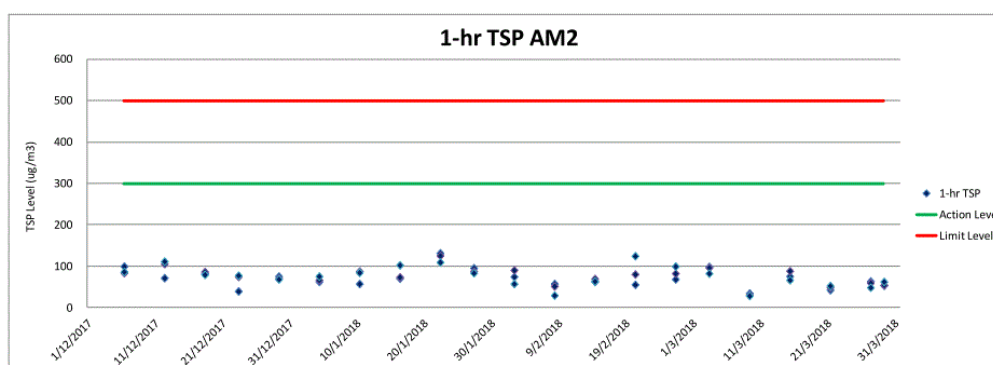
1-hr TSP Monitoring Result for AM2

Date	Weather	Temperature (°C) *	Wind Direction *	Wind Speed (m/s) *	Sampling Time			Reading (µg/m³)			
					1	2	3	1	2	3	Average
3/3/2018	Overcast	20.8 - 24.0	SE	<5m/s	9:00	10:01	11:02	98	96	82	92
9/3/2018	Sunny	10.3 - 19.0	NE	<5m/s	9:00	10:01	11:02	34	30	28	31
15/3/2018	Sunny	20.3 - 25.3	SE	<5m/s	9:00	10:01	11:02	75	88	66	76
21/3/2018	Sunny	13.3 - 22.9	NE	<5m/s	9:00	10:01	11:02	42	48	52	47
27/3/2018	Sunny	20.3 - 26.0	SE	<5m/s	9:00	10:01	11:02	63	59	48	57
29/3/2018	Overcast	20.3 - 25.3	NE	<5m/s	9:00	10:01	11:02	53	54	62	56

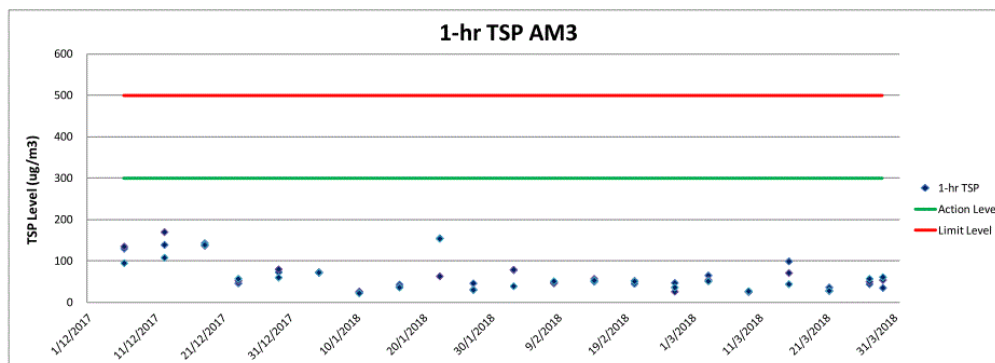
1-hr TSP Monitoring Result for AM3

Date	Weather	Temperature (°C) *	Wind Direction *	Wind Speed (m/s) *	Sampling Time			Reading (µg/m³)			
					1	2	3	1	2	3	Average
3/3/2018	Overcast	20.8 - 24.0	SE	<5m/s	10:44	11:45	12:46	66	55	52	58
9/3/2018	Sunny	10.3 - 19.0	NE	<5m/s	13:49	14:50	15:51	26	27	28	27
15/3/2018	Sunny	20.3 - 25.3	SE	<5m/s	11:16	12:17	13:18	100	72	45	72
21/3/2018	Sunny	13.3 - 22.9	NE	<5m/s	14:00	15:01	16:02	37	29	29	32
27/3/2018	Sunny	20.3 - 26.0	SE	<5m/s	11:50	12:51	13:52	45	51	58	51
29/3/2018	Overcast	20.3 - 25.3	NE	<5m/s	14:12	15:13	16:14	36	55	62	51

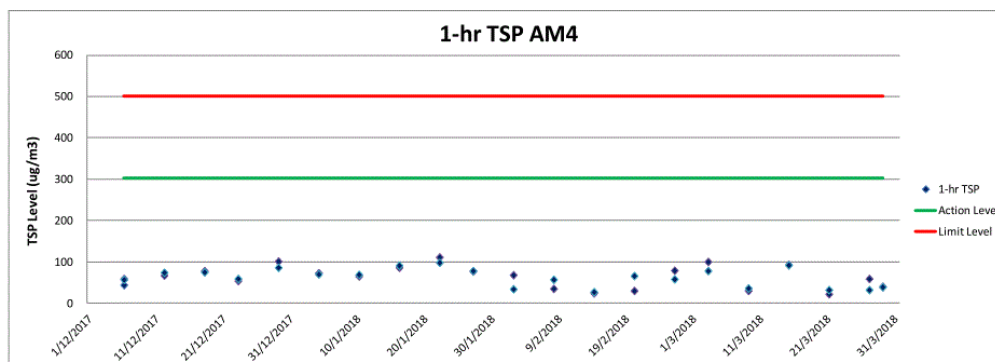
1-hr TSP Monitoring Result for AM4

Date	Weather	Temperature (°C) *	Wind Direction *	Wind Speed (m/s) *	Sampling Time			Reading (µg/m³)			
					1	2	3	1	2	3	Average
3/3/2018	Overcast	20.8 - 24.0	SE	<5m/s	9:30	10:31	11:32	89	100	78	89
9/3/2018	Sunny	10.3 - 19.0	NE	<5m/s	9:30	10:31	11:32	29	30	36	32
15/3/2018	Sunny	20.3 - 25.3	SE	<5m/s	9:30	10:31	11:32	99	93	92	95
21/3/2018	Sunny	13.3 - 22.9	NE	<5m/s	9:30	10:31	11:32	42	22	32	32
27/3/2018	Sunny	20.3 - 26.0	SE	<5m/s	9:30	10:31	11:32	48	59	32	46
29/3/2018	Overcast	20.3 - 25.3	NE	<5m/s	9:30	10:31	11:32	44	40	39	41

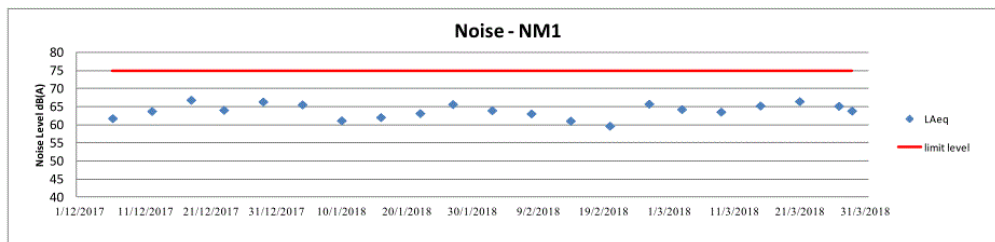
Noise Monitoring Result for NM1

Location	NM1					
Date	3/3/2018	9/3/2018	15/3/2018	21/3/2018	27/3/2018	29/3/2018
Weather Condition	Overcast	Sunny	Sunny	Sunny	Sunny	Overcast
Start Time	10:00	10:00	10:00	10:00	15:33	10:00
Measurement Period	30min	30min	30min	30min	30min	30min
Baseline Level	75.1					
L <sub>Aeq</sub>	64.3	63.6	65.3	66.5	65.2	63.9
L <sub>10</sub>	66.7	65.3	67.8	67.9	65.5	65.0
L <sub>90</sub>	61.1	60.8	61.6	64.6	60.1	61.6

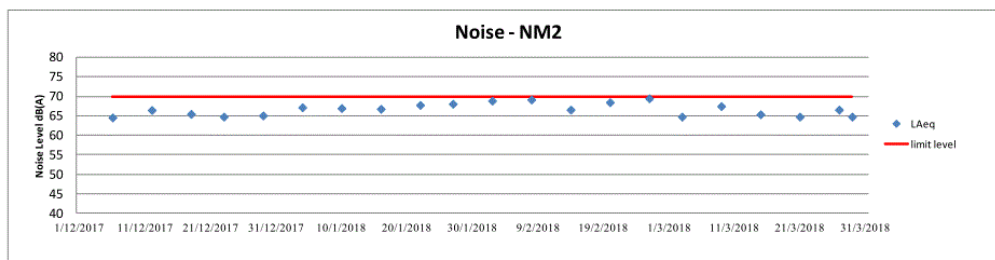
Noise Monitoring Result for NM2

Location	NM2					
Date	3/3/2018	9/3/2018	15/3/2018	21/3/2018	27/3/2018	29/3/2018
Weather Condition	Overcast	Sunny	Sunny	Sunny	Sunny	Overcast
Start Time	9:00	9:00	9:00	9:00	9:00	9:00
Measurement Period	30min	30min	30min	30min	30min	30min
Baseline Level	66.5					
L <sub>Aeq</sub>	64.8	67.5	65.4	64.8	66.6	64.8
L <sub>10</sub>	69.2	70.6	69.7	65.2	69.7	66.6
L <sub>90</sub>	59.3	60.5	60.2	59.9	61.2	60.7

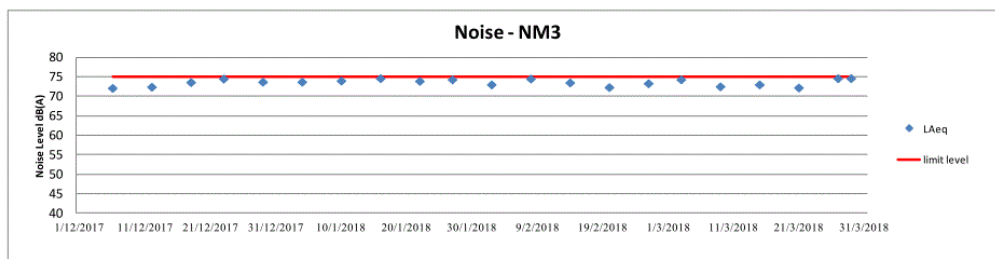
Noise Monitoring Result for NM3

Location	NM3					
Date	3/3/2018	9/3/2018	15/3/2018	21/3/2018	27/3/2018	29/3/2018
Weather Condition	Overcast	Sunny	Sunny	Sunny	Sunny	Overcast
Start Time	11:00	11:00	11:00	11:00	14:38	16:17
Measurement Period	30min	30min	30min	30min	30min	30min
Baseline Level	74.5					
L <sub>Aeq</sub>	74.4	72.6	73.1	72.3	74.7	74.7
L <sub>10</sub>	76.4	74.8	75.7	74.6	77.5	77.7
L <sub>90</sub>	70.3	70.1	69.9	68.4	69.9	68.9

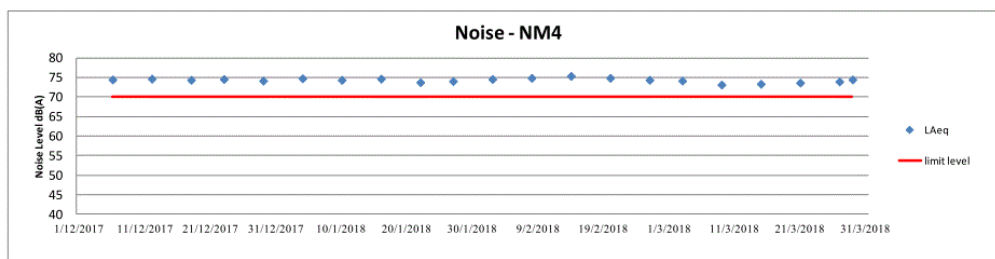
Noise Monitoring Result for NM4

The noise source for causing exceedances at NM4 was from the traffic of Canton Road. The NM4 was directly affected by the noise generated from the traffic. The recorded monitoring results at the NM4 were near the baseline noise level. The exceedances were not caused by the construction works of this project.

Location	NM4						NM4 (Re-measurement) *					
Date	3/3/2018	9/3/2018	15/3/2018	21/3/2018	27/3/2018	29/3/2018	3/3/2018	9/3/2018	15/3/2018	21/3/2018	27/3/2018	29/3/2018
Weather Condition	Overcast	Sunny	Sunny	Sunny	Sunny	Overcast	Overcast	Sunny	Sunny	Sunny	Sunny	Overcast
Start Time	13:00	13:00	13:00	13:00	13:00	13:00	13:31	13:31	13:31	13:31	13:31	13:31
Measurement Period	30min	30min	30min	30min	30min	30min	30min	30min	30min	30min	30min	30min
Baseline Level	73.3						73.3					
L <sub>Aeq</sub>	74.3	73.3	73.5	73.8	74.1	74.6	73.9	73.5	73.2	74.0	74.8	74.4
L <sub>10</sub>	77.8	76.9	77.0	77.4	76.9	78.1	77.7	77.0	77.3	78.0	77.2	78.3
L <sub>90</sub>	66.9	68.0	70.1	70.2	69.9	71.1	68.8	69.7	68.1	67.1	69.9	70.1

\* Repeat noise measurement when exceedance is recorded. The result is used to confirm the findings and it would not be showed on the graph plot

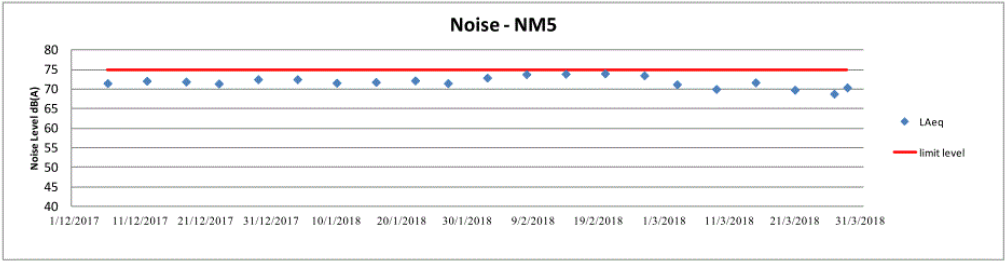
Noise Monitoring Result for NM5

Location	NM5					
Date	3/3/2018	9/3/2018	15/3/2018	21/3/2018	27/3/2018	29/3/2018
Weather Condition	Overcast	Sunny	Sunny	Sunny	Sunny	Overcast
Start Time	14:45	16:55	14:27	13:57	14:45	14:37
Measurement Period	30min	30min	30min	30min	30min	30min
Baseline Level	71.8					
L <sub>Aeq</sub>	71.2	70.0	71.7	69.8	68.8	70.4
L <sub>10</sub>	73.2	71.9	74.0	70.9	71.3	72.9
L <sub>90</sub>	68.7	68.1	69.3	67.2	65.0	67.6
