Proposed Road Improvement Works in West Kowloon Reclamation Development – Phase 1

Environmental Monitoring & Audit Report

01/11/2018 – 30/11/2018

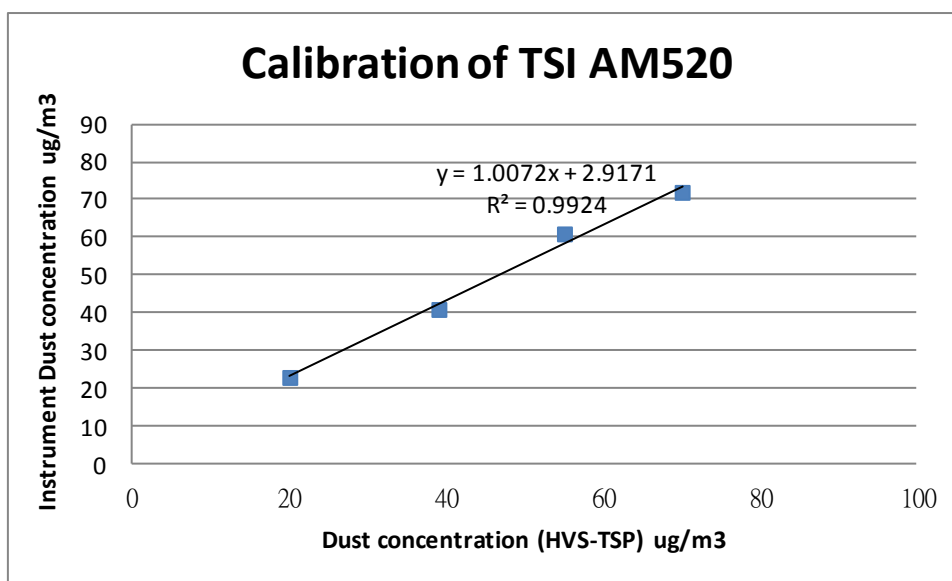
Calibration Record

HVS - TSP	20	39	55	70
TSI AM520	23	41	61	72

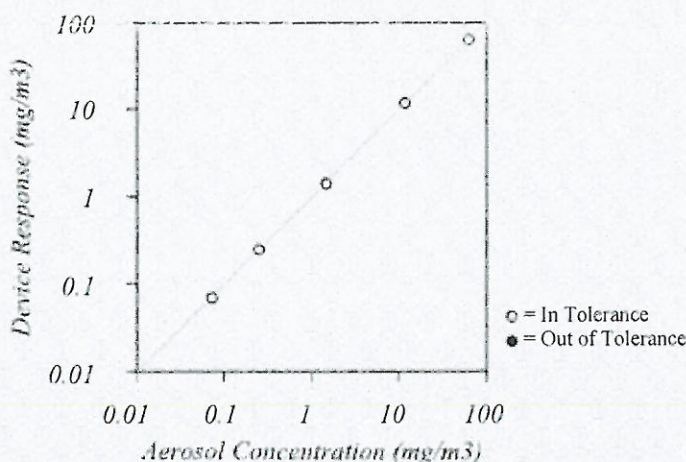
Concentration Linearity Plot

CONCENTRATION				Unit: mg/m ³			
#	STANDARD	MEASURED	ALLOWABLE RANGE	#	STANDARD	MEASURED	ALLOWABLE RANGE
1	0.072	0.070	0.050~0.094	4	11.745	11.612	10.571~12.919
2	0.250	0.246	0.213~0.287	5	63.293	63.376	56.964~69.622
3	1.468	1.403	1.321~1.615

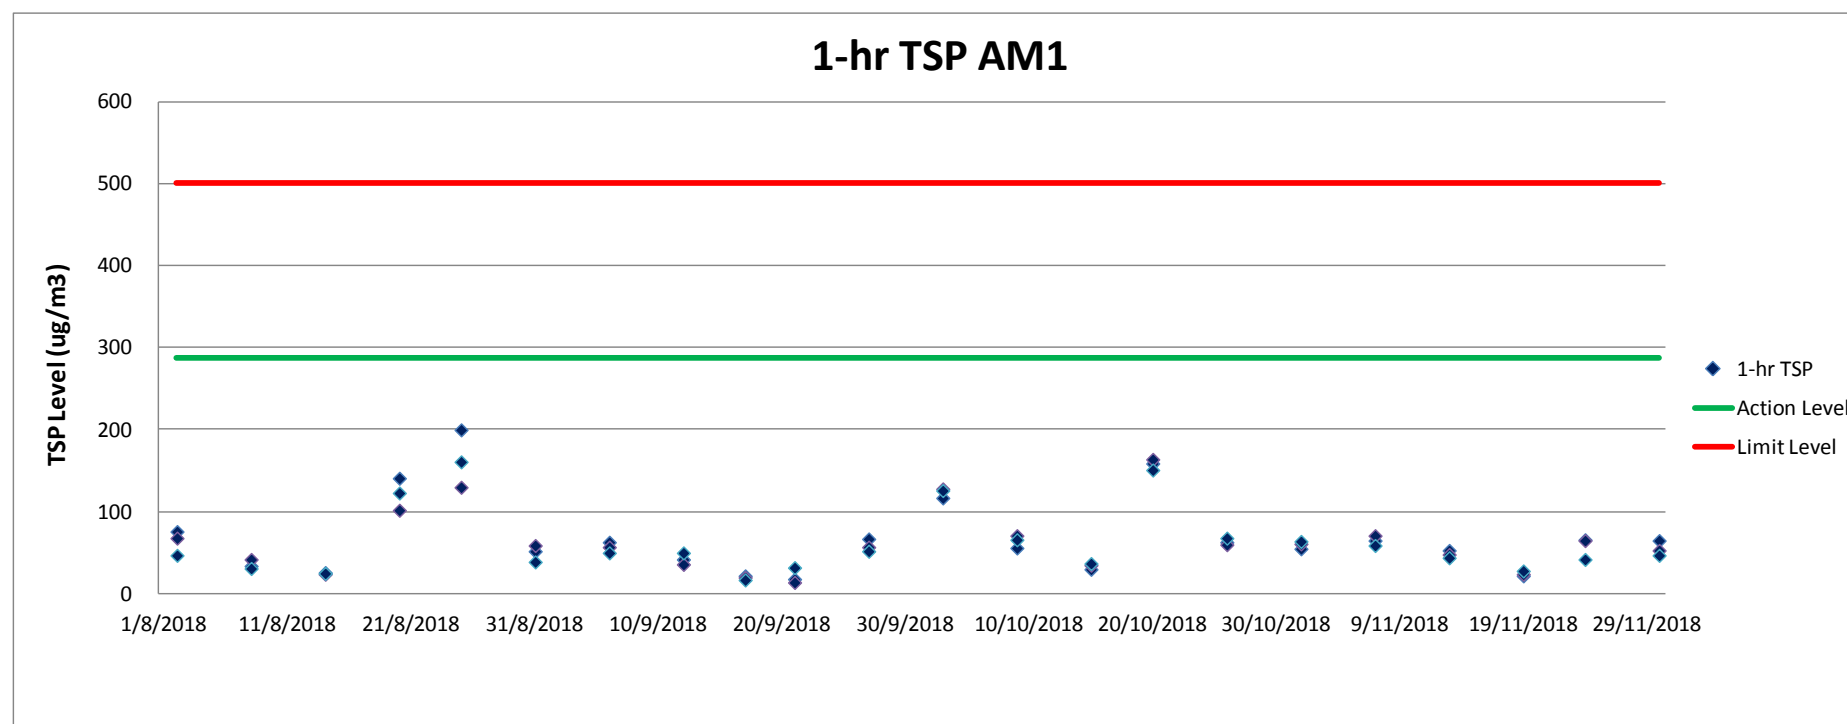
Date	Weather	Temperature (°C) *	Wind Direction *	Wind Speed (m/s) *	Sampling Time			Reading (µg/m ³)			
					1	2	3	1	2	3	Average
1/11/2018	Sunny	21.9 - 27.0	N	<5m/s	13:00	14:01	15:02	55	61	64	60
7/11/2018	Sunny	23.0 - 28.0	E	<5m/s	13:07	14:08	15:09	65	71	59	65
13/11/2018	Sunny	22.6 - 26.9	E	<5m/s	13:10	14:11	15:12	53	48	44	48
19/11/2018	Sunny	21.3 - 27.1	E	<5m/s	9:15	10:16	11:17	22	24	28	25
24/11/2018	Overcast	19.8 - 23.2	E	<5m/s	14:05	15:06	16:07	66	65	42	58
30/11/2018	Sunny	19.3 - 23.4	E	<5m/s	13:00	14:01	15:02	65	53	47	55

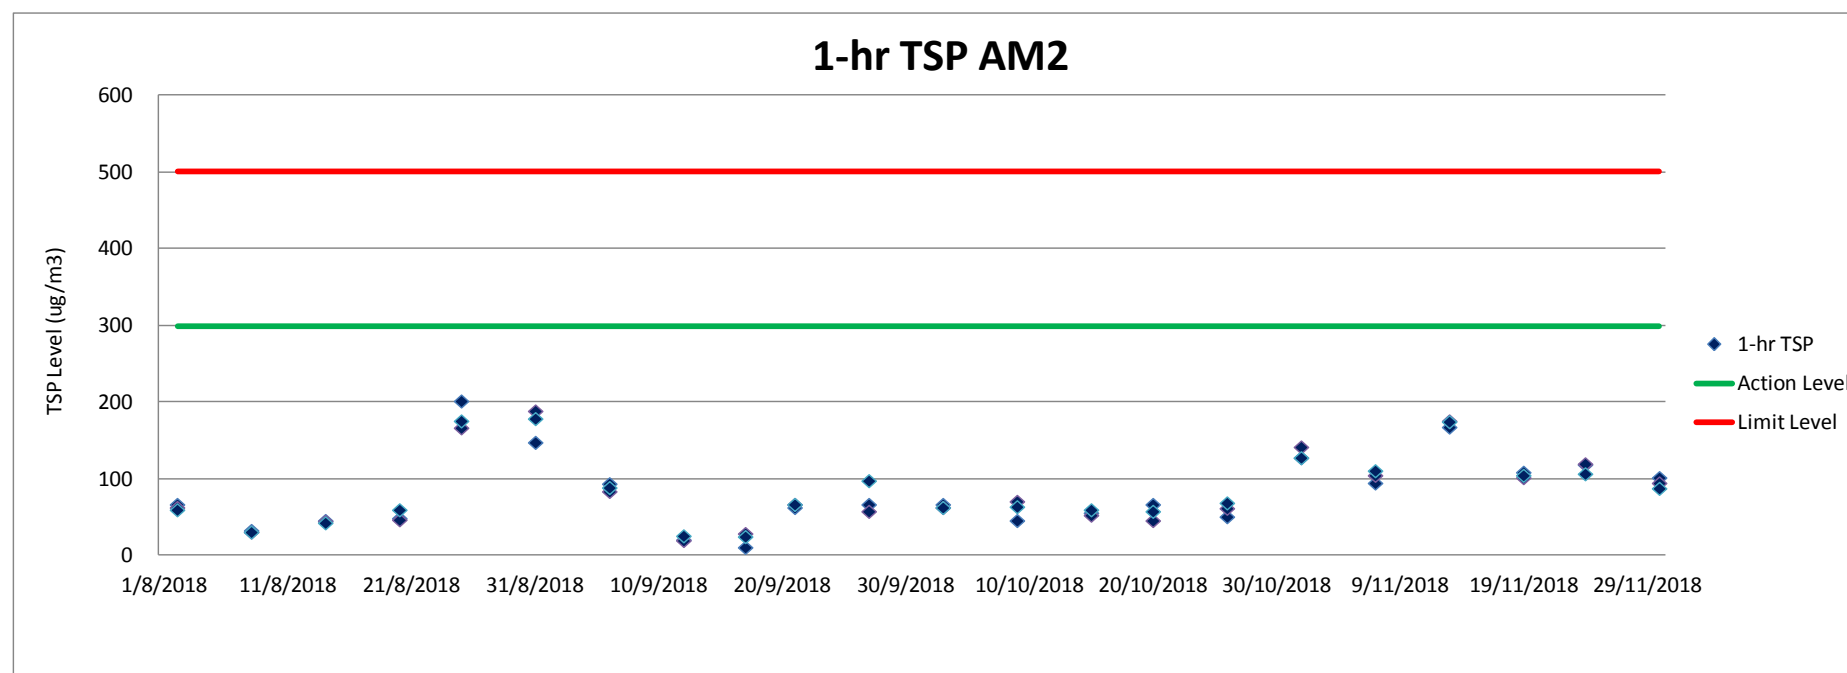
1-hr TSP Monitoring Result for AM2

Date	Weather	Temperature (°C) *	Wind Direction *	Wind Speed (m/s) *	Sampling Time			Reading (µg/m ³)			
					1	2	3	1	2	3	Average
1/11/2018	Sunny	21.9 - 27.0	N	<5m/s	10:42	11:43	12:44	127	141	127	132
7/11/2018	Sunny	23.0 - 28.0	E	<5m/s	10:43	11:44	12:45	94	104	110	103
13/11/2018	Sunny	22.6 - 26.9	E	<5m/s	10:10	11:11	12:12	167	175	174	172
19/11/2018	Sunny	21.3 - 27.1	E	<5m/s	10:19	11:20	12:21	108	101	104	104
24/11/2018	Overcast	19.8 - 23.2	E	<5m/s	9:59	11:00	12:01	118	119	106	114
30/11/2018	Sunny	19.3 - 23.4	E	<5m/s	10:06	11:07	12:08	101	94	87	94

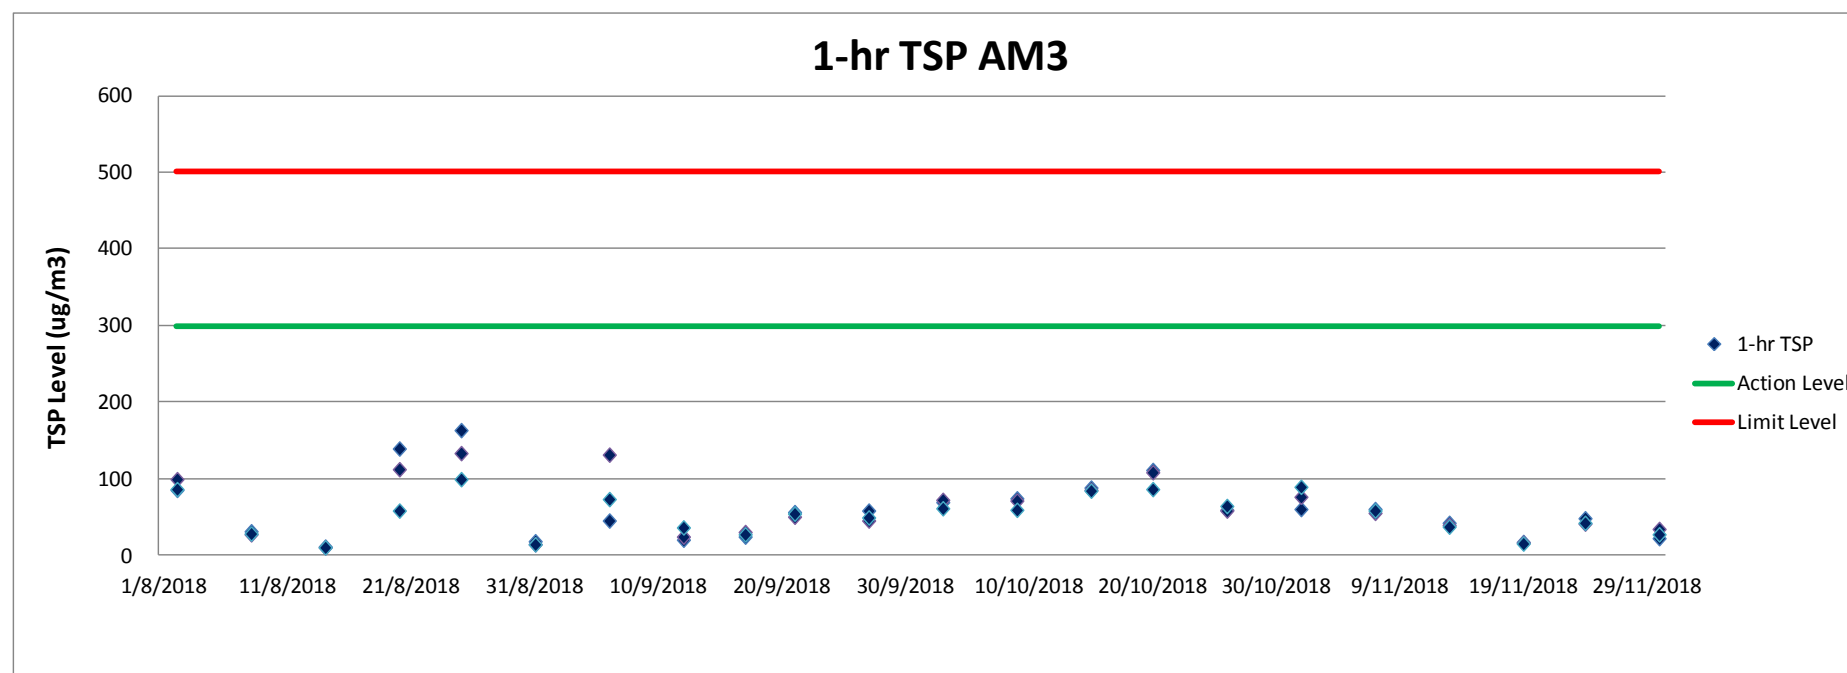
1-hr TSP Monitoring Result for AM3

Date	Weather	Temperature (°C) *	Wind Direction *	Wind Speed (m/s) *	Sampling Time			Reading (µg/m ³)			
					1	2	3	1	2	3	Average
1/11/2018	Sunny	21.9 - 27.0	N	<5m/s	13:05	14:06	15:07	60	76	89	75
7/11/2018	Sunny	23.0 - 28.0	E	<5m/s	13:12	14:13	15:14	60	55	58	58
13/11/2018	Sunny	22.6 - 26.9	E	<5m/s	13:05	14:06	15:07	42	39	37	39
19/11/2018	Sunny	21.3 - 27.1	E	<5m/s	9:49	10:50	11:51	17	16	15	16
24/11/2018	Overcast	19.8 - 23.2	E	<5m/s	13:38	14:39	15:40	48	41	42	44
30/11/2018	Sunny	19.3 - 23.4	E	<5m/s	13:20	14:21	15:22	22	34	27	28

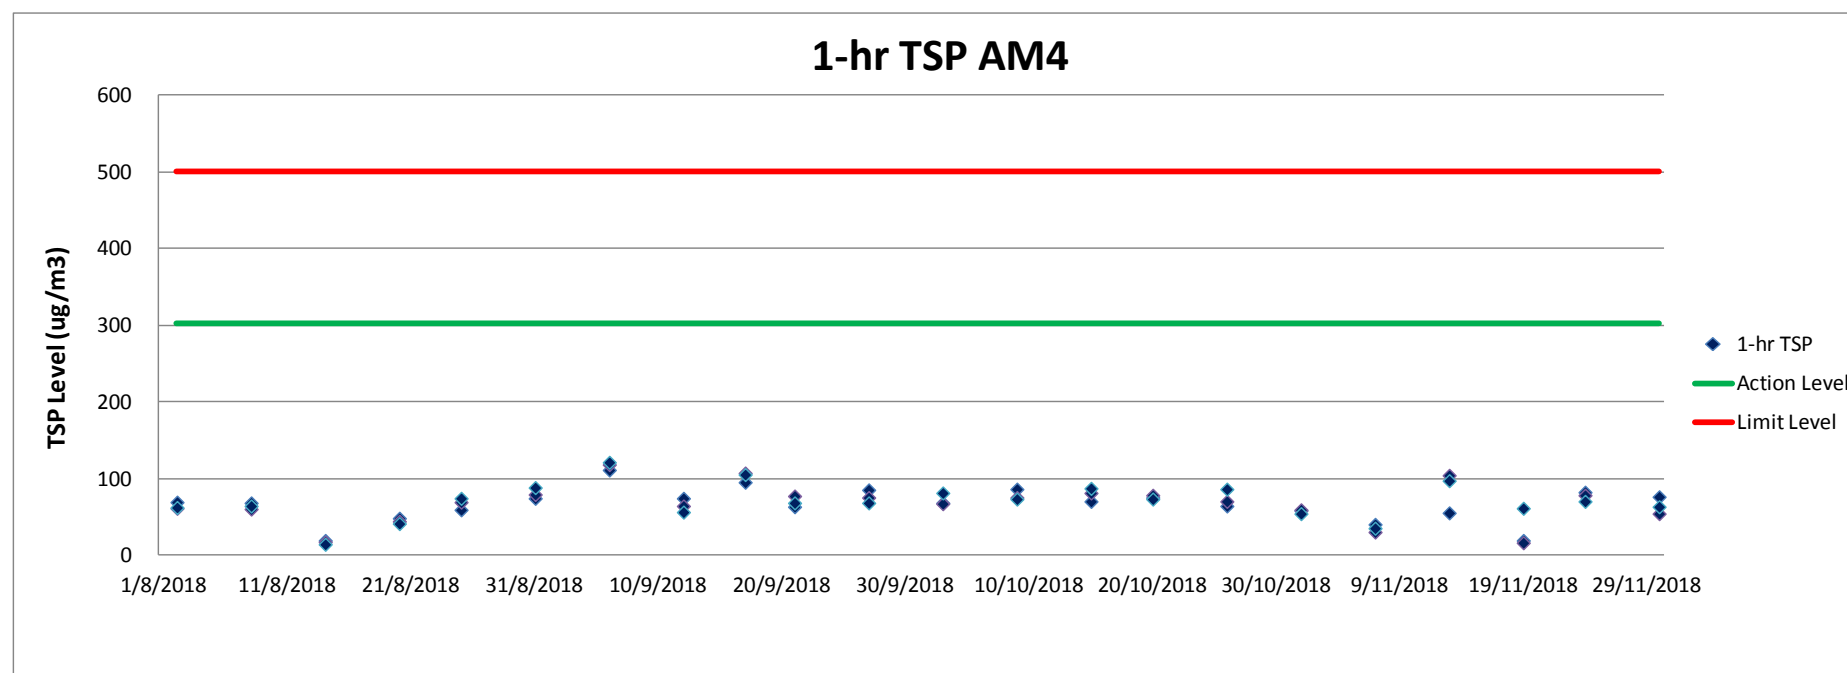
1-hr TSP Monitoring Result for AM4

Date	Weather	Temperature (°C) *	Wind Direction *	Wind Speed (m/s) *	Sampling Time			Reading (µg/m ³)			
					1	2	3	1	2	3	Average
1/11/2018	Sunny	21.9 - 27.0	N	<5m/s	9:55	10:56	11:57	58	59	54	57
7/11/2018	Sunny	23.0 - 28.0	E	<5m/s	9:59	11:00	12:01	40	30	35	35
13/11/2018	Sunny	22.6 - 26.9	E	<5m/s	10:01	11:02	12:03	55	104	97	85
19/11/2018	Sunny	21.3 - 27.1	E	<5m/s	10:05	11:06	12:07	19	16	61	32
24/11/2018	Overcast	19.8 - 23.2	E	<5m/s	10:35	11:36	12:37	82	78	70	77
30/11/2018	Sunny	19.3 - 23.4	E	<5m/s	10:20	11:21	12:22	76	54	63	64

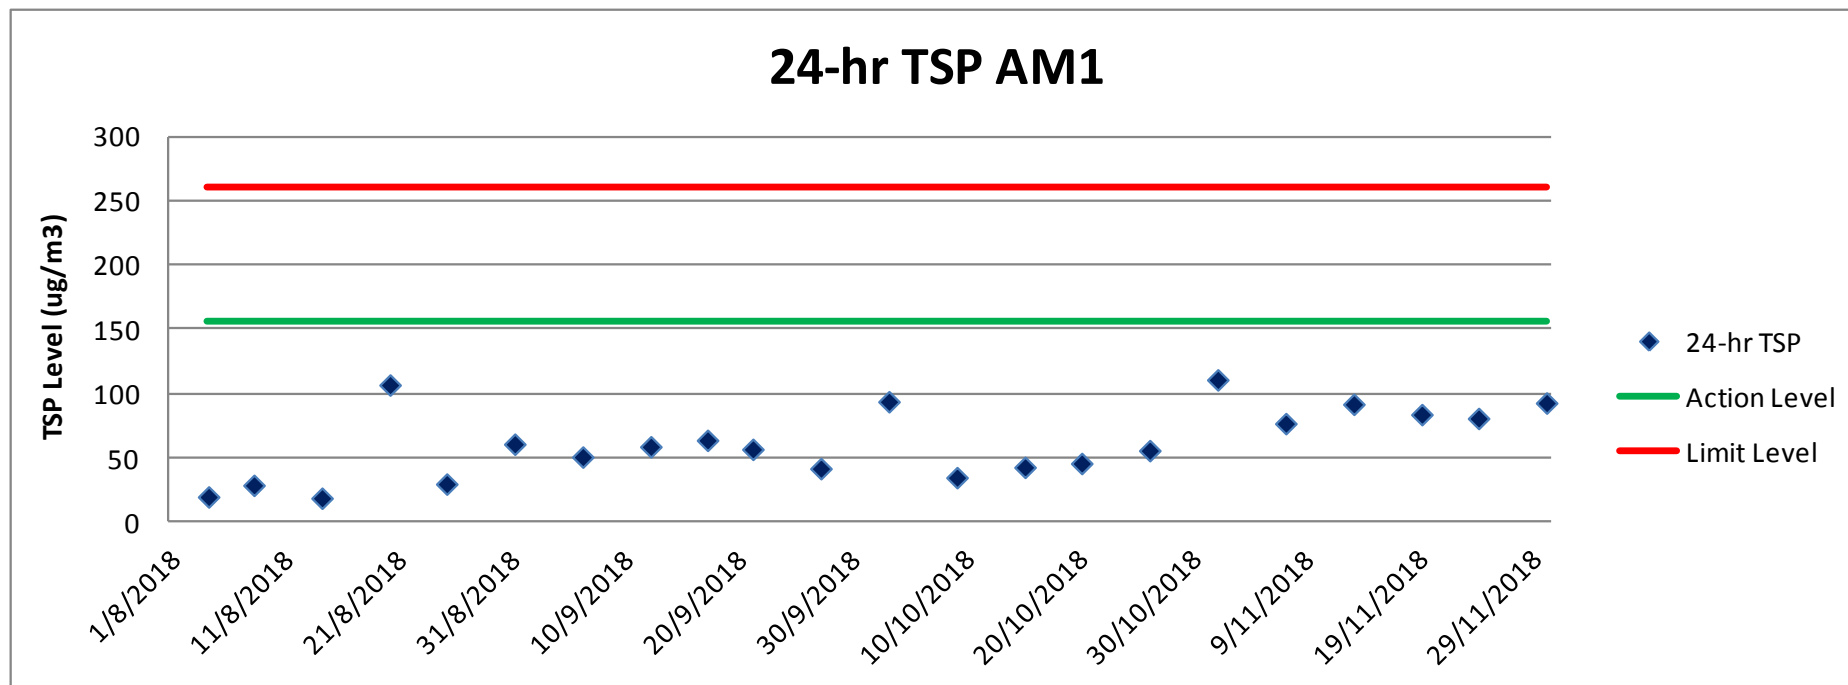
24-hr TSP Monitoring Result for AM1

Sampling ID & Paper No.	Temperature (°C) * ¹	Wind Direction * ¹	Wind Speed (m/s) * ¹	Sampling Date	Wt. of paper (g)			Flow Rate (CFM)	Total Volume * ² (m ³)	TSP Concentration (µg/m ³)
					Initial Wt.	Final Wt.	Wt. of dust			
AM11101 205456	21.9 - 27.0	N	<5m/s	1/11/2018	2.6728	2.8918	0.2190	50.0	1978.39	111
AM11107 206468	23.0 - 28.0	E	<5m/s	7/11/2018	2.6945	2.8474	0.1529	50.0	1978.39	77
AM11113 205494	22.6 - 26.9	E	<5m/s	13/11/2018	2.6527	2.8345	0.1818	50.0	1978.39	92
AM11119 205397	21.3 - 27.1	E	<5m/s	19/11/2018	2.6665	2.8318	0.1653	50.0	1978.39	84
AM11124 295451	19.8 - 23.2	E	<5m/s	24/11/2018	2.6632	2.8230	0.1598	50.0	1978.39	81
AM11130 205452	19.3 - 23.4	E	<5m/s	30/11/2018	2.6933	2.8767	0.1834	50.0	1978.39	93

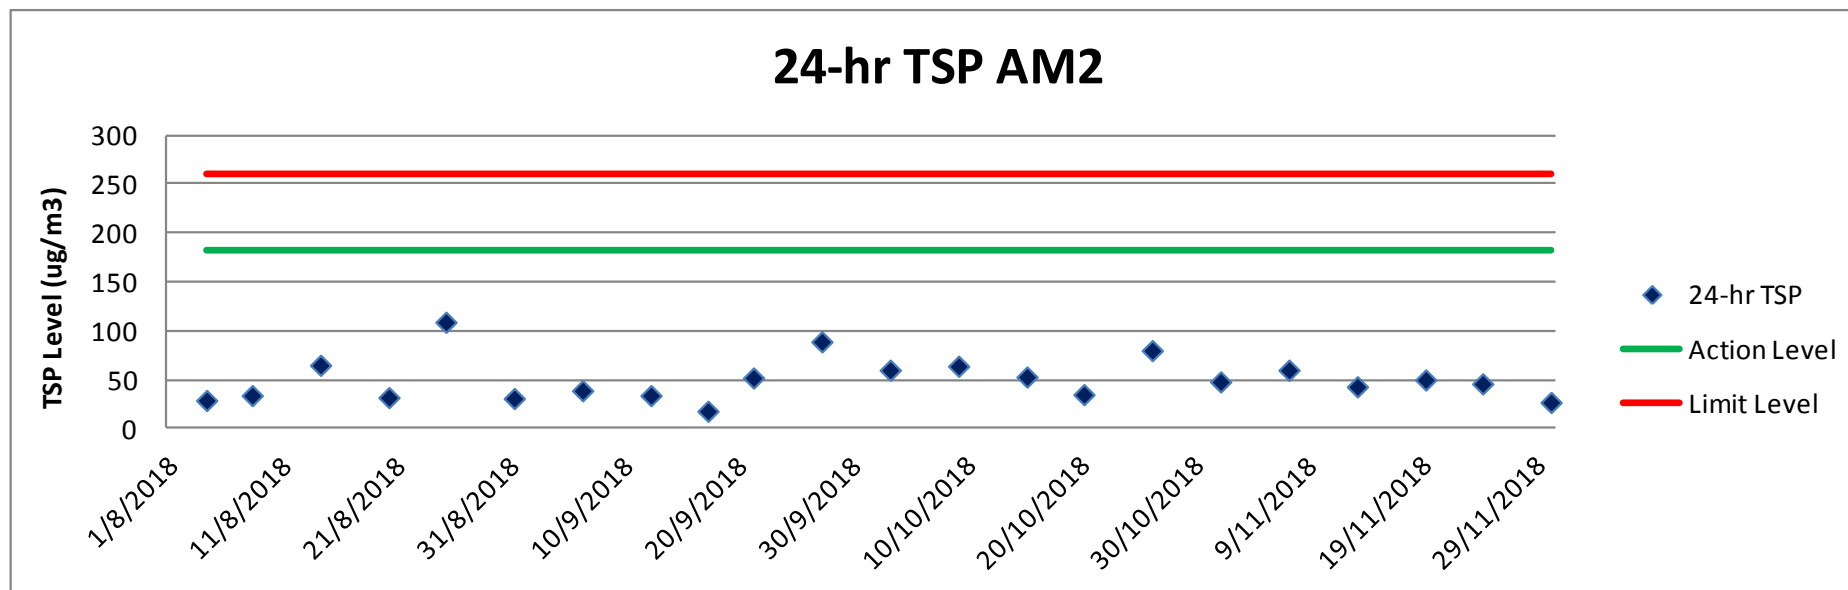
24-hr TSP Monitoring Result for AM2

Sampling ID & Paper No.	Temperature (°C) * ¹	Wind Direction * ¹	Wind Speed (m/s) * ¹	Sampling Date	Wt. of paper (g)			Flow Rate (CFM)	Total Volume * ² (m ³)	TSP Concentration (µg/m ³)
					Initial Wt.	Final Wt.	Wt. of dust			
AM21101 205495	21.9 - 27.0	N	<5m/s	1/11/2018	2.6467	2.7423	0.0956	50.0	2011.93	48
AM21107 205493	23.0 - 28.0	E	<5m/s	7/11/2018	2.6555	2.7755	0.1200	50.0	2011.93	60
AM21113 205492	22.6 - 26.9	E	<5m/s	13/11/2018	2.6563	2.7430	0.0867	50.0	2011.93	43
AM21119 205475	21.3 - 27.1	E	<5m/s	19/11/2018	2.6710	2.7717	0.1007	50.0	2011.93	50
AM21124 205476	19.8 - 23.2	E	<5m/s	24/11/2018	2.6831	2.7753	0.0922	50.0	2011.93	46
AM21130 206465	19.3 - 23.4	E	<5m/s	30/11/2018	2.6864	2.7414	0.0550	50.0	2011.93	27

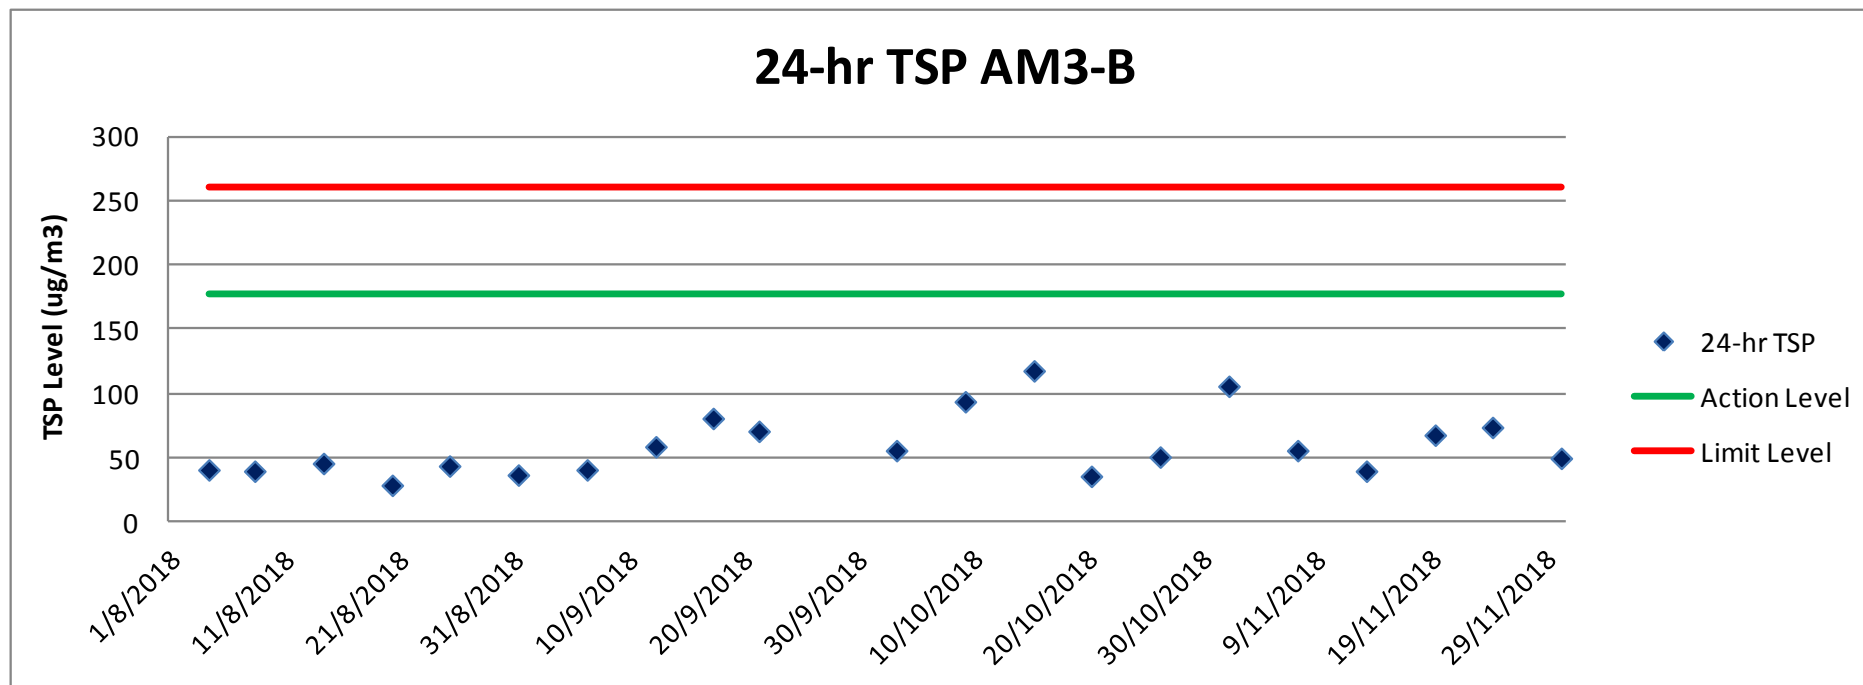
24-hr TSP Monitoring Result for AM3-B

Sampling ID & Paper No.	Temperature (°C) * ¹	Wind Direction * ¹	Wind Speed (m/s) * ¹	Sampling Date	Wt. of paper (g)			Flow Rate (CFM)	Total Volume * ² (m ³)	TSP Concentration (µg/m ³) * ³
					Initial Wt.	Final Wt.	Wt. of dust			
AM3-B1101 205487	21.9 - 27.0	N	<5m/s	1/11/2018	2.6563	2.9024	0.2461	60.0	2322.54	106
AM3-B1107 205480	23.0 - 28.0	E	<5m/s	7/11/2018	2.6832	2.8144	0.1312	60.0	2322.54	56
AM3-B1113 205474	22.6 - 26.9	E	<5m/s	13/11/2018	2.6715	2.7641	0.0926	60.0	2322.54	40
AM3-B1119 205455	21.3 - 27.1	E	<5m/s	19/11/2018	2.6789	2.8378	0.1589	60.0	2322.54	68
AM3-B1124 205453	19.8 - 23.2	E	<5m/s	24/11/2018	2.6826	2.8543	0.1717	60.0	2322.54	74
AM3-B1130 206550	19.3 - 23.4	E	<5m/s	30/11/2018	2.6814	2.7968	0.1154	60.0	2322.54	50

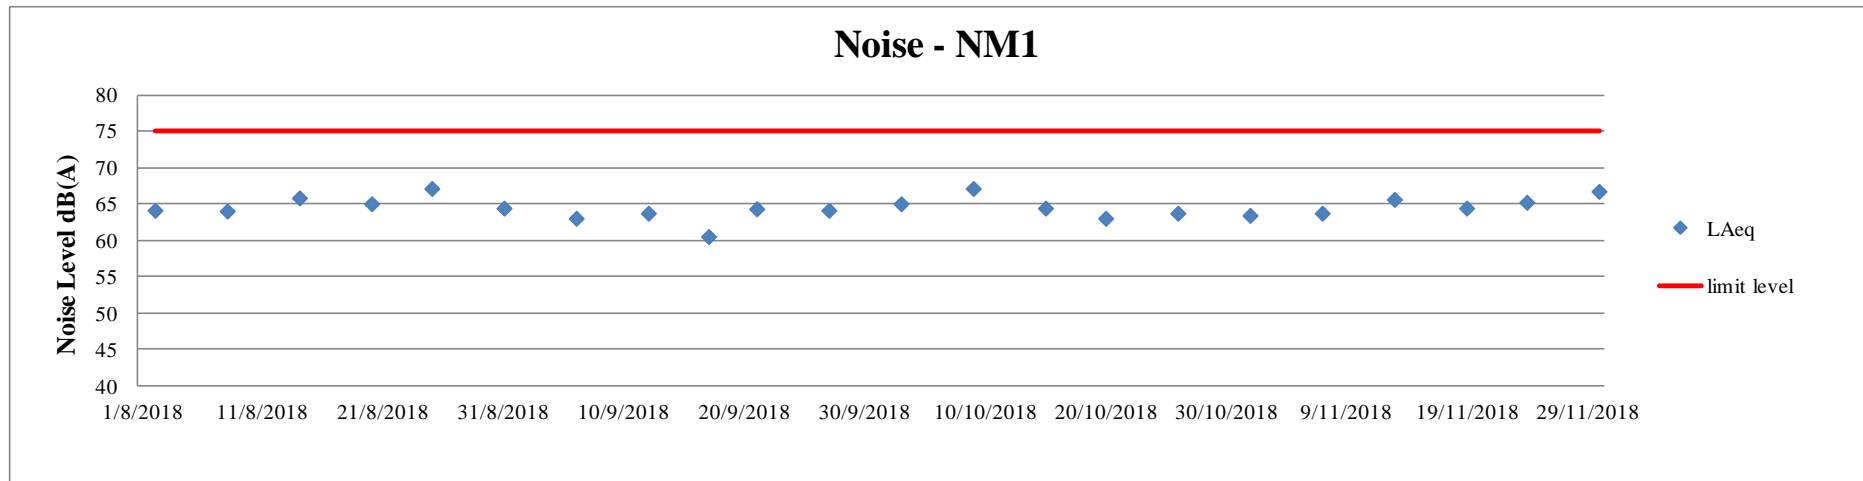
Noise Monitoring Result for NM1

Location	NM1					
Date	1/11/2018	7/11/2018	13/11/2018	19/11/2018	24/11/2018	30/11/2018
Weather Condition	Sunny	Sunny	Sunny	Sunny	Overcast	Sunny
Start Time	13:00	11:00	12:00	11:00	14:00	14:20
Measurement Period	30min	30min	30min	30min	30min	30min
Baseline Level	75.1					
L _{Aeq}	63.5	63.8	65.7	64.5	65.3	66.8
L ₁₀	65.5	65.8	68.2	65.9	67.7	69.2
L ₉₀	60.9	61.3	62.5	62.1	61.6	61.7

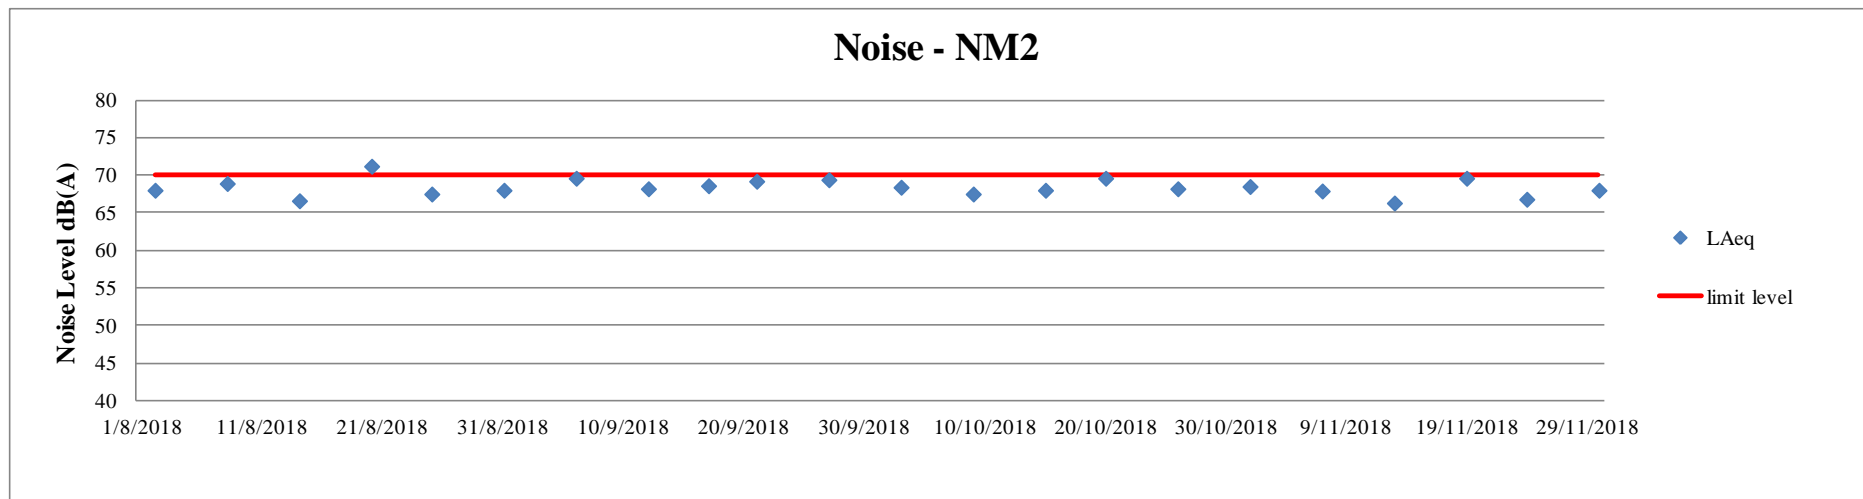
Noise Monitoring Result for NM2

Location	NM2						NM2(Re-measurement)
Date	1/11/2018	7/11/2018	13/11/2018	19/11/2018	24/11/2018	30/11/2018	13/11/2018
Weather Condition	Sunny	Sunny	Sunny	Sunny	Overcast	Sunny	Sunny
Start Time	9:00	9:00	9:00	9:00	9:00	9:00	9:30
Measurement Period	30min	30min	30min	30min	30min	30min	30min
Baseline Level	66.5						66.5
L _{Aeq}	68.5	67.9	66.3	69.6	66.8	68.0	66.9
L ₁₀	70.0	72.0	70.2	72.6	70.2	69.9	70.5
L ₉₀	63.4	62.9	61.4	64.0	61.1	63.0	61.7

The noise source for causing exceedance at NM2 during examination period was from other construction site, Design and Construction of West Kowloon Government Offices (DCWKGO), which located at No.11 Hoi Ting Road. The construction site of DCWKGO is located between Portion J and the NM2 and close to the NM2. There is no noisy work has been carried out in Portion J during this reporting period. The NM2 was directly affected by the noise generated from the construction site of DCWKGO. The exceedance was not caused by the construction works of this project.

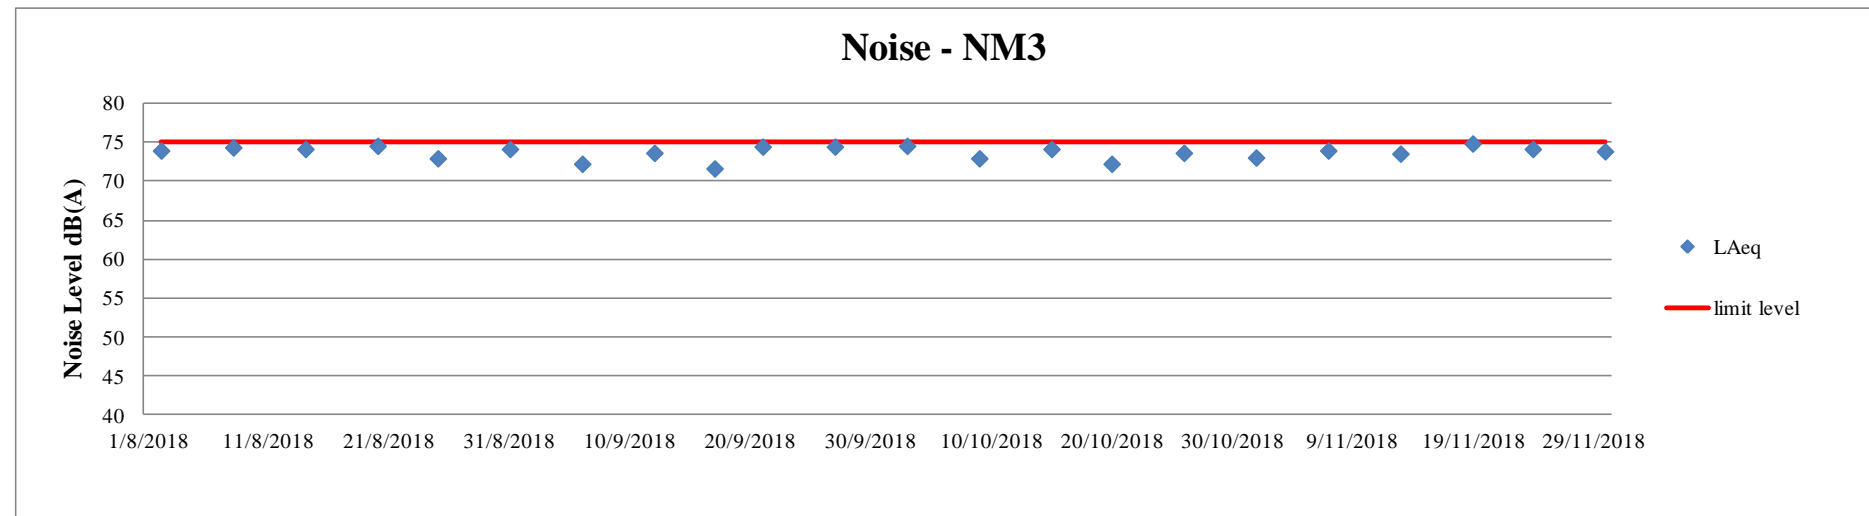
Noise Monitoring Result for NM3

Location	NM3					
Date	1/11/2018	7/11/2018	13/11/2018	19/11/2018	24/11/2018	30/11/2018
Weather Condition	Sunny	Sunny	Sunny	Sunny	Overcast	Sunny
Start Time	13:45	10:00	11:00	10:05	13:00	13:30
Measurement Period	30min	30min	30min	30min	30min	30min
Baseline Level	74.5					
L _{Aeq}	73.0	73.9	73.5	74.8	74.1	73.8
L ₁₀	75.8	76.5	76.2	77.7	76.2	76.7
L ₉₀	68.8	69.2	69.0	69.1	69.4	69.5

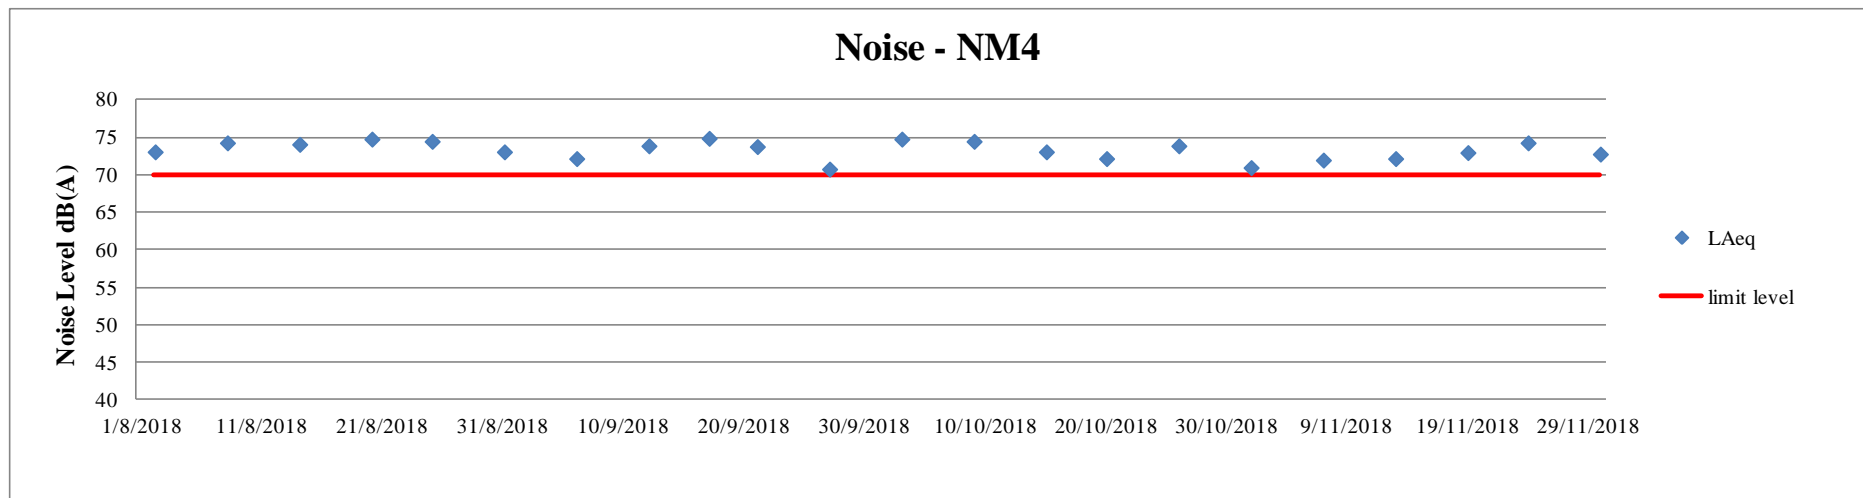
Noise Monitoring Result for NM4

Location	NM4						NM4 (Re-measurement) *					
Date	1/11/2018	7/11/2018	13/11/2018	19/11/2018	24/11/2018	30/11/2018	1/11/2018	7/11/2018	13/11/2018	19/11/2018	24/11/2018	30/11/2018
Weather Condition	Sunny	Sunny	Sunny	Sunny	Overcast	Sunny	Sunny	Sunny	Sunny	Sunny	Overcast	Sunny
Start Time	13:00	13:00	13:00	13:00	10:10	11:00	13:30	13:30	13:30	13:30	10:40	11:30
Measurement Period	30min	30min	30min	30min	30min	30min	30min	30min	30min	30min	30min	30min
Baseline Level	73.3						73.3					
L _{Aeq}	71.0	72.0	72.2	73.0	74.3	72.8	72.1	72.8	72.7	74.4	75.0	72.1
L ₁₀	73.9	75.1	75.4	75.9	77.4	75.4	74.4	75.4	75.1	76.0	77.4	74.7
L ₉₀	64.5	63.4	65.6	65.9	68.3	67.1	64.8	64.4	65.3	66.2	68.2	65.6

* Repeat noise measurement when exceedance is recorded. The result is used to confirm the findings and it would not be showed on the graph plot

The noise source for causing exceedances at NM4 was from the traffic of Canton Road. The NM4 was directly affected by the noise generated from the traffic. The recorded monitoring results at the NM4 were near the baseline noise level. The exceedances were not caused by the construction works of this project.

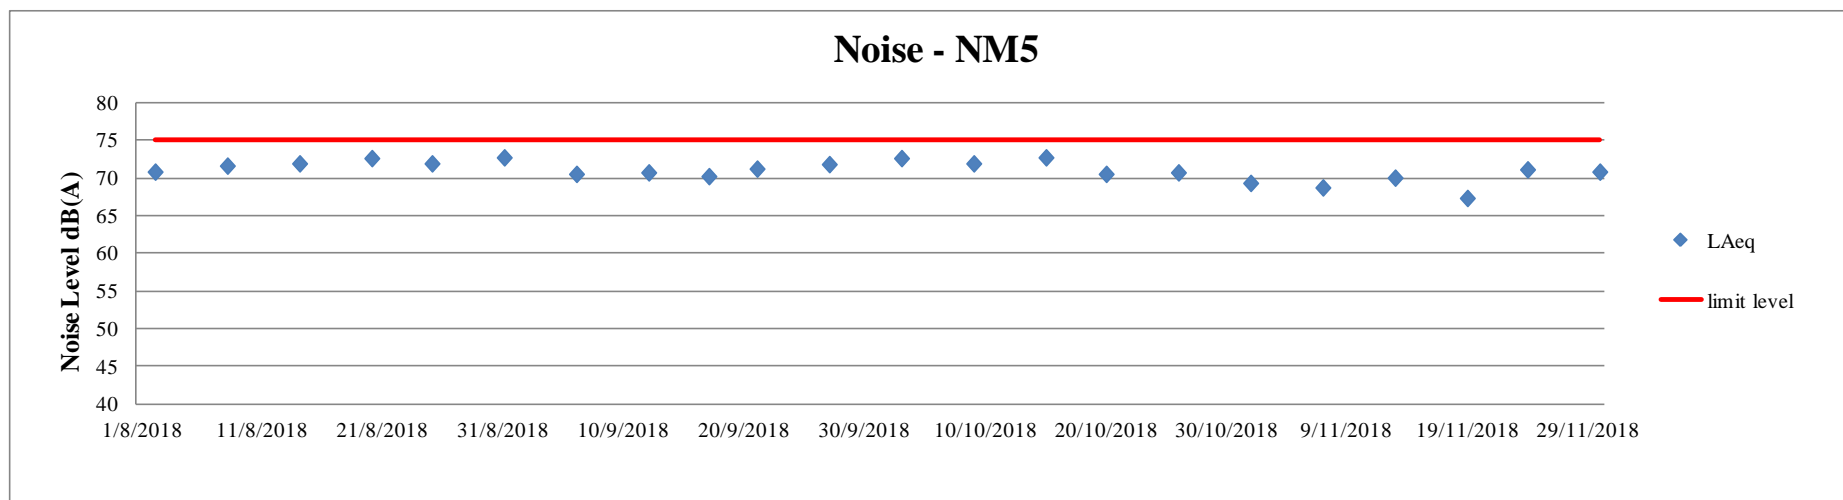
Noise Monitoring Result for NM5

Location	NM5					
Date	1/11/2018	7/11/2018	13/11/2018	19/11/2018	24/11/2018	30/11/2018
Weather Condition	Sunny	Sunny	Sunny	Sunny	Overcast	Sunny
Start Time	15:00	15:00	15:00	15:00	15:00	13:01
Measurement Period	30min	30min	30min	30min	30min	30min
Baseline Level	71.8					
L _{Aeq}	69.3	68.7	70.0	67.3	71.1	70.8
L ₁₀	71.1	72.5	73.1	69.3	74.1	73.8
L ₉₀	63.2	62.8	64.1	64.0	65.0	65.5
