Proposed Road Improvement Works in West Kowloon Reclamation Development – Phase 1

Environmental Monitoring & Audit Report

01/12/2018 – 31/12/2018

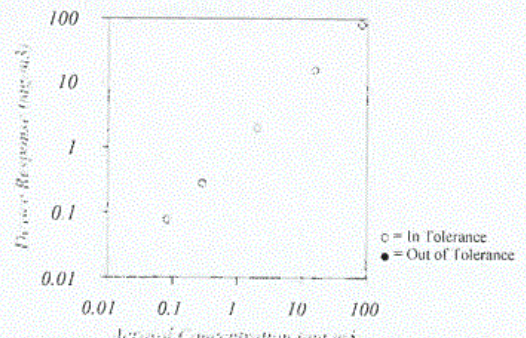
Concentration Linearity Plot

CONCENTRATION				Unit: mg/m³			
#	STANDARD	MEASURED	ALLOWABLE RANGE	#	STANDARD	MEASURED	ALLOWABLE RANGE
1	0.080	0.076	0.056~0.104	4	15.536	15.495	13.982~17.090
2	0.283	0.281	0.241~0.325	5	82.272	81.134	74.045~90.499
3	2.012	1.983	1.811~2.213

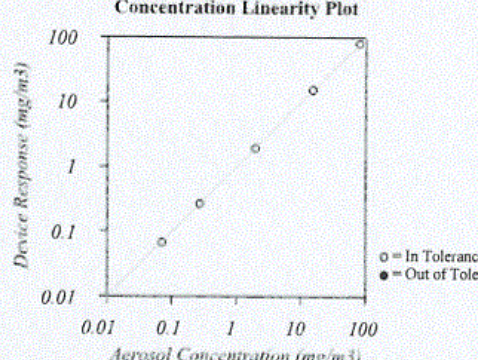
Concentration Linearity Plot

CONCENTRATION				Unit: mg/m ³			
#	STANDARD	MEASURED	ALLOWABLE RANGE	#	STANDARD	MEASURED	ALLOWABLE RANGE
1	0.071	0.068	0.050–0.092	4	15.159	15.063	13.643–16.675
2	0.269	0.265	0.229–0.309	5	80.323	78.980	72.291–88.355
3	1.944	1.894	1.750–2.138

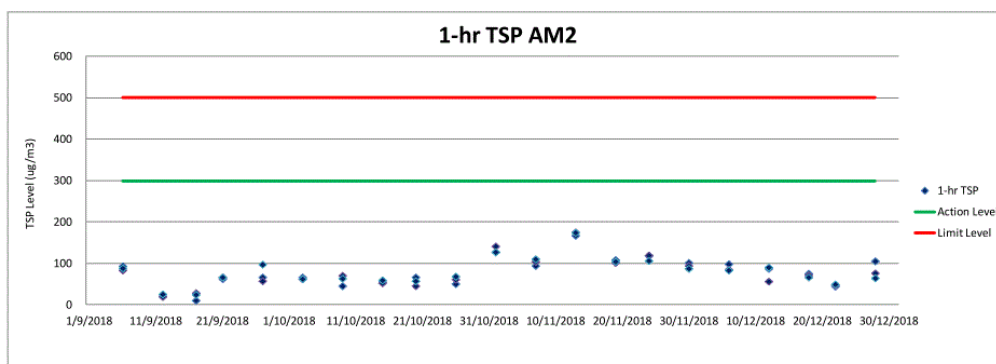
1-hr TSP Monitoring Result for AM2

Date	Weather	Temperature (°C) *	Wind Direction *	Wind Speed (m/s) *	Sampling Time			Reading (µg/m³)			
					1	2	3	1	2	3	Average
6/12/2018	Cloudy	21.1 - 25.2	SE	<5m/s	10:35	11:36	12:37	98	85	83	89
12/12/2018	Cloudy	13.5 - 15.9	N	<5m/s	9:45	10:46	11:47	87	56	90	78
18/12/2018	Sunny	14.9 - 20.9	E	<5m/s	9:21	10:22	11:23	75	71	66	71
22/12/2018	Cloudy	19.0 - 26.0	E	<5m/s	11:34	12:35	13:36	44	47	49	47
28/12/2018	Cloudy	15.4 - 20.4	NE	<5m/s	9:15	10:16	11:17	105	76	64	82

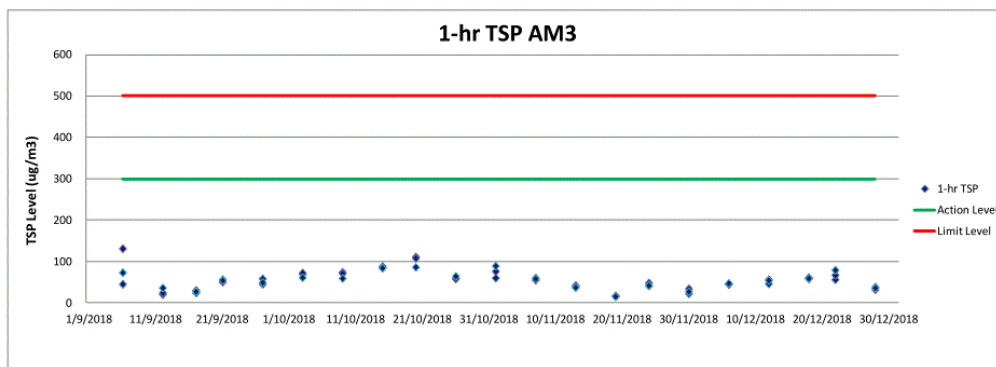
1-hr TSP Monitoring Result for AM3

Date	Weather	Temperature (°C) *	Wind Direction *	Wind Speed (m/s) *	Sampling Time			Reading (µg/m³)			
					1	2	3	1	2	3	Average
6/12/2018	Cloudy	21.1 - 25.2	SE	<5m/s	13:00	14:01	15:02	45	45	47	46
12/12/2018	Cloudy	13.5 - 15.9	N	<5m/s	13:00	14:01	15:02	46	56	54	52
18/12/2018	Sunny	14.9 - 20.9	E	<5m/s	13:00	14:01	15:02	61	58	59	59
22/12/2018	Cloudy	19.0 - 26.0	E	<5m/s	10:30	11:31	12:32	56	67	79	67
28/12/2018	Cloudy	15.4 - 20.4	NE	<5m/s	11:17	12:18	13:19	38	32	36	35

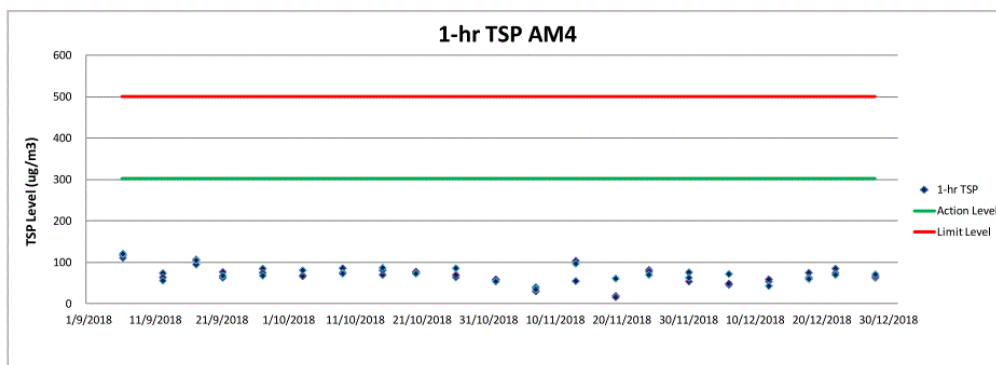
1-hr TSP Monitoring Result for AM4

Date	Weather	Temperature (°C) *	Wind Direction *	Wind Speed (m/s) *	Sampling Time			Reading (µg/m³)			
					1	2	3	1	2	3	Average
6/12/2018	Cloudy	21.1 - 25.2	SE	<5m/s	10:42	11:43	12:44	46	49	72	56
12/12/2018	Cloudy	13.5 - 15.9	N	<5m/s	9:35	10:36	11:37	54	59	43	52
18/12/2018	Sunny	14.9 - 20.9	E	<5m/s	9:16	10:17	11:18	75	63	60	66
22/12/2018	Cloudy	19.0 - 26.0	E	<5m/s	11:28	12:29	13:30	85	74	70	76
28/12/2018	Cloudy	15.4 - 20.4	NE	<5m/s	9:04	10:05	11:06	63	66	71	67

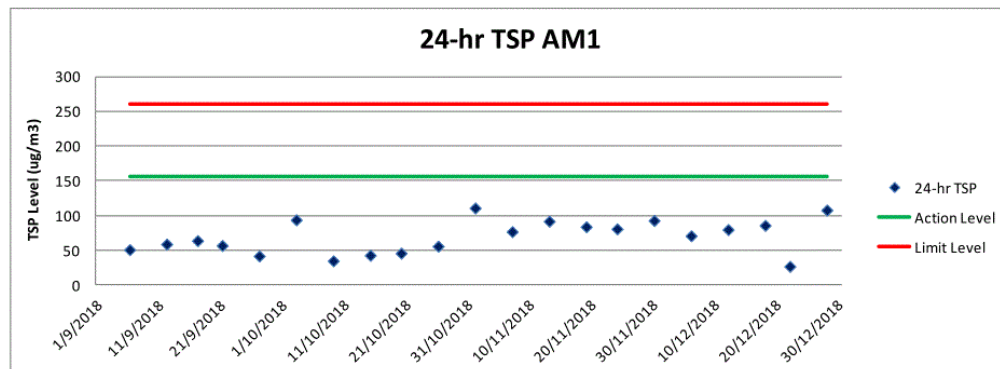
24-hr TSP Monitoring Result for AM1

Sampling ID & Paper No.	Temperature (°C) *1	Wind Direction *1	Wind Speed (m/s) *1	Sampling Date	Wt. of paper (g)			Flow Rate (CFM)	Total Volume *2 (m³)	TSP Concentration (µg/m³)
					Initial Wt.	Final Wt.	Wt. of dust			
AM11206 205481	21.1 - 25.2	SE	<5m/s	6/12/2018	2.6683	2.8121	0.1438	50.0	2011.64	71
AM11212 206560	13.5 - 15.9	N	<5m/s	12/12/2018	2.6886	2.8489	0.1603	50.0	2011.64	80
AM11218 206552	14.9 - 20.9	E	<5m/s	18/12/2018	2.6711	2.8442	0.1731	50.0	2011.64	86
AM11222 205489	19.0 - 26.0	E	<5m/s	22/12/2018	2.6622	2.7172	0.0550	50.0	2011.64	27
AM11228 206556	15.4 - 20.4	NE	<5m/s	28/12/2018	2.6812	2.8983	0.2171	50.0	2011.64	108

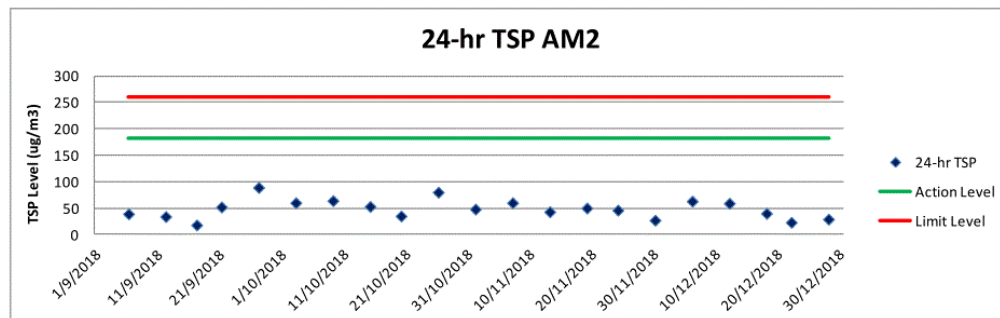
24-hr TSP Monitoring Result for AM2

Sampling ID & Paper No.	Temperature (°C) *1	Wind Direction *1	Wind Speed (m/s) *1	Sampling Date	Wt. of paper (g)			Flow Rate (CFM)	Total Volume *2 (m³)	TSP Concentration (µg/m³)
					Initial Wt.	Final Wt.	Wt. of dust			
AM21101 205495	21.1 - 25.2	SE	<5m/s	6/12/2018	2.6746	2.7973	0.1227	50.0	1952.96	63
AM21107 205493	13.5 - 15.9	N	<5m/s	12/12/2018	2.6980	2.8137	0.1157	50.0	1952.96	59
AM21113 205492	14.9 - 20.9	E	<5m/s	18/12/2018	2.6703	2.7487	0.0784	50.0	1952.96	40
AM21119 205475	19.0 - 26.0	E	<5m/s	22/12/2018	2.6814	2.7271	0.0457	50.0	1952.96	23
AM21124 205476	15.4 - 20.4	NE	<5m/s	28/12/2018	2.6900	2.7457	0.0557	50.0	1952.96	29

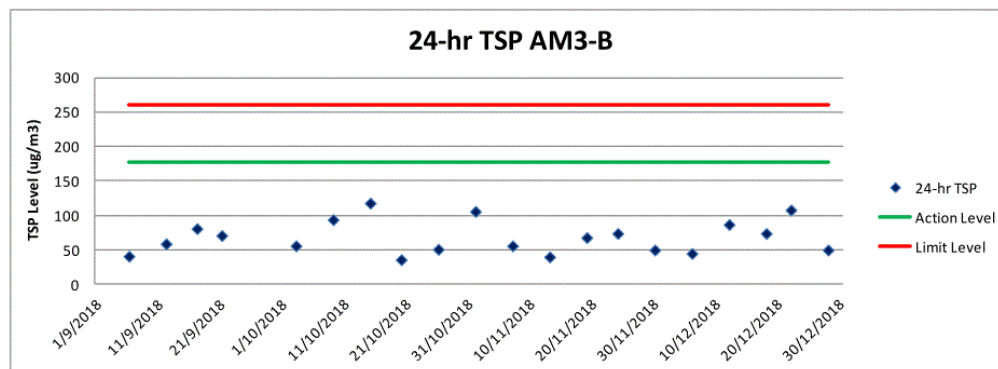
24-hr TSP Monitoring Result for AM3-B

Sampling ID & Paper No.	Temperature (°C) *1	Wind Direction *1	Wind Speed (m/s) *1	Sampling Date	Wt. of paper (g)			Flow Rate (CFM)	Total Volume *2 (m³)	TSP Concentration (µg/m³) *3
					Initial Wt.	Final Wt.	Wt. of dust			
AM3-B1206 205478	21.1 - 25.2	SE	<5m/s	6/12/2018	2.6952	2.7843	0.0891	50.0	1967.14	45
AM3-B1212 206549	13.5 - 15.9	N	<5m/s	12/12/2018	2.6905	2.8607	0.1702	50.0	1967.14	87
AM3-B1218 206564	14.9 - 20.9	E	<5m/s	18/12/2018	2.6789	2.8238	0.1449	50.0	1967.14	74
AM3-B1222 206563	19.0 - 26.0	E	<5m/s	22/12/2018	2.6673	2.8790	0.2117	50.0	1967.14	108
AM3-B1228 205490	15.4 - 20.4	NE	<5m/s	28/12/2018	2.6525	2.7502	0.0977	50.0	1967.14	50

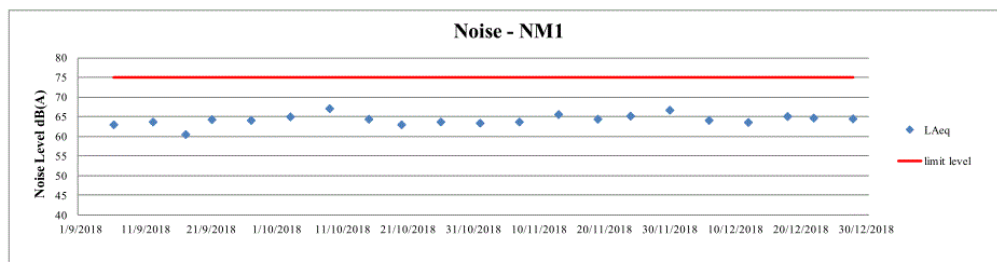
Noise Monitoring Result for NM1

Location	NM1				
Date	6/12/2018	12/12/2018	18/12/2018	22/12/2018	28/12/2018
Weather Condition	Cloudy	Cloudy	Sunny	Cloudy	Cloudy
Start Time	11:00	11:00	11:00	11:00	11:00
Measurement Period	30min	30min	30min	30min	30min
Baseline Level	75.1				
L _{Aeq}	64.2	63.7	65.2	64.8	64.6
L ₁₀	65.2	64.9	66.1	66.4	65.9
L ₉₀	60.6	62.0	62.6	60.8	62.1

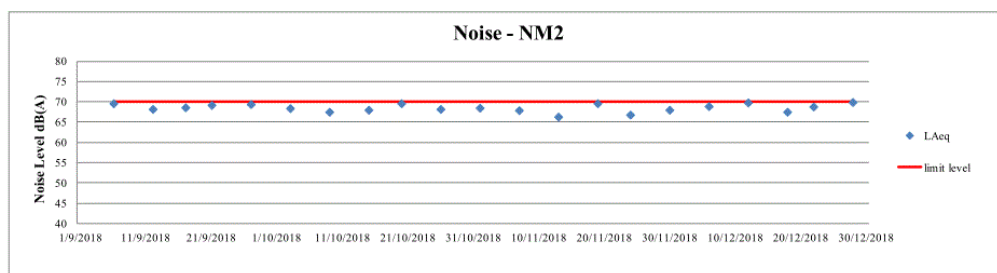
Noise Monitoring Result for NM2

Location	NM2				
Date	6/12/2018	12/12/2018	18/12/2018	22/12/2018	28/12/2018
Weather Condition	Cloudy	Cloudy	Sunny	Cloudy	Cloudy
Start Time	9:00	9:00	9:00	9:00	9:00
Measurement Period	30min	30min	30min	30min	30min
Baseline Level	66.5				
L _{Aeq}	68.9	69.8	67.5	68.8	69.9
L ₁₀	69.9	72.8	69.6	70.4	72.8
L ₉₀	64.8	64.7	64.2	63.9	65.1

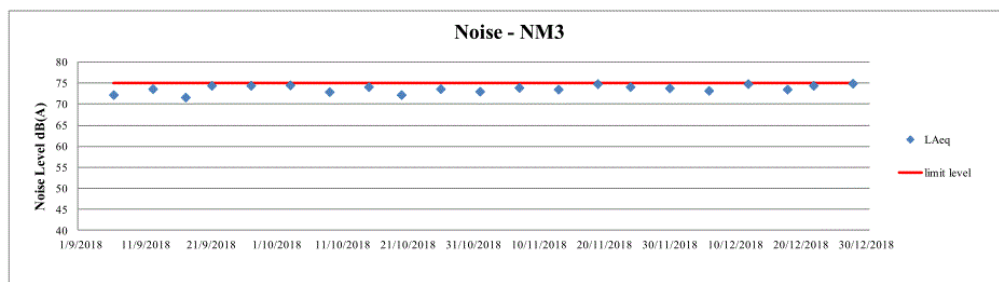
Noise Monitoring Result for NM3

Location	NM3				
Date	6/12/2018	12/12/2018	18/12/2018	22/12/2018	28/12/2018
Weather Condition	Cloudy	Cloudy	Sunny	Cloudy	Cloudy
Start Time	10:00	10:00	10:00	10:00	10:00
Measurement Period	30min	30min	30min	30min	30min
Baseline Level	74.5				
L _{Aeq}	73.2	74.8	73.5	74.4	74.9
L ₁₀	75.5	77.8	76.5	76.9	77.2
L ₉₀	69.8	70.1	70.8	70.3	69.4

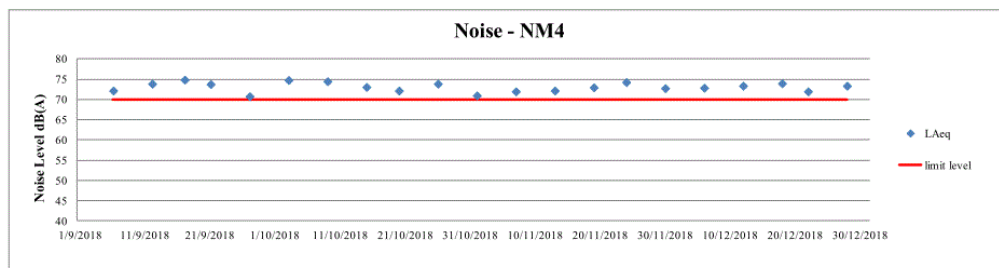
Noise Monitoring Result for NM4

The noise source for causing exceedances at NM4 was from the traffic of Canton Road. The NM4 was directly affected by the noise generated from the traffic. The recorded monitoring results at the NM4 were near the baseline noise level. The exceedances were not caused by the construction works of this project.

Location	NM4					NM4 (Re-measurement) *				
Date	6/12/2018	12/12/2018	18/12/2018	22/12/2018	28/12/2018	6/12/2018	12/12/2018	18/12/2018	22/12/2018	28/12/2018
Weather Condition	Cloudy	Cloudy	Sunny	Cloudy	Cloudy	Cloudy	Cloudy	Sunny	Cloudy	Cloudy
Start Time	13:00	13:00	13:00	13:00	13:00	13:30	13:30	13:30	13:30	13:30
Measurement Period	30min	30min	30min	30min	30min	30min	30min	30min	30min	30min
Baseline Level	73.3					73.3				
L _{Aeq}	72.9	73.4	74.0	72.0	73.4	73.0	73.9	73.6	74.3	74.5
L ₁₀	74.5	75.3	76.9	74.9	75.4	74.4	75.6	75.5	76.0	76.5
L ₉₀	64.5	66.5	67.4	65.8	66.1	65.8	67.1	66.5	66.1	65.8

* Repeat noise measurement when exceedance is recorded. The result is used to confirm the findings and it would not be showed on the graph plot

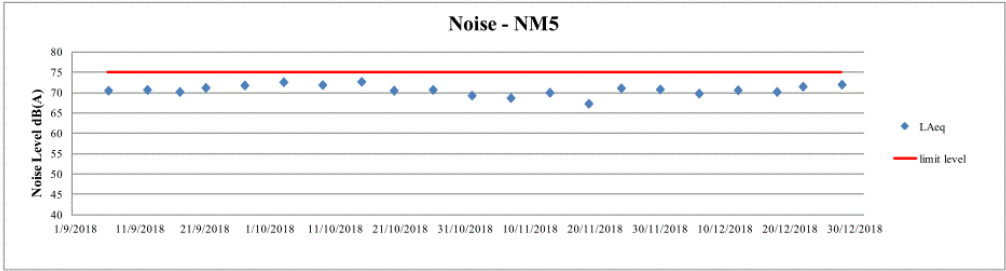
Noise Monitoring Result for NM5

Location	NM5				
Date	6/12/2018	12/12/2018	18/12/2018	22/12/2018	28/12/2018
Weather Condition	Cloudy	Cloudy	Sunny	Cloudy	Cloudy
Start Time	15:00	15:00	15:00	15:00	15:00
Measurement Period	30min	30min	30min	30min	30min
Baseline Level	71.8				
L _{Aeq}	69.8	70.6	70.2	71.5	72.0
L ₁₀	72.6	73.4	73.2	74.4	74.9
L ₉₀	65.6	64.9	65.0	65.5	65.3
