Proposed Road Improvement Works in West Kowloon Reclamation Development – Phase 1

Environmental Monitoring & Audit Report

01/03/2019 – 31/03/2019

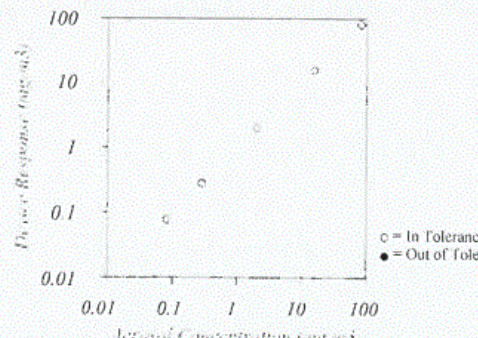
Concentration Linearity Plot

Environment Conditions			Model		AM520	
Temperature	76.4 (24.7)	°F (°C)	Serial Number		5201750010	
Relative Humidity	45	%RH				
Barometric Pressure	29.16 (987.5)	inHg (hPa)

☒ In Tolerance
☐ Out of Tolerance

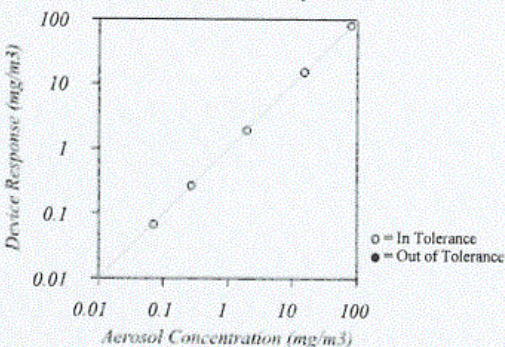
Concentration Linearity Plot

Environment Conditions			Model	AM520
Temperature	74.3 (23.5)	°F (°C)	Serial Number	5201707004
Relative Humidity	43	%RH		
Barometric Pressure	29.09 (985.1)	inHg (hPa)

CONCENTRATION				Unit: mg/m ³			
#	STANDARD	MEASURED	ALLOWABLE RANGE	#	STANDARD	MEASURED	ALLOWABLE RANGE
1	0.071	0.068	0.050–0.092	4	15.159	15.063	13.643–16.675
2	0.269	0.265	0.229–0.309	5	80.323	78.980	72.291–88.355
3	1.944	1.894	1.750–2.138

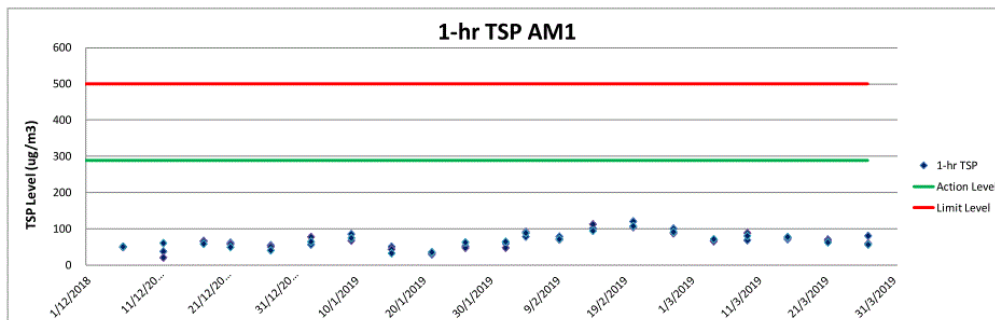
Date	Weather	Temperature (°C) *	Wind Direction *	Wind Speed (m/s) *	Sampling Time			Reading (µg/m³)			
					1	2	3	1	2	3	Average
4/3/2019	Overcast	19 - 22	E	<5m/s	13:00	14:01	15:02	68	65	71	68
9/3/2019	Overcast	18 - 21	E	<5m/s	14:00	15:01	16:02	68	88	80	79
15/3/2019	Overcast	18 - 20	N	<5m/s	8:00	9:01	10:02	71	75	77	74
21/3/2019	Overcast	27 - 29	S	<5m/s	9:00	10:01	11:02	70	68	62	67
27/3/2019	Overcast	23 - 25	E	<5m/s	9:00	10:01	11:02	80	59	56	65

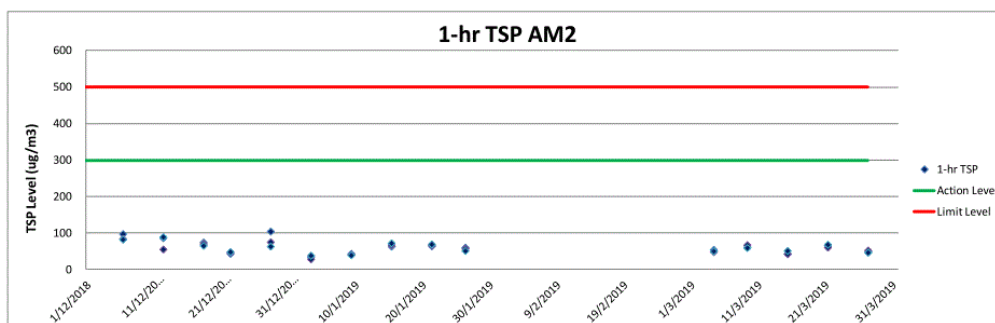
1-hr TSP Monitoring Result for AM2

Date	Weather	Temperature (°C) *	Wind Direction *	Wind Speed (m/s) *	Sampling Time			Reading (µg/m³)			
					1	2	3	1	2	3	Average
4/3/2019	Overcast	19 - 22	E	<5m/s	14:00	15:01	16:02	55	49	51	52
9/3/2019	Overcast	18 - 21	E	<5m/s	13:00	14:01	15:02	62	68	60	63
15/3/2019	Overcast	18 - 20	N	<5m/s	9:00	10:01	11:02	44	43	52	46
21/3/2019	Overcast	27 - 29	S	<5m/s	8:00	9:01	10:02	66	61	69	65
27/3/2019	Overcast	23 - 25	E	<5m/s	8:00	9:01	10:02	50	53	47	50

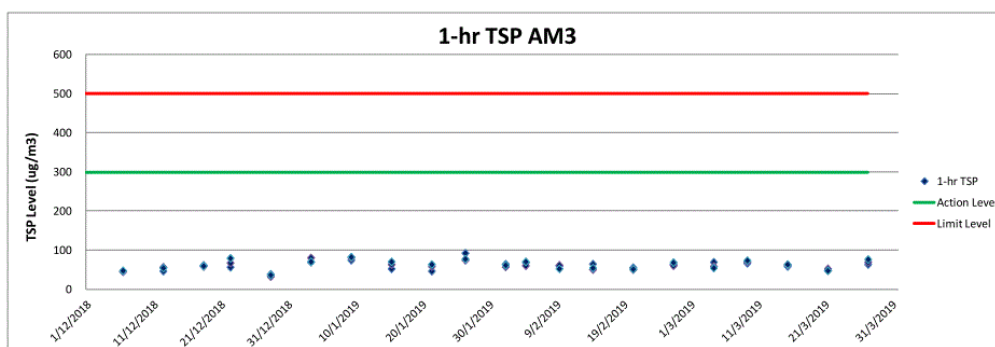
1-hr TSP Monitoring Result for AM3

Date	Weather	Temperature (°C) *	Wind Direction *	Wind Speed (m/s) *	Sampling Time			Reading (µg/m³)			
					1	2	3	1	2	3	Average
4/3/2019	Overcast	19 - 22	E	<5m/s	14:00	15:01	16:02	69	58	54	60
9/3/2019	Overcast	18 - 21	E	<5m/s	14:00	15:01	16:02	66	70	73	70
15/3/2019	Overcast	18 - 20	N	<5m/s	8:00	9:01	10:02	58	62	63	61
21/3/2019	Overcast	27 - 29	S	<5m/s	8:00	9:01	10:02	48	52	47	49
27/3/2019	Overcast	23 - 25	E	<5m/s	9:00	10:01	11:02	63	69	76	69

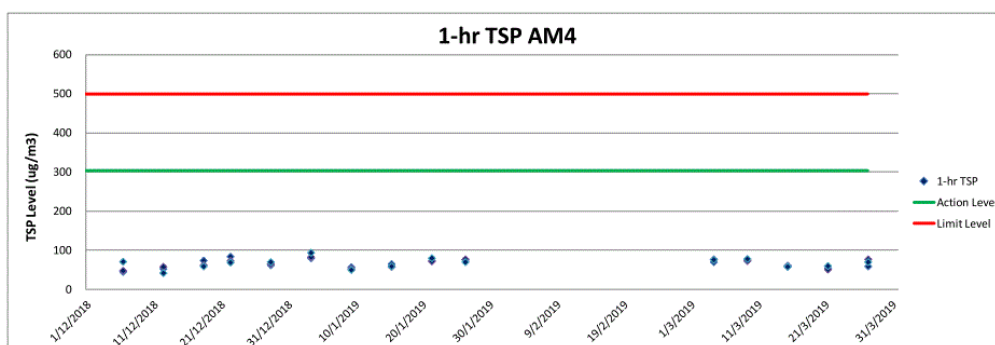
1-hr TSP Monitoring Result for AM4

Date	Weather	Temperature (°C) *	Wind Direction *	Wind Speed (m/s) *	Sampling Time			Reading (µg/m³)			
					1	2	3	1	2	3	Average
4/3/2019	Overcast	19 - 22	E	<5m/s	13:30	14:31	15:32	71	78	77	75
9/3/2019	Overcast	18 - 21	E	<5m/s	13:30	14:31	15:32	76	74	79	76
15/3/2019	Overcast	18 - 20	N	<5m/s	8:30	9:31	10:32	62	60	59	60
21/3/2019	Overcast	27 - 29	S	<5m/s	8:30	9:31	10:32	55	52	61	56
27/3/2019	Overcast	23 - 25	E	<5m/s	8:30	9:31	10:32	60	78	71	70

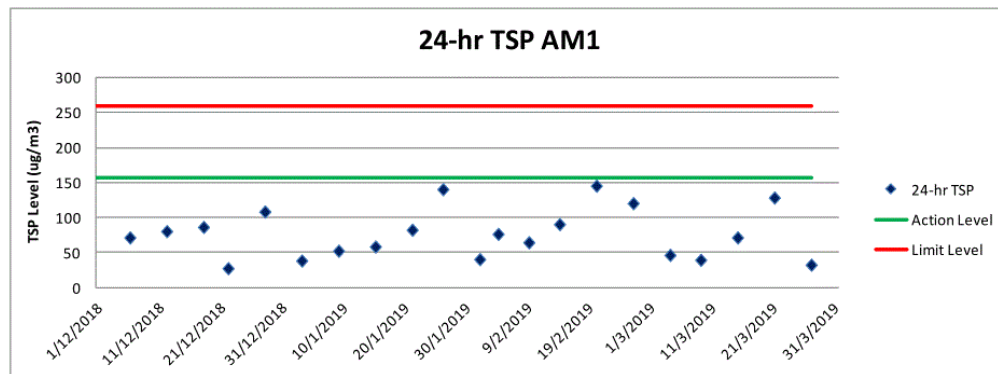
24-hr TSP Monitoring Result for AM1

Sampling ID & Paper No.	Temperature (°C) *1	Wind Direction *1	Wind Speed (m/s) *1	Sampling Date	Wt. of paper (g)			Flow Rate (CFM)	Total Volume *2 (m³)	TSP Concentration (µg/m³)
					Initial Wt.	Final Wt.	Wt. of dust			
AM10304	19 - 22	E	<5m/s	4/3/2019	2.6936	2.7843	0.0907	50.0	1982.57	46
AM10309	18 - 21	E	<5m/s	9/3/2019	2.6943	2.7715	0.0772	50.0	1982.57	39
AM10315	18 - 20	N	<5m/s	15/3/2019	2.6826	2.8224	0.1398	50.0	1982.57	71
AM10321	27 - 29	S	<5m/s	21/3/2019	2.6674	2.9202	0.2528	50.0	1982.57	128
AM10327	23 - 25	E	<5m/s	27/3/2019	2.6807	2.7439	0.0632	50.0	1982.57	32

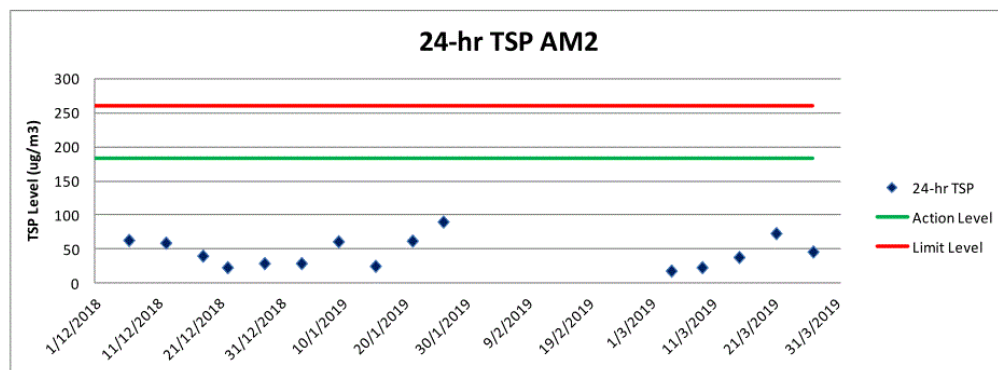
24-hr TSP Monitoring Result for AM2

Sampling ID & Paper No.	Temperature (°C) *1	Wind Direction *1	Wind Speed (m/s) *1	Sampling Date	Wt. of paper (g)			Flow Rate (CFM)	Total Volume *2 (m³)	TSP Concentration (µg/m³)
					Initial Wt.	Final Wt.	Wt. of dust			
AM20304	19 - 22	E	<5m/s	4/3/2019	2.6904	2.7273	0.0369	50.0	2008.33	18
AM20309	18 - 21	E	<5m/s	9/3/2019	2.6632	2.7094	0.0462	50.0	2008.33	23
AM20315	18 - 20	N	<5m/s	15/3/2019	2.6911	2.7676	0.0765	50.0	2008.33	38
AM20321	27 - 29	S	<5m/s	21/3/2019	2.6955	2.8420	0.1465	50.0	2008.33	73
AM20327	23 - 25	E	<5m/s	27/3/2019	2.6962	2.7893	0.0931	50.0	2008.33	46

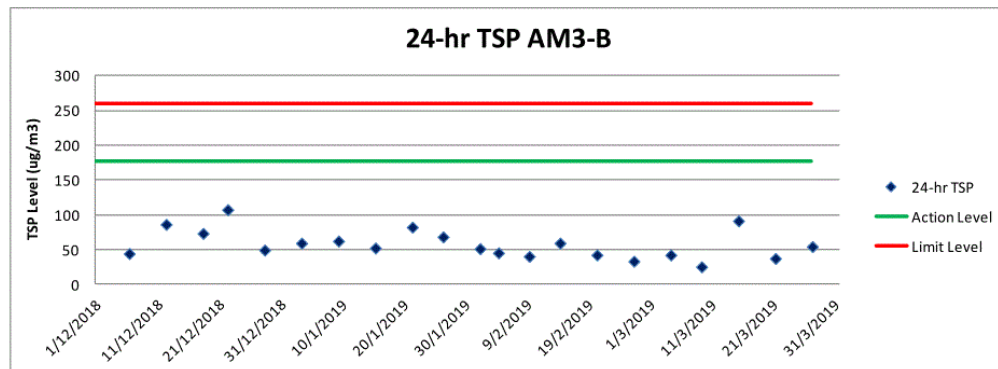
24-hr TSP Monitoring Result for AM3-B

Sampling ID & Paper No.	Temperature (°C) *1	Wind Direction *1	Wind Speed (m/s) *1	Sampling Date	Wt. of paper (g)			Flow Rate (CFM)	Total Volume *2 (m³)	TSP Concentration (µg/m³)
					Initial Wt.	Final Wt.	Wt. of dust			
AM3B0304	19 - 22	E	<5m/s	4/3/2019	2.6999	2.8018	0.1019	50.0	2352.05	43
AM3B0309	18 - 21	E	<5m/s	9/3/2019	2.6805	2.7413	0.0608	50.0	2352.05	26
AM3B0315	18 - 20	N	<5m/s	15/3/2019	2.6958	2.9132	0.2174	50.0	2352.05	92
AM3B0321	27 - 29	S	<5m/s	21/3/2019	2.6920	2.7808	0.0888	50.0	2352.05	38
AM3B0327	23 - 25	E	<5m/s	27/3/2019	2.7072	2.8375	0.1303	50.0	2352.05	55

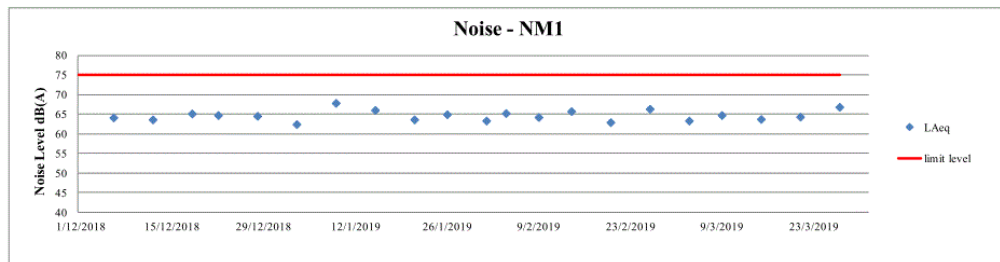
Noise Monitoring Result for NM1

Location	NM1				
Date	4/3/2019	9/3/2019	15/3/2019	21/3/2019	27/3/2019
Weather Condition	Overcast	Overcast	Overcast	Overcast	Overcast
Start Time	10:00	10:00	10:00	10:00	10:00
Measurement Period	30min	30min	30min	30min	30min
Baseline Level	75.1				
L _{Aeq}	63.4	64.8	63.8	64.4	66.9
L ₁₀	64.2	65.5	67.5	66.7	68.6
L ₉₀	60.4	60.4	60.8	59.6	61.2

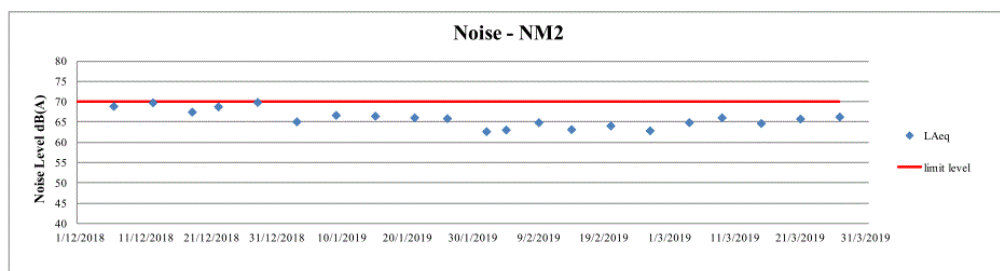
Noise Monitoring Result for NM2

Location	NM2				
Date	4/3/2019	9/3/2019	15/3/2019	21/3/2019	27/3/2019
Weather Condition	Overcast	Overcast	Overcast	Overcast	Overcast
Start Time	14:00	14:00	14:00	14:00	14:00
Measurement Period	30min	30min	30min	30min	30min
Baseline Level	66.5				
L _{Aeq}	64.9	66.1	64.7	65.8	66.3
L ₁₀	66.2	68.6	69.2	69.0	68.2
L ₉₀	57.9	57.5	58.1	58.9	59.1

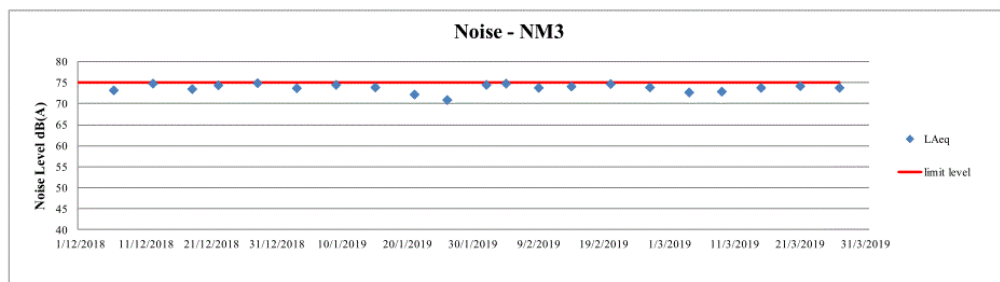
Noise Monitoring Result for NM3

Location	NM3				
Date	4/3/2019	9/3/2019	15/3/2019	21/3/2019	27/3/2019
Weather Condition	Overcast	Overcast	Overcast	Overcast	Overcast
Start Time	9:00	9:00	9:00	9:00	9:00
Measurement Period	30min	30min	30min	30min	30min
Baseline Level	74.5				
L _{Aeq}	72.7	72.9	73.8	74.2	73.8
L ₁₀	75.2	75.4	75.2	75.8	74.9
L ₉₀	69.5	67.3	66.4	66.2	66.9

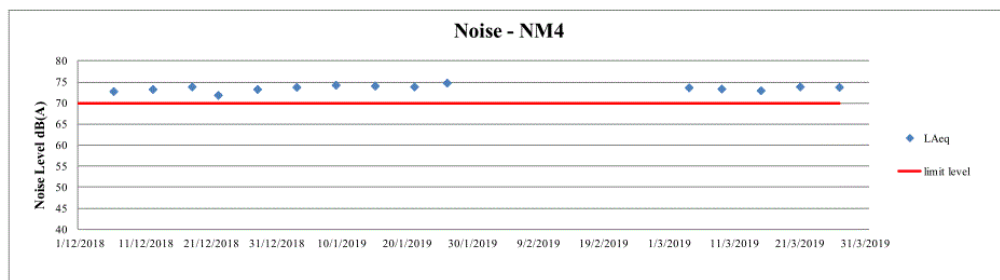
Noise Monitoring Result for NM4

Location	NM4					NM4 (Re-measurement) *				
Date	4/3/2019	9/3/2019	15/3/2019	21/3/2019	27/3/2019	4/3/2019	9/3/2019	15/3/2019	21/3/2019	27/3/2019
Weather Condition	Overcast	Overcast	Overcast	Overcast	Overcast	Overcast	Overcast	Overcast	Overcast	Overcast
Start Time	13:00	13:00	13:00	13:00	13:00	13:30	13:30	13:30	13:30	13:30
Measurement Period	30min	30min	30min	30min	30min	30min	30min	30min	30min	30min
Baseline Level	73.3					73.3				
L _{Aeq}	73.8	73.5	73.1	74.0	73.9	73.4	73.8	74.1	73.7	73.2
L ₁₀	77.6	77.4	78.0	77.8	77.9	77.8	77.7	78.1	77.9	77.2
L ₉₀	65.9	66.1	65.7	66.0	66.4	66.5	66.3	66.7	65.9	66.1

* Repeat noise measurement when exceedance is recorded. The result is used to confirm the findings and it would not be showed on the graph plot

The noise source for causing exceedances at NM4 was from the traffic of Canton Road. The NM4 was directly affected by the noise generated from the traffic. The recorded monitoring results at the NM4 were near the baseline noise level. The exceedances were not caused by the construction works of this project.

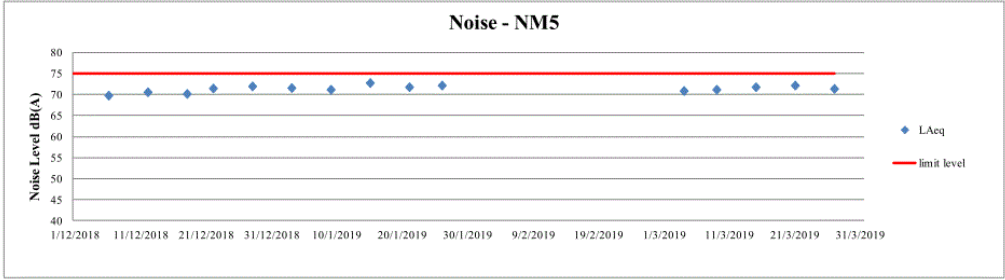
Noise Monitoring Result for NM5

Location	NM5				
Date	4/3/2019	9/3/2019	15/3/2019	21/3/2019	27/3/2019
Weather Condition	Overcast	Overcast	Overcast	Overcast	Overcast
Start Time	15:00	15:00	15:00	15:00	15:00
Measurement Period	30min	30min	30min	30min	30min
Baseline Level	71.8				
L _{Aeq}	70.9	71.2	71.8	72.2	71.4
L ₁₀	73.9	74.2	74.8	75.1	73.8
L ₉₀	65.0	64.8	65.2	64.8	64.1
