Proposed Road Improvement Works in West Kowloon Reclamation Development – Phase 1

Environmental Monitoring & Audit Report

01/04/2019 – 30/04/2019

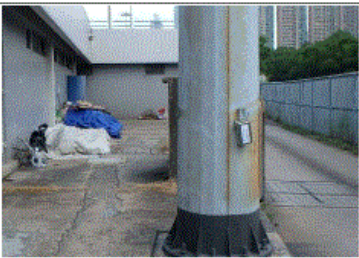
Monitoring Location	Photo Record
AM1 Marine Department New Yau Ma Tei Public Cargo Working Area Administrative Building

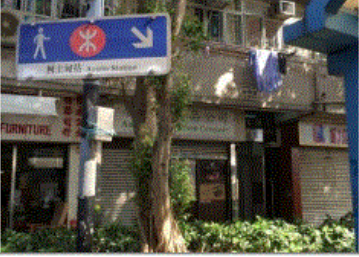
AM2 Garden Building

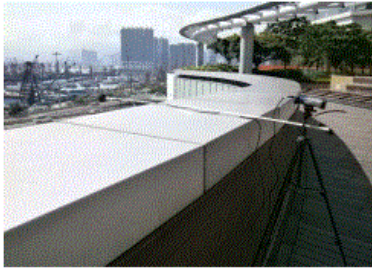
Monitoring Location	Photo Record
NM1 Sorrento - Tower 1

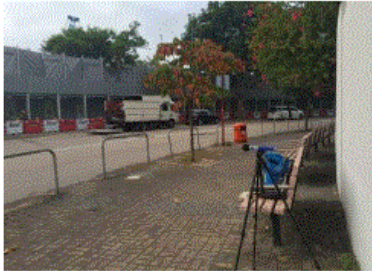
NM2 Yau Ma Tei Catholic Primary School (Hoi Wang Road)

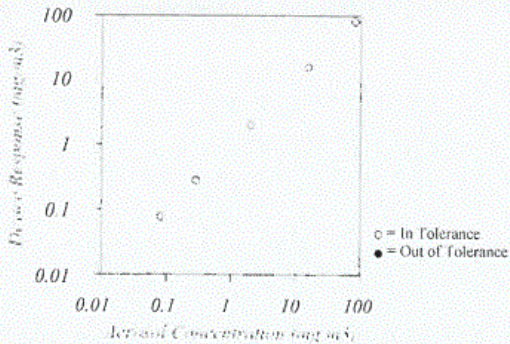
Concentration Linearity Plot

CONCENTRATION				Unit: mg/m³			
#	STANDARD	MEASURED	ALLOWABLE RANGE	#	STANDARD	MEASURED	ALLOWABLE RANGE
1	0.080	0.076	0.056–0.104	4	15.536	15.495	13.982–17.090
2	0.283	0.281	0.241–0.325	5	82.272	81.134	74.045–90.499
3	2.012	1.983	1.811–2.213

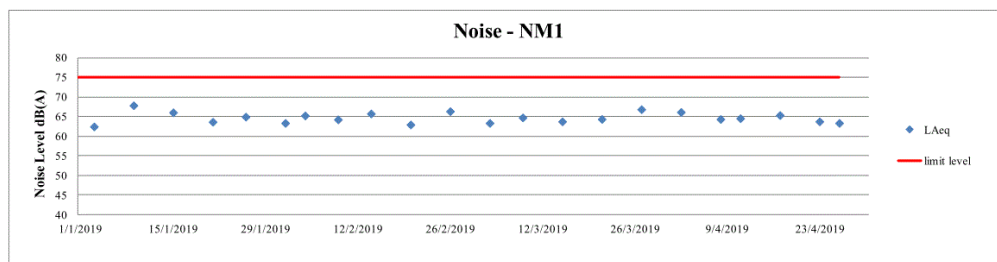
Noise Monitoring Result for NM1

Location	NM1					
Date	2/4/2019	8/4/2019	11/4/2019	17/4/2019	23/4/2019	26/4/2019
Weather Condition	Sunny	Overcast	Sunny	Sunny	Sunny	Overcast
Start Time	10:00	10:00	10:00	10:00	10:00	10:00
Measurement Period	30min	30min	30min	30min	30min	30min
Baseline Level	75.1					
L _{Aeq}	66.2	64.4	64.6	65.4	63.8	63.4
L ₁₀	65.8	64.4	66.0	66.4	65.8	64.2
L ₉₀	61.4	62.4	63.0	61.0	62.4	60.4

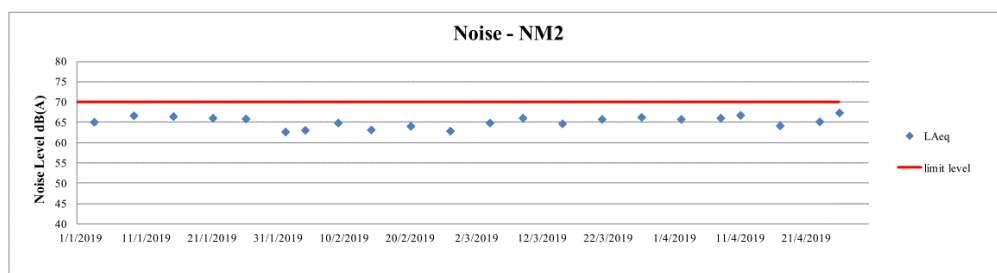
Noise Monitoring Result for NM2

Location	NM2					
Date	2/4/2019	8/4/2019	11/4/2019	17/4/2019	23/4/2019	26/4/2019
Weather Condition	Sunny	Overcast	Sunny	Sunny	Sunny	Overcast
Start Time	14:00	14:00	14:00	14:00	14:00	14:00
Measurement Period	30min	30min	30min	30min	30min	30min
Baseline Level	66.5					
L _{Aeq}	65.8	66.1	66.8	64.2	65.2	67.4
L ₁₀	67.2	68.2	69.9	66.4	67.3	69.1
L ₉₀	62.1	61.7	62.3	61.2	62.0	61.5

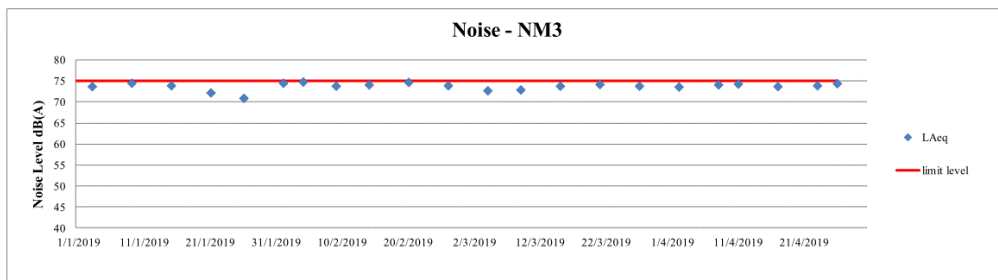
Noise Monitoring Result for NM3

Location	NM3					
Date	2/4/2019	8/4/2019	11/4/2019	17/4/2019	23/4/2019	26/4/2019
Weather Condition	Sunny	Overcast	Sunny	Sunny	Sunny	Overcast
Start Time	9:00	9:00	9:00	9:00	9:00	9:00
Measurement Period	30min	30min	30min	30min	30min	30min
Baseline Level	74.5					
L _{Aeq}	73.6	74.1	74.3	73.7	73.9	74.4
L ₁₀	74.8	75.5	76.9	75.5	75.3	76.7
L ₉₀	64.8	67.5	67.1	66.8	66.3	66.1

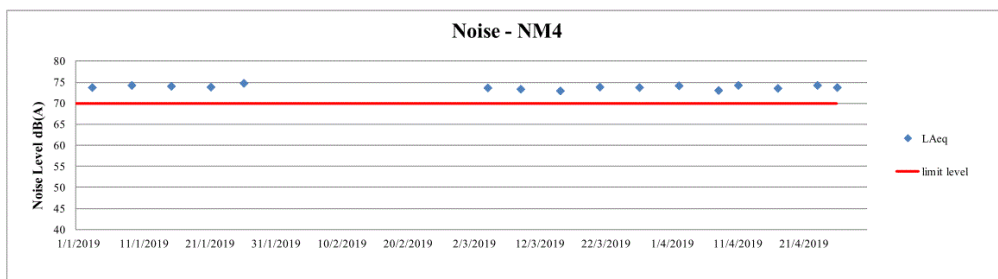
Noise Monitoring Result for NM4

Location	NM4						NM4 (Re-measurement) *					
Date	2/4/2019	8/4/2019	11/4/2019	17/4/2019	23/4/2019	26/4/2019	2/4/2019	8/4/2019	11/4/2019	17/4/2019	23/4/2019	26/4/2019
Weather Condition	Sunny	Overcast	Sunny	Sunny	Sunny	Overcast	Sunny	Overcast	Sunny	Sunny	Sunny	Overcast
Start Time	13:00	13:00	13:00	13:00	13:00	13:00	13:30	13:30	13:30	13:30	13:30	13:30
Measurement Period	30min	30min	30min	30min	30min	30min	30min	30min	30min	30min	30min	30min
Baseline Level	73.3						73.3					
L _{Aeq}	74.3	73.2	74.4	73.7	74.4	73.9	74.1	73.2	74.5	73.8	74.0	73.8
L ₁₀	76.3	76.8	77.4	76.1	76.8	76.1	76.9	77.0	77.1	76.4	77.0	76.2
L ₉₀	67.0	67.2	67.2	67.2	67.8	66.8	66.4	67.6	68.0	68.0	68.0	67.2

* Repeat noise measurement when exceedance is recorded. The result is used to confirm the findings and it would not be showed on the graph plot

The noise source for causing exceedances at NM4 was from the traffic of Canton Road. The NM4 was directly affected by the noise generated from the traffic. The recorded monitoring results at the NM4 were near the baseline noise level. The exceedances were not caused by the construction works of this project.

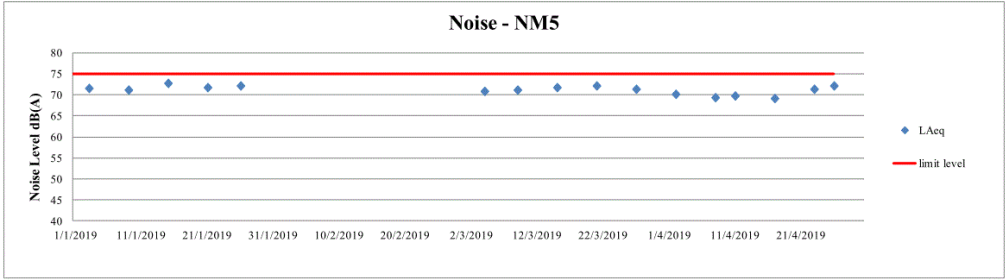
Noise Monitoring Result for NM5

Location	NM5					
Date	2/4/2019	8/4/2019	11/4/2019	17/4/2019	23/4/2019	26/4/2019
Weather Condition	Sunny	Overcast	Sunny	Sunny	Sunny	Overcast
Start Time	15:00	15:00	15:00	15:00	15:00	15:00
Measurement Period	30min	30min	30min	30min	30min	30min
Baseline Level	71.8					
L _{Aeq}	70.2	69.4	69.8	69.2	71.4	72.2
L ₋₁₀	74.7	72.3	74.7	72.9	73.1	75.1
L ₋₉₀	62.0	67.8	67.8	65.8	67.2	64.8
