Proposed Road Improvement Works in West Kowloon Reclamation Development – Phase 1

Environmental Monitoring & Audit Report

01/05/2019 – 31/05/2019

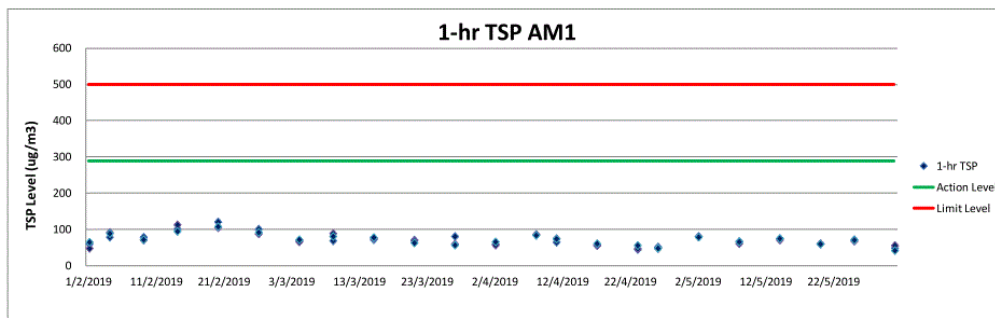
Date	Weather	Temperature (°C) *	Wind Direction *	Wind Speed (m/s) *	Sampling Time			Reading (µg/m ³)			
					1	2	3	1	2	3	Average
2/5/2019	Sunny	23.9 - 29.0	E	<5m/s	13:00	14:01	15:02	80	79	78	79
8/5/2019	Overcast	25.1 - 30.9	E	<5m/s	13:00	14:01	15:02	66	60	65	64
14/5/2019	Sunny	25.3 - 31.3	N	<5m/s	13:00	14:01	15:02	74	70	74	73
20/5/2019	Overcast	24.5 - 29.1	SW	<5m/s	13:00	14:01	15:02	59	60	59	59
25/5/2019	Overcast	28.0 - 31.0	SW	<5m/s	13:00	14:01	15:02	71	67	70	69
31/5/2019	Overcast	26.8 - 31.5	E	<5m/s	13:00	14:01	15:02	48	55	41	48

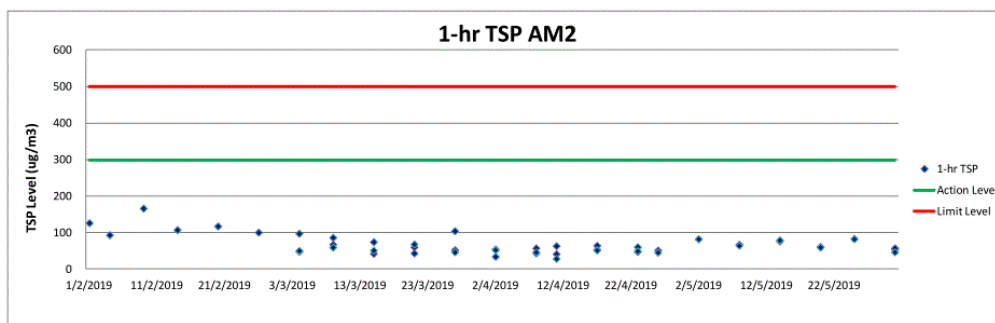
1-hr TSP Monitoring Result for AM2

Date	Weather	Temperature (°C) *	Wind Direction *	Wind Speed (m/s) *	Sampling Time			Reading (µg/m ³)			
					1	2	3	1	2	3	Average
2/5/2019	Sunny	23.9 - 29.0	E	<5m/s	9:00	10:01	11:02	82	83	83	83
8/5/2019	Overcast	25.1 - 30.9	E	<5m/s	9:00	10:01	11:02	66	68	65	66
14/5/2019	Sunny	25.3 - 31.3	N	<5m/s	9:00	10:01	11:02	73	77	80	77
20/5/2019	Overcast	24.5 - 29.1	SW	<5m/s	9:00	10:01	11:02	60	62	60	61
25/5/2019	Overcast	28.0 - 31.0	SW	<5m/s	9:00	10:01	11:02	86	84	83	84
31/5/2019	Overcast	26.8 - 31.5	E	<5m/s	9:00	10:01	11:02	51	58	47	52

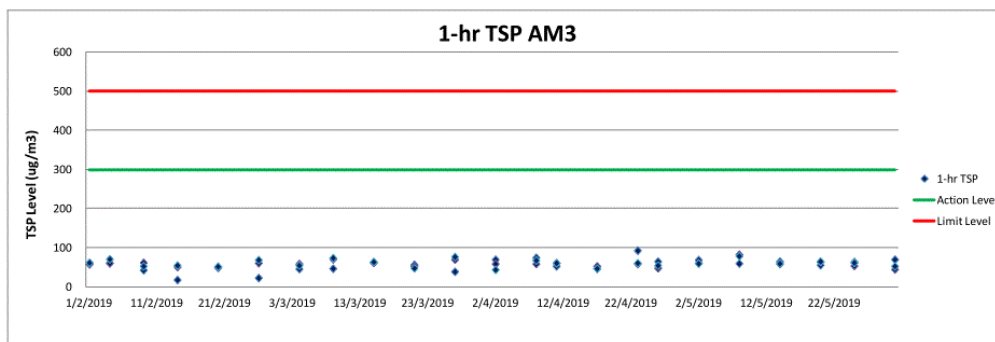
1-hr TSP Monitoring Result for AM3

Date	Weather	Temperature (°C) *	Wind Direction *	Wind Speed (m/s) *	Sampling Time			Reading (µg/m³)			
					1	2	3	1	2	3	Average
2/5/2019	Sunny	23.9 - 29.0	E	<5m/s	14:00	15:01	16:02	54	60	59	58
8/5/2019	Overcast	25.1 - 30.9	E	<5m/s	14:00	15:01	16:02	78	82	78	79
14/5/2019	Sunny	25.3 - 31.3	N	<5m/s	14:00	15:01	16:02	55	58	59	57
20/5/2019	Overcast	24.5 - 29.1	SW	<5m/s	14:00	15:01	16:02	57	63	64	61
25/5/2019	Overcast	28.0 - 31.0	SW	<5m/s	14:00	15:01	16:02	54	53	61	56
31/5/2019	Overcast	26.8 - 31.5	E	<5m/s	14:00	15:01	16:02	48	44	52	48

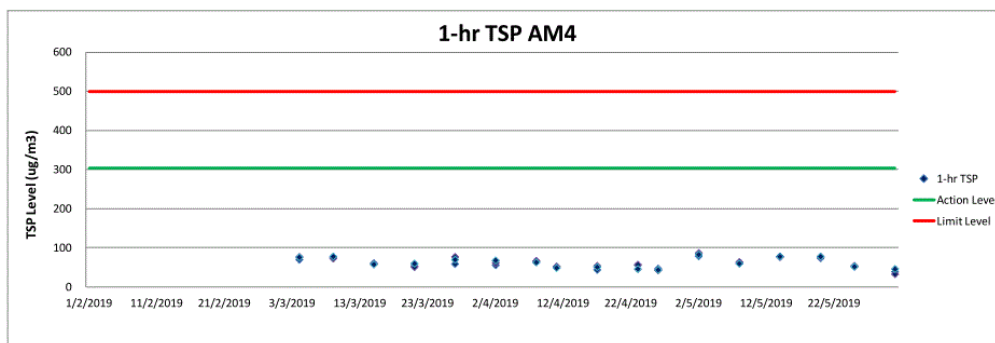
1-hr TSP Monitoring Result for AM4

Date	Weather	Temperature (°C) *	Wind Direction *	Wind Speed (m/s) *	Sampling Time			Reading (µg/m³)			
					1	2	3	1	2	3	Average
2/5/2019	Sunny	23.9 - 29.0	E	<5m/s	13:30	14:31	15:32	80	88	84	84
8/5/2019	Overcast	25.1 - 30.9	E	<5m/s	13:30	14:31	15:32	62	65	61	63
14/5/2019	Sunny	25.3 - 31.3	N	<5m/s	13:30	14:31	15:32	79	78	79	79
20/5/2019	Overcast	24.5 - 29.1	SW	<5m/s	13:30	14:31	15:32	75	78	79	77
25/5/2019	Overcast	28.0 - 31.0	SW	<5m/s	13:30	14:31	15:32	55	54	53	54
31/5/2019	Overcast	26.8 - 31.5	E	<5m/s	13:30	14:31	15:32	40	34	47	40

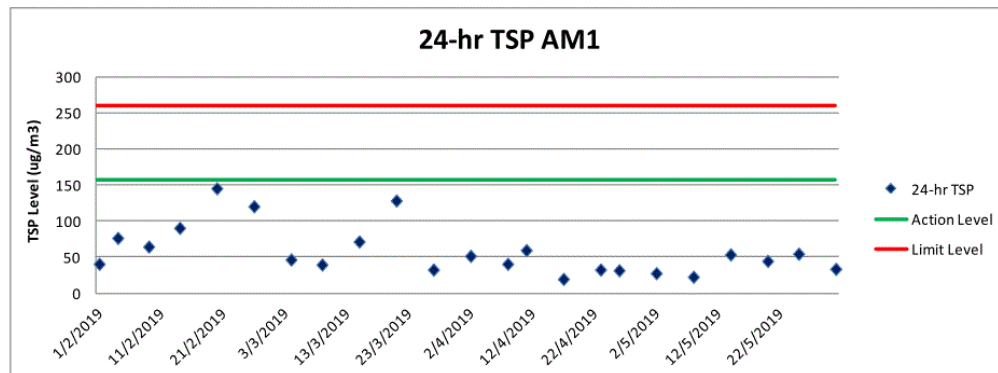
24-hr TSP Monitoring Result for AM1

Sampling ID & Paper No.	Temperature (°C) *1	Wind Direction *1	Wind Speed (m/s) *1	Sampling Date	Wt. of paper (g)			Flow Rate (CFM)	Total Volume *2 (m³)	TSP Concentration (µg/m³)
					Initial Wt.	Final Wt.	Wt. of dust			
AM10502 206473	23.9 - 29.0	E	<5m/s	2/5/2019	2.6846	2.7468	0.0622	50.0	2280.45	27
AM10508 206474	25.1 - 30.9	E	<5m/s	8/5/2019	2.6746	2.7246	0.0500	50.0	2280.45	22
AM10514 207202	25.3 - 31.3	N	<5m/s	14/5/2019	2.6613	2.7813	0.1200	50.0	2280.45	53
AM10520 206483	24.5 - 29.1	SW	<5m/s	20/5/2019	2.7041	2.8041	0.1000	50.0	2280.45	44
AM10525 207171	28.0 - 31.0	SW	<5m/s	25/5/2019	2.7069	2.8300	0.1231	50.0	2280.45	54
AM10531 207175	26.8 - 31.5	E	<5m/s	31/5/2019	2.6508	2.7270	0.0762	50.0	2280.45	33

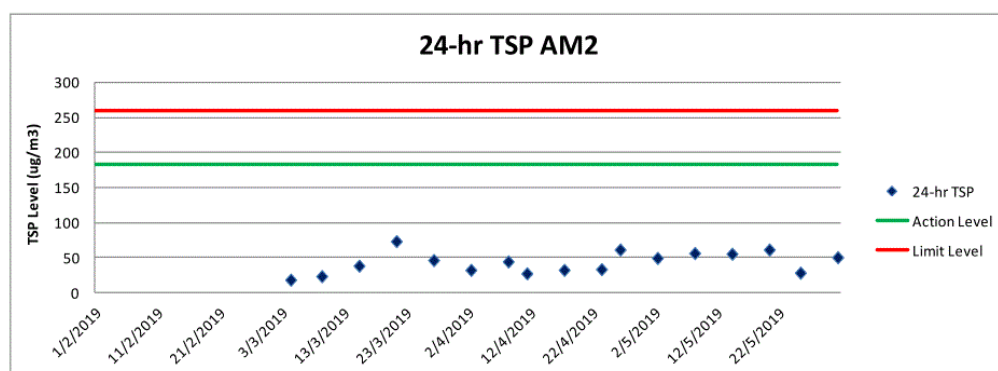
24-hr TSP Monitoring Result for AM2

Sampling ID & Paper No.	Temperature (°C) *1	Wind Direction *1	Wind Speed (m/s) *1	Sampling Date	Wt. of paper (g)			Flow Rate (CFM)	Total Volume *2 (m³)	TSP Concentration (µg/m³)
					Initial Wt.	Final Wt.	Wt. of dust			
AM20502 206487	23.9 - 29.0	E	<5m/s	2/5/2019	2.6880	2.7914	0.1034	50.0	2128.57	49
AM20508 206482	25.1 - 30.9	E	<5m/s	8/5/2019	2.7011	2.8207	0.1196	50.0	2128.57	56
AM20514 206470	25.3 - 31.3	N	<5m/s	14/5/2019	2.7094	2.8259	0.1165	50.0	2128.57	55
AM20520 206486	24.5 - 29.1	SW	<5m/s	20/5/2019	2.6844	2.8147	0.1303	50.0	2128.57	61
AM20525 206469	28.0 - 31.0	SW	<5m/s	25/5/2019	2.6977	2.7578	0.0601	50.0	2128.57	28
AM20531 207184	26.8 - 31.5	E	<5m/s	31/5/2019	2.6828	2.7901	0.1073	50.0	2128.57	50

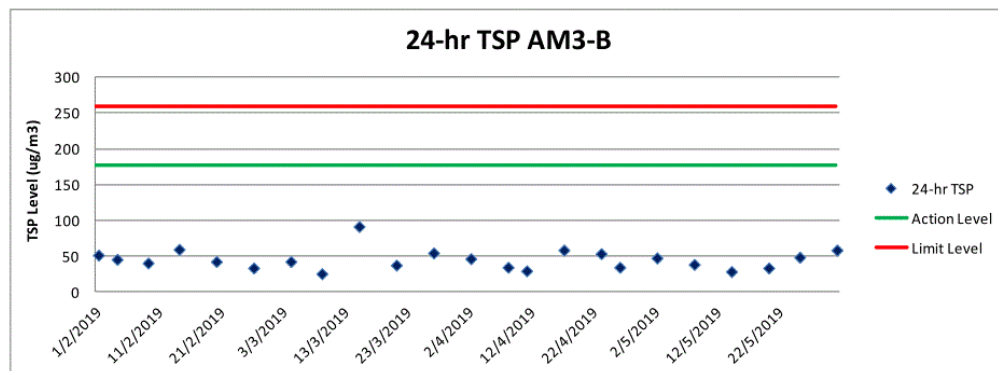
24-hr TSP Monitoring Result for AM3-B

Sampling ID & Paper No.	Temperature (°C) *1	Wind Direction *1	Wind Speed (m/s) *1	Sampling Date	Wt. of paper (g)			Flow Rate (CFM)	Total Volume *2 (m³)	TSP Concentration (µg/m³)
					Initial Wt.	Final Wt.	Wt. of dust			
AM3-B0502 206485	23.9 - 29.0	E	<5m/s	2/5/2019	2.6973	2.8062	0.1089	50.0	2262.01	48
AM3-B0508 207203	25.1 - 30.9	E	<5m/s	8/5/2019	2.6641	2.7513	0.0872	50.0	2262.01	39
AM3-B0514 206475	25.3 - 31.3	N	<5m/s	14/5/2019	2.6800	2.7458	0.0658	50.0	2262.01	29
AM3-B0520 207180	24.5 - 29.1	SW	<5m/s	20/5/2019	2.6570	2.7345	0.0775	50.0	2262.01	34
AM3-B0525 207176	28.0 - 31.0	SW	<5m/s	25/5/2019	2.6739	2.7843	0.1104	50.0	2262.01	49
AM3-B0531 207181	26.8 - 31.5	E	<5m/s	31/5/2019	2.6633	2.7969	0.1336	50.0	2262.01	59

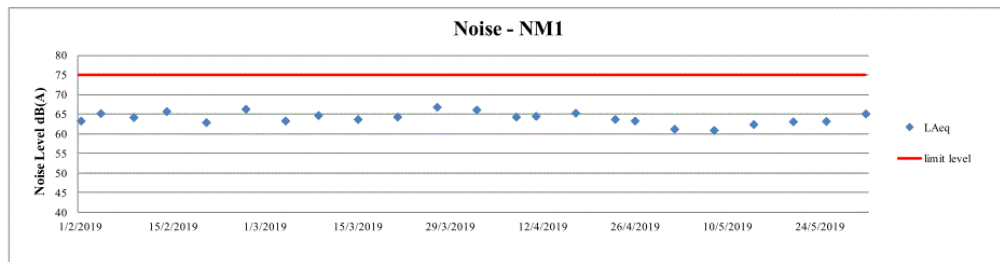
Noise Monitoring Result for NM1

Location	NM1					
Date	2/5/2019	8/5/2019	14/5/2019	20/5/2019	25/5/2019	31/5/2019
Weather Condition	Sunny	Overcast	Sunny	Overcast	Overcast	Overcast
Start Time	10:00	10:00	10:00	10:00	10:00	10:00
Measurement Period	30min	30min	30min	30min	30min	30min
Baseline Level	75.1					
L _{Aeq}	61.3	61.0	62.5	63.2	63.3	65.2
L ₁₀	65.3	65.5	66.4	66.7	65.6	67.2
L ₉₀	54.8	54.3	54.7	55.6	54.6	56.8

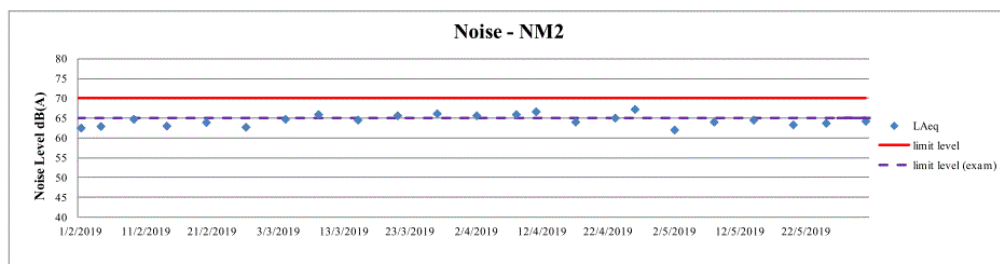
Noise Monitoring Result for NM2

Location	NM2					
Date	2/5/2019	8/5/2019	14/5/2019	20/5/2019	25/5/2019	31/5/2019
Weather Condition	Sunny	Overcast	Sunny	Overcast	Overcast	Overcast
Start Time	14:00	14:00	14:00	14:00	14:00	14:00
Measurement Period	30min	30min	30min	30min	30min	30min
Baseline Level	66.5					
L _{Aeq}	62.2	64.2	64.7	63.5	63.9	64.4
L ₁₀	65.3	66.7	66.2	65.9	65.8	66.7
L ₉₀	54.6	58.2	59.5	59.1	58.5	59.3

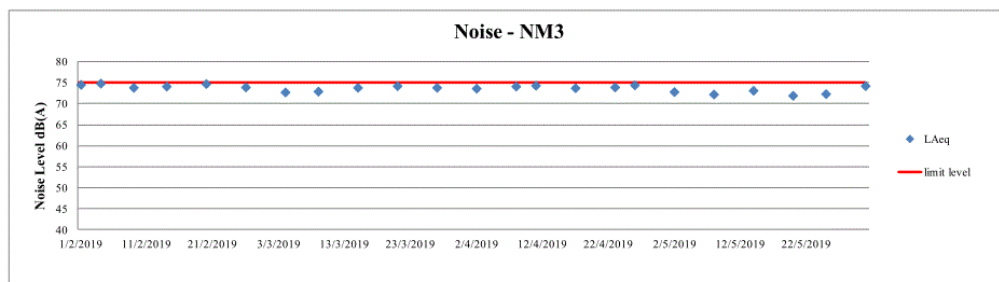
Noise Monitoring Result for NM3

Location	NM3					
Date	2/5/2019	8/5/2019	14/5/2019	20/5/2019	25/5/2019	31/5/2019
Weather Condition	Sunny	Overcast	Sunny	Overcast	Overcast	Overcast
Start Time	9:00	9:00	9:00	9:00	9:00	9:00
Measurement Period	30min	30min	30min	30min	30min	30min
Baseline Level	74.5					
L _{Aeq}	72.8	72.2	73.1	71.9	72.3	74.2
L ₁₀	75.8	74.1	74.2	74.8	74.5	76.3
L ₉₀	63.1	63.0	62.6	62.0	61.3	62.7

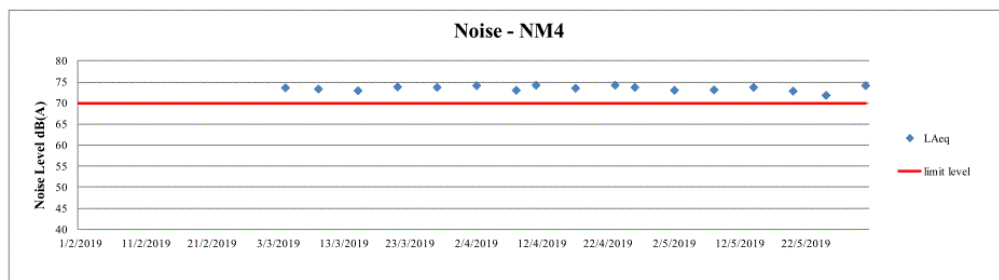
Noise Monitoring Result for NM4

The noise source for causing exceedances at NM4 was from the traffic of Canton Road. The NM4 was directly affected by the noise generated from the traffic. The recorded monitoring results at the NM4 were near the baseline noise level. The exceedances were not caused by the construction works of this project.

Location	NM4						NM4 (Re-measurement) *					
Date	2/5/2019	8/5/2019	14/5/2019	20/5/2019	25/5/2019	26/4/2019	2/5/2019	8/5/2019	14/5/2019	20/5/2019	25/5/2019	26/4/2019
Weather Condition	Sunny	Overcast	Sunny	Overcast	Overcast	Overcast	Sunny	Overcast	Sunny	Overcast	Overcast	Overcast
Start Time	13:00	13:00	13:00	13:00	13:00	13:00	13:30	13:30	13:30	13:30	13:30	13:30
Measurement Period	30min	30min	30min	30min	30min	30min	30min	30min	30min	30min	30min	30min
Baseline Level	73.3						73.3					
L _{Aeq}	73.2	73.3	73.9	73.0	72.0	74.3	73.1	73.0	73.6	73.1	73.4	74.8
L ₁₀	74.7	75.5	75.9	75.1	75.0	77.0	75.3	75.1	75.5	75.8	75.8	76.9
L ₉₀	62.6	61.9	62.4	61.7	63.2	64.7	62.5	62.1	63.2	63.0	61.7	63.5

* Repeat noise measurement when exceedance is recorded. The result is used to confirm the findings and it would not be showed on the graph plot

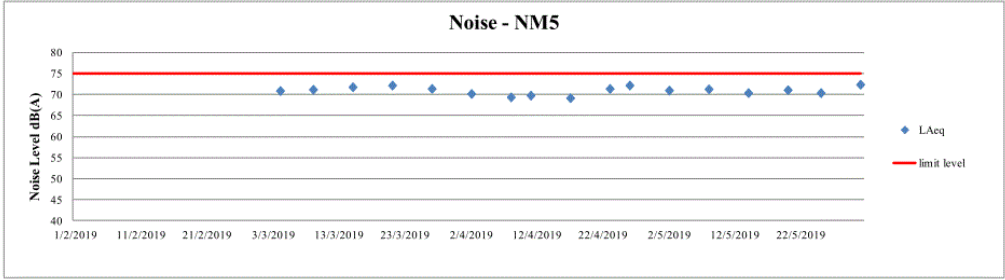
Noise Monitoring Result for NM5

Location	NM5					
Date	2/5/2019	8/5/2019	14/5/2019	20/5/2019	25/5/2019	31/5/2019
Weather Condition	Sunny	Overcast	Sunny	Overcast	Overcast	Overcast
Start Time	15:00	15:00	15:00	15:00	15:00	15:00
Measurement Period	30min	30min	30min	30min	30min	30min
Baseline Level	71.8					
L _{Aeq}	71.0	71.3	70.4	71.1	70.4	72.4
L ₁₀	73.4	74.5	73.7	73.3	72.6	74.1
L ₉₀	64.8	63.8	64.8	64.3	64.7	65.3
