Proposed Road Improvement Works in West Kowloon Reclamation Development – Phase 1

Environmental Monitoring & Audit Report

01/06/2019 – 30/06/2019

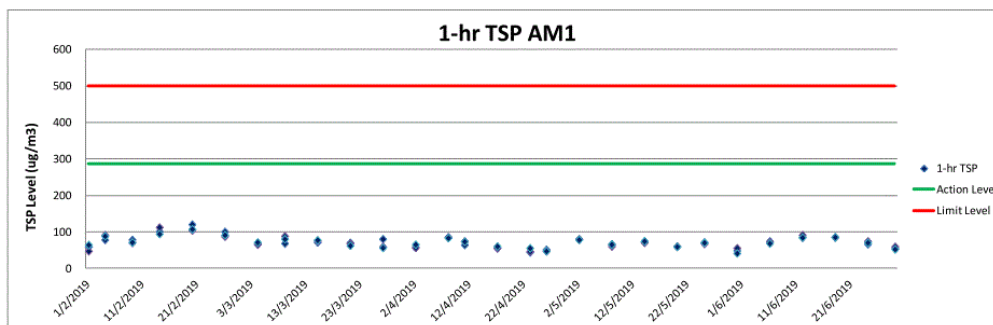
Date	Weather	Temperature (°C) *	Wind Direction *	Wind Speed (m/s) *	Sampling Time			Reading (µg/m³)			
					1	2	3	1	2	3	Average
6/6/2019	Overcast	23.9 - 29.0	E	<5m/s	13:00	14:01	15:02	74	72	68	71
12/6/2019	Sunny	25.8 - 31.4	E	<5m/s	13:00	14:01	15:02	85	91	84	87
18/6/2019	Overcast	27.0 - 30.3	SE	<5m/s	13:00	14:01	15:02	85	85	85	85
24/6/2019	Sunny	24.0 - 30.3	SW	<5m/s	13:00	14:01	15:02	66	74	70	70
29/6/2019	Overcast	29.2 - 34.2	S	<5m/s	13:00	14:01	15:02	54	59	52	55

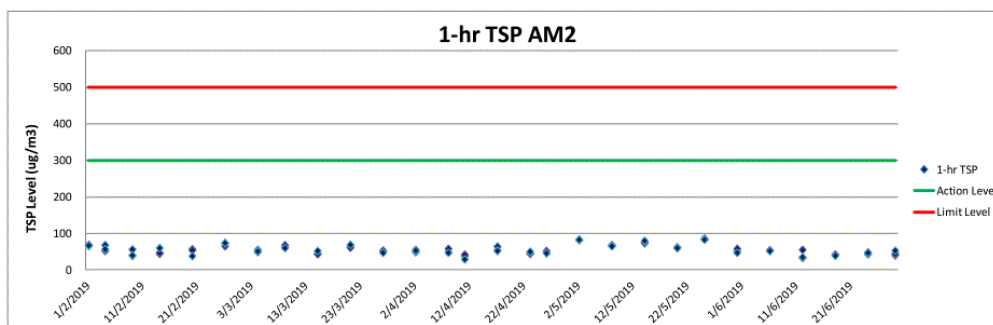
1-hr TSP Monitoring Result for AM2

Date	Weather	Temperature (°C) *	Wind Direction *	Wind Speed (m/s) *	Sampling Time			Reading (µg/m³)			
					1	2	3	1	2	3	Average
6/6/2019	Overcast	23.9 - 29.0	E	<5m/s	9:00	10:01	11:02	53	54	52	53
12/6/2019	Sunny	25.8 - 31.4	E	<5m/s	9:00	10:01	11:02	33	55	35	41
18/6/2019	Overcast	27.0 - 30.3	SE	<5m/s	9:00	10:01	11:02	42	42	39	41
24/6/2019	Sunny	24.0 - 30.3	SW	<5m/s	9:00	10:01	11:02	43	48	47	46
29/6/2019	Overcast	29.2 - 34.2	S	<5m/s	9:00	10:01	11:02	40	44	53	46

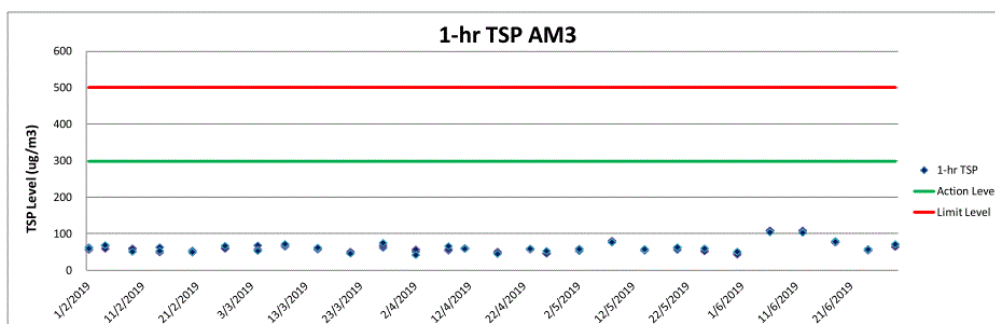
1-hr TSP Monitoring Result for AM3

Date	Weather	Temperature (°C) *	Wind Direction *	Wind Speed (m/s) *	Sampling Time			Reading (µg/m³)			
					1	2	3	1	2	3	Average
6/6/2019	Overcast	23.9 - 29.0	E	<5m/s	14:00	15:01	16:02	110	110	105	108
12/6/2019	Sunny	25.8 - 31.4	E	<5m/s	14:00	15:01	16:02	110	109	104	108
18/6/2019	Overcast	27.0 - 30.3	SE	<5m/s	14:00	15:01	16:02	81	77	79	79
24/6/2019	Sunny	24.0 - 30.3	SW	<5m/s	14:00	15:01	16:02	55	59	58	57
29/6/2019	Overcast	29.2 - 34.2	S	<5m/s	14:00	15:01	16:02	72	65	72	70

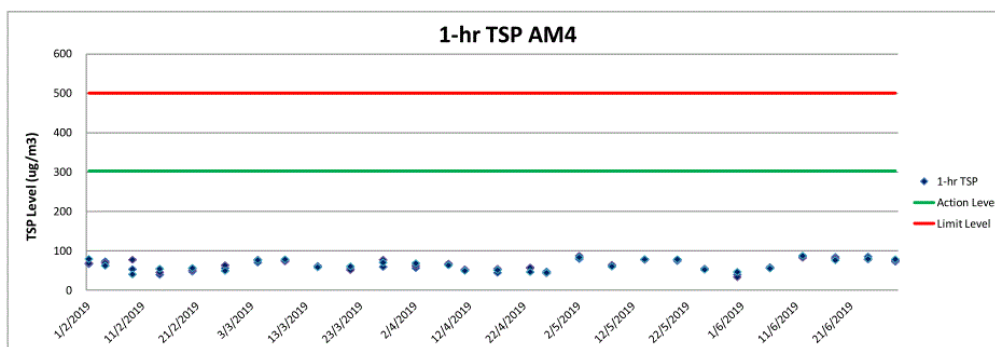
1-hr TSP Monitoring Result for AM4

Date	Weather	Temperature (°C) *	Wind Direction *	Wind Speed (m/s) *	Sampling Time			Reading (µg/m³)			
					1	2	3	1	2	3	Average
6/6/2019	Overcast	23.9 - 29.0	E	<5m/s	13:30	14:31	15:32	59	57	56	57
12/6/2019	Sunny	25.8 - 31.4	E	<5m/s	13:30	14:31	15:32	87	83	88	86
18/6/2019	Overcast	27.0 - 30.3	SE	<5m/s	13:30	14:31	15:32	85	81	77	81
24/6/2019	Sunny	24.0 - 30.3	SW	<5m/s	13:30	14:31	15:32	86	79	80	82
29/6/2019	Overcast	29.2 - 34.2	S	<5m/s	13:30	14:31	15:32	73	76	79	76

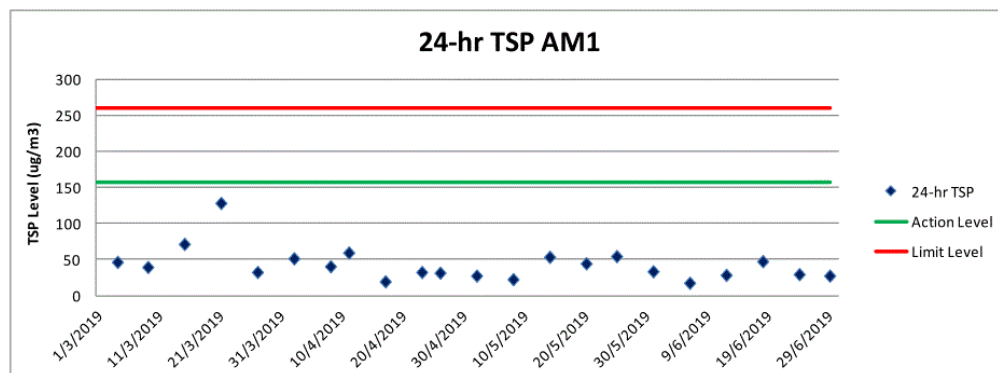
24-hr TSP Monitoring Result for AM1

Sampling ID & Paper No.	Temperature (°C) *1	Wind Direction *1	Wind Speed (m/s) *1	Sampling Date	Wt. of paper (g)			Flow Rate (CFM)	Total Volume *2 (m³)	TSP Concentration (µg/m³)
					Initial Wt.	Final Wt.	Wt. of dust			
AM10606 207177	23.9 - 29.0	E	<5m/s	6/6/2019	2.6734	2.7144	0.0410	50.0	2355.26	17
AM10612 207182	25.8 - 31.4	E	<5m/s	12/6/2019	2.6893	2.7558	0.0665	50.0	2355.26	28
AM10618 207183	27.0 - 30.3	SE	<5m/s	18/6/2019	2.6827	2.7944	0.1117	50.0	2355.26	47
AM10624 207179	24.0 - 30.3	SW	<5m/s	24/6/2019	2.6555	2.7242	0.0687	50.0	2355.26	29
AM10629 206472	29.2 - 34.2	S	<5m/s	29/6/2019	2.6863	2.7505	0.0642	50.0	2355.26	27

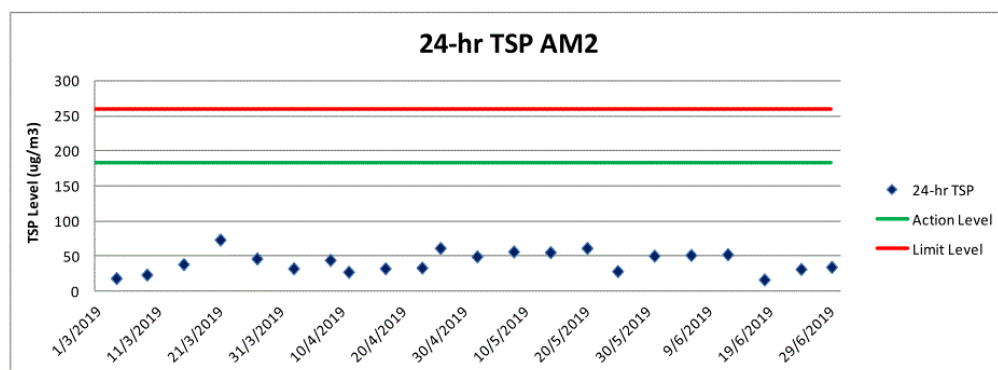
24-hr TSP Monitoring Result for AM2

Sampling ID & Paper No.	Temperature (°C) *1	Wind Direction *1	Wind Speed (m/s) *1	Sampling Date	Wt. of paper (g)			Flow Rate (CFM)	Total Volume *2 (m³)	TSP Concentration (µg/m³)
					Initial Wt.	Final Wt.	Wt. of dust			
AM20606 207172	23.9 - 29.0	E	<5m/s	6/6/2019	2.6918	2.8114	0.1196	50.0	2350.74	51
AM20612 207173	25.8 - 31.4	E	<5m/s	12/6/2019	2.7022	2.8252	0.1230	50.0	2350.74	52
AM20618 207140	27.0 - 30.3	SE	<5m/s	18/6/2019	2.6732	2.7112	0.0380	50.0	2350.74	16
AM20624 207145	24.0 - 30.3	SW	<5m/s	24/6/2019	2.6833	2.7559	0.0726	50.0	2350.74	31
AM20629 207137	29.2 - 34.2	S	<5m/s	29/6/2019	2.6926	2.7735	0.0809	50.0	2350.74	34

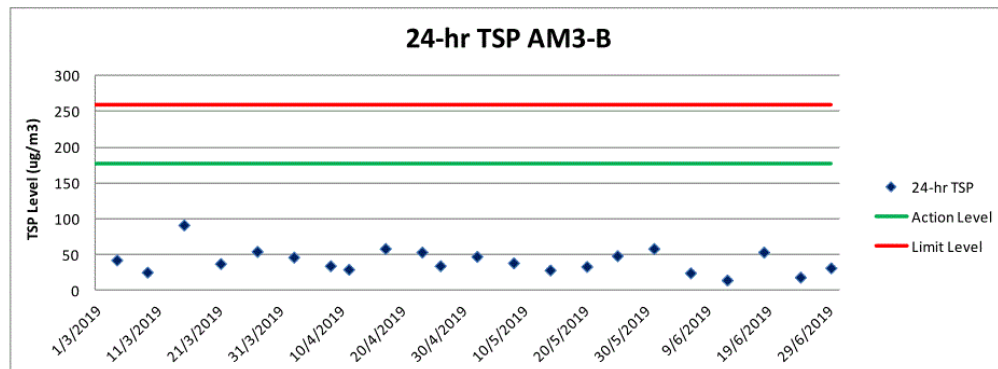
24-hr TSP Monitoring Result for AM3-B

Sampling ID & Paper No.	Temperature (°C) *1	Wind Direction *1	Wind Speed (m/s) *1	Sampling Date	Wt. of paper (g)			Flow Rate (CFM)	Total Volume *2 (m³)	TSP Concentration (µg/m³)
					Initial Wt.	Final Wt.	Wt. of dust			
AM3-B0606 207178	23.9 - 29.0	E	<5m/s	6/6/2019	2.6718	2.7310	0.0592	50.0	2396.98	25
AM3-B0612 207136	25.8 - 31.4	E	<5m/s	12/6/2019	2.6731	2.7082	0.0351	50.0	2396.98	15
AM3-B0618 207174	27.0 - 30.3	SE	<5m/s	18/6/2019	2.6782	2.8082	0.1300	50.0	2396.98	54
AM3-B0624 206471	24.0 - 30.3	SW	<5m/s	24/6/2019	2.6818	2.7277	0.0459	50.0	2396.98	19
AM3-B0629 207138	29.2 - 34.2	S	<5m/s	29/6/2019	2.6874	2.7650	0.0776	50.0	2396.98	32

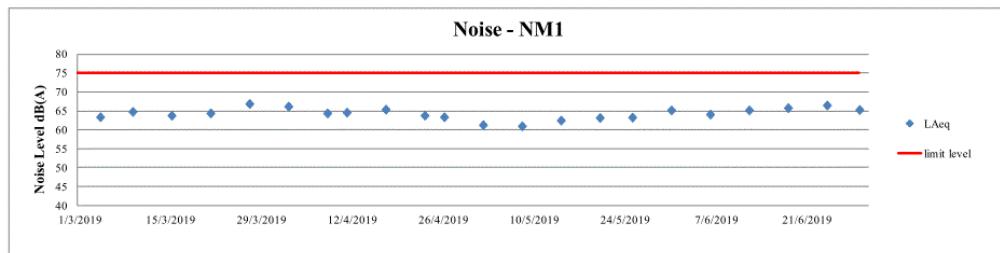
Noise Monitoring Result for NM1

Location	NM1				
Date	6/6/2019	12/6/2019	18/6/2019	24/6/2019	29/6/2019
Weather Condition	Overcast	Sunny	Overcast	Sunny	Overcast
Start Time	10:00	10:00	10:00	10:00	10:00
Measurement Period	30min	30min	30min	30min	30min
Baseline Level	75.1				
L _{Aeq}	64.1	65.2	65.8	66.5	65.3
L ₁₀	68.7	67.9	67.3	69.7	67.4
L ₉₀	60.8	61.8	60.5	59.4	59.0

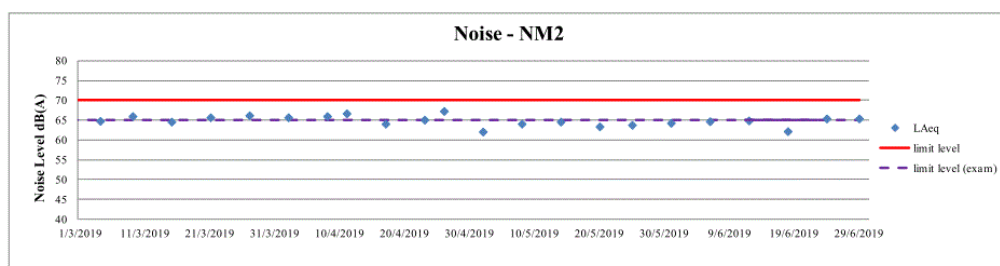
Noise Monitoring Result for NM2

Location	NM2				
Date	6/6/2019	12/6/2019	18/6/2019	24/6/2019	29/6/2019
Weather Condition	Overcast	Sunny	Overcast	Sunny	Overcast
Start Time	14:00	14:00	14:00	14:00	14:00
Measurement Period	30min	30min	30min	30min	30min
Baseline Level	66.5				
L _{Aeq}	64.8	65.0	62.3	65.5	65.5
L ₁₀	68.3	69.1	67.1	68.9	67.7
L ₉₀	61.1	60.6	59.7	59.2	60.9

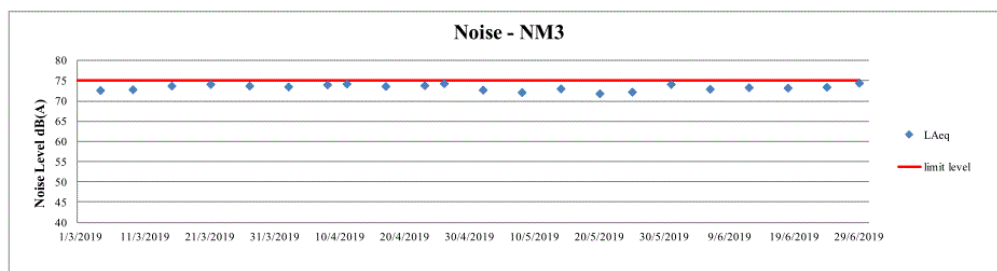
Noise Monitoring Result for NM3

Location	NM3				
Date	6/6/2019	12/6/2019	18/6/2019	24/6/2019	29/6/2019
Weather Condition	Overcast	Sunny	Overcast	Sunny	Overcast
Start Time	9:00	9:00	9:00	9:00	9:00
Measurement Period	30min	30min	30min	30min	30min
Baseline Level	74.5				
L _{Aeq}	73.0	73.4	73.3	73.5	74.5
L ₁₀	73.4	73.1	75.0	75.6	76.6
L ₉₀	66.3	67.2	66.1	68.1	69.7

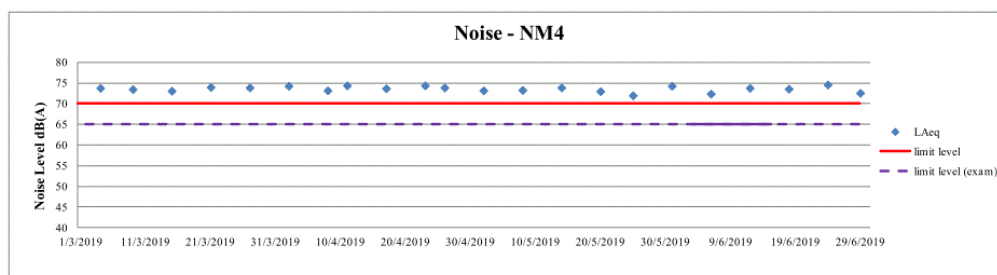
Noise Monitoring Result for NM4

The noise source for causing exceedances at NM4 was from the traffic of Canton Road. The NM4 was directly affected by the noise generated from the traffic. The recorded monitoring results at the NM4 were near the baseline noise level. The exceedances were not caused by the construction works of this project.

Location	NM4					NM4 (Re-measurement) *				
Date	6/6/2019	12/6/2019	18/6/2019	24/6/2019	29/6/2019	6/6/2019	12/6/2019	18/6/2019	24/6/2019	29/6/2019
Weather Condition	Overcast	Sunny	Overcast	Sunny	Overcast	Overcast	Sunny	Overcast	Sunny	Overcast
Start Time	13:00	13:00	13:00	13:00	13:00	13:30	13:30	13:30	13:30	13:30
Measurement Period	30min	30min	30min	30min	30min	30min	30min	30min	30min	30min
Baseline Level	73.3					73.3				
L _{Aeq}	72.4	73.8	73.6	74.6	72.6	72.4	75.1	74.8	73.9	73.0
L ₁₀	75.4	78.7	78.9	77.2	75.3	75.8	79.9	76.7	75.6	78.8
L ₉₀	67.9	69.8	69.9	68.7	66.0	70.2	71.8	70.7	67.2	67.5

* Repeat noise measurement when exceedance is recorded. The result is used to confirm the findings and it would not be showed on the graph plot

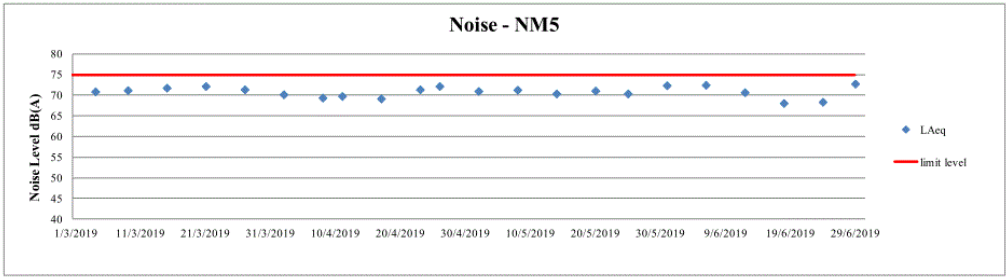
Noise Monitoring Result for NM5

Location	NM5				
Date	6/6/2019	12/6/2019	18/6/2019	24/6/2019	29/6/2019
Weather Condition	Overcast	Sunny	Overcast	Sunny	Overcast
Start Time	15:00	15:00	15:00	15:00	15:00
Measurement Period	30min	30min	30min	30min	30min
Baseline Level	71.8				
L _{Aeq}	72.5	70.7	68.1	68.4	72.8
L ₁₀	71.1	72.3	73.9	72.6	70.5
L ₉₀	67.8	66.7	64.4	68.8	66.9
