Proposed Road Improvement Works in West Kowloon Reclamation Development – Phase 1

Environmental Monitoring & Audit Report

01/07/2019 – 31/07/2019

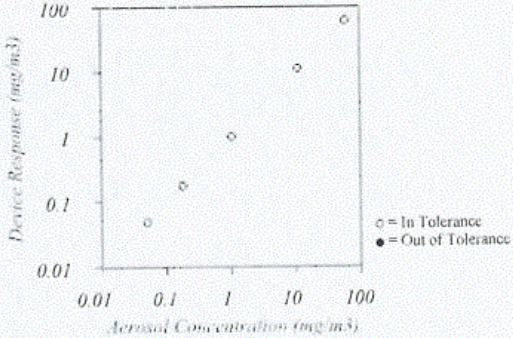
Concentration Linearity Plot

CONCENTRATION				Unit: mg/m3			
#	STANDARD	MEASURED	ALLOWABLE RANGE	#	STANDARD	MEASURED	ALLOWABLE RANGE
1	0.051	0.048	0.036-0.066	4	11.158	11.030	10.042-12.274
2	0.178	0.174	0.151-0.205	5	60.537	59.827	54.483-66.591
3	1.039	0.998	0.935-1.143

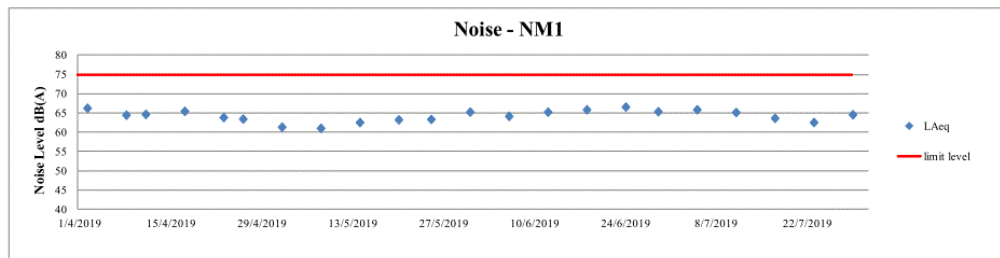
Noise Monitoring Result for NM1

Location	NM1				
Date	5/7/2019	11/7/2019	17/7/2019	23/7/2019	29/7/2019
Weather Condition	Overcast	Overcast	Overcast	Sunny	Sunny
Start Time	10:00	10:00	10:00	10:00	10:00
Measurement Period	30min	30min	30min	30min	30min
Baseline Level	75.1				
L_{Aeq}	65.8	65.1	63.6	62.5	64.5
L_{10}	67.2	67.4	64.6	66.8	67.8
L_{90}	61.5	60.5	60.2	59.8	61.9

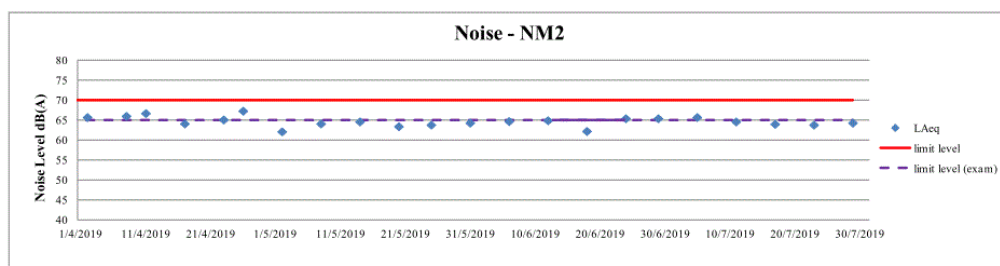
Noise Monitoring Result for NM2

Location	NM2				
Date	5/7/2019	11/7/2019	17/7/2019	23/7/2019	29/7/2019
Weather Condition	Overcast	Overcast	Overcast	Sunny	Sunny
Start Time	14:00	14:00	14:00	14:00	14:00
Measurement Period	30min	30min	30min	30min	30min
Baseline Level	66.5				
L_{Aeq}	65.8	64.7	64.1	63.9	64.4
L_{10}	67.0	66.9	67.5	66.8	66.7
L_{90}	59.9	60.1	58.7	59.2	60.3

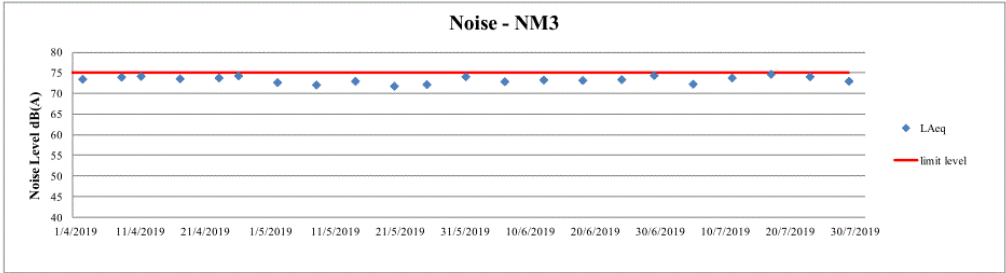
Noise Monitoring Result for NM3

Location	NM3				
Date	5/7/2019	11/7/2019	17/7/2019	23/7/2019	29/7/2019
Weather Condition	Overcast	Overcast	Overcast	Sunny	Sunny
Start Time	9:00	9:00	9:00	9:00	9:00
Measurement Period	30min	30min	30min	30min	30min
Baseline Level	74.5				
L _{Aeq}	72.4	73.9	74.8	74.2	73.1
L ₁₀	76.5	76.1	77.6	77.5	76.5
L ₉₀	67.6	65.7	69.2	67.9	68.2

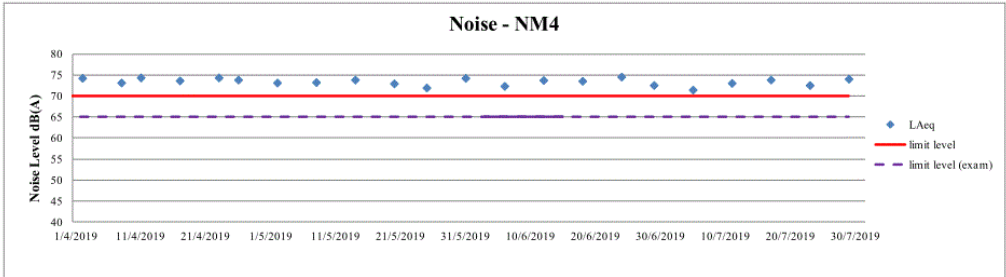
Noise Monitoring Result for NM4

The noise source for causing exceedances at NM4 was from the traffic of Canton Road. The NM4 was directly affected by the noise generated from the traffic. The recorded monitoring results at the NM4 were near the baseline noise level. The exceedances were not caused by the construction works of this project.

Location	NM4					NM4 (Re-measurement) *				
Date	5/7/2019	11/7/2019	17/7/2019	23/7/2019	29/7/2019	5/7/2019	11/7/2019	17/7/2019	23/7/2019	29/7/2019
Weather Condition	Overcast	Overcast	Overcast	Sunny	Sunny	Overcast	Overcast	Overcast	Sunny	Sunny
Start Time	13:00	13:00	13:00	13:00	13:00	13:30	13:30	13:30	13:30	13:30
Measurement Period	30min	30min	30min	30min	30min	30min	30min	30min	30min	30min
Baseline Level	73.3					73.3				
L _{Aeq}	71.5	73.1	73.9	72.6	74.1	72.6	73.3	73.8	73.4	73.9
L ₁₀	76.8	76.4	78.9	74.9	77.8	76.2	76.2	78.3	76.6	77.4
L ₉₀	67.9	66.3	66.4	65.6	68.1	67.4	65.8	66.7	65.1	67.5

* Repeat noise measurement when exceedance is recorded. The result is used to confirm the findings and it would not be showed on the graph plot

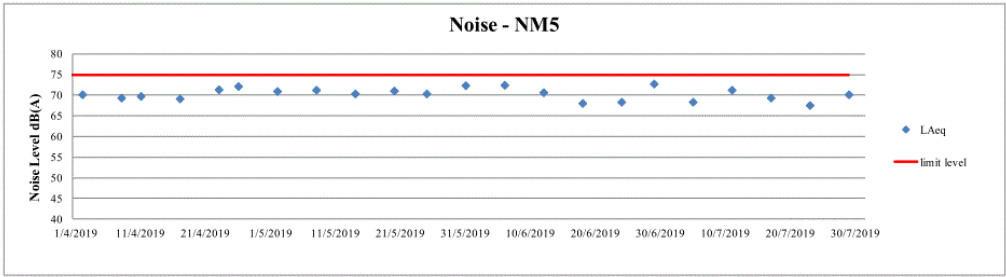
Noise Monitoring Result for NM5

Location	NM5				
Date	5/7/2019	11/7/2019	17/7/2019	23/7/2019	29/7/2019
Weather Condition	Overcast	Overcast	Overcast	Sunny	Sunny
Start Time	15:00	15:00	15:00	15:00	15:00
Measurement Period	30min	30min	30min	30min	30min
Baseline Level	71.8				
L _{Aeq}	68.4	71.3	69.4	67.6	70.2
L ₁₀	70.5	72.9	73.8	72.5	72.6
L ₉₀	63.5	63.7	60.0	64.2	65.8
