Proposed Road Improvement Works in West Kowloon Reclamation Development – Phase 1

Environmental Monitoring & Audit Report

01/08/2019 – 31/08/2019

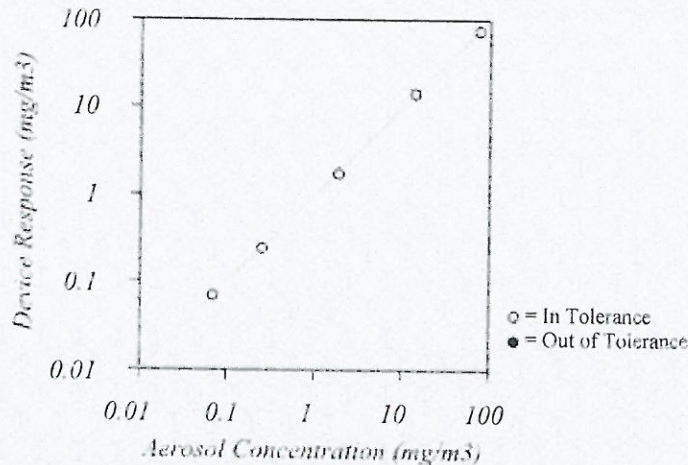
Concentration Linearity Plot

CONCENTRATION				Unit: mg/m ³			
#	STANDARD	MEASURED	ALLOWABLE RANGE	#	STANDARD	MEASURED	ALLOWABLE RANGE
1	0.070	0.070	0.049-0.091	4	14.010	14.191	12.609-15.411
2	0.251	0.241	0.213-0.289	5	74.881	73.746	67.393-82.369
3	1.834	1.723	1.651-2.017

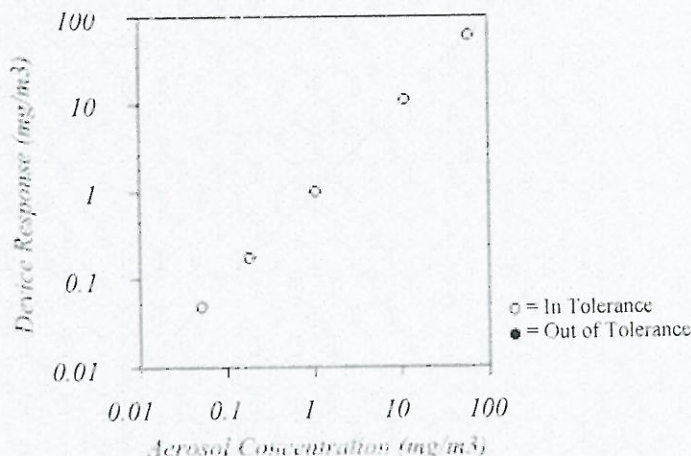
Concentration Linearity Plot

CONCENTRATION						Unit: mg/m ³	
#	STANDARD	MEASURED	ALLOWABLE RANGE	#	STANDARD	MEASURED	ALLOWABLE RANGE
1	0.051	0.048	0.036-0.066	4	11.158	11.030	10.042-12.274
2	0.178	0.174	0.151-0.205	5	60.537	59.827	54.483-66.591
3	1.039	0.998	0.935-1.143

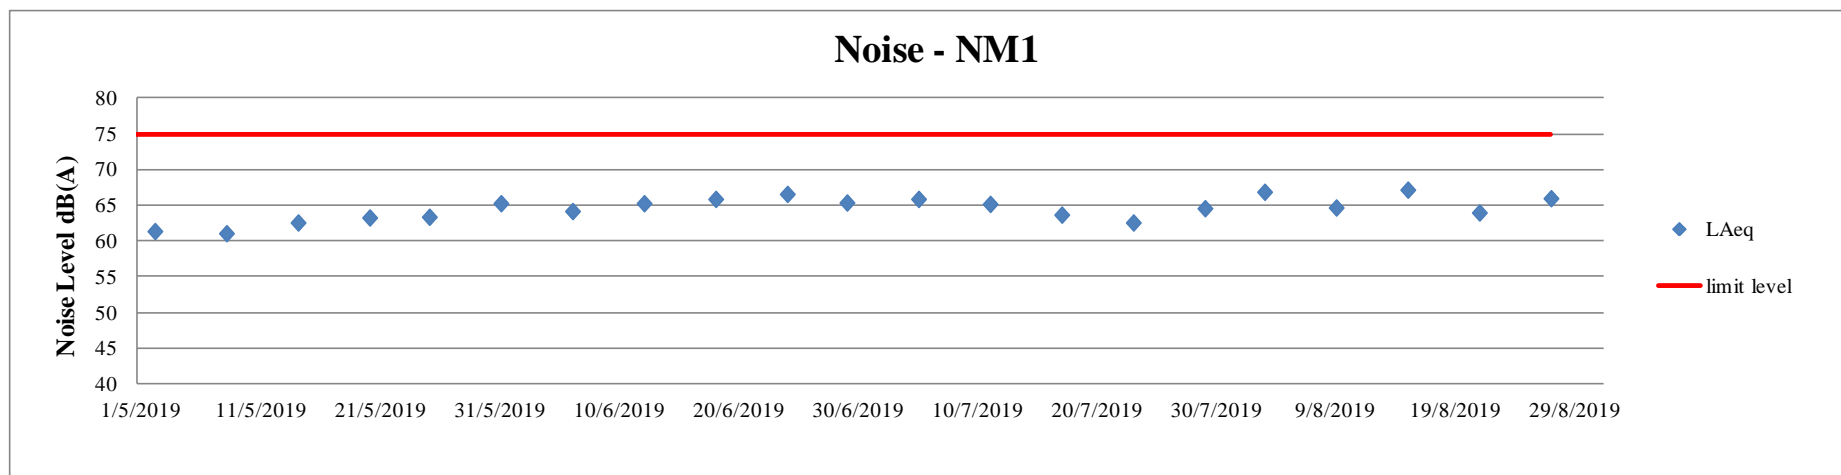
Noise Monitoring Result for NM1

Location	NM1				
Date	3/8/2019	9/8/2019	15/8/2019	21/8/2019	27/8/2019
Weather Condition	Overcast	Overcast	Sunny	Overcast	Overcast
Start Time	10:00	10:00	10:00	10:00	10:00
Measurement Period	30min	30min	30min	30min	30min
Baseline Level	75.1				
L _{Aeq}	66.8	64.6	67.1	63.9	65.9
L ₁₀	70.4	69.1	69.2	67.5	68.2
L ₉₀	61.5	62.5	62.1	60.3	62.2

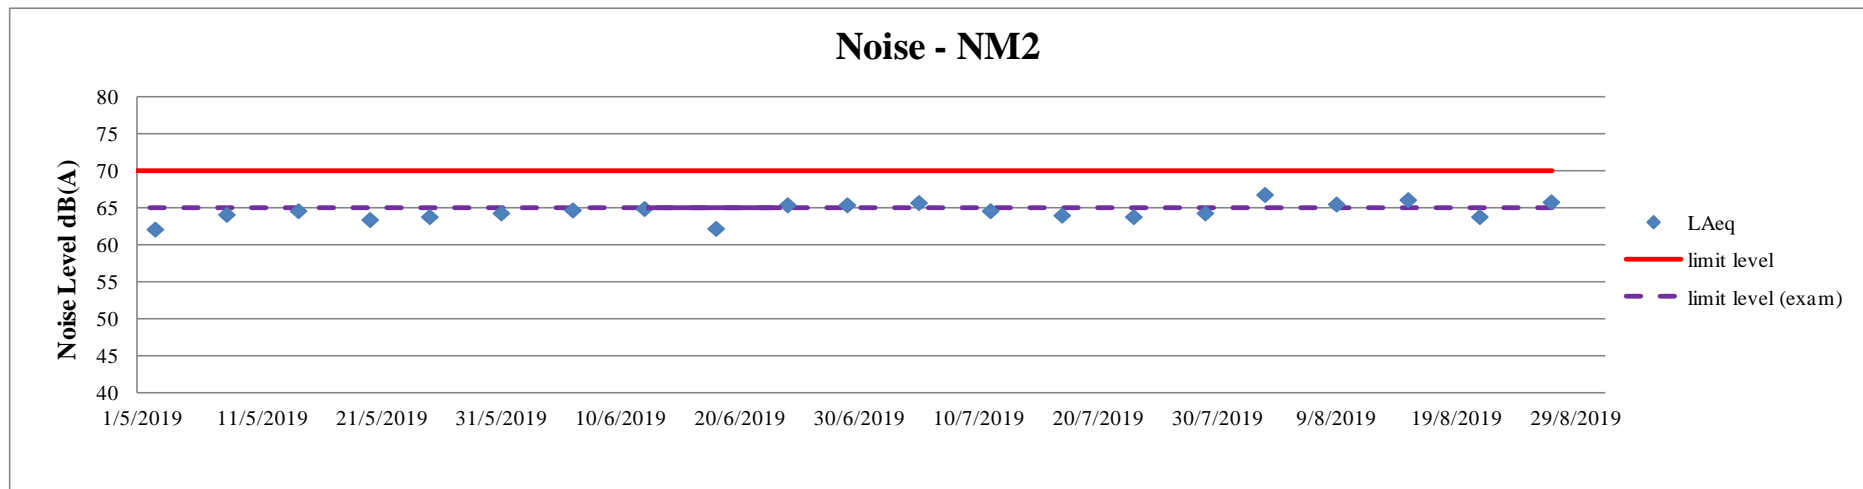
Noise Monitoring Result for NM2

Location	NM2				
Date	3/8/2019	9/8/2019	15/8/2019	21/8/2019	27/8/2019
Weather Condition	Overcast	Overcast	Sunny	Overcast	Overcast
Start Time	14:00	14:00	14:00	14:00	14:00
Measurement Period	30min	30min	30min	30min	30min
Baseline Level	66.5				
L _{Aeq}	66.9	65.6	66.2	63.9	65.9
L ₁₀	68.1	66.9	68.9	66.9	68.6
L ₉₀	60.1	61.1	60.9	60.9	62.2

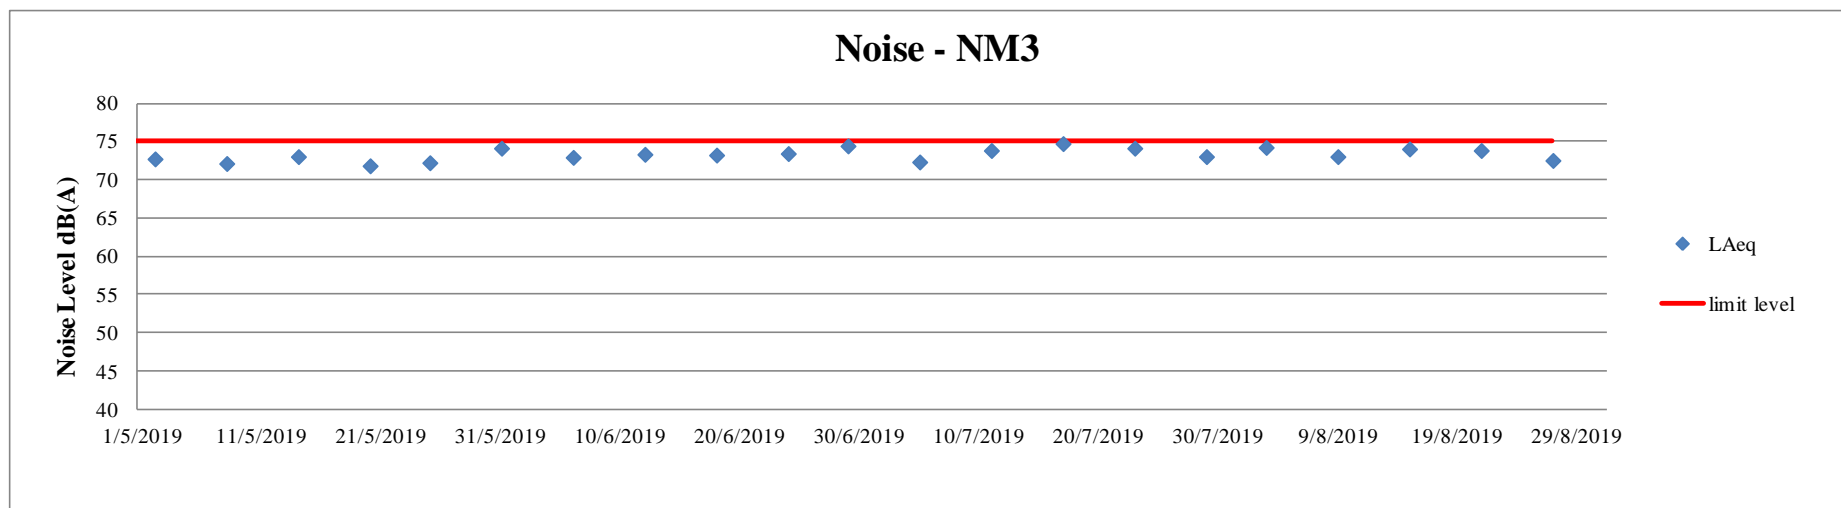
Noise Monitoring Result for NM3

Location	NM3				
Date	3/8/2019	9/8/2019	15/8/2019	21/8/2019	27/8/2019
Weather Condition	Overcast	Overcast	Sunny	Overcast	Overcast
Start Time	9:00	9:00	9:00	9:00	9:00
Measurement Period	30min	30min	30min	30min	30min
Baseline Level	74.5				
L _{Aeq}	74.3	73.1	74.1	73.9	72.6
L ₁₀	76.3	74.9	76.5	75.9	75.2
L ₉₀	68.0	68.2	68.7	67.9	66.9

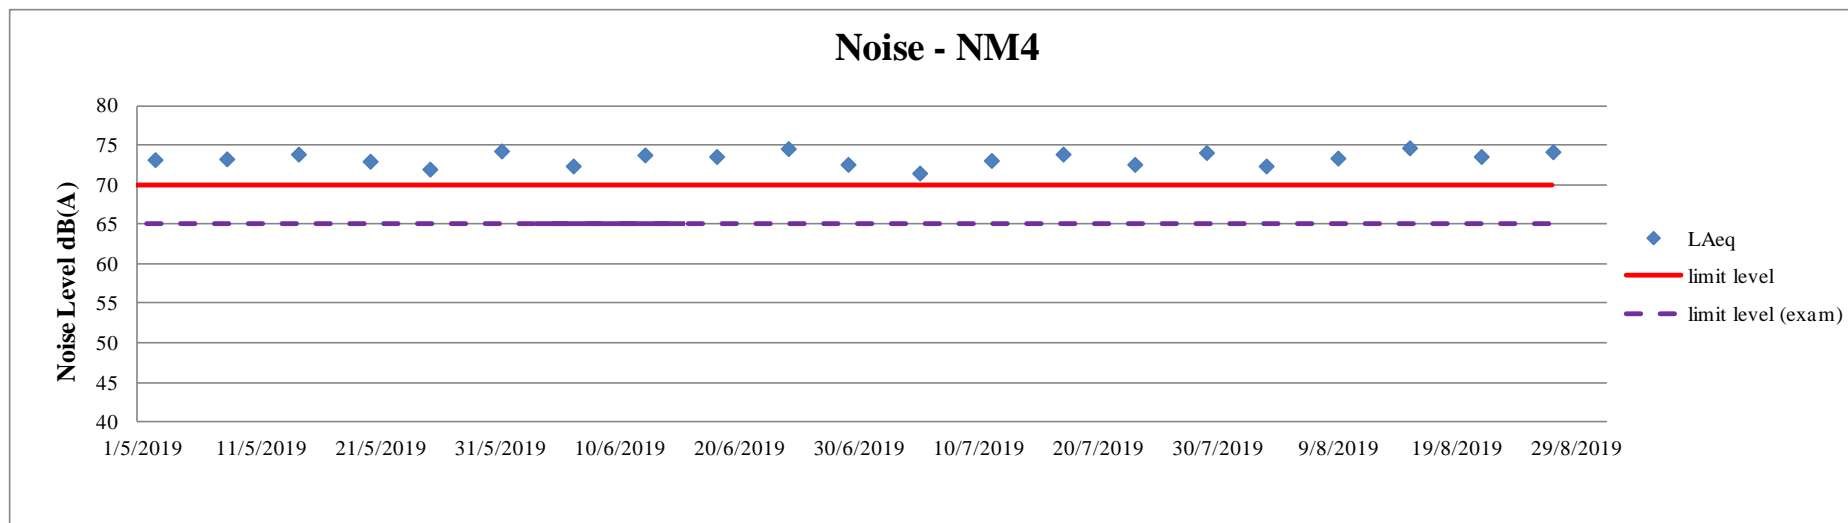
Noise Monitoring Result for NM4

The noise source for causing exceedances at NM4 was from the traffic of Canton Road. The NM4 was directly affected by the noise generated from the traffic. The recorded monitoring results at the NM4 were near the baseline noise level. The exceedances were not caused by the construction works of this project.

Location	NM4					NM4 (Re-measurement) *				
Date	3/8/2019	9/8/2019	15/8/2019	21/8/2019	27/8/2019	3/8/2019	9/8/2019	15/8/2019	21/8/2019	27/8/2019
Weather Condition	Overcast	Overcast	Sunny	Overcast	Overcast	Overcast	Overcast	Sunny	Overcast	Overcast
Start Time	13:00	13:00	13:00	13:00	13:00	13:30	13:30	13:30	13:30	13:30
Measurement Period	30min	30min	30min	30min	30min	30min	30min	30min	30min	30min
Baseline Level	73.3					73.3				
L _{Aeq}	72.4	73.4	74.7	73.6	74.2	72.6	73.8	74.6	74.1	74.6
L ₁₀	76.9	75.4	78.1	75.2	76.9	76.4	75.9	77.9	75.9	77.2
L ₉₀	68.9	67.9	67.4	66.6	67.2	68.3	68.0	67.5	67.2	66.9

* Repeat noise measurement when exceedance is recorded. The result is used to confirm the findings and it would not be showed on the graph plot

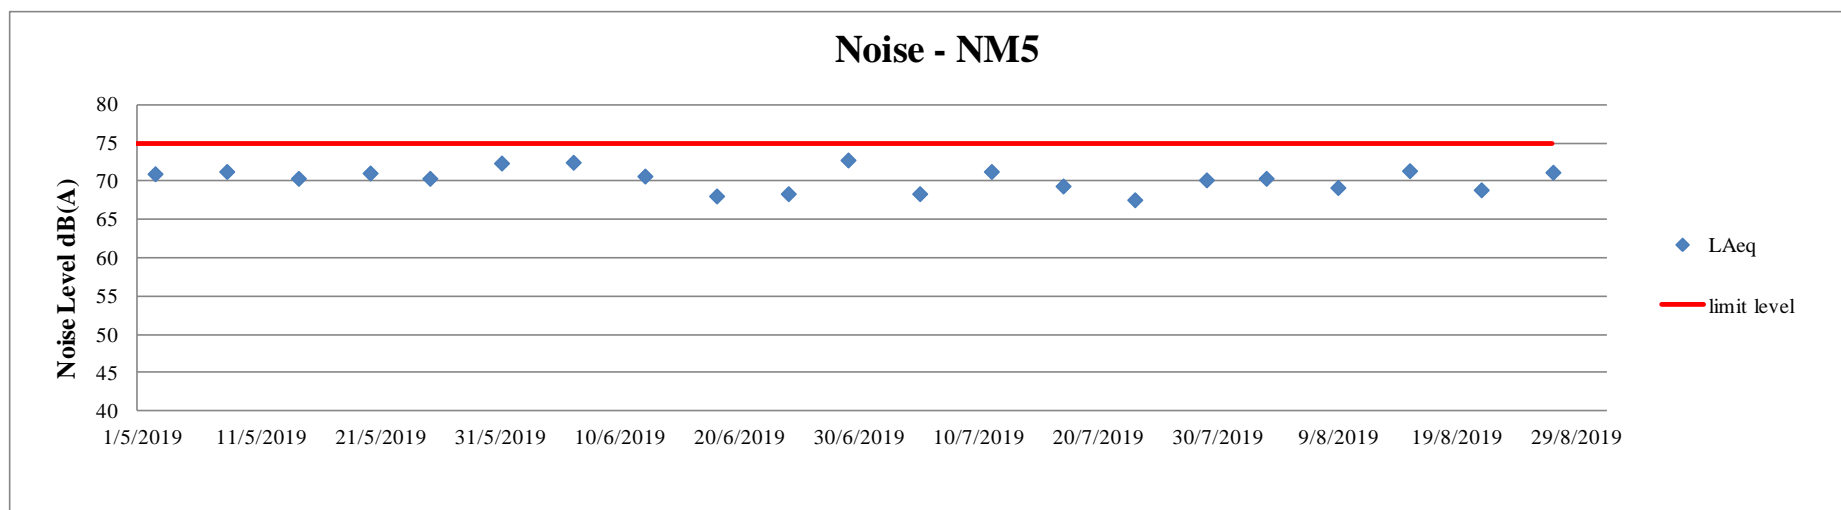
Noise Monitoring Result for NM5

Location	NM5				
Date	3/8/2019	9/8/2019	15/8/2019	21/8/2019	27/8/2019
Weather Condition	Overcast	Overcast	Sunny	Overcast	Overcast
Start Time	15:00	15:00	15:00	15:00	15:00
Measurement Period	30min	30min	30min	30min	30min
Baseline Level	71.8				
L _{Aeq}	70.4	69.2	71.4	68.9	71.2
L ₁₀	71.6	70.9	73.6	72.2	73.3
L ₉₀	66.8	64.8	64.5	65.9	66.9
