Proposed Road Improvement Works in West Kowloon Reclamation Development – Phase 1

Environmental Monitoring & Audit Report

01/09/2019 – 30/09/2019

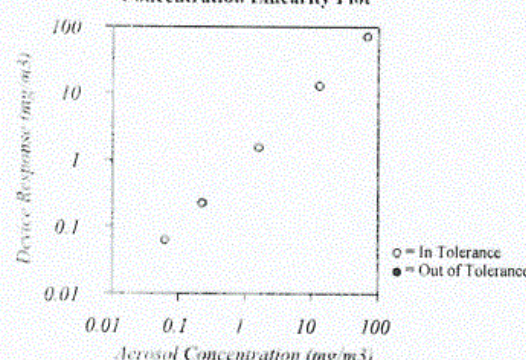
Concentration Linearity Plot

CONCENTRATION				Unit: mg/m3			
#	STANDARD	MEASURED	ALLOWABLE RANGE	#	STANDARD	MEASURED	ALLOWABLE RANGE
1	0.063	0.063	0.044-0.082	4	12.955	12.919	11.659-14.251
2	0.226	0.226	0.192-0.260	5	67.631	71.237	60.868-74.394
3	1.587	1.529	1.428-1.746

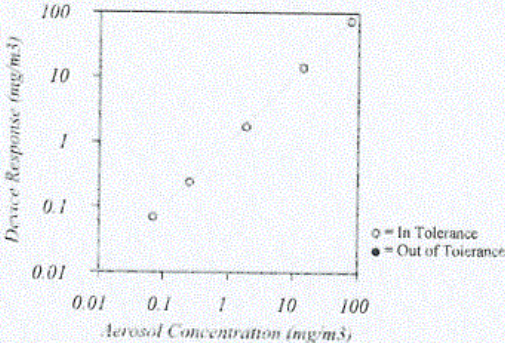
Concentration Linearity Plot

CONCENTRATION				Unit: mg/m3			
#	STANDARD	MEASURED	ALLOWABLE RANGE	#	STANDARD	MEASURED	ALLOWABLE RANGE
1	0.070	0.070	0.049-0.091	4	14.010	14.191	12.609-15.411
2	0.251	0.241	0.213-0.289	5	74.881	73.746	67.393-82.369
3	1.834	1.723	1.651-2.017

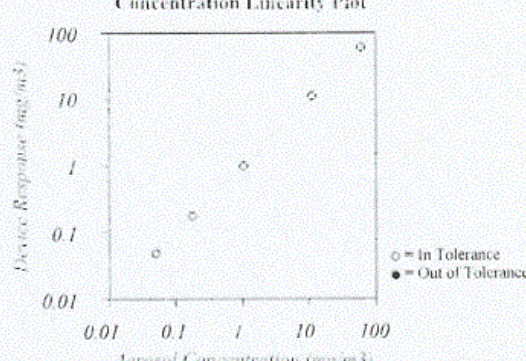
Concentration Linearity Plot

CONCENTRATION				Unit: mg/m3			
#	STANDARD	MEASURED	ALLOWABLE RANGE	#	STANDARD	MEASURED	ALLOWABLE RANGE
1	0.051	0.048	0.036-0.066	4	11.158	11.008	10.042-12.274
2	0.178	0.172	0.151-0.205	5	60.537	59.868	54.483-66.591
3	1.039	0.989	0.935-1.143

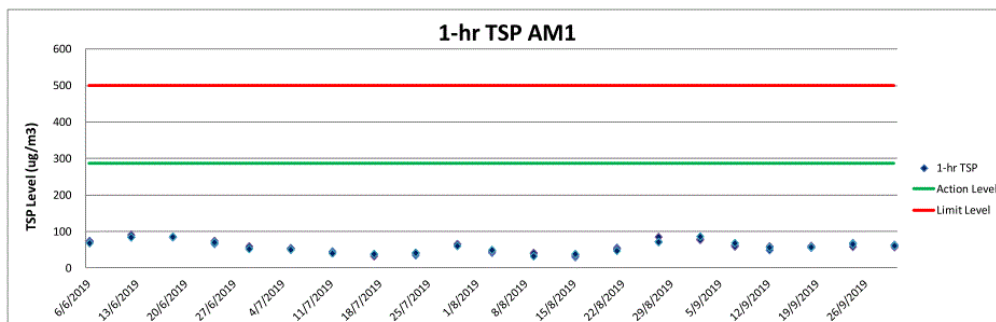
Date	Weather	Temperature (°C) *	Wind Direction *	Wind Speed (m/s) *	Sampling Time			Reading (µg/m³)			
					1	2	3	1	2	3	Average
2/9/2019	Cloudy	26	NE	<5m/s	13:00	14:01	15:02	79	77	86	81
7/9/2019	Cloudy	31	S	<5m/s	13:00	14:01	15:02	62	59	68	63
12/9/2019	Sunny	32	SE	<5m/s	13:00	14:01	15:02	49	59	56	55
18/9/2019	Sunny	32	SE	<5m/s	13:00	14:01	15:02	56	60	57	58
24/9/2019	Sunny	30	NE	<5m/s	13:00	14:01	15:02	68	58	65	64
30/9/2019	Cloudy	34	SW	<5m/s	13:00	14:01	15:02	63	57	61	60

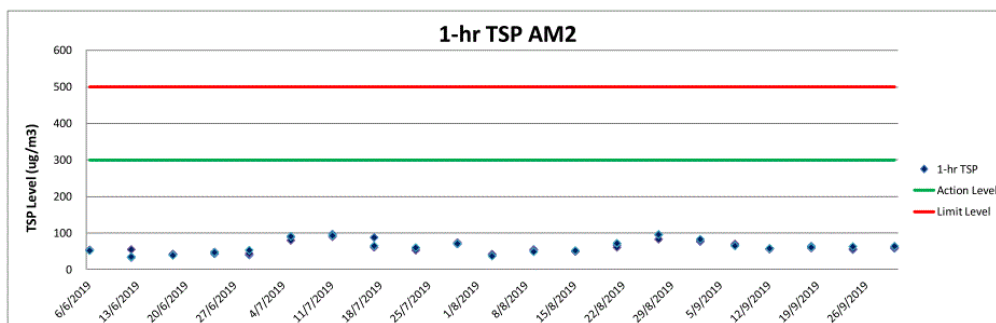
1-hr TSP Monitoring Result for AM2

Date	Weather	Temperature (°C) *	Wind Direction *	Wind Speed (m/s) *	Sampling Time			Reading (µg/m³)			
					1	2	3	1	2	3	Average
2/9/2019	Cloudy	26	NE	<5m/s	9:00	10:01	11:02	77	78	83	79
7/9/2019	Cloudy	31	S	<5m/s	9:00	10:01	11:02	67	70	65	67
12/9/2019	Sunny	32	SE	<5m/s	9:00	10:01	11:02	57	56	58	57
18/9/2019	Sunny	32	SE	<5m/s	9:00	10:01	11:02	64	59	61	61
24/9/2019	Sunny	30	NE	<5m/s	8:00	9:01	10:02	55	56	63	58
30/9/2019	Cloudy	34	SW	<5m/s	9:00	10:01	11:02	58	60	64	61

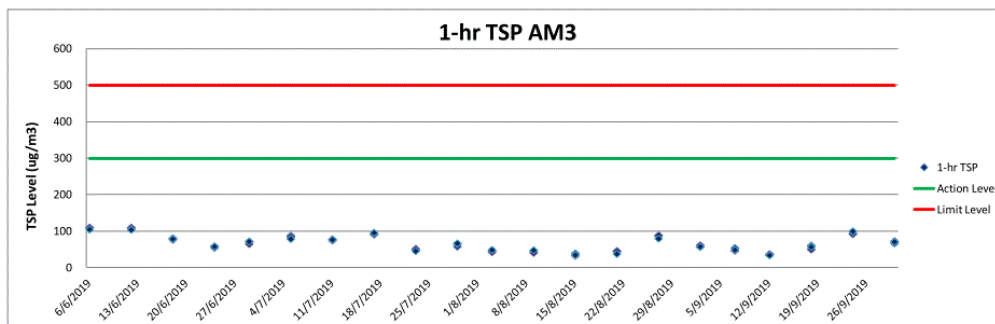
1-hr TSP Monitoring Result for AM3

Date	Weather	Temperature (°C) *	Wind Direction *	Wind Speed (m/s) *	Sampling Time			Reading (µg/m³)			
					1	2	3	1	2	3	Average
2/9/2019	Cloudy	26	NE	<5m/s	14:00	15:01	16:02	57	62	58	59
7/9/2019	Cloudy	31	S	<5m/s	14:00	15:01	16:02	54	47	49	50
12/9/2019	Sunny	32	SE	<5m/s	14:00	15:01	16:02	37	37	34	36
18/9/2019	Sunny	32	SE	<5m/s	14:00	15:01	16:02	61	50	57	56
24/9/2019	Sunny	30	NE	<5m/s	13:00	14:01	15:02	92	94	100	95
30/9/2019	Cloudy	34	SW	<5m/s	14:00	15:01	16:02	67	73	71	70

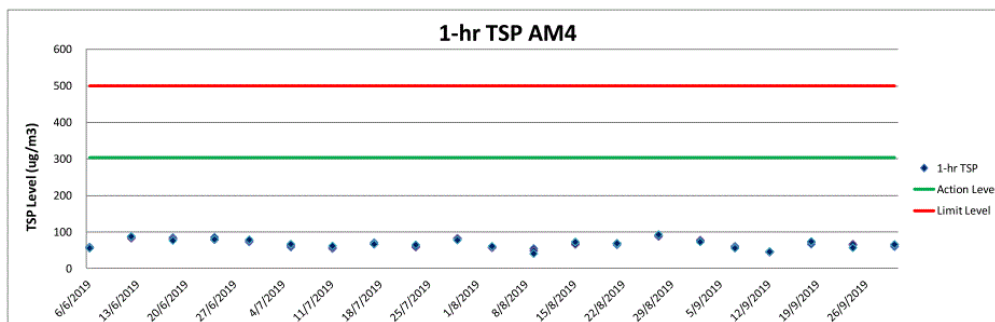
1-hr TSP Monitoring Result for AM4

Date	Weather	Temperature (°C) *	Wind Direction *	Wind Speed (m/s) *	Sampling Time			Reading (µg/m³)			
					1	2	3	1	2	3	Average
2/9/2019	Cloudy	26	NE	<5m/s	13:30	14:31	15:32	76	78	73	76
7/9/2019	Cloudy	31	S	<5m/s	13:30	14:31	15:32	61	58	56	58
12/9/2019	Sunny	32	SE	<5m/s	13:30	14:31	15:32	46	45	46	46
18/9/2019	Sunny	32	SE	<5m/s	13:30	14:31	15:32	67	73	74	71
24/9/2019	Sunny	30	NE	<5m/s	12:30	13:31	14:32	64	67	57	63
30/9/2019	Cloudy	34	SW	<5m/s	13:30	14:31	15:32	60	65	66	64

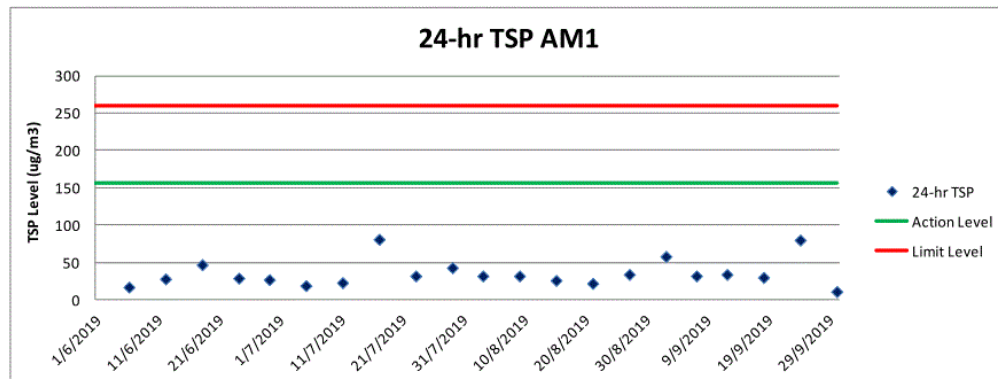
24-hr TSP Monitoring Result for AM1

Sampling ID & Paper No.	Temperature (°C) *1	Wind Direction *1	Wind Speed (m/s) *1	Sampling Date	Wt. of paper (g)			Flow Rate (CFM)	Total Volume *2 (m³)	TSP Concentration (µg/m³)
					Initial Wt.	Final Wt.	Wt. of dust			
AM10902 207131	26.0 - 29.3	NE	<5m/s	2/9/2019	2.6527	2.7900	0.1373	50.0	2379.75	58
AM10907 207110	31.0 - 34.2	S	<5m/s	7/9/2019	2.6752	2.7521	0.0769	50.0	2379.75	32
AM10912 207130	32.1 - 34.3	SE	<5m/s	12/9/2019	2.6648	2.7454	0.0806	50.0	2379.75	34
AM10918 207167	31.5 - 32.0	SE	<5m/s	18/9/2019	2.7045	2.7767	0.0722	50.0	2379.75	30
AM10924 207393	29.8 - 31.8	NE	<5m/s	24/9/2019	2.6953	2.8848	0.1895	50.0	2379.75	80
AM10930 207390	33.4 - 34.5	SW	<5m/s	30/9/2019	2.7074	2.7336	0.0262	50.0	2280.45	11

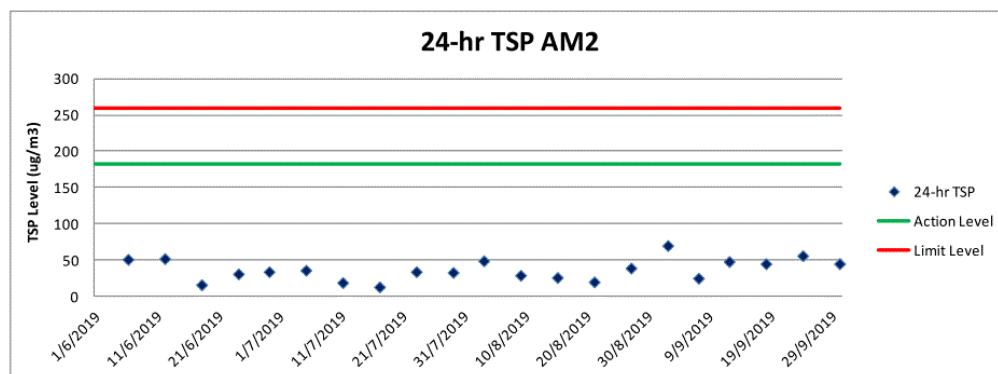
24-hr TSP Monitoring Result for AM2

Sampling ID & Paper No.	Temperature (°C) *1	Wind Direction *1	Wind Speed (m/s) *1	Sampling Date	Wt. of paper (g)			Flow Rate (CFM)	Total Volume *2 (m³)	TSP Concentration (µg/m³)
					Initial Wt.	Final Wt.	Wt. of dust			
AM20902 207165	26.0 - 29.3	NE	<5m/s	2/9/2019	2.6885	2.8497	0.1612	50.0	2292.32	70
AM20907 207166	31.0 - 34.2	S	<5m/s	7/9/2019	2.6789	2.7366	0.0577	50.0	2292.32	25
AM20912 207135	32.1 - 34.3	SE	<5m/s	12/9/2019	2.6875	2.7986	0.1111	50.0	2292.32	48
AM20918 207158	31.5 - 32.0	SE	<5m/s	18/9/2019	2.6856	2.7888	0.1032	50.0	2292.32	45
AM20924 207111	29.8 - 31.8	NE	<5m/s	24/9/2019	2.6633	2.7913	0.1280	50.0	2292.32	56
AM20930 207134	33.4 - 34.5	SW	<5m/s	30/9/2019	2.6710	2.7673	0.0963	50.0	2128.57	45

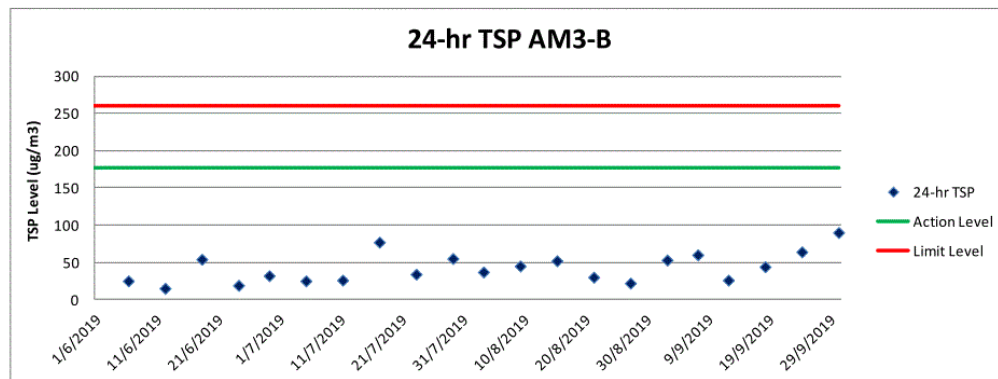
24-hr TSP Monitoring Result for AM3-B

Sampling ID & Paper No.	Temperature (°C) *1	Wind Direction *1	Wind Speed (m/s) *1	Sampling Date	Wt. of paper (g)			Flow Rate (CFM)	Total Volume *2 (m³)	TSP Concentration (µg/m³)
					Initial Wt.	Final Wt.	Wt. of dust			
AM3-B0902 207396	26.0 - 29.3	NE	<5m/s	2/9/2019	2.7477	2.8730	0.1253	50.0	2372.13	53
AM3-B0907 207392	31.0 - 34.2	S	<5m/s	7/9/2019	2.7028	2.8461	0.1433	50.0	2372.13	60
AM3-B0912 207116	32.1 - 34.3	SE	<5m/s	12/9/2019	2.6909	2.7536	0.0627	50.0	2372.13	26
AM3-B0918 207109	31.5 - 32.0	SE	<5m/s	18/9/2019	2.6718	2.7773	0.1055	50.0	2372.13	44
AM3-B0924 207117	29.8 - 31.8	NE	<5m/s	24/9/2019	2.6760	2.8269	0.1509	50.0	2372.13	64
AM3-B0930 207168	33.4 - 34.5	SW	<5m/s	30/9/2019	2.6771	2.8817	0.2046	50.0	2262.01	90

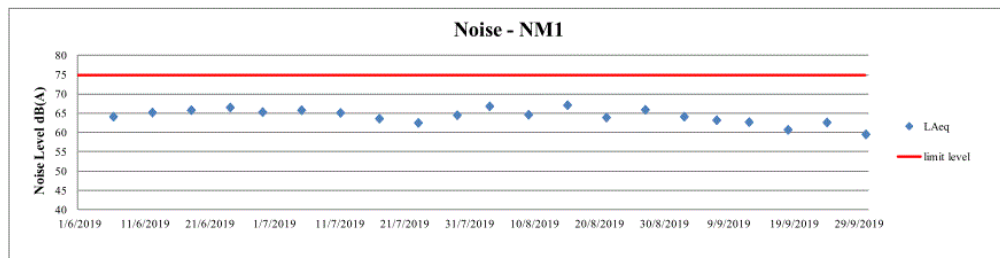
Noise Monitoring Result for NM1

Location	NM1					
Date	2/9/2019	7/9/2019	12/9/2019	18/9/2019	24/9/2019	30/9/2019
Weather Condition	Cloudy	Cloudy	Sunny	Sunny	Sunny	Cloudy
Start Time	10:00	10:00	10:00	10:00	10:00	10:00
Measurement Period	30min	30min	30min	30min	30min	30min
Baseline Level	75.1					
L _{Aeq}	64.1	63.2	62.7	60.7	62.6	59.5
L ₁₀	66.5	67.2	67.3	61.7	66.2	60.7
L ₉₀	59.4	59.3	60.3	59.1	58.9	68.2

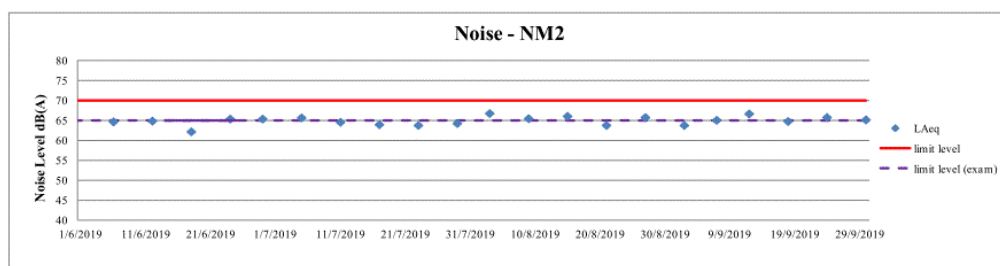
Noise Monitoring Result for NM2

Location	NM2					
Date	2/9/2019	7/9/2019	12/9/2019	18/9/2019	24/9/2019	30/9/2019
Weather Condition	Cloudy	Cloudy	Sunny	Sunny	Sunny	Cloudy
Start Time	14:00	14:00	14:00	14:00	14:00	14:00
Measurement Period	30min	30min	30min	30min	30min	30min
Baseline Level	66.5					
L _{Aeq}	63.9	65.2	66.8	64.9	65.9	65.3
L ₁₀	66.9	67.6	68.2	67.1	66.9	67.3
L ₉₀	61.2	60.0	62.9	61.6	61.2	61.4

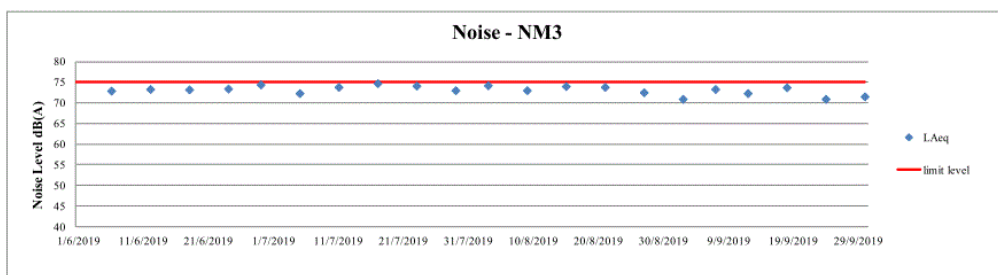
Noise Monitoring Result for NM3

Location	NM3					
Date	2/9/2019	7/9/2019	12/9/2019	18/9/2019	24/9/2019	30/9/2019
Weather Condition	Cloudy	Cloudy	Sunny	Sunny	Sunny	Cloudy
Start Time	9:00	9:00	9:00	9:00	9:00	9:00
Measurement Period	30min	30min	30min	30min	30min	30min
Baseline Level	74.5					
L _{Aeq}	71.0	73.4	72.4	73.8	71.0	71.6
L ₁₀	74.0	73.8	74.0	76.8	76.2	75.8
L ₉₀	65.4	69.0	70.6	68.4	68.5	68.0

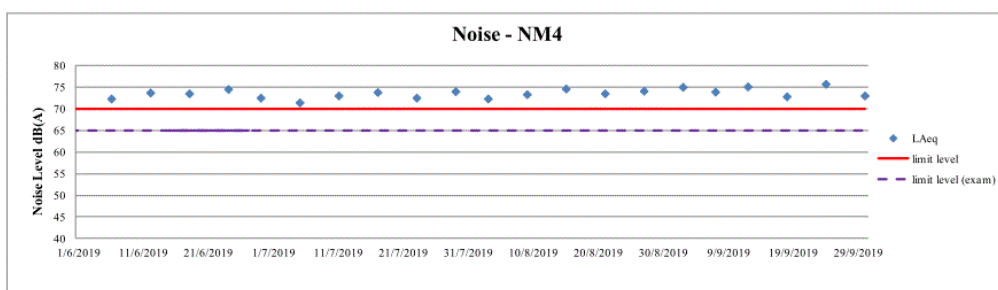
Noise Monitoring Result for NM4

The noise source for causing exceedances at NM4 was from the traffic of Canton Road. The NM4 was directly affected by the noise generated from the traffic. The recorded monitoring results at the NM4 were near the baseline noise level. The exceedances were not caused by the construction works of this project.

Location	NM4						NM4 (Re-measurement) *					
Date	2/9/2019	7/9/2019	12/9/2019	18/9/2019	24/9/2019	30/9/2019	2/9/2019	7/9/2019	12/9/2019	18/9/2019	24/9/2019	30/9/2019
Weather Condition	Cloudy	Cloudy	Sunny	Sunny	Sunny	Cloudy	Cloudy	Cloudy	Sunny	Sunny	Sunny	Cloudy
Start Time	13:00	13:00	13:00	13:00	13:00	13:00	13:30	13:30	13:30	13:30	13:30	13:30
Measurement Period	30min	30min	30min	30min	30min	30min	30min	30min	30min	30min	30min	30min
Baseline Level	73.3						73.3					
L _{Aeq}	75.1	74.0	75.2	72.9	75.8	73.1	75.8	73.6	76.2	74.4	73.9	73.4
L ₁₀	78.9	77.1	79.6	75.7	78.8	75.3	77.8	76.3	77.8	77.2	75.9	75.4
L ₉₀	67.7	68.7	70.0	65.8	69.2	66.4	68.4	68.5	69.0	67.0	66.9	66.0

* Repeat noise measurement when exceedance is recorded. The result is used to confirm the findings and it would not be showed on the graph plot

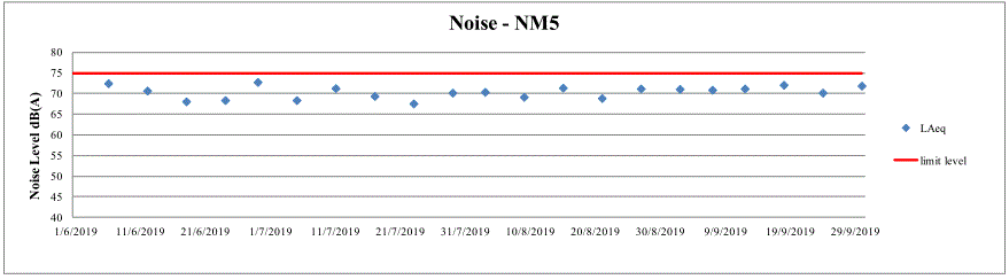
Noise Monitoring Result for NM5

Location	NM5					
Date	2/9/2019	7/9/2019	12/9/2019	18/9/2019	24/9/2019	30/9/2019
Weather Condition	Cloudy	Cloudy	Sunny	Sunny	Sunny	Cloudy
Start Time	15:00	15:00	15:00	15:00	15:00	15:00
Measurement Period	30min	30min	30min	30min	30min	30min
Baseline Level	71.8					
L _{Aeq}	71.1	70.9	71.2	72.1	70.2	71.9
L ₋₁₀	74.2	73.9	73.6	74.8	73.3	75.2
L ₋₉₀	64.4	63.9	63.6	64.2	65.9	66.0
