# **Proposed Road Improvement Works in West Kowloon Reclamation Development – Phase 1**

## **Environmental Monitoring & Audit Report**

**01/11/2019 – 30/11/2019**

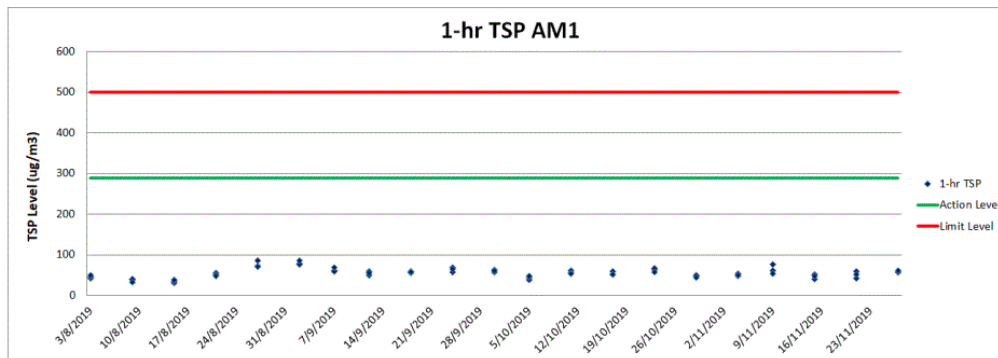
Date	Weather	Temperature (°C) *	Wind Direction *	Wind Speed (m/s) *	Sampling Time			Reading (µg/m³)			
					1	2	3	1	2	3	Average
4/11/2019	Cloudy	29	NE	<5m/s	13:00	14:01	15:02	48	53	50	50
9/11/2019	Cloudy	25.7	E	<5m/s	13:00	14:01	15:02	77	61	53	64
15/11/2019	Cloudy	26.8	E	<5m/s	13:00	14:01	15:02	40	52	48	47
21/11/2019	Sunny	26.5	SE	<5m/s	13:00	14:01	15:02	42	60	52	51
27/11/2019	Sunny	27	E	<5m/s	13:00	14:01	15:02	58	58	61	59

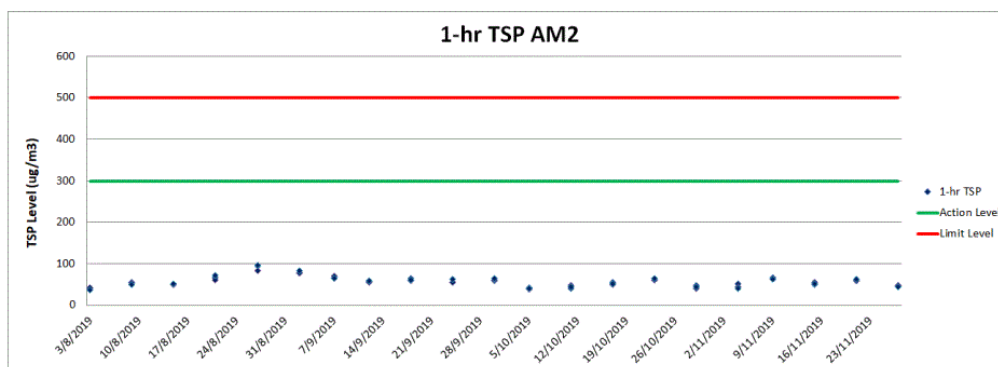
1-hr TSP Monitoring Result for AM2

Date	Weather	Temperature (°C) *	Wind Direction *	Wind Speed (m/s) *	Sampling Time			Reading (µg/m³)			
					1	2	3	1	2	3	Average
4/11/2019	Cloudy	29	NE	<5m/s	9:00	10:01	11:02	52	44	41	46
9/11/2019	Cloudy	25.7	E	<5m/s	9:00	10:01	11:02	67	62	63	64
15/11/2019	Cloudy	26.8	E	<5m/s	9:00	10:01	11:02	50	55	51	52
21/11/2019	Sunny	26.5	SE	<5m/s	9:00	10:01	11:02	58	59	62	60
27/11/2019	Sunny	27	E	<5m/s	8:00	9:01	10:02	45	48	44	46

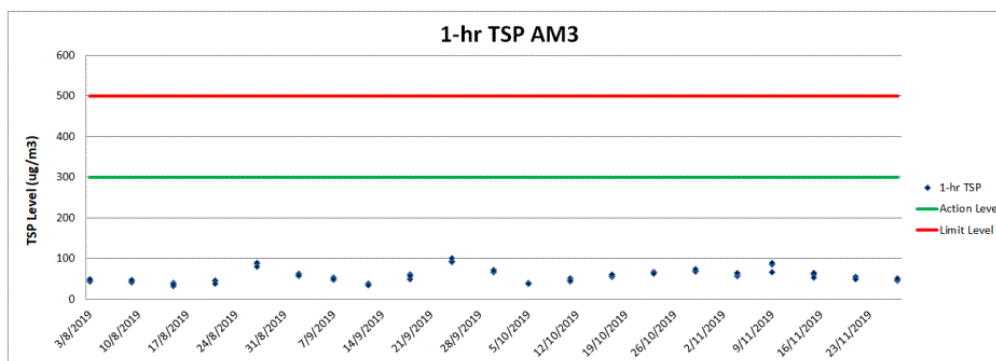
1-hr TSP Monitoring Result for AM3

Date	Weather	Temperature (°C) *	Wind Direction *	Wind Speed (m/s) *	Sampling Time			Reading (µg/m³)			
					1	2	3	1	2	3	Average
4/11/2019	Cloudy	29	NE	<5m/s	14:00	15:01	16:02	56	63	65	61
9/11/2019	Cloudy	25.7	E	<5m/s	14:00	15:01	16:02	67	85	89	80
15/11/2019	Cloudy	26.8	E	<5m/s	14:00	15:01	16:02	60	64	53	59
21/11/2019	Sunny	26.5	SE	<5m/s	14:00	15:01	16:02	55	50	49	51
27/11/2019	Sunny	27	E	<5m/s	13:00	14:01	15:02	46	47	52	48

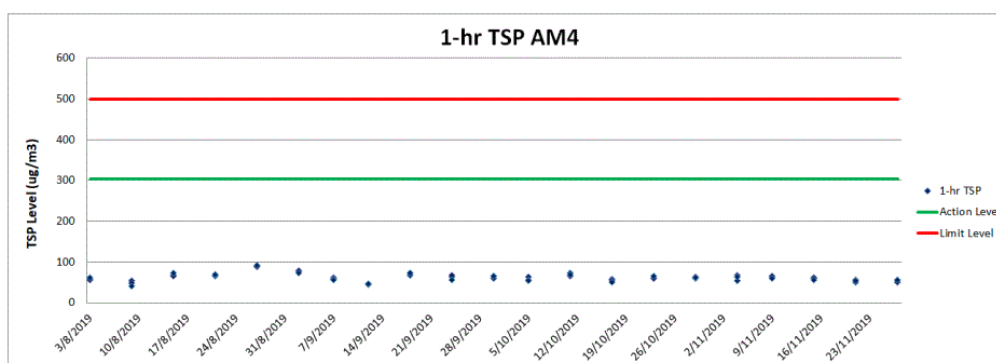
1-hr TSP Monitoring Result for AM4

Date	Weather	Temperature (°C) *	Wind Direction *	Wind Speed (m/s) *	Sampling Time			Reading (µg/m³)			
					1	2	3	1	2	3	Average
4/11/2019	Cloudy	29	NE	<5m/s	13:30	14:31	15:32	54	68	64	62
9/11/2019	Cloudy	25.7	E	<5m/s	13:30	14:31	15:32	62	66	59	62
15/11/2019	Cloudy	26.8	E	<5m/s	13:30	14:31	15:32	60	62	56	59
21/11/2019	Sunny	26.5	SE	<5m/s	13:30	14:31	15:32	51	56	54	54
27/11/2019	Sunny	27	E	<5m/s	12:30	13:31	14:32	55	51	57	54

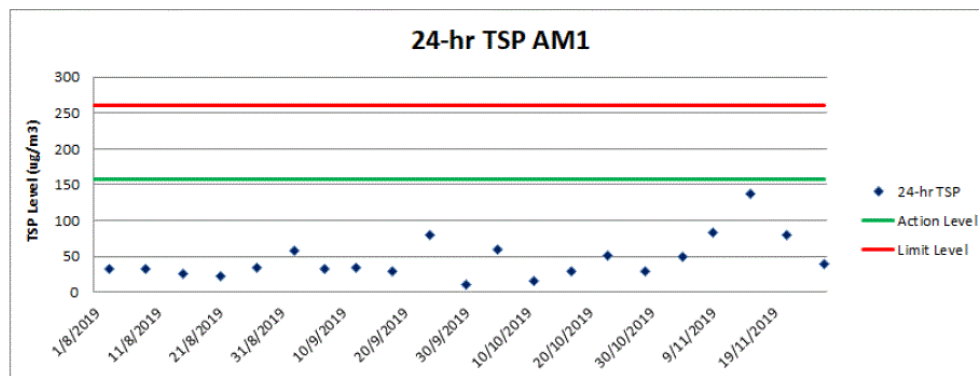
24-hr TSP Monitoring Result for AM1

Sampling ID & Paper No.	Temperature (°C) *1	Wind Direction *1	Wind Speed (m/s) *1	Sampling Date	Wt. of paper (g)			Flow Rate (CFM)	Total Volume *2 (m³)	TSP Concentration (µg/m³)
					Initial Wt.	Final Wt.	Wt. of dust			
AM11104 207399	22.2 - 29.0	NE	<5m/s	4/11/2019	2.7744	2.8848	0.1104	50.0	2230.81	49
AM11109 207407	19.6 - 25.7	E	<5m/s	9/11/2019	2.6818	2.8696	0.1878	50.0	2230.81	84
AM11115 207408	19.2 - 26.8	E	<5m/s	15/11/2019	2.6933	3.0001	0.3068	50.0	2230.81	138
AM11121 207133	17.6 - 26.5	SE	<5m/s	21/11/2019	2.6659	2.8449	0.1790	50.0	2230.81	80
AM11127 207424	21.5 - 27.0	E	<5m/s	27/11/2019	2.6960	2.7862	0.0902	50.0	2230.81	40

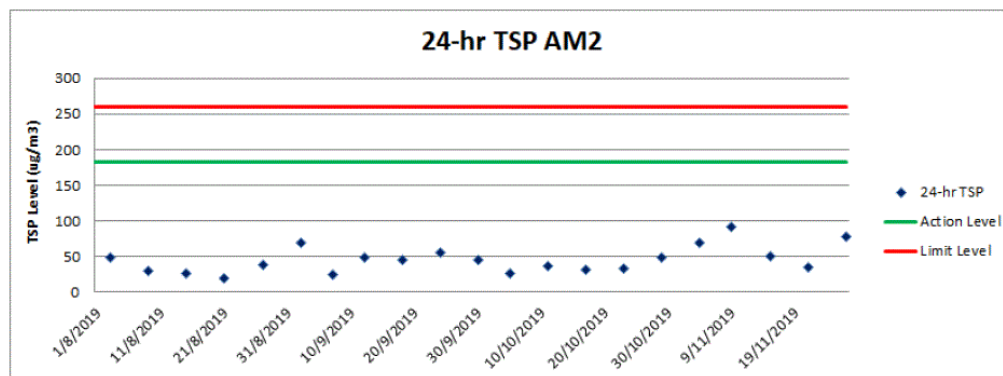
24-hr TSP Monitoring Result for AM2

Sampling ID & Paper No.	Temperature (°C) *1	Wind Direction *1	Wind Speed (m/s) *1	Sampling Date	Wt. of paper (g)			Flow Rate (CFM)	Total Volume *2 (m³)	TSP Concentration (µg/m³)
					Initial Wt.	Final Wt.	Wt. of dust			
AM21104 207132	22.2 - 29.0	NE	<5m/s	4/11/2019	2.6586	2.8277	0.1691	50.0	2402.88	70
AM21109 207396	19.6 - 25.7	E	<5m/s	9/11/2019	2.7626	2.9836	0.2210	50.0	2402.88	92
AM21115 207423	19.2 - 26.8	E	<5m/s	15/11/2019	2.6845	2.8069	0.1224	50.0	2402.88	51
AM21121 207413	17.6 - 26.5	SE	<5m/s	21/11/2019	2.6841	2.7691	0.0850	50.0	2402.88	35
AM21127 207412	21.5 - 27.0	E	<5m/s	27/11/2019	2.6934	2.8786	0.1852	50.0	2402.88	77

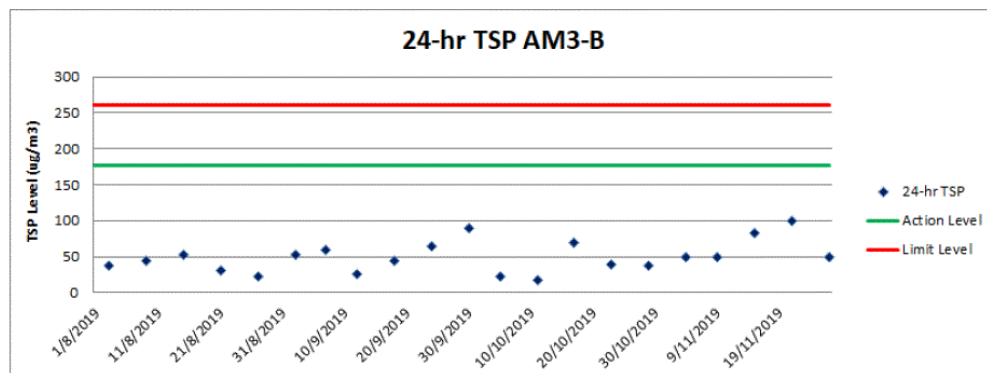
24-hr TSP Monitoring Result for AM3-B

Sampling ID & Paper No.	Temperature (°C) *1	Wind Direction *1	Wind Speed (m/s) *1	Sampling Date	Wt. of paper (g)			Flow Rate (CFM)	Total Volume *2 (m³)	TSP Concentration (µg/m³)
					Initial Wt.	Final Wt.	Wt. of dust			
AM3-B1104 207402	22.2 - 29.0	NE	<5m/s	4/11/2019	2.6809	2.7953	0.1144	50.0	2343.10	49
AM3-B1109 207155	19.6 - 25.7	E	<5m/s	9/11/2019	2.6867	2.8009	0.1142	50.0	2343.10	49
AM3-B1115 207403	19.2 - 26.8	E	<5m/s	15/11/2019	2.6847	2.8770	0.1923	50.0	2343.10	82
AM3-B1121 207409	17.6 - 26.5	SE	<5m/s	21/11/2019	2.6854	2.9172	0.2318	50.0	2343.10	99
AM3-B1127 207425	21.5 - 27.0	E	<5m/s	27/11/2019	2.6849	2.8018	0.1169	50.0	2343.10	50

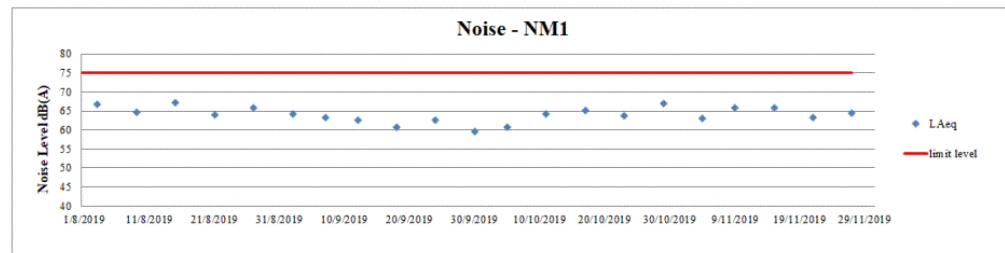
Noise Monitoring Result for NM1

Location	NM1				
Date	4/11/2019	9/11/2019	15/11/2019	21/11/2019	27/11/2019
Weather Condition	Cloudy	Cloudy	Cloudy	Sunny	Sunny
Start Time	9:42	10:02	10:04	9:45	9:30
Measurement Period	30min	30min	30min	30min	30min
Baseline Level	75.1				
L <sub>Aeq</sub>	63.1	65.8	65.8	63.2	64.4
L <sub>10</sub>	66.7	68.4	69.7	68.2	67.2
L <sub>90</sub>	59.5	61.2	62.7	60.2	61.2

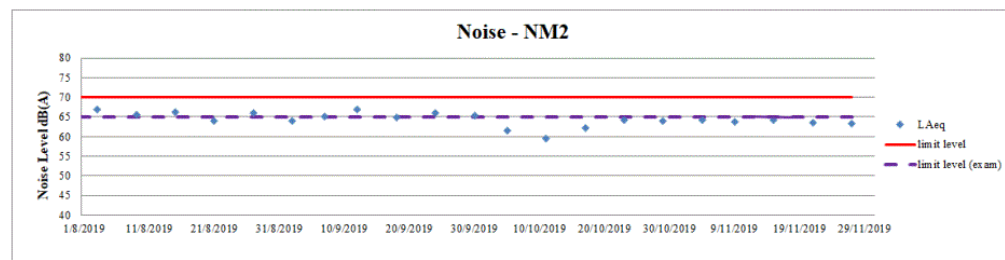
Noise Monitoring Result for NM2

Location	NM2				
Date	4/11/2019	9/11/2019	15/11/2019	21/11/2019	27/11/2019
Weather Condition	Cloudy	Cloudy	Cloudy	Sunny	Sunny
Start Time	14:00	14:00	14:00	14:00	14:00
Measurement Period	30min	30min	30min	30min	30min
Baseline Level	66.5				
L <sub>Aeq</sub>	64.2	63.8	64.3	63.5	63.4
L <sub>10</sub>	67.1	66.4	67.2	66.7	67.2
L <sub>90</sub>	57.9	59.2	60.1	59.3	58.2

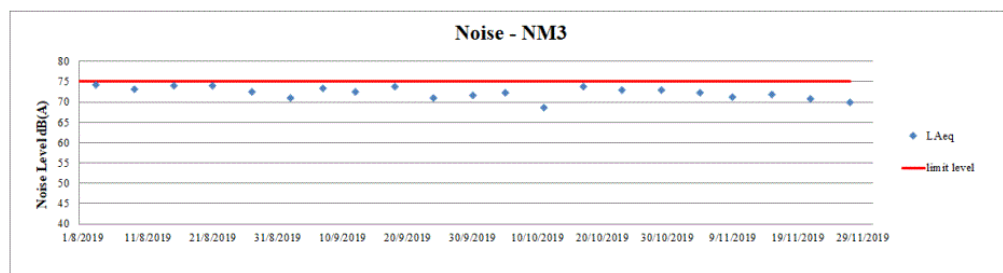
Noise Monitoring Result for NM3

Location	NM3				
Date	4/11/2019	9/11/2019	15/11/2019	21/11/2019	27/11/2019
Weather Condition	Cloudy	Cloudy	Cloudy	Sunny	Sunny
Start Time	9:00	9:00	9:00	9:00	9:00
Measurement Period	30min	30min	30min	30min	30min
Baseline Level	74.5				
L <sub>Aeq</sub>	72.3	71.2	71.9	70.7	69.8
L <sub>10</sub>	76.0	75.4	76.5	75.4	74.1
L <sub>90</sub>	65.1	66.5	64.8	66.8	66.9

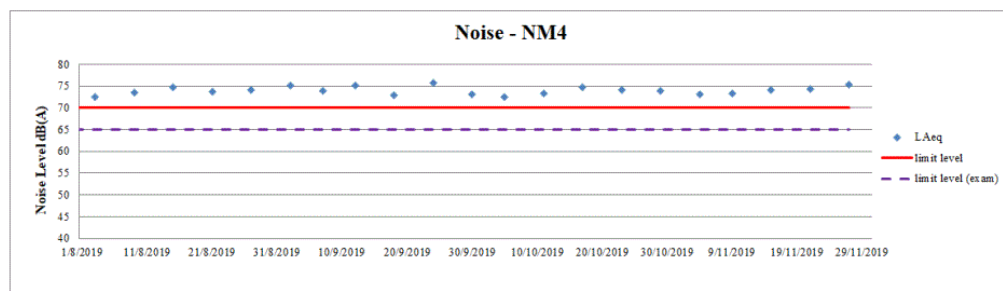
Noise Monitoring Result for NM4

Location	NM4					NM4 (Re-measurement) *				
Date	4/11/2019	9/11/2019	15/11/2019	21/11/2019	27/11/2019	4/11/2019	9/11/2019	15/11/2019	21/11/2019	27/11/2019
Weather Condition	Cloudy	Cloudy	Cloudy	Sunny	Sunny	Cloudy	Cloudy	Cloudy	Sunny	Sunny
Start Time	13:00	13:00	13:00	13:00	13:00	13:30	13:30	13:30	13:30	13:30
Measurement Period	30min	30min	30min	30min	30min	30min	30min	30min	30min	30min
Baseline Level	73.3					73.3				
L <sub>Aeq</sub>	73.1	73.2	74.1	74.3	75.3	73.5	74.1	74.8	74.1	75.4
L <sub>10</sub>	77.4	75.2	76.5	77.1	77.5	76.8	76.5	76.6	76.8	77.1
L <sub>90</sub>	68.3	67.4	68.3	67.8	69.2	68.9	68.2	68.3	67.5	68.9

\* Repeat noise measurement when exceedance is recorded. The result is used to confirm the findings and it would not be showed on the graph plot

The noise source for causing exceedances at NM4 was from the traffic of Canton Road. The NM4 was directly affected by the noise generated from the traffic. The recorded monitoring results at the NM4 were near the baseline noise level. The exceedances were not caused by the construction works of this project.

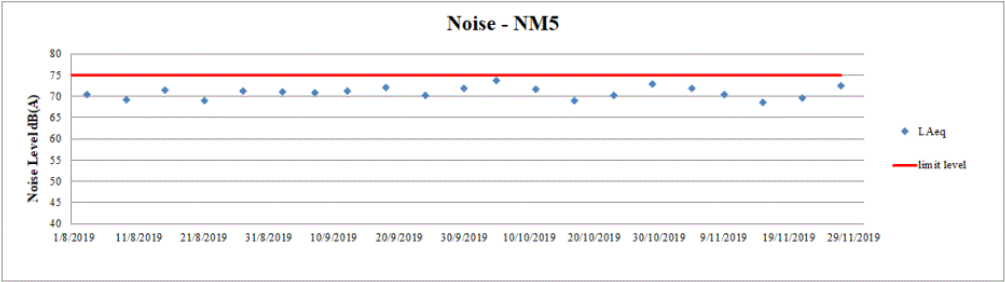
Noise Monitoring Result for NM5

Location	NM5				
Date	4/11/2019	9/11/2019	15/11/2019	21/11/2019	27/11/2019
Weather Condition	Cloudy	Cloudy	Cloudy	Sunny	Sunny
Start Time	15:00	15:00	15:00	15:00	15:00
Measurement Period	30min	30min	30min	30min	30min
Baseline Level	71.8				
L <sub>Aeq</sub>	71.8	70.5	68.6	69.7	72.4
L <sub>10</sub>	75.2	74.6	73.1	72.6	74.2
L <sub>90</sub>	64.7	64.8	63.9	64.8	64.2
