# **Proposed Road Improvement Works in West Kowloon Reclamation Development – Phase 1**

## **Environmental Monitoring & Audit Report**

**01/01/2020 – 31/01/2020**

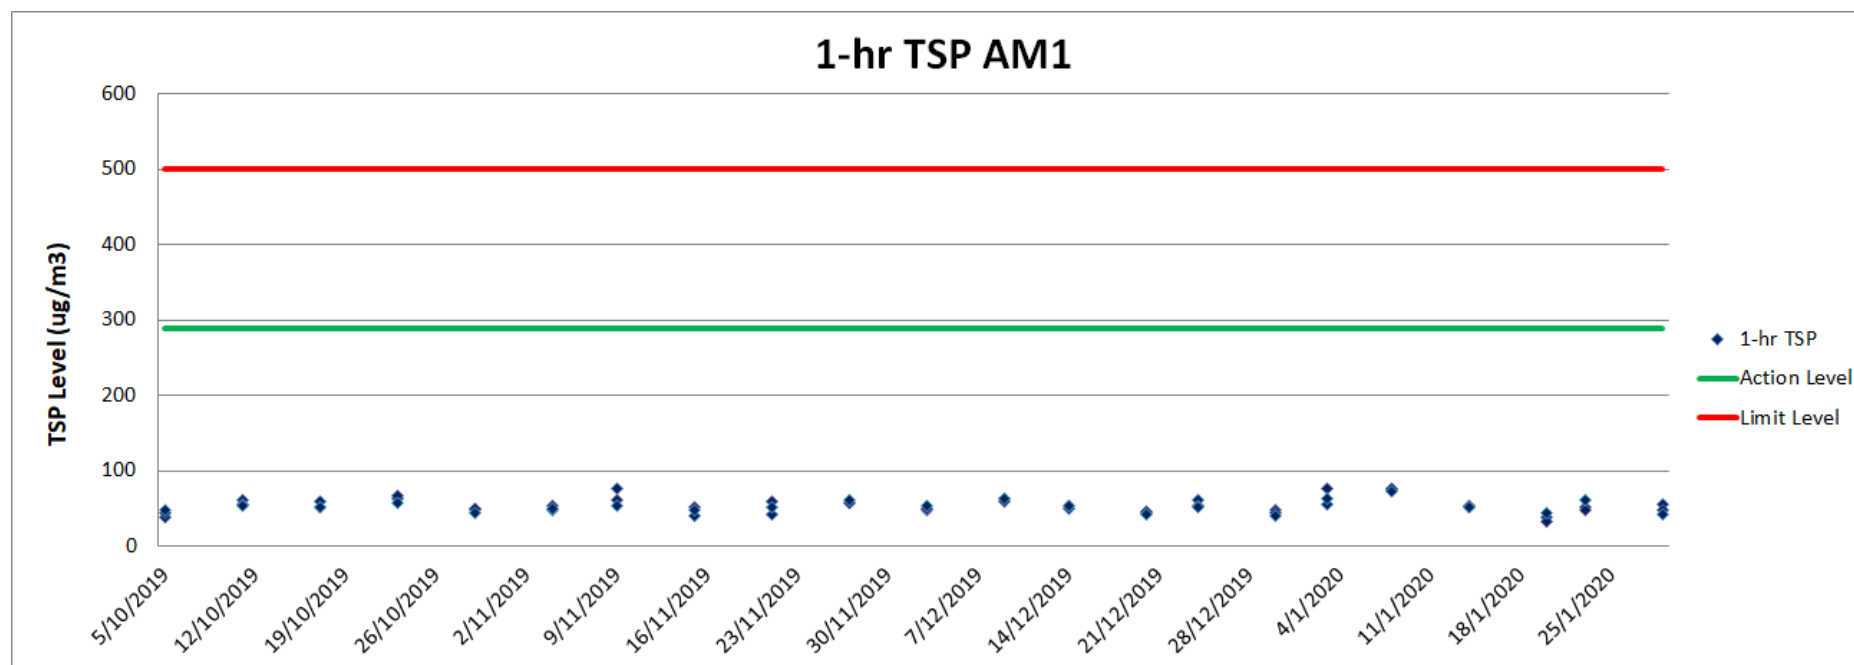
Date	Weather	Temperature (°C) *	Wind Direction *	Wind Speed (m/s) *	Sampling Time			Reading (µg/m³)			
					1	2	3	1	2	3	Average
3/1/2020	Sunny	17.2 - 22.0	NE	<5m/s	13:00	14:01	15:02	56	77	64	66
8/1/2020	Sunny	19.7 - 26.0	NE	<5m/s	13:05	14:06	15:07	74	77	73	75
14/1/2020	Sunny	14.6 - 19.0	NE	<5m/s	13:00	14:01	15:02	51	53	52	52
20/1/2020	Sunny	13.5 - 18.0	N	<5m/s	13:00	14:01	15:02	39	33	45	39
23/1/2020	Overcast	19.5 - 21.9	N	<5m/s	13:00	14:01	15:02	52	47	62	54
29/1/2020	Overcast	17.4 - 18.3	NE	<5m/s	14:00	15:01	16:02	55	48	42	48

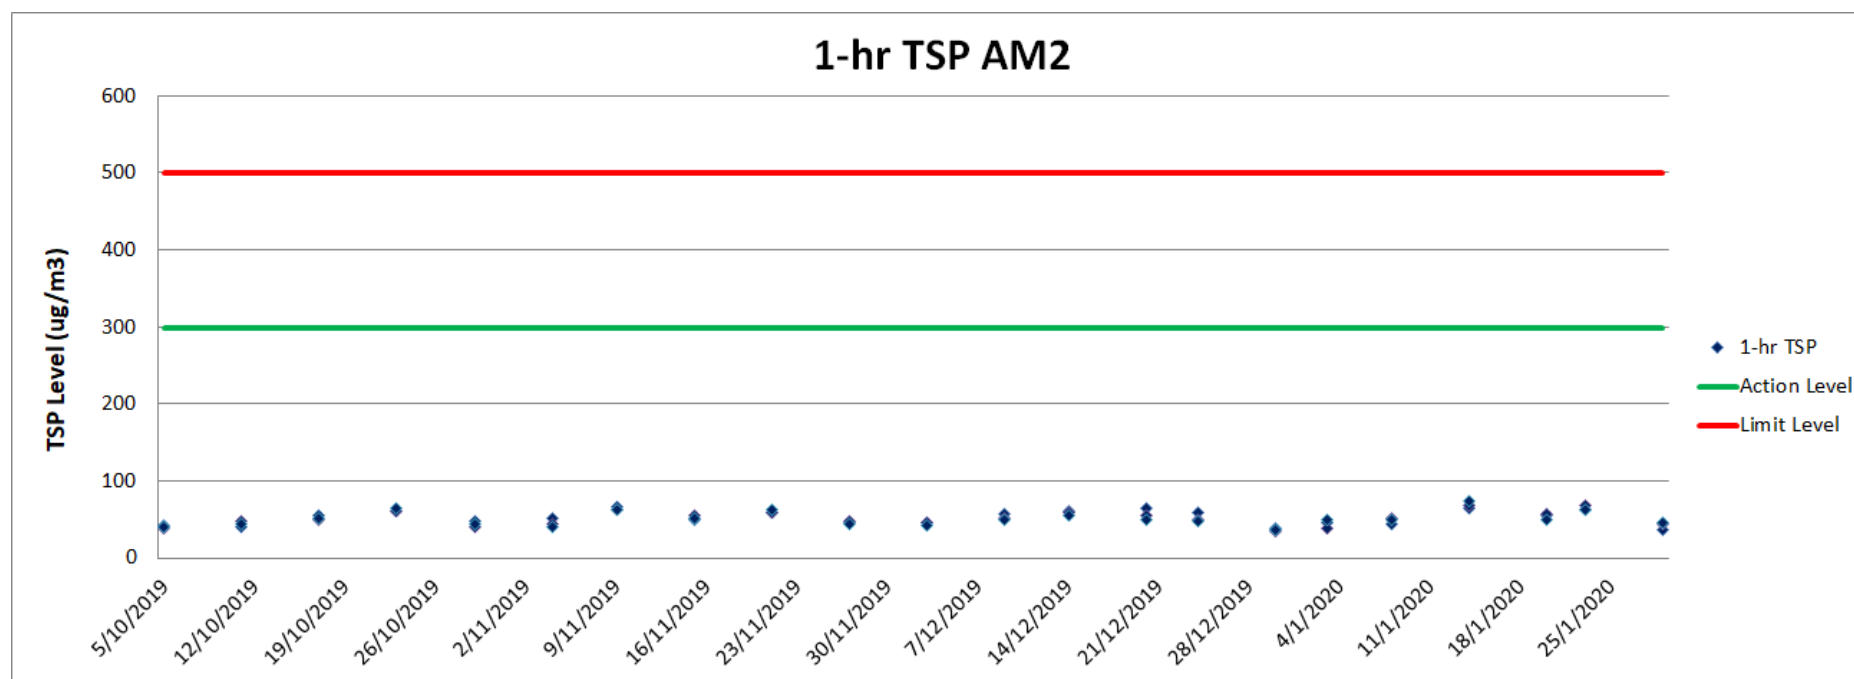
### 1-hr TSP Monitoring Result for AM2

Date	Weather	Temperature (°C) *	Wind Direction *	Wind Speed (m/s) *	Sampling Time			Reading (µg/m³)			
					1	2	3	1	2	3	Average
3/1/2020	Sunny	17.2 - 22.0	NE	<5m/s	8:50	9:51	10:52	45	39	49	44
8/1/2020	Sunny	19.7 - 26.0	NE	<5m/s	8:45	9:46	10:47	44	51	50	48
14/1/2020	Sunny	14.6 - 19.0	NE	<5m/s	9:00	10:01	11:02	64	68	73	68
20/1/2020	Sunny	13.5 - 18.0	N	<5m/s	9:00	10:01	11:02	56	57	50	54
23/1/2020	Overcast	19.5 - 21.9	N	<5m/s	8:50	9:51	10:52	62	68	62	64
29/1/2020	Overcast	17.4 - 18.3	NE	<5m/s	9:00	10:01	11:02	37	44	45	42

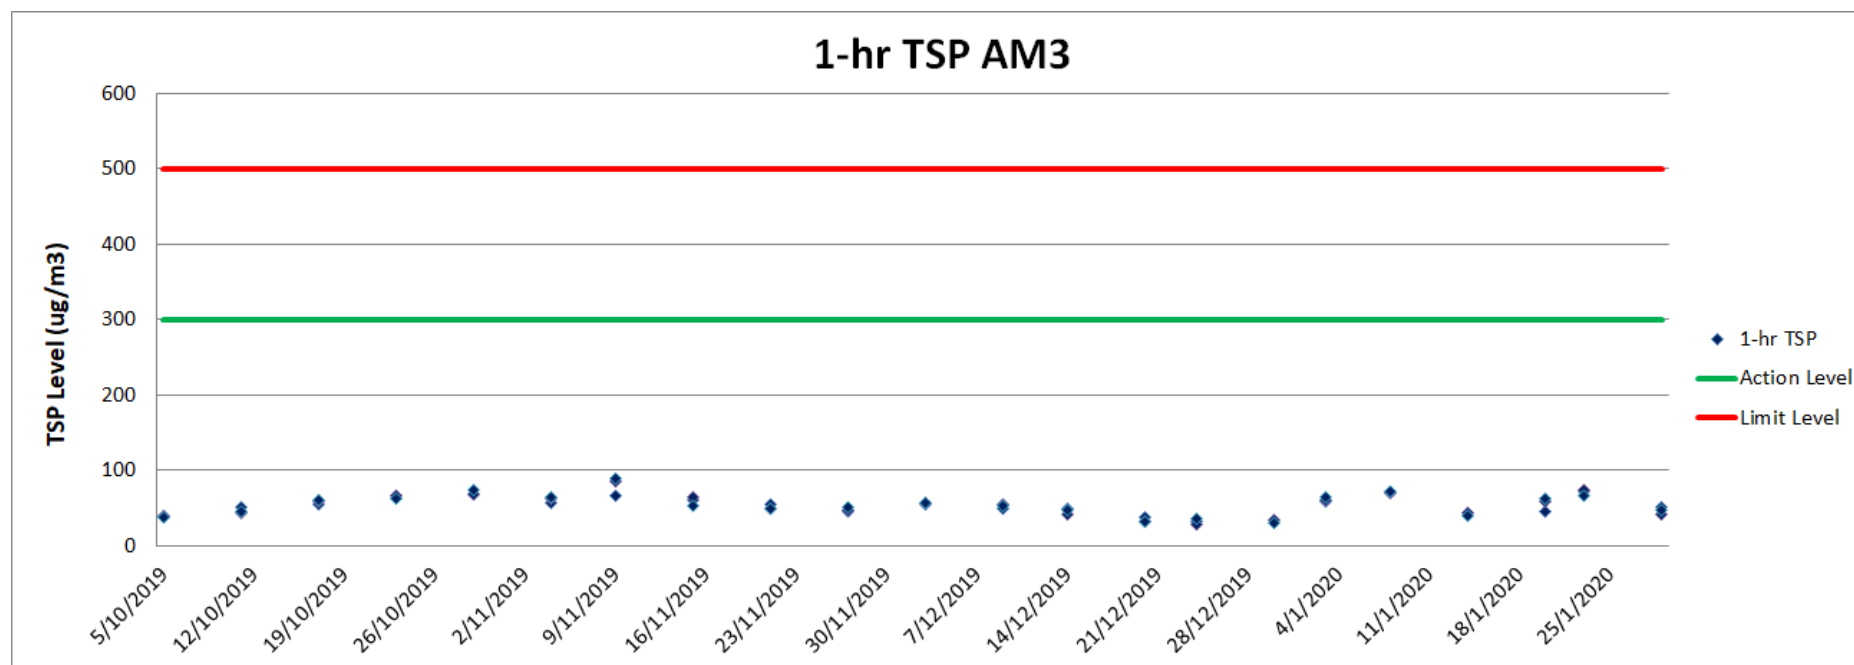
### 1-hr TSP Monitoring Result for AM3

Date	Weather	Temperature (°C) *	Wind Direction *	Wind Speed (m/s) *	Sampling Time			Reading (µg/m³)			
					1	2	3	1	2	3	Average
3/1/2020	Sunny	17.2 - 22.0	NE	<5m/s	14:00	15:01	16:02	59	60	65	61
8/1/2020	Sunny	19.7 - 26.0	NE	<5m/s	14:00	15:01	16:02	71	70	72	71
14/1/2020	Sunny	14.6 - 19.0	NE	<5m/s	13:30	14:31	15:32	43	43	40	42
20/1/2020	Sunny	13.5 - 18.0	N	<5m/s	13:45	14:46	15:47	46	58	63	56
23/1/2020	Overcast	19.5 - 21.9	N	<5m/s	13:00	14:01	15:02	72	74	67	71
29/1/2020	Overcast	17.4 - 18.3	NE	<5m/s	14:00	15:01	16:02	51	42	47	47

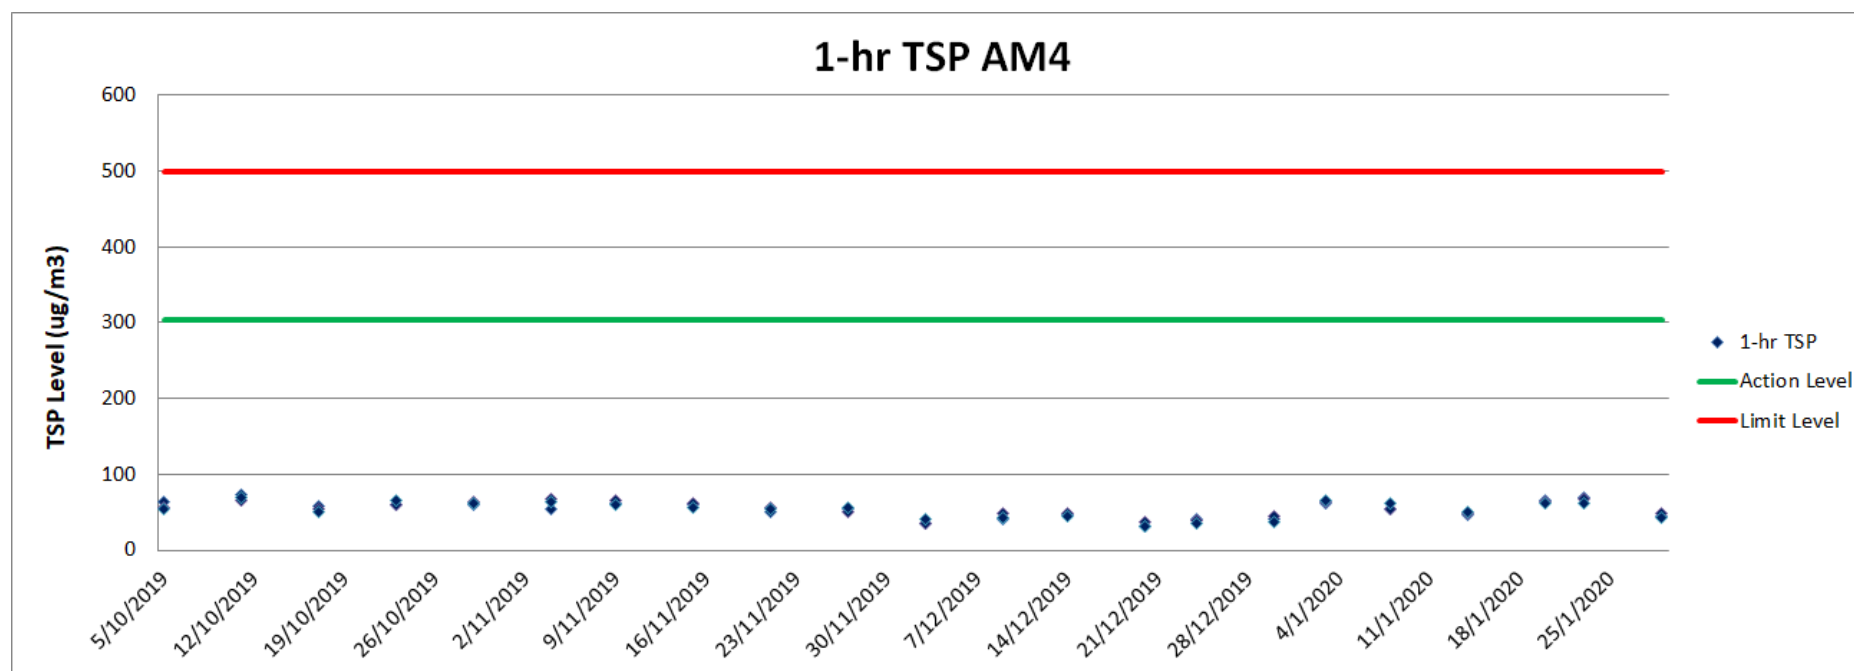
# 1-hr TSP Monitoring Result for AM4

Date	Weather	Temperature (°C) *	Wind Direction *	Wind Speed (m/s) *	Sampling Time			Reading (µg/m³)			
					1	2	3	1	2	3	Average
3/1/2020	Sunny	17.2 - 22.0	NE	<5m/s	13:30	14:31	15:32	61	64	65	63
8/1/2020	Sunny	19.7 - 26.0	NE	<5m/s	13:30	14:31	15:32	54	54	61	56
14/1/2020	Sunny	14.6 - 19.0	NE	<5m/s	13:15	14:16	15:17	46	49	50	48
20/1/2020	Sunny	13.5 - 18.0	N	<5m/s	13:30	14:31	15:32	65	63	61	63
23/1/2020	Overcast	19.5 - 21.9	N	<5m/s	12:30	13:31	14:32	70	68	61	66
29/1/2020	Overcast	17.4 - 18.3	NE	<5m/s	13:30	14:31	15:32	44	48	43	45

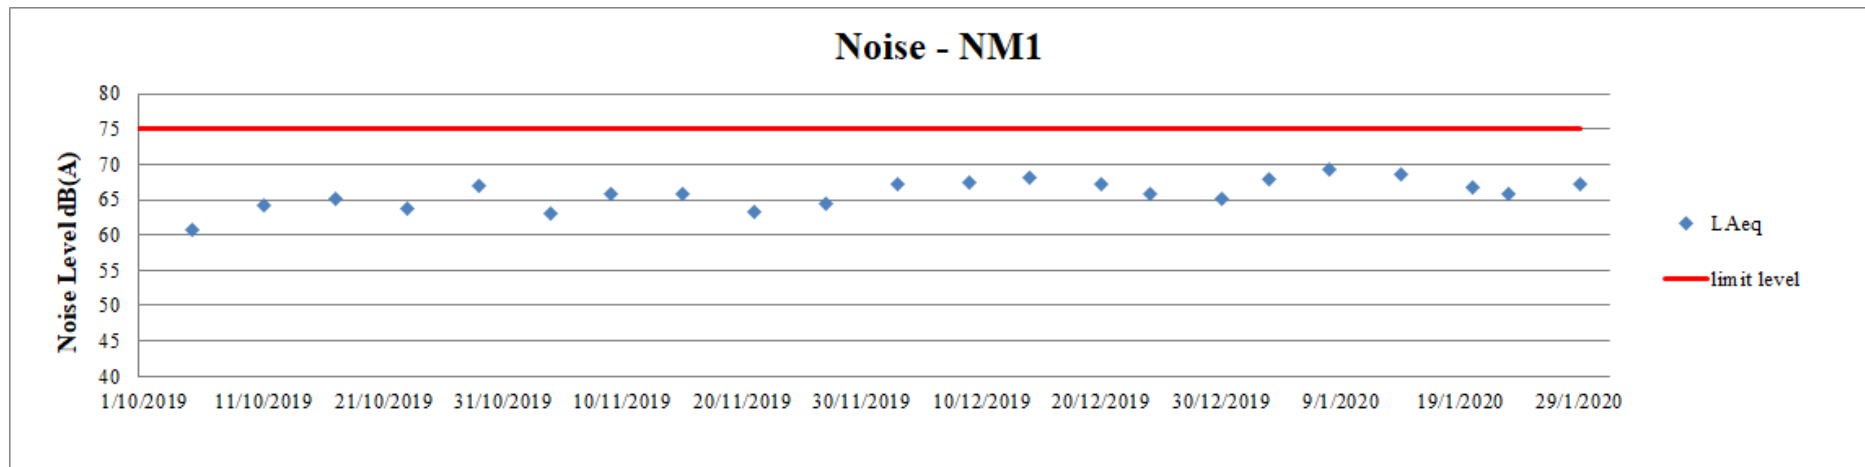
### Noise Monitoring Result for NM1

Location	NM1					
Date	3/1/2020	8/1/2020	14/1/2020	20/1/2020	23/1/2020	29/1/2020
Weather Condition	Sunny	Sunny	Sunny	Sunny	Overcast	Overcast
Start Time	10:00	10:00	10:00	10:00	10:00	10:00
Measurement Period	30min	30min	30min	30min	30min	30min
Baseline Level	75.1					
L <sub>Aeq</sub>	67.9	69.4	68.5	66.7	65.8	67.3
L <sub>10</sub>	69.8	70.5	70.1	68.1	67.4	69.1
L <sub>90</sub>	62.3	62.5	61.2	61.3	60.3	61.4

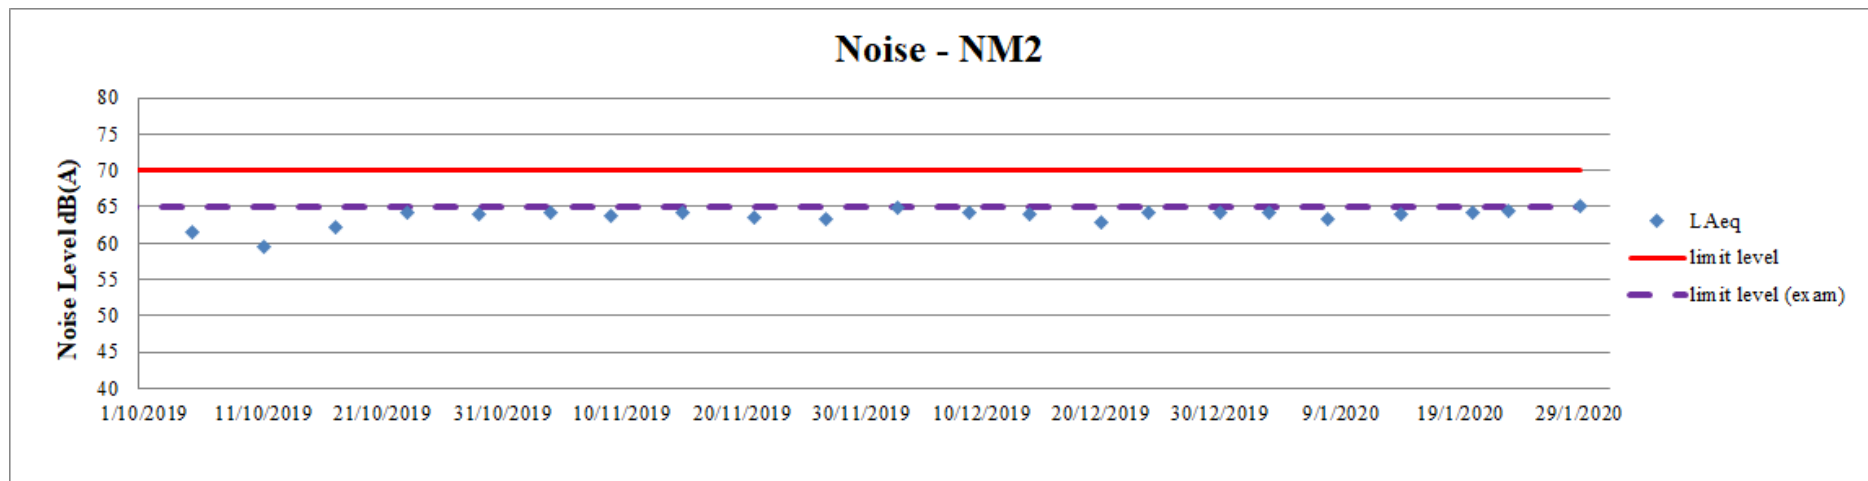
# Noise Monitoring Result for NM2

Location	NM2					
Date	3/1/2020	8/1/2020	14/1/2020	20/1/2020	23/1/2020	29/1/2020
Weather Condition	Sunny	Sunny	Sunny	Sunny	Overcast	Overcast
Start Time	14:00	14:00	14:00	14:00	14:00	14:00
Measurement Period	30min	30min	30min	30min	30min	30min
Baseline Level	66.5					
L <sub>Aeq</sub>	64.1	63.3	63.9	64.2	64.4	65.0
L <sub>10</sub>	66.3	66.0	67.3	66.9	66.8	67.1
L <sub>90</sub>	58.9	59.1	58.9	59.7	59.9	60.5

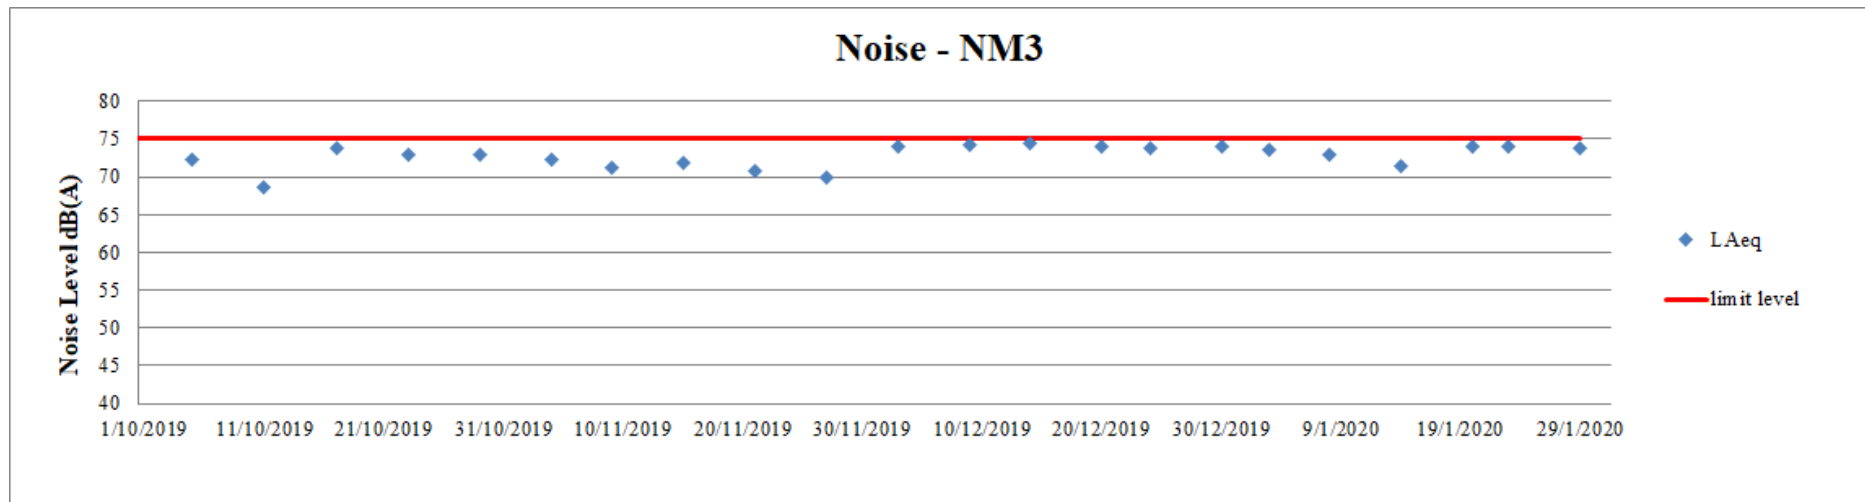
### Noise Monitoring Result for NM3

Location	NM3					
Date	3/1/2020	8/1/2020	14/1/2020	20/1/2020	23/1/2020	29/1/2020
Weather Condition	Sunny	Sunny	Sunny	Sunny	Overcast	Overcast
Start Time	9:00	9:00	9:00	9:00	9:00	9:00
Measurement Period	30min	30min	30min	30min	30min	30min
Baseline Level	74.5					
L <sub>Aeq</sub>	73.5	72.9	71.5	73.9	74.0	73.8
L <sub>10</sub>	74.8	74.1	74.0	75.8	76.2	76.3
L <sub>90</sub>	67.7	66.1	66.8	68.4	68.9	68.1

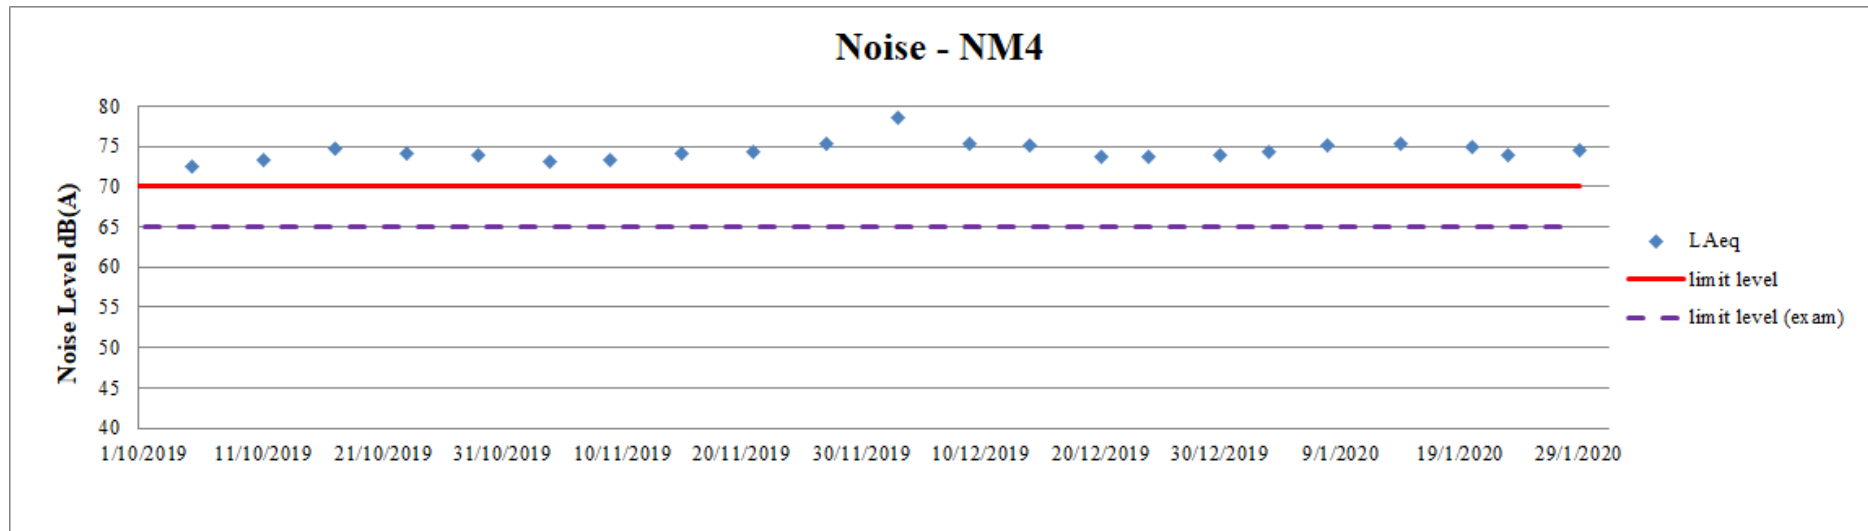
### Noise Monitoring Result for NM4

The noise source for causing exceedances at NM4 was from the traffic of Canton Road. The NM4 was directly affected by the noise generated from the traffic. The recorded monitoring results at the NM4 were near the baseline noise level. The exceedances were not caused by the construction works of this project.

Location	NM4						NM4 (Re-measurement) *					
Date	3/1/2020	8/1/2020	14/1/2020	20/1/2020	23/1/2020	29/1/2020	3/1/2020	8/1/2020	14/1/2020	20/1/2020	23/1/2020	29/1/2020
Weather Condition	Sunny	Sunny	Sunny	Sunny	Overcast	Overcast	Sunny	Sunny	Sunny	Sunny	Overcast	Overcast
Start Time	13:00	13:00	13:00	13:00	13:00	13:00	13:30	13:30	13:30	13:30	13:30	13:30
Measurement Period	30min	30min	30min	30min	30min	30min	30min	30min	30min	30min	30min	30min
Baseline Level	73.3						73.3					
L <sub>Aeq</sub>	74.4	75.1	75.3	74.9	73.9	74.6	74.8	75.8	76.1	74.8	73.7	74.1
L <sub>10</sub>	76.1	77.0	77.8	77.4	76.8	77.5	76.2	77.4	77.4	77.1	77.1	77.2
L <sub>90</sub>	69.3	70.8	70.5	68.1	66.4	67.0	69.0	70.5	69.4	68.3	66.8	67.4

\* Repeat noise measurement when exceedance is recorded. The result is used to confirm the findings and it would not be showed on the graph plot

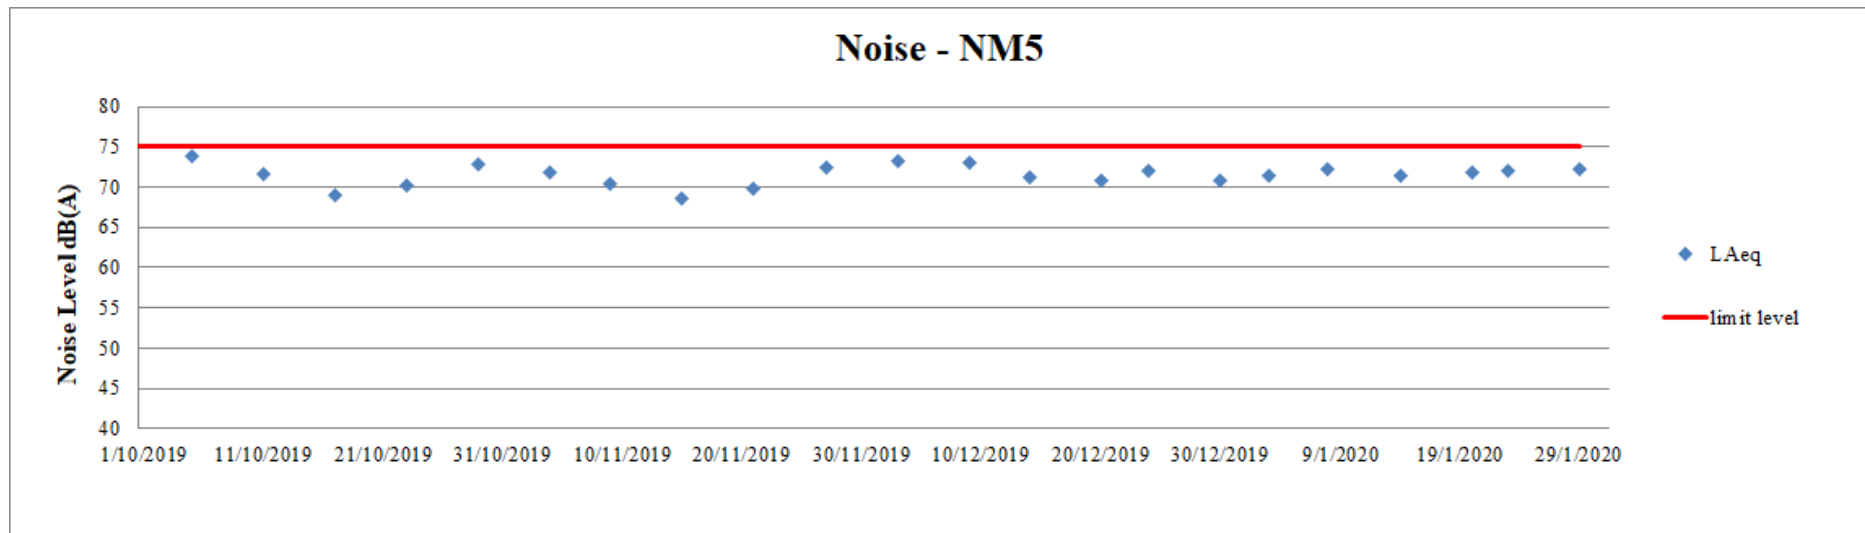
# Noise Monitoring Result for NM5

Location	NM5					
Date	3/1/2020	8/1/2020	14/1/2020	20/1/2020	23/1/2020	29/1/2020
Weather Condition	Sunny	Sunny	Sunny	Sunny	Overcast	Overcast
Start Time	15:00	15:00	15:00	15:00	15:00	15:00
Measurement Period	30min	30min	30min	30min	30min	30min
Baseline Level	71.8					
L <sub>Aeq</sub>	71.5	72.2	71.5	71.8	72.1	72.2
L <sub>10</sub>	73.5	73.9	73.0	73.9	74.0	74.1
L <sub>90</sub>	64.8	64.2	65.7	67.2	66.8	66.1
