Proposed Road Improvement Works in West Kowloon Reclamation Development – Phase 1

Environmental Monitoring & Audit Report

01/03/2020 – 31/03/2020

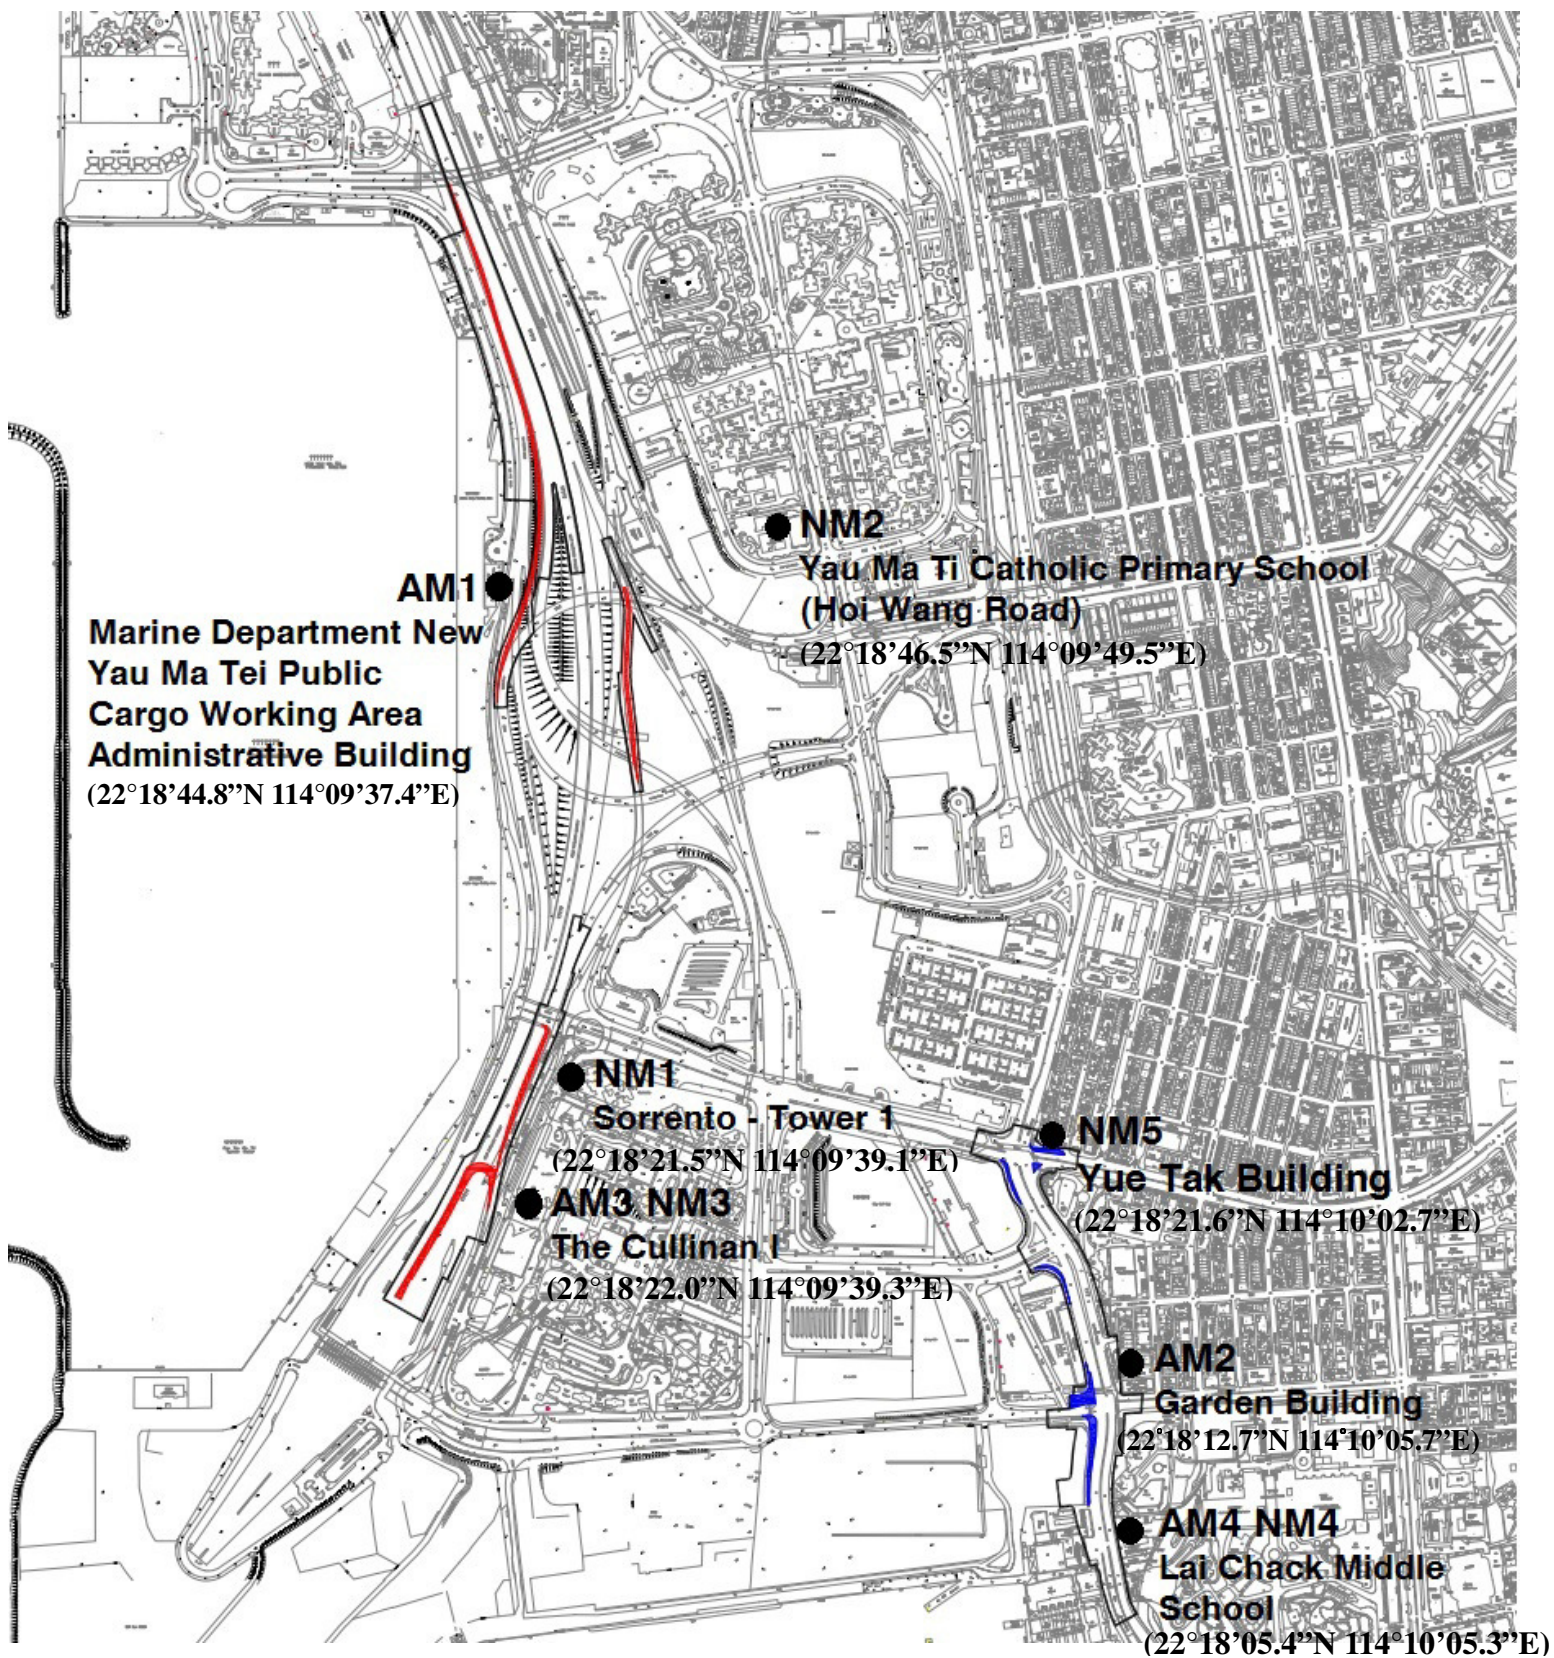
Locations for 1-hr TSP and Noise monitoring

Monitoring Location	Photo Record
<p>AM1</p> <p>Marine Department New Yau Ma Tei Public Cargo Working Area Administrative Building</p>	 
<p>AM2</p> <p>Garden Building</p>	 
<p>AM3</p> <p>The Cullinan I</p>	 
<p>AM4</p> <p>Lai Chack Middle School</p>

Monitoring Location	Photo Record
<p>NM1</p> <p>Sorrento - Tower 1</p>	 
<p>NM2</p> <p>Yau Ma Ti Catholic Primary School (Hoi Wang Road)</p>	 
<p>NM3</p> <p>The Cullinan I</p>	 
<p>NM4</p> <p>Lai Chack Middle School</p>	 
<p>NM5</p> <p>Yue Tak Building</p>

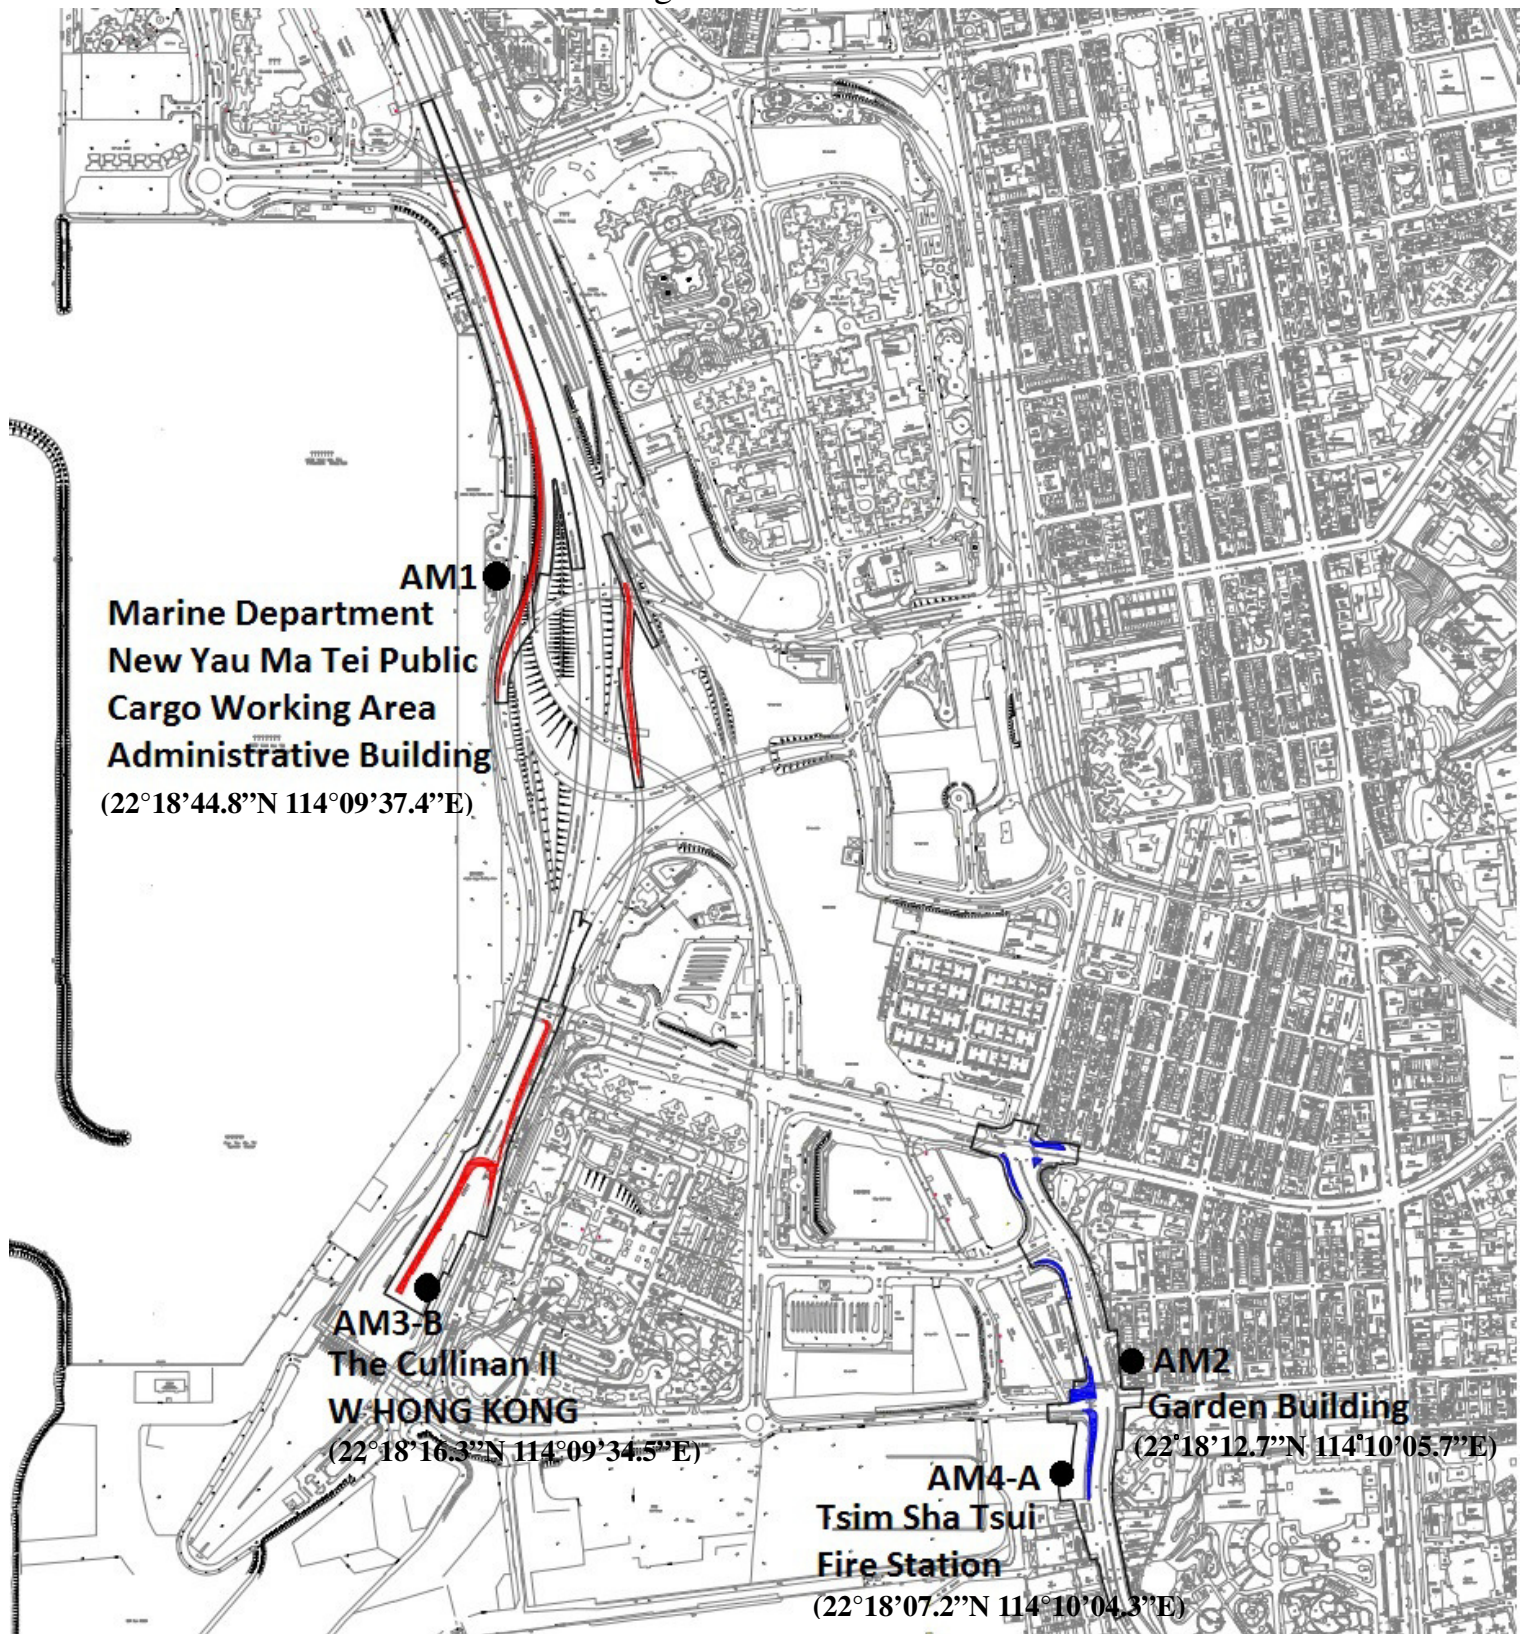
Locations for 24-hr TSP monitoring

Monitoring Location	Photo Record
<p>AM1</p> <p>Marine Department New Yau Ma Tei Public Cargo Working Area Administrative Building</p>

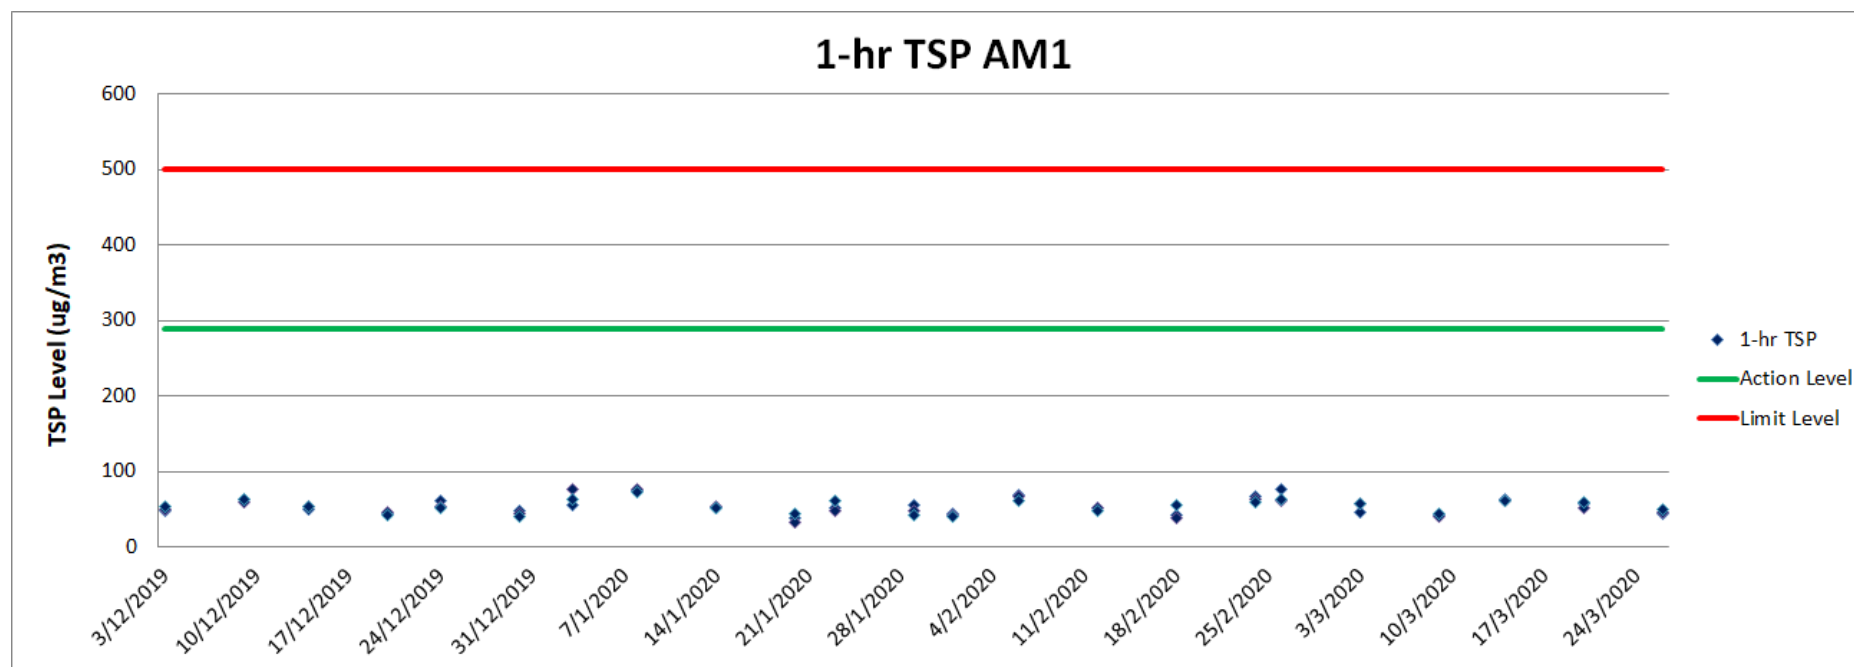
Date	Weather	Temperature (°C) *	Wind Direction *	Wind Speed (m/s) *	Sampling Time			Reading (µg/m³)			
					1	2	3	1	2	3	Average
3/3/2020	Overcast	17.5 - 20.8	E	<5m/s	13:00	14:01	15:02	46	57	58	54
9/3/2020	Overcast	20.3 - 26.8	NE	<5m/s	13:15	14:16	15:17	42	40	45	42
14/3/2020	Overcast	19.2 - 24.8	NE	<5m/s	13:05	14:06	15:07	64	61	62	62
20/3/2020	Overcast	19.9 - 23.0	NE	<5m/s	13:00	14:01	15:02	58	52	59	56
26/3/2020	Overcast	21.5 - 26.0	E	<5m/s	13:20	14:21	15:22	45	46	49	47

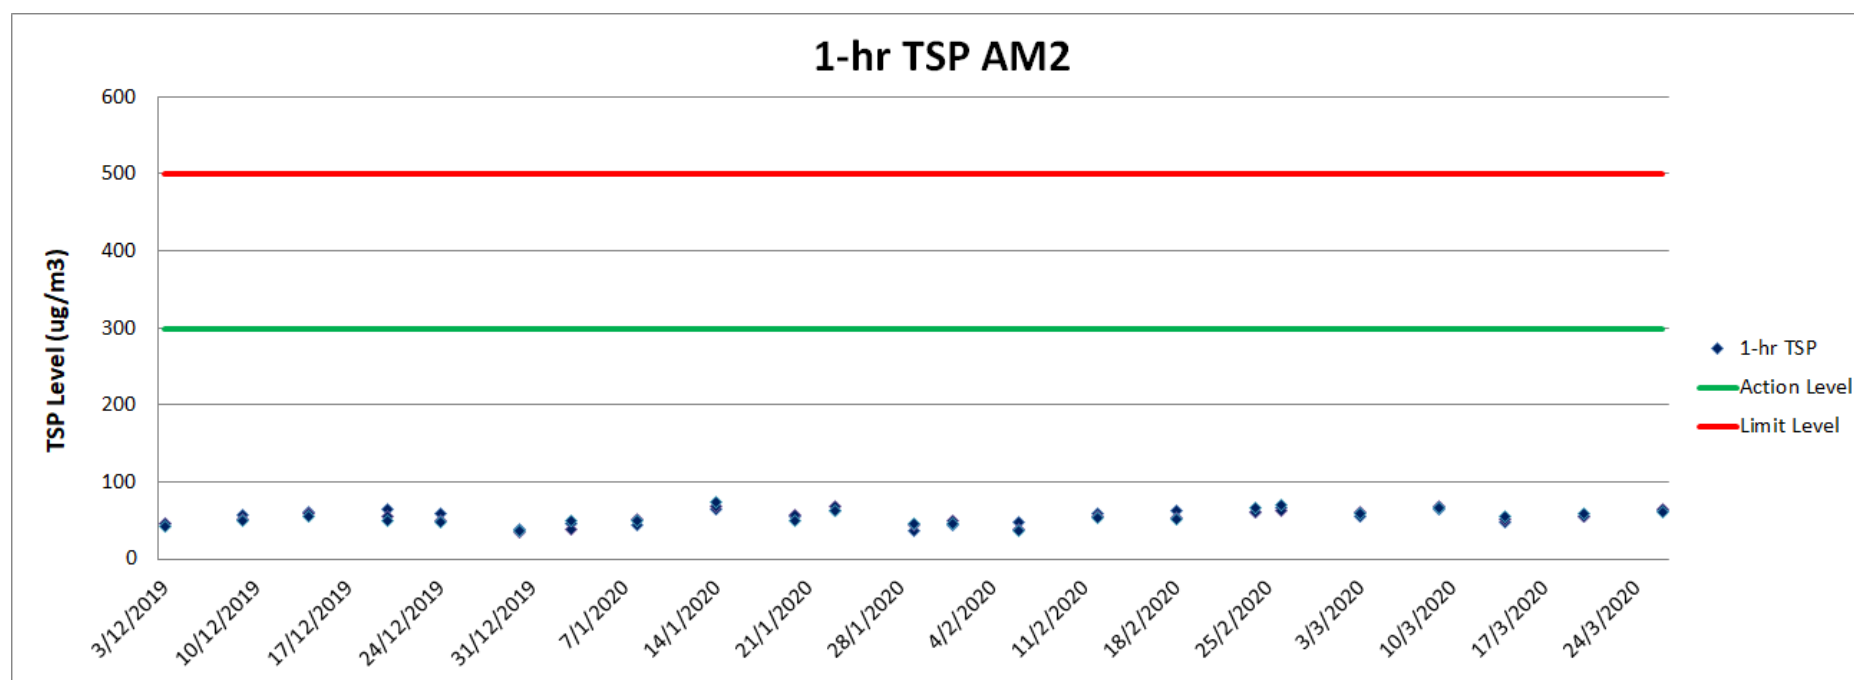
1-hr TSP Monitoring Result for AM2

Date	Weather	Temperature (°C) *	Wind Direction *	Wind Speed (m/s) *	Sampling Time			Reading (µg/m³)			
					1	2	3	1	2	3	Average
3/3/2020	Overcast	17.5 - 20.8	E	<5m/s	8:50	9:51	10:52	56	60	58	58
9/3/2020	Overcast	20.3 - 26.8	NE	<5m/s	9:00	10:01	11:02	64	68	66	66
14/3/2020	Overcast	19.2 - 24.8	NE	<5m/s	8:45	9:46	10:47	48	51	56	52
20/3/2020	Overcast	19.9 - 23.0	NE	<5m/s	8:45	9:46	10:47	56	55	58	56
26/3/2020	Overcast	21.5 - 26.0	E	<5m/s	9:05	10:06	11:07	63	65	60	63

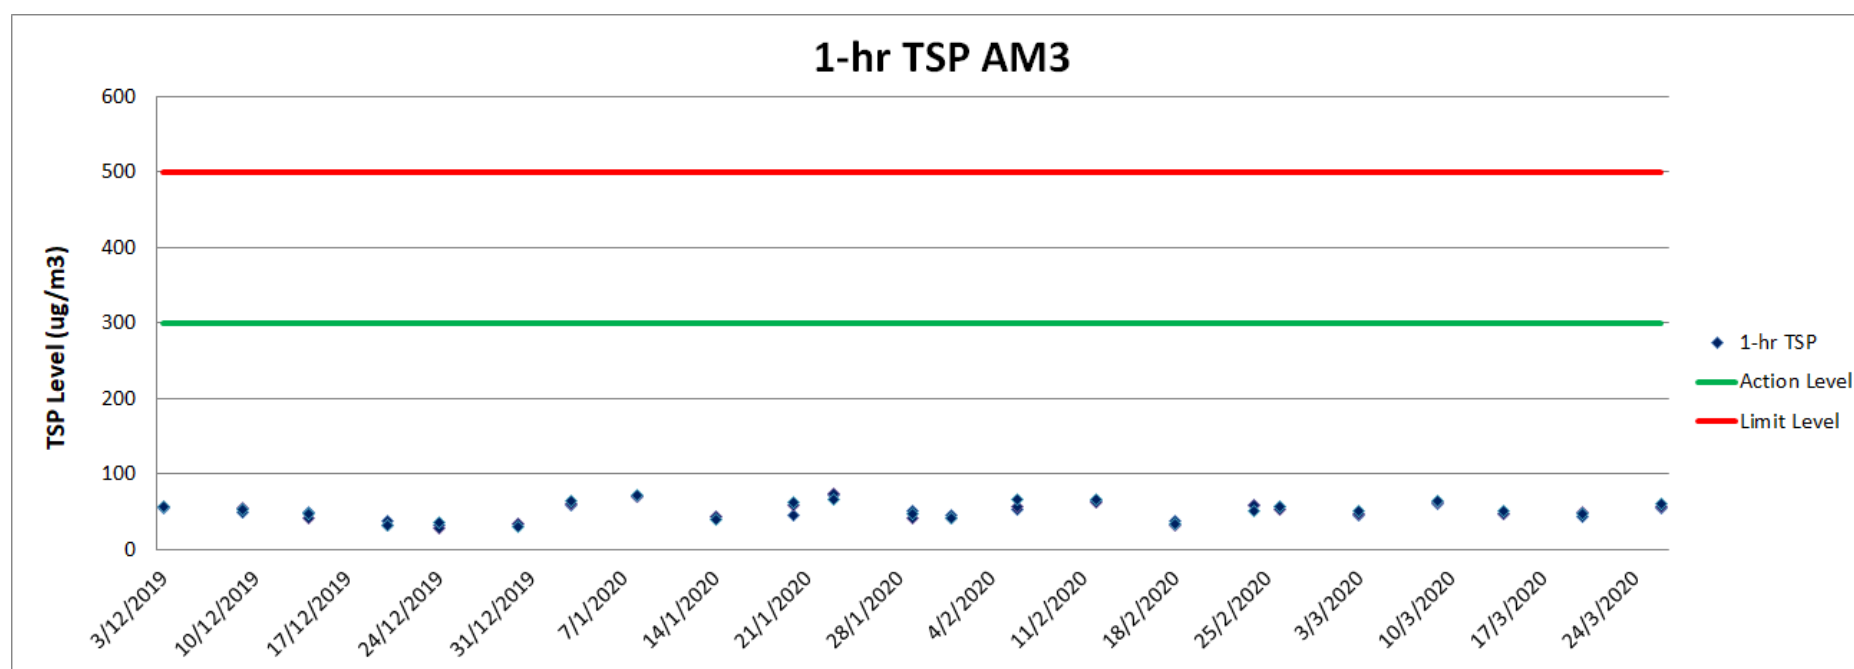
1-hr TSP Monitoring Result for AM3

Date	Weather	Temperature (°C) *	Wind Direction *	Wind Speed (m/s) *	Sampling Time			Reading (µg/m³)			
					1	2	3	1	2	3	Average
3/3/2020	Overcast	17.5 - 20.8	E	<5m/s	13:15	14:16	15:17	46	47	52	48
9/3/2020	Overcast	20.3 - 26.8	NE	<5m/s	13:30	14:31	15:32	60	62	64	62
14/3/2020	Overcast	19.2 - 24.8	NE	<5m/s	13:20	14:21	15:22	47	48	51	49
20/3/2020	Overcast	19.9 - 23.0	NE	<5m/s	13:15	14:16	15:17	43	50	48	47
26/3/2020	Overcast	21.5 - 26.0	E	<5m/s	13:30	14:31	15:32	55	56	61	57

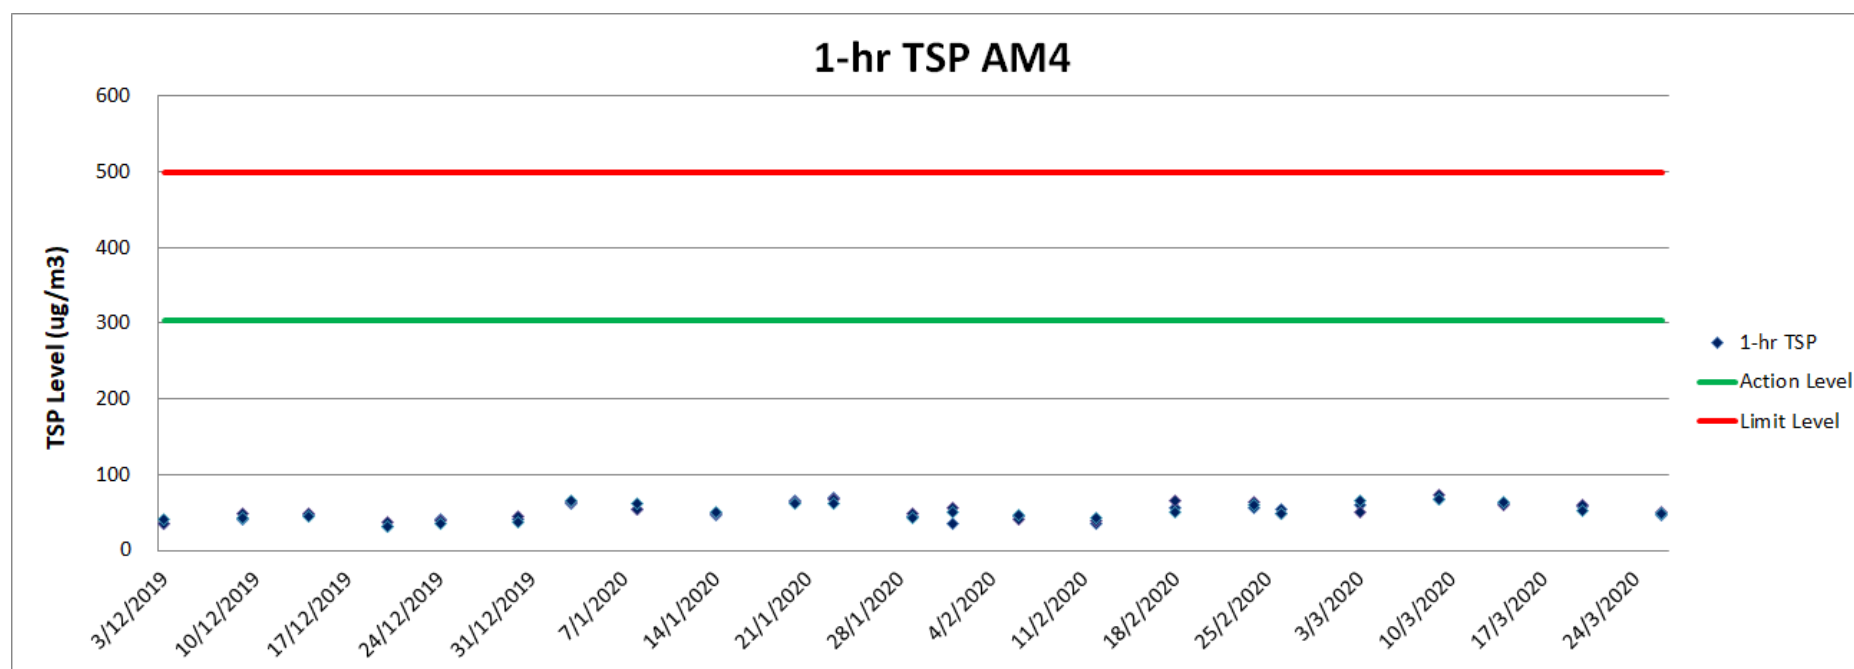
1-hr TSP Monitoring Result for AM4

Date	Weather	Temperature (°C) *	Wind Direction *	Wind Speed (m/s) *	Sampling Time			Reading (µg/m ³)			
					1	2	3	1	2	3	Average
3/3/2020	Overcast	17.5 - 20.8	E	<5m/s	9:00	10:01	11:02	59	50	66	58
9/3/2020	Overcast	20.3 - 26.8	NE	<5m/s	9:15	10:16	11:17	67	73	68	69
14/3/2020	Overcast	19.2 - 24.8	NE	<5m/s	9:00	10:01	11:02	62	60	63	62
20/3/2020	Overcast	19.9 - 23.0	NE	<5m/s	8:55	9:56	10:57	58	59	52	56
26/3/2020	Overcast	21.5 - 26.0	E	<5m/s	9:00	10:01	11:02	47	50	49	49

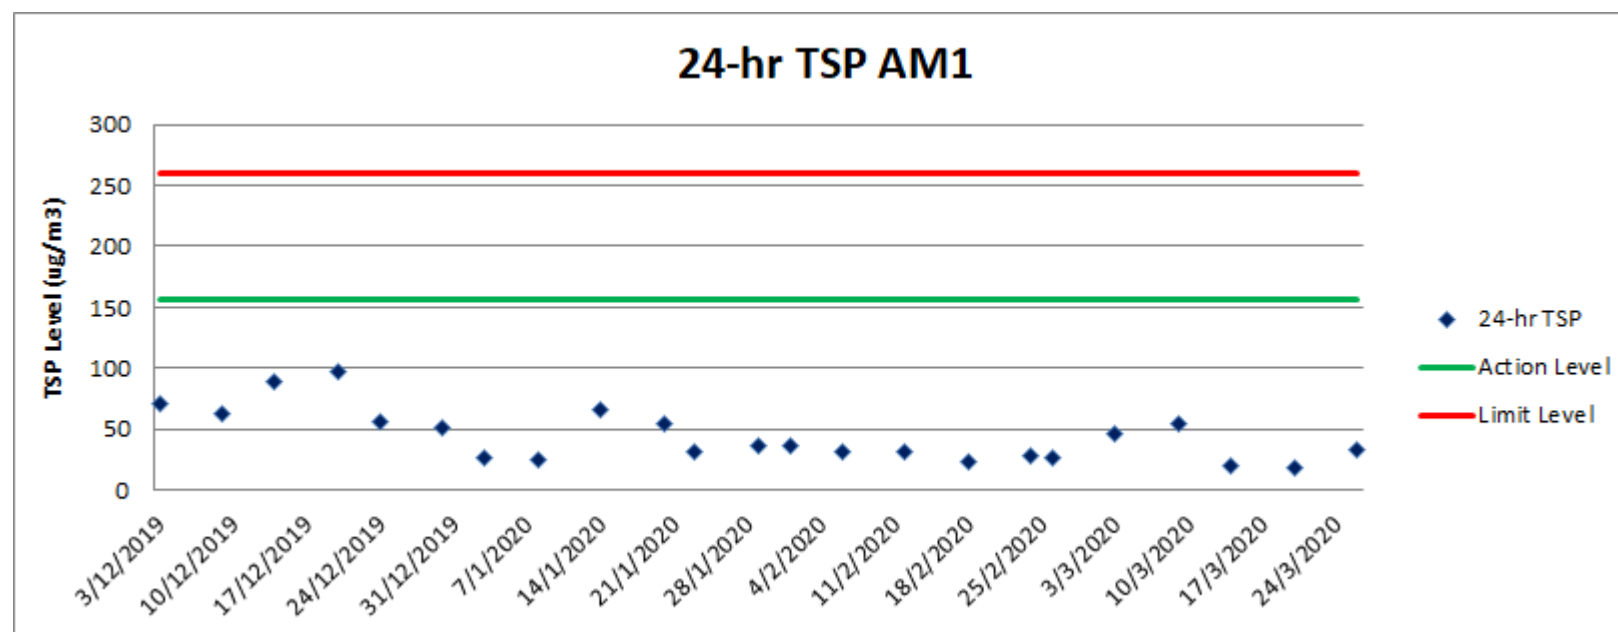
24-hr TSP Monitoring Result for AM1

Sampling ID & Paper No.	Temperature (°C) *1	Wind Direction *1	Wind Speed (m/s) *1	Sampling Date	Wt. of paper (g)			Flow Rate (CFM)	Total Volume *2 (m³)	TSP Concentration (µg/m³)
					Initial Wt.	Final Wt.	Wt. of dust			
AM10303 207496	17.5 - 20.8	E	<5m/s	3/3/2020	2.6662	2.7680	0.1018	50.0	2146.13	47
AM10309 207478	20.3 - 26.8	NE	<5m/s	9/3/2020	2.6776	2.7958	0.1182	50.0	2146.13	55
AM10314 207474	19.2 - 24.8	NE	<5m/s	14/3/2020	2.6905	2.7343	0.0438	50.0	2146.13	20
AM10320 207476	19.9 - 23.0	NE	<5m/s	20/3/2020	2.6784	2.7188	0.0404	50.0	2146.13	19
AM10326 207701	21.5 - 26.0	E	<5m/s	26/3/2020	2.7159	2.7891	0.0732	50.0	2146.13	34

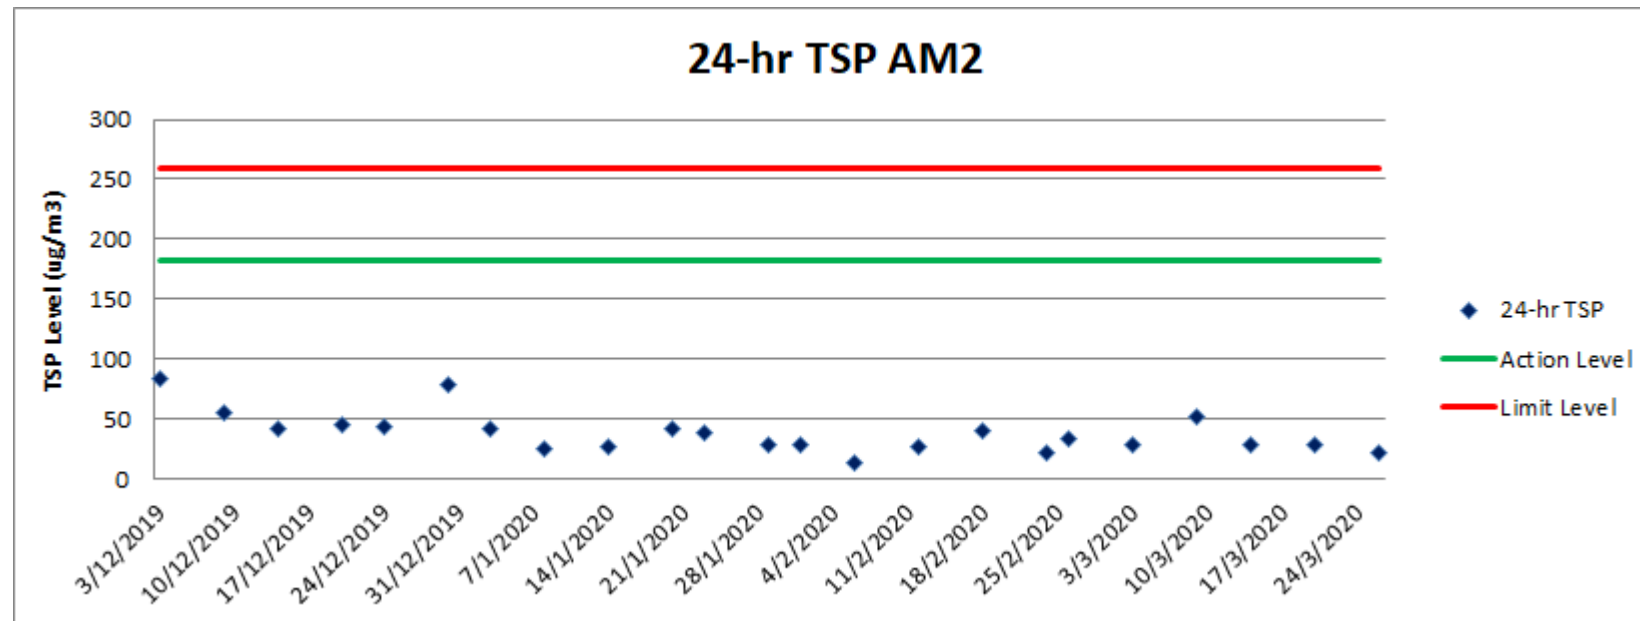
24-hr TSP Monitoring Result for AM2

Sampling ID & Paper No.	Temperature (°C) *1	Wind Direction *1	Wind Speed (m/s) *1	Sampling Date	Wt. of paper (g)			Flow Rate (CFM)	Total Volume *2 (m³)	TSP Concentration (µg/m³)
					Initial Wt.	Final Wt.	Wt. of dust			
AM20303 207477	17.5 - 20.8	E	<5m/s	3/3/2020	2.6848	2.7540	0.0692	50.0	2378.65	29
AM20309 207691	20.3 - 26.8	NE	<5m/s	9/3/2020	2.6912	2.8158	0.1246	50.0	2378.65	52
AM20314 207702	19.2 - 24.8	NE	<5m/s	14/3/2020	2.6938	2.7638	0.0700	50.0	2378.65	29
AM20320 207698	19.9 - 23.0	NE	<5m/s	20/3/2020	2.6700	2.7359	0.0659	50.0	2378.65	28
AM20326 207699	21.5 - 26.0	E	<5m/s	26/3/2020	2.6876	2.7399	0.0523	50.0	2378.65	22

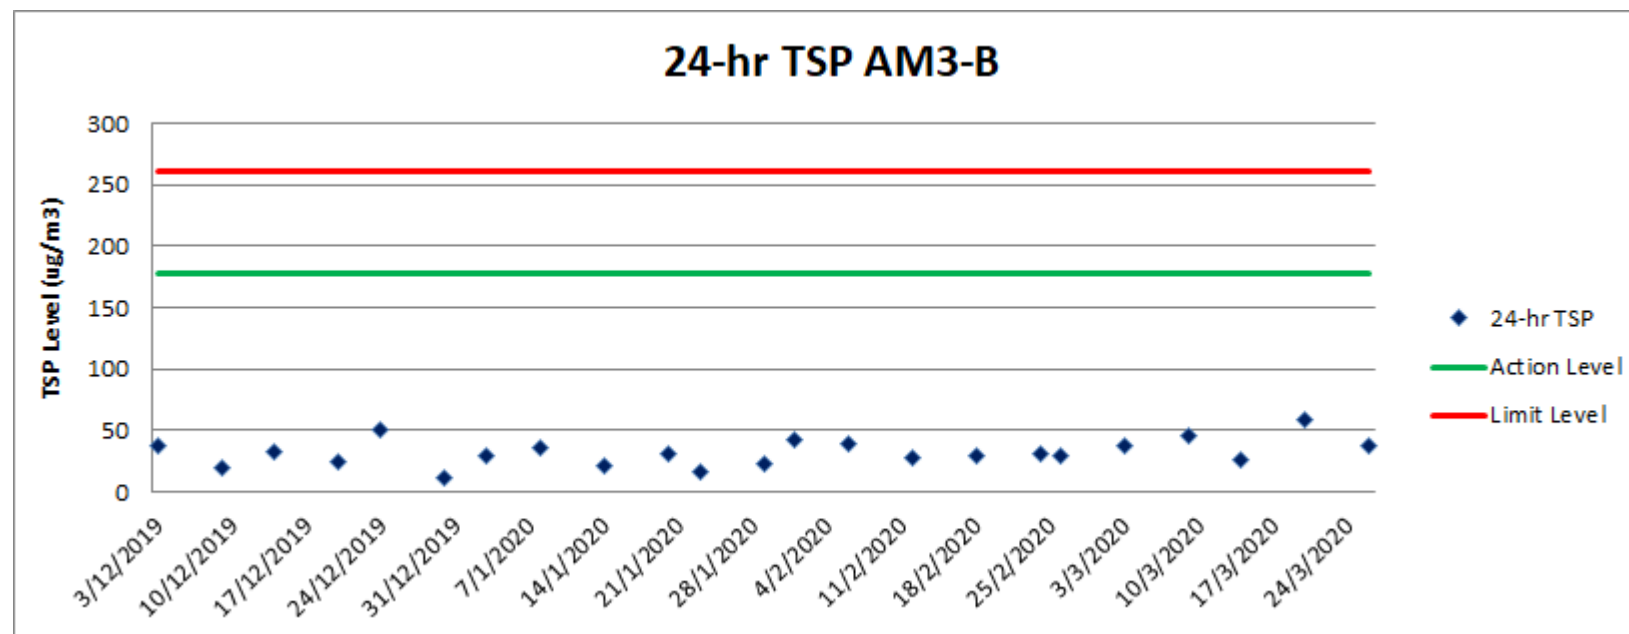
24-hr TSP Monitoring Result for AM3-B

Sampling ID & Paper No.	Temperature (°C) *1	Wind Direction *1	Wind Speed (m/s) *1	Sampling Date	Wt. of paper (g)			Flow Rate (CFM)	Total Volume *2 (m³)	TSP Concentration (µg/m³)
					Initial Wt.	Final Wt.	Wt. of dust			
AM3-B0303 207153	17.5 - 20.8	E	<5m/s	3/3/2020	2.6788	2.7666	0.0878	50.0	2338.62	38
AM3-B0309 207692	20.3 - 26.8	NE	<5m/s	9/3/2020	2.6753	2.7830	0.1077	50.0	2338.62	46
AM3-B0314 207693	19.2 - 24.8	NE	<5m/s	14/3/2020	2.7021	2.7623	0.0602	50.0	2338.62	26
AM3-B0320 207694	19.9 - 23.0	NE	<5m/s	20/3/2020	2.6852	2.8231	0.1379	50.0	2338.62	59
AM3-B0326 207200	21.5 - 26.0	E	<5m/s	26/3/2020	2.7077	2.7957	0.0880	50.0	2338.62	38

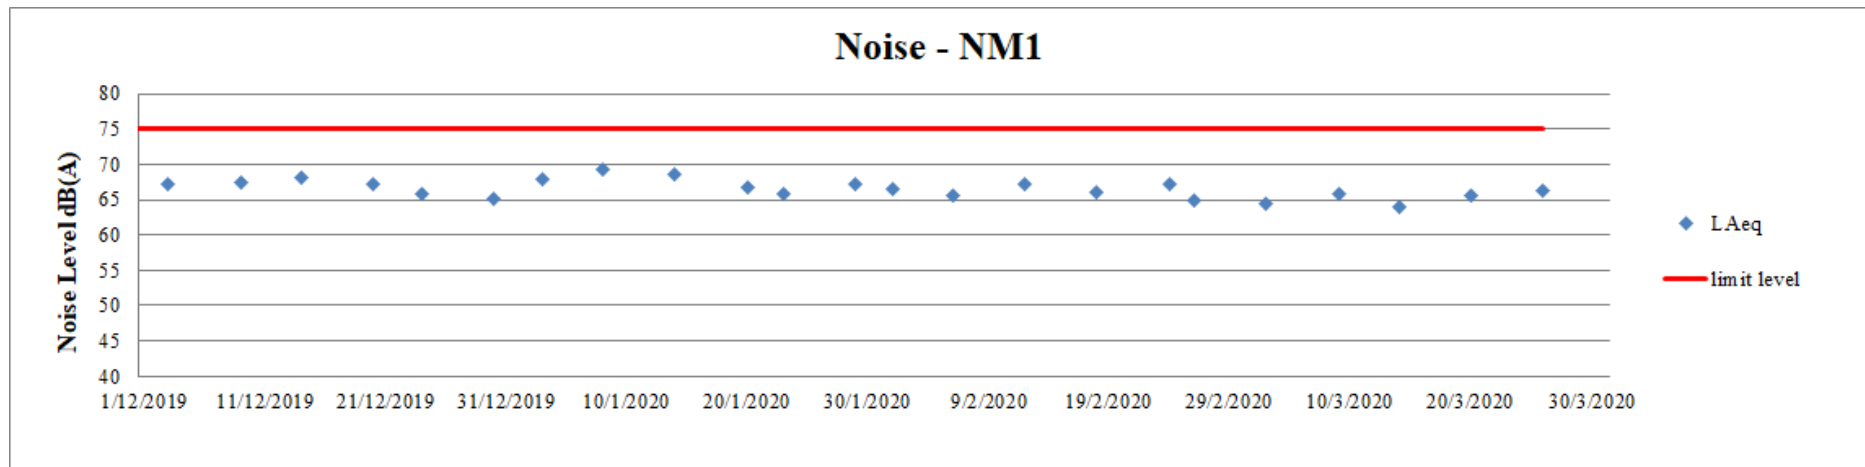
Noise Monitoring Result for NM1

Location	NM1				
Date	3/3/2020	9/3/2020	14/3/2020	20/3/2020	26/3/2020
Weather Condition	Overcast	Overcast	Overcast	Overcast	Overcast
Start Time	10:00	10:00	10:00	10:00	10:00
Measurement Period	30min	30min	30min	30min	30min
Baseline Level	75.1				
L _{Aeq}	64.4	65.8	63.9	65.6	66.4
L ₁₀	66.2	67.5	65.6	67.4	68.2
L ₉₀	60.3	60.2	59.7	60.0	60.7

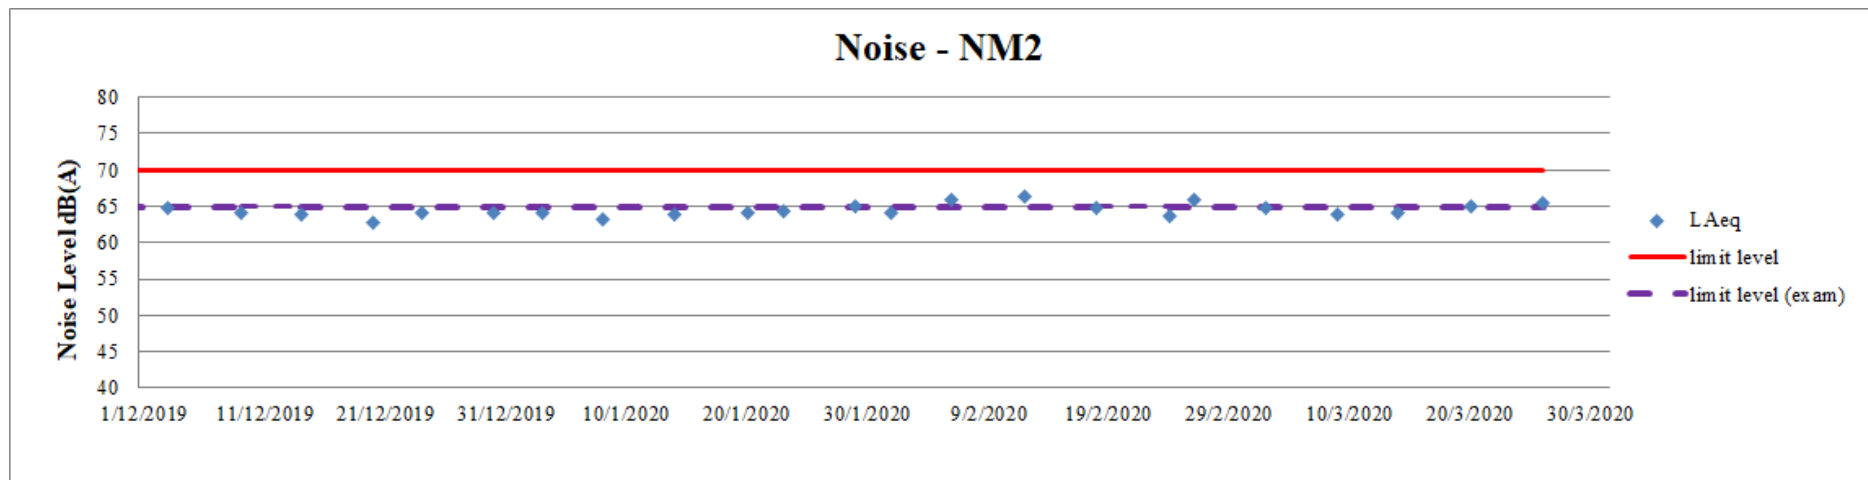
Noise Monitoring Result for NM2

Location	NM2				
Date	3/3/2020	9/3/2020	14/3/2020	20/3/2020	26/3/2020
Weather Condition	Overcast	Overcast	Overcast	Overcast	Overcast
Start Time	14:00	14:00	14:00	14:00	14:00
Measurement Period	30min	30min	30min	30min	30min
Baseline Level	66.5				
L _{Aeq}	64.8	63.9	64.2	65.1	65.5
L ₁₀	66.1	65.1	68.3	66.8	67.9
L ₉₀	58.2	58.4	59.3	58.6	58.7

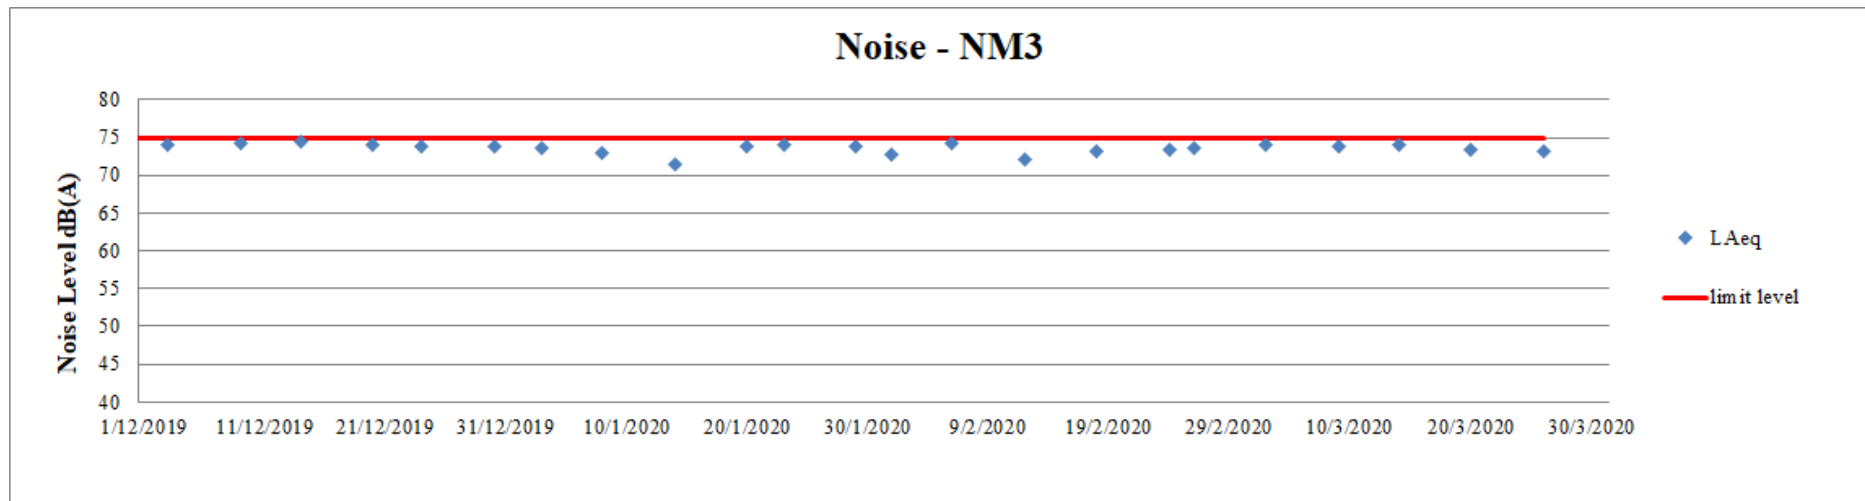
Noise Monitoring Result for NM3

Location	NM3				
Date	3/3/2020	9/3/2020	14/3/2020	20/3/2020	26/3/2020
Weather Condition	Overcast	Overcast	Overcast	Overcast	Overcast
Start Time	9:00	9:00	9:00	9:00	9:00
Measurement Period	30min	30min	30min	30min	30min
Baseline Level	74.5				
L _{Aeq}	74.1	73.9	74.1	73.3	73.2
L ₁₀	76.1	75.5	76.2	75.4	76.3
L ₉₀	66.9	67.1	66.8	66.2	67.2

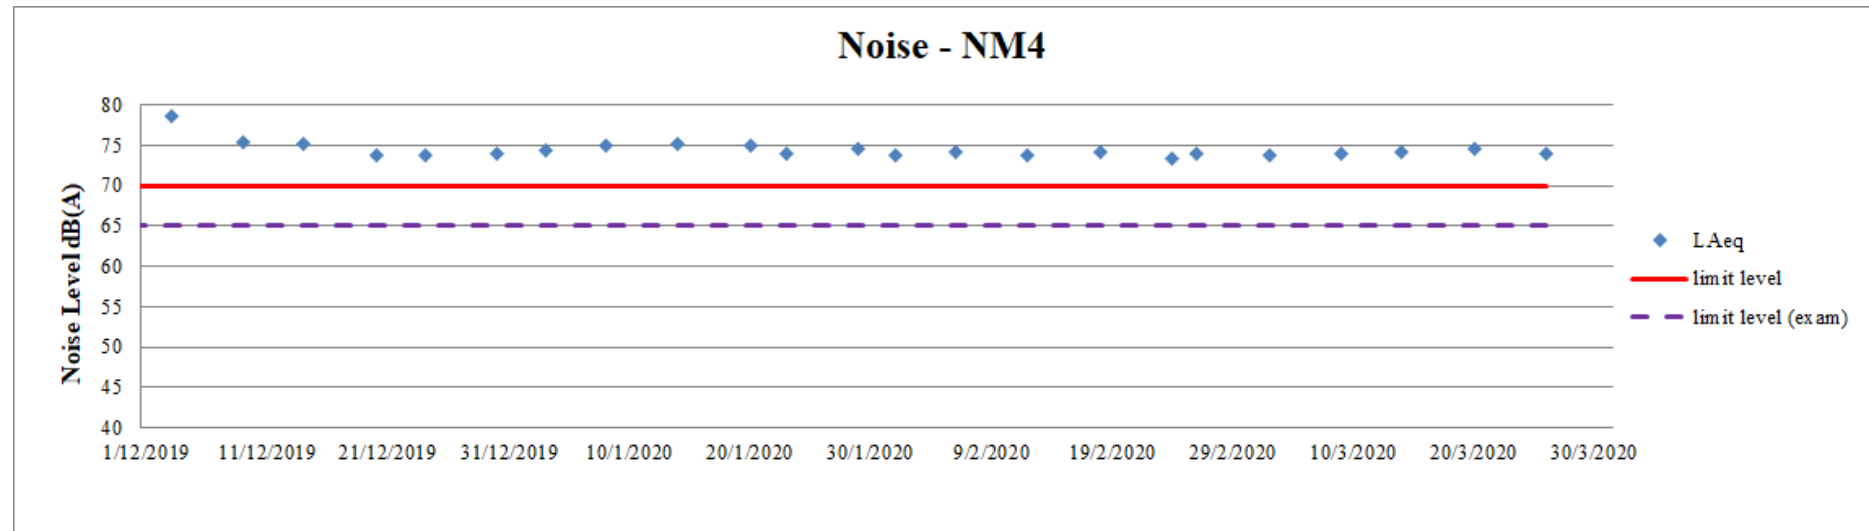
Noise Monitoring Result for NM4

The noise source for causing exceedances at NM4 was from the traffic of Canton Road. The NM4 was directly affected by the noise generated from the traffic. The recorded monitoring results at the NM4 were near the baseline noise level. The exceedances were not caused by the construction works of this project.

Location	NM4					NM4 (Re-measurement) *				
Date	3/3/2020	9/3/2020	14/3/2020	20/3/2020	26/3/2020	3/3/2020	9/3/2020	14/3/2020	20/3/2020	26/3/2020
Weather Condition	Overcast	Overcast	Overcast	Overcast	Overcast	Overcast	Overcast	Overcast	Overcast	Overcast
Start Time	13:00	13:00	13:00	13:00	13:00	13:30	13:30	13:30	13:30	13:30
Measurement Period	30min	30min	30min	30min	30min	30min	30min	30min	30min	30min
Baseline Level	73.3					73.3				
L _{Aeq}	73.7	73.9	74.1	74.5	73.9	73.8	74.0	74.5	74.4	74.1
L ₁₀	77.4	77.5	77.8	77.9	77.0	77.8	77.2	77.9	77.1	77.2
L ₉₀	65.2	66.0	66.1	66.8	66.9	75.4	66.2	66.4	66.1	66.5

* Repeat noise measurement when exceedance is recorded. The result is used to confirm the findings and it would not be showed on the graph plot

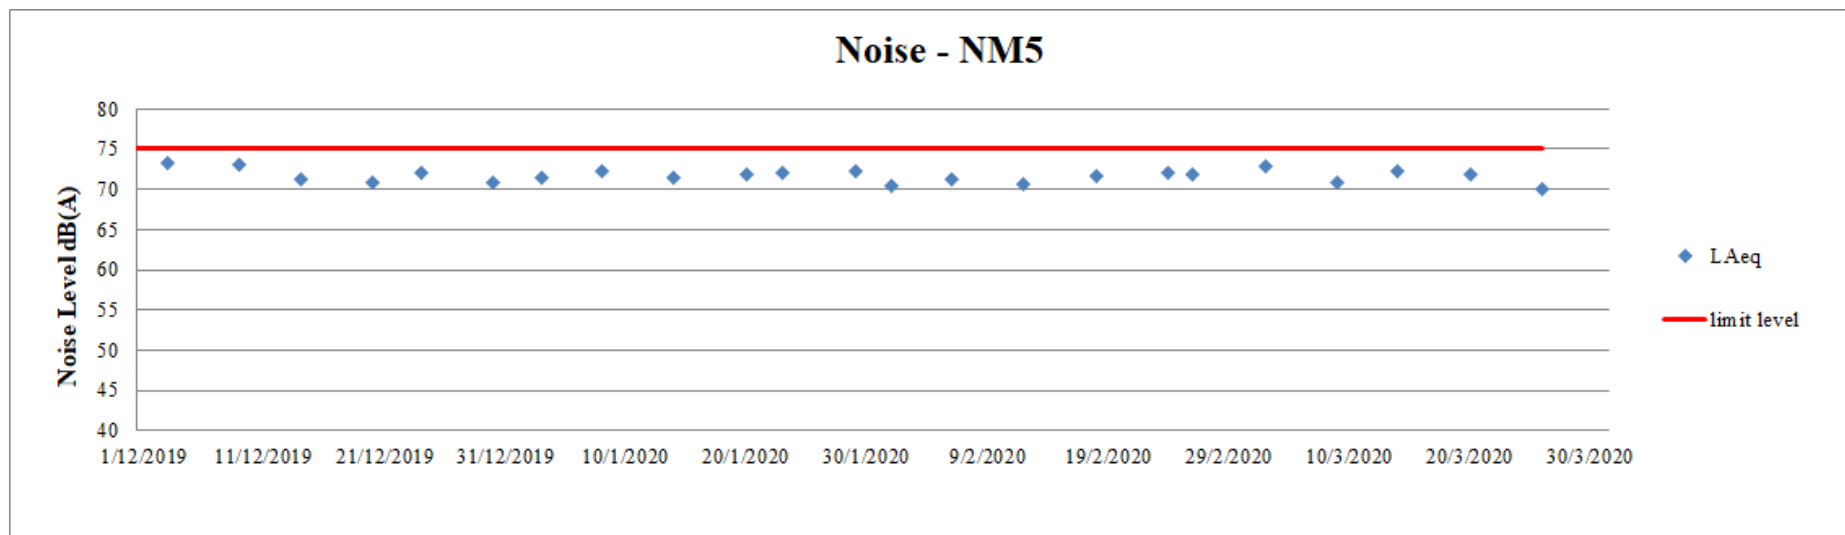
Noise Monitoring Result for NM5

Location	NM5				
Date	3/3/2020	9/3/2020	14/3/2020	20/3/2020	26/3/2020
Weather Condition	Overcast	Overcast	Overcast	Overcast	Overcast
Start Time	15:00	15:00	15:00	15:00	15:00
Measurement Period	30min	30min	30min	30min	30min
Baseline Level	71.8				
L _{Aeq}	72.8	70.8	72.2	71.9	70.0
L ₁₀	74.1	72.8	74.1	74.0	73.8
L ₉₀	64.0	63.8	63.0	61.5	60.1
