Proposed Road Improvement Works in West Kowloon Reclamation Development – Phase 1

Environmental Monitoring & Audit Report

01/04/2020 – 30/04/2020

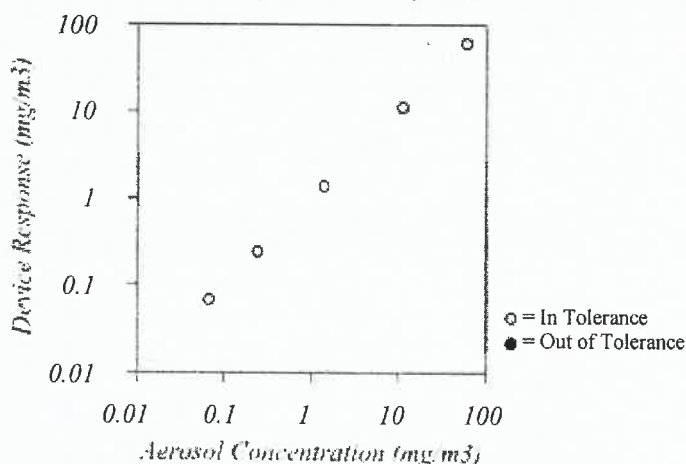
Concentration Linearity Plot

CONCENTRATION				Unit: mg/m ³			
#	STANDARD	MEASURED	ALLOWABLE RANGE	#	STANDARD	MEASURED	ALLOWABLE RANGE
1	0.068	0.068	0.048~0.088	4	11.185	11.111	10.066~12.304
2	0.243	0.239	0.207~0.279	5	60.075	59.832	54.067~66.083
3	1.403	1.358	1.263~1.543

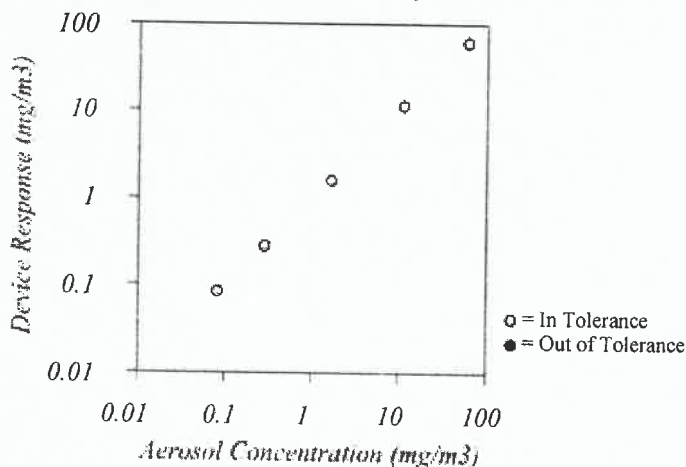
Concentration Linearity Plot

CONCENTRATION				Unit: mg/m ³			
#	STANDARD	MEASURED	ALLOWABLE RANGE	#	STANDARD	MEASURED	ALLOWABLE RANGE
1	0.083	0.083	0.058~0.108	4	11.419	11.425	10.277~12.561
2	0.290	0.278	0.247~0.333	5	61.302	61.286	55.172~67.432
3	1.687	1.603	1.518~1.856
