Proposed Road Improvement Works in West Kowloon Reclamation Development – Phase 1

Environmental Monitoring & Audit Report

01/07/2020 – 31/07/2020

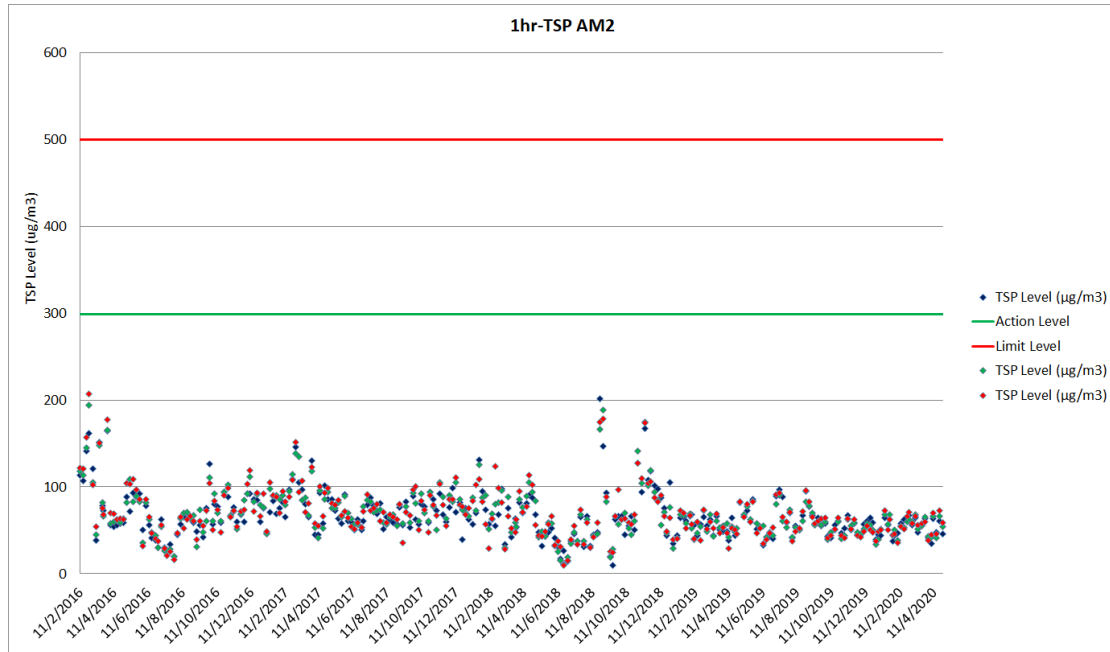
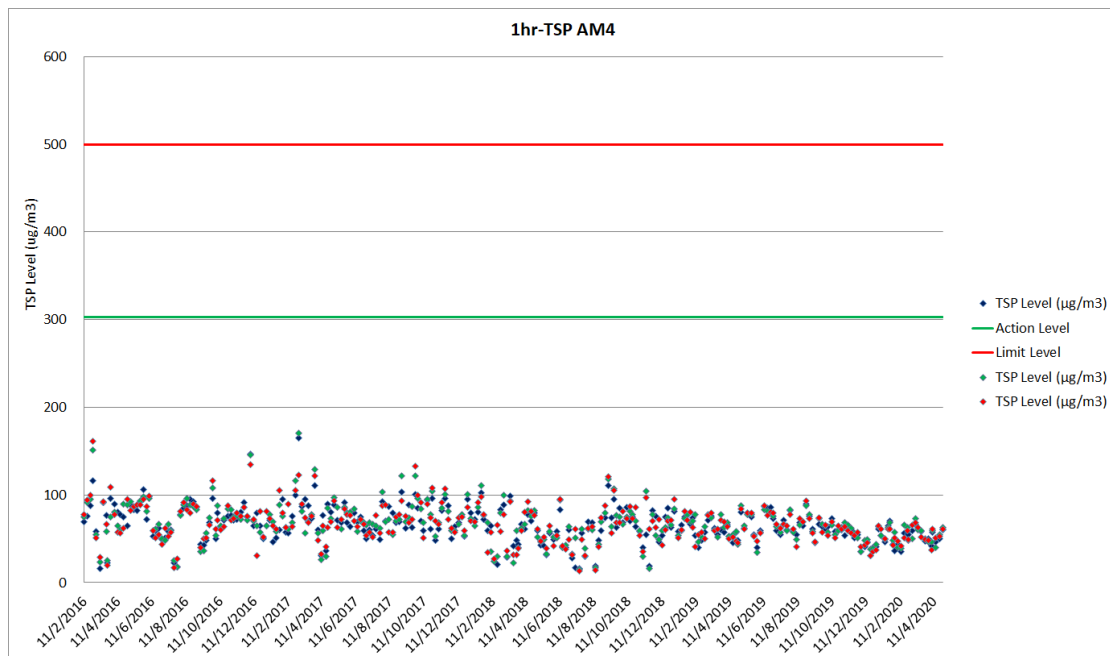
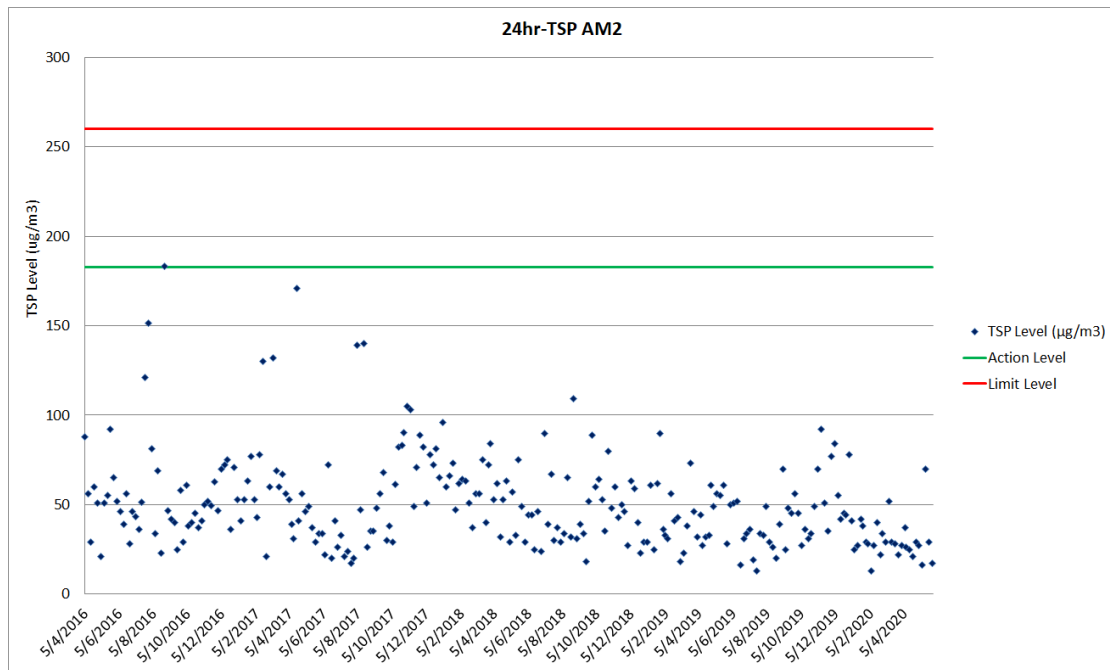
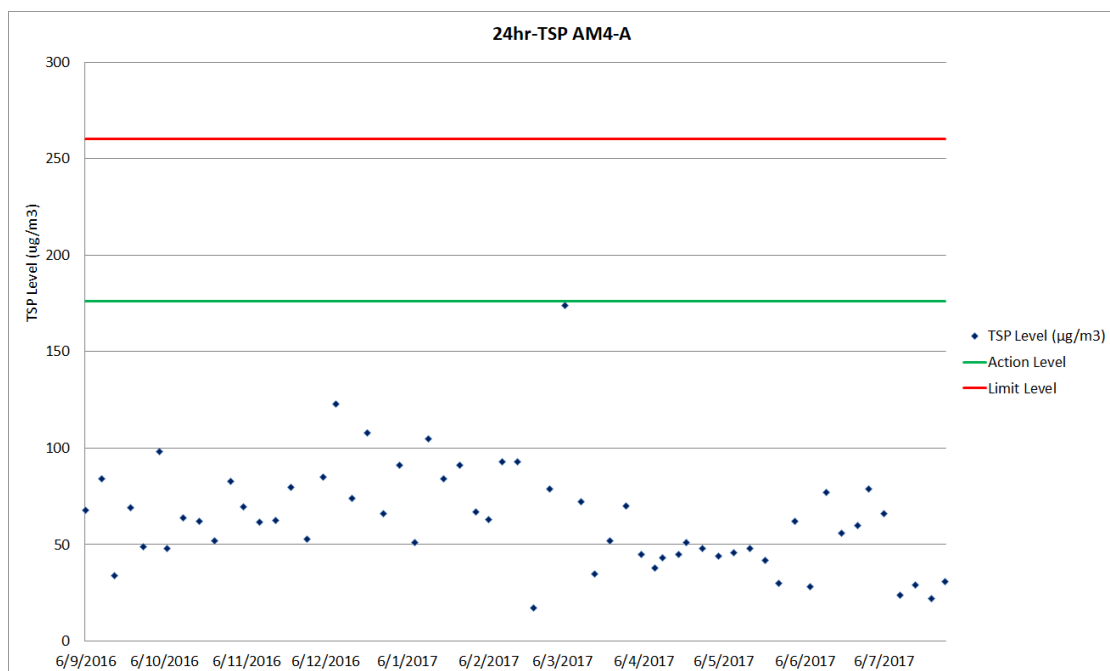
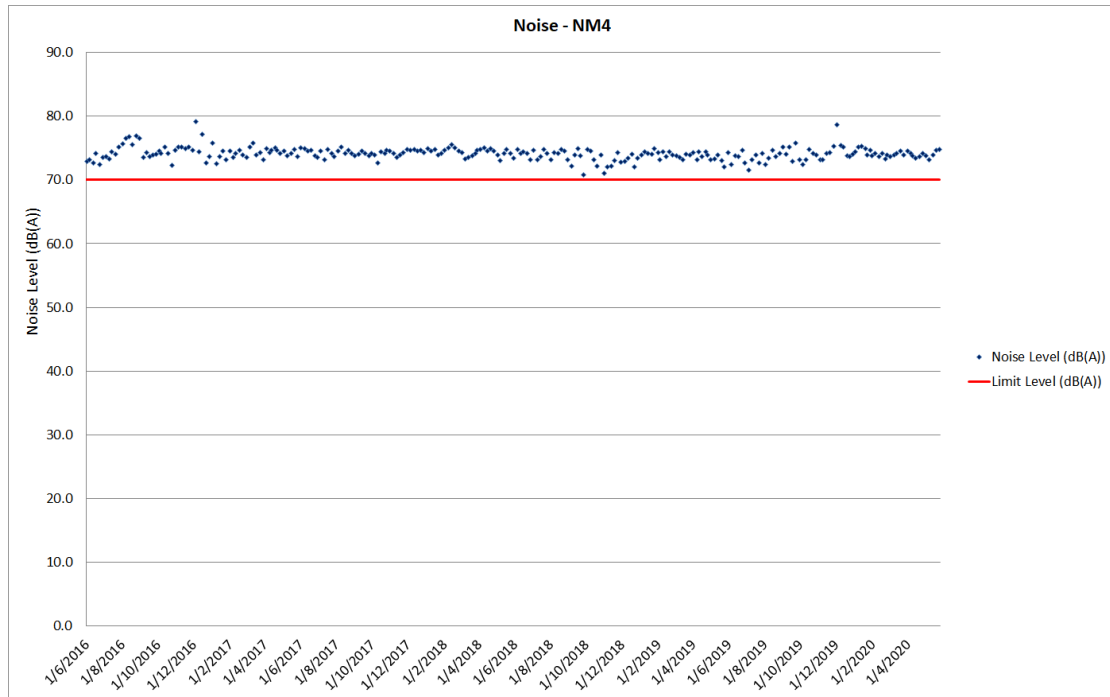
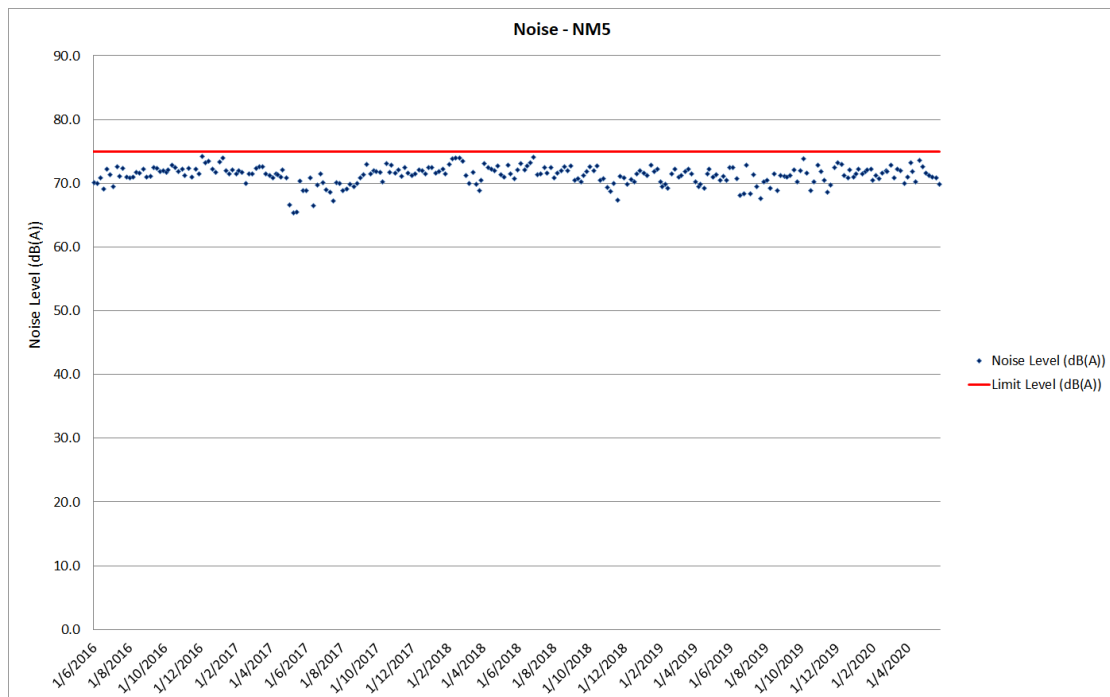
Monitoring Result and Trends Analysis

The trends of the 1-hr TSP, 24-hr TSP and noise monitoring results from February 2016 and the comparison with action and limit level are shown below:

The dust impact monitoring results of 1-hr TSP and 24-hr TSP at AM2 and AM4/AM4-A obtained from February 2016 to May 2020 were much lower than the action levels established by baseline monitoring data and closed to the baseline level. The noise impact monitoring results obtained at NM4 and NM5 from February 2016 to May 2020 were closed to the baseline level.

During the measurement period from February 2016 to May 2020, the impact

monitoring results presented that no dust and noise impacts obviously caused by the construction works and affected the sensitive receivers near Portion Q.

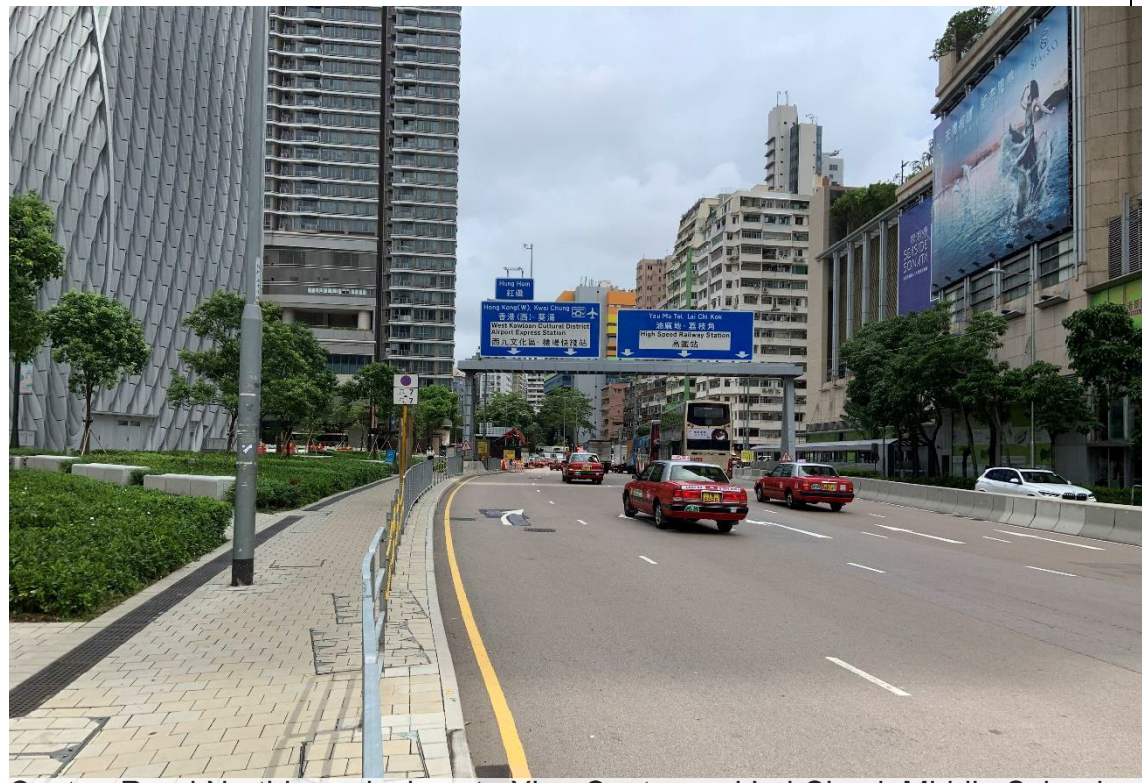
Canton Road Northbound, close to Xiqu Centre and Lai Chack Middle School

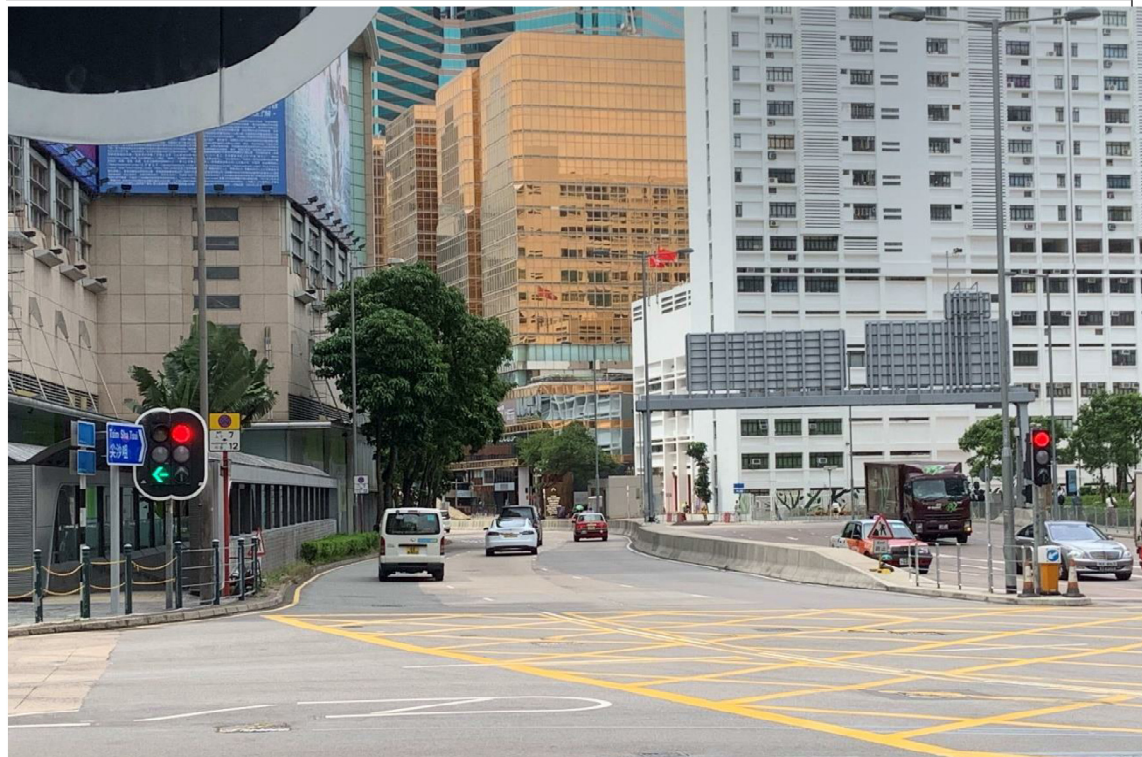
Canton Road Southbound, close to Grand Austin Tower 1 and Garden Building

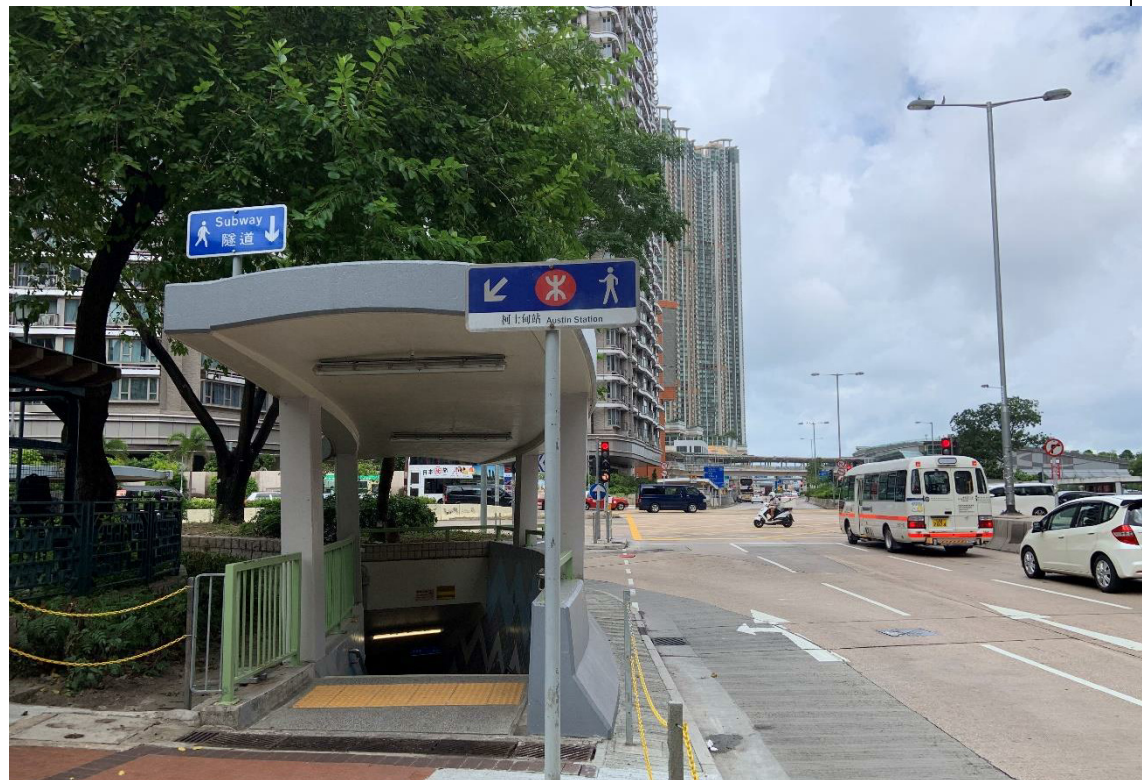
Jordan Road, close to Kowloon King George V Memorial Park

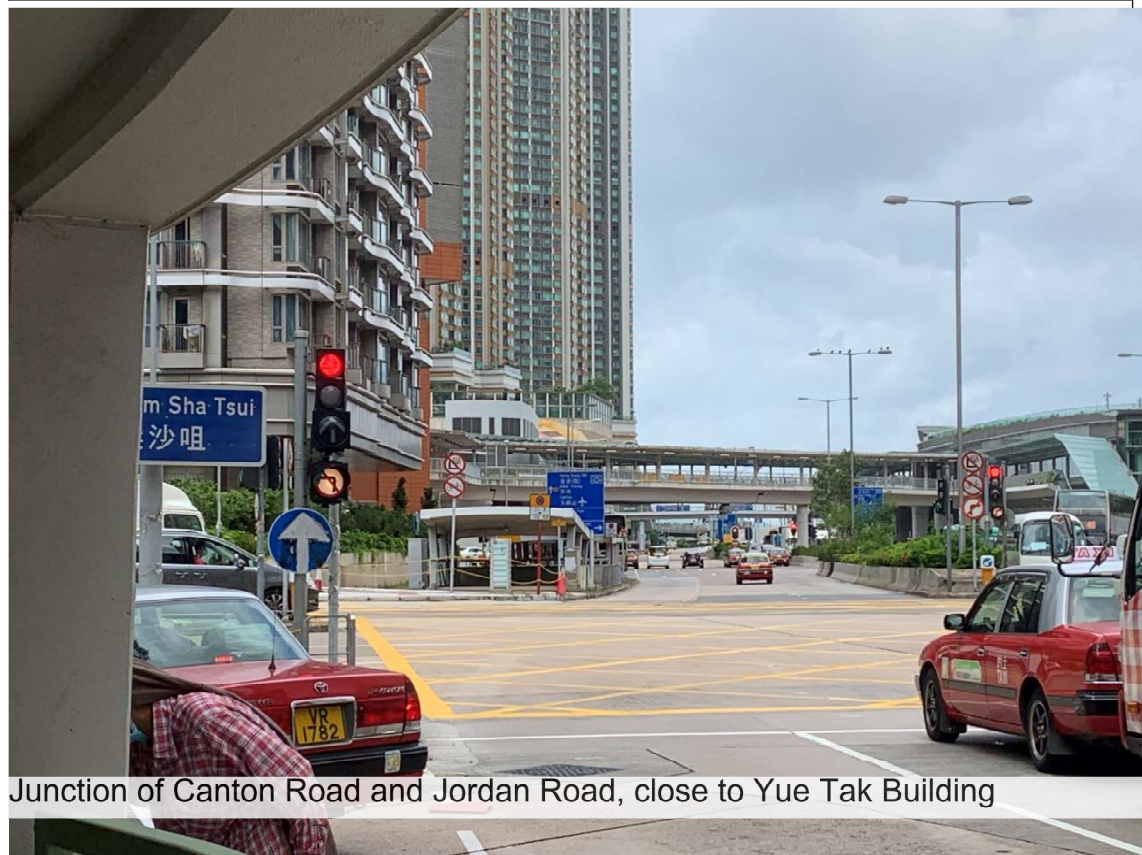
Junction of Canton Road and Jordan Road, close to Yue Tak Building

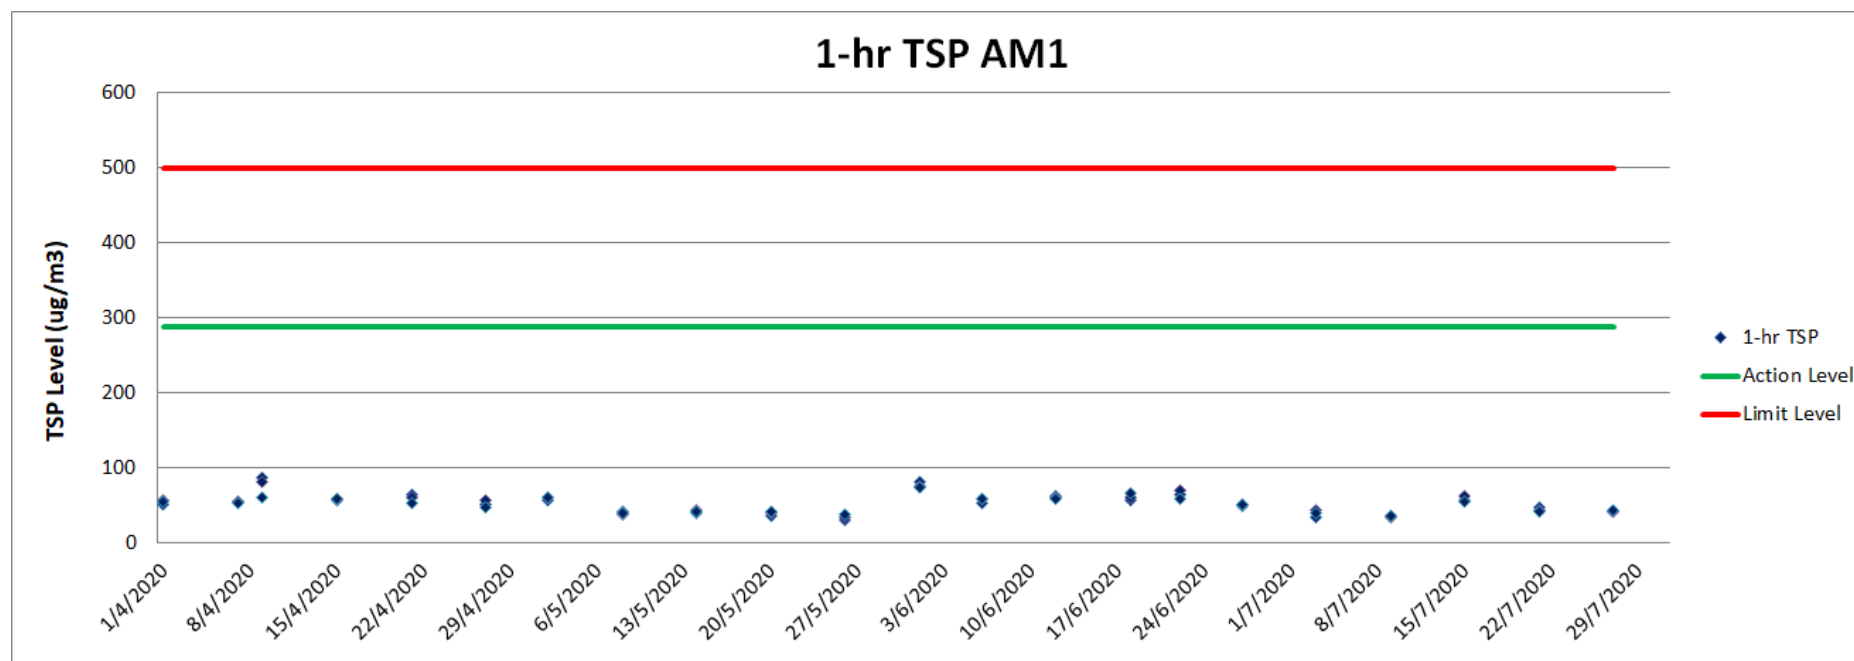
Date	Weather	Temperature (°C) *	Wind Direction *	Wind Speed (m/s) *	Sampling Time			Reading (µg/m³)			
					1	2	3	1	2	3	Average
3/7/2020	Overcast	28.7 - 32.2	SE	<5m/s	9:00	10:01	11:02	33	43	40	39
9/7/2020	Overcast	24.1 - 29.9	SE	<5m/s	9:00	10:01	11:02	35	34	35	35
15/7/2020	Sunny	27.8 - 35.0	S	<5m/s	9:00	10:01	11:02	56	62	55	58
21/7/2020	Sunny	27.7 - 31.8	S	<5m/s	9:00	10:01	11:02	46	44	42	44
27/7/2020	Overcast	29.2 - 32.6	SE	<5m/s	9:00	10:01	11:02	41	42	44	42

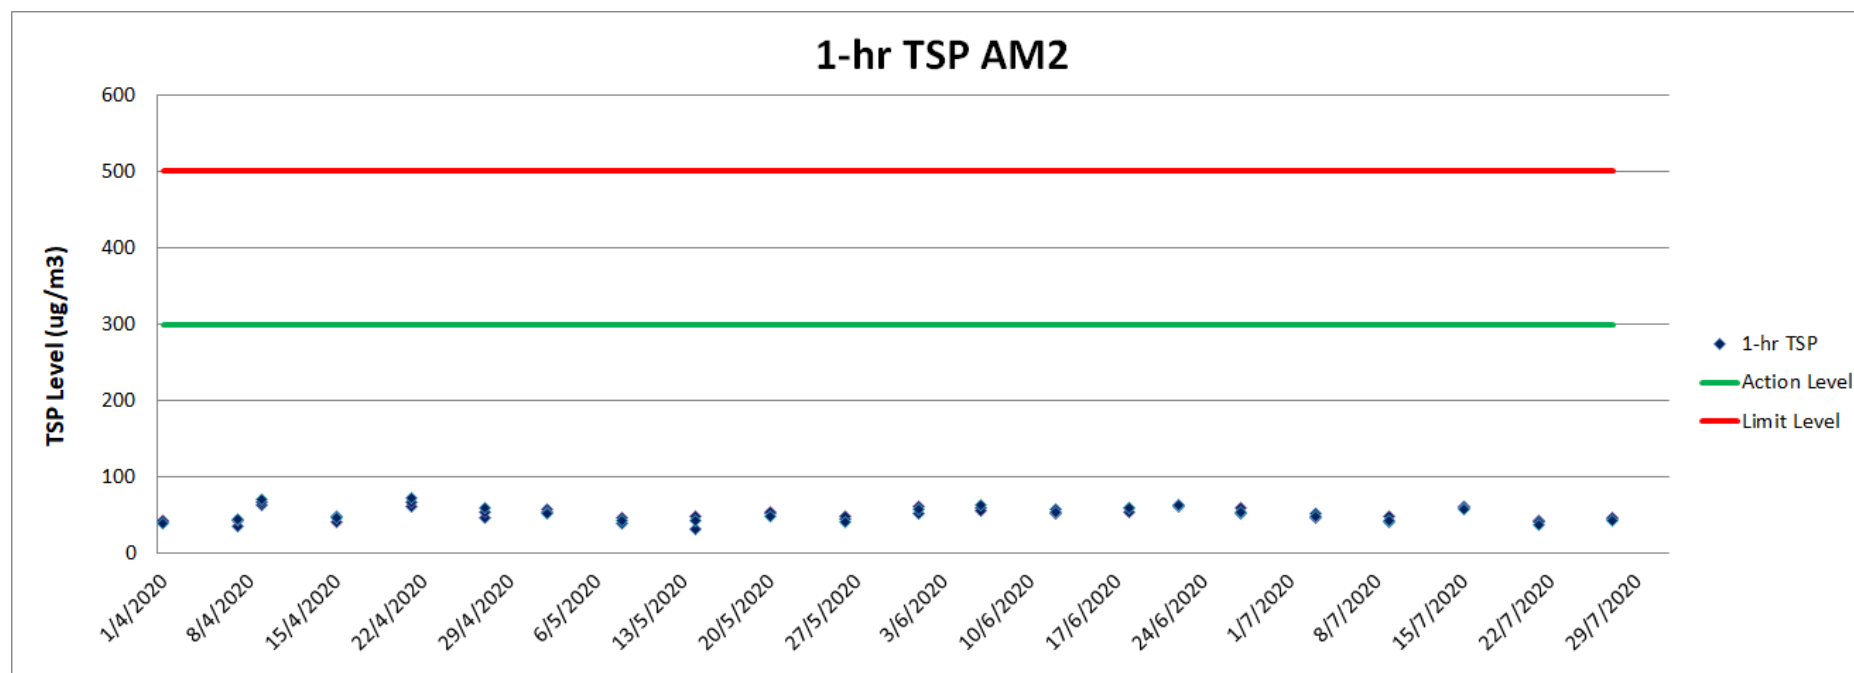
1-hr TSP Monitoring Result for AM2

Date	Weather	Temperature (°C) *	Wind Direction *	Wind Speed (m/s) *	Sampling Time			Reading (µg/m³)			
					1	2	3	1	2	3	Average
3/7/2020	Overcast	28.7 - 32.2	SE	<5m/s	13:00	14:01	15:02	51	46	48	48
9/7/2020	Overcast	24.1 - 29.9	SE	<5m/s	13:00	14:01	15:02	40	48	42	43
15/7/2020	Sunny	27.8 - 35.0	S	<5m/s	13:00	14:01	15:02	61	60	57	59
21/7/2020	Sunny	27.7 - 31.8	S	<5m/s	13:00	14:01	15:02	42	40	37	40
27/7/2020	Overcast	29.2 - 32.6	SE	<5m/s	13:00	14:01	15:02	44	47	42	44

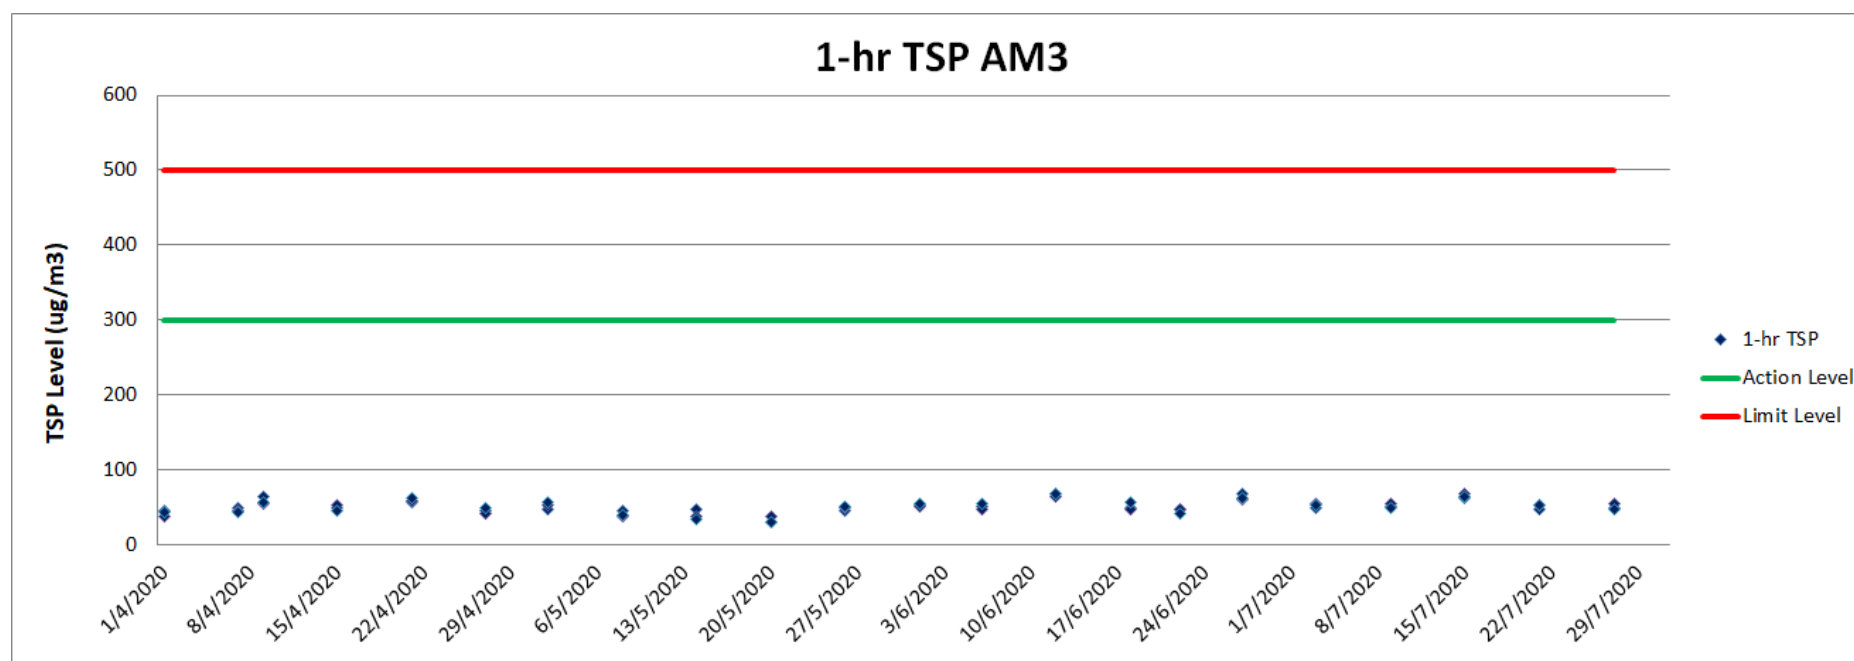
1-hr TSP Monitoring Result for AM3

Date	Weather	Temperature (°C) *	Wind Direction *	Wind Speed (m/s) *	Sampling Time			Reading (µg/m³)			
					1	2	3	1	2	3	Average
3/7/2020	Overcast	28.7 - 32.2	SE	<5m/s	9:00	10:01	11:02	49	55	52	52
9/7/2020	Overcast	24.1 - 29.9	SE	<5m/s	9:00	10:01	11:02	51	54	49	51
15/7/2020	Sunny	27.8 - 35.0	S	<5m/s	9:00	10:01	11:02	61	67	63	64
21/7/2020	Sunny	27.7 - 31.8	S	<5m/s	9:00	10:01	11:02	47	52	53	51
27/7/2020	Overcast	29.2 - 32.6	SE	<5m/s	9:00	10:01	11:02	48	55	47	50

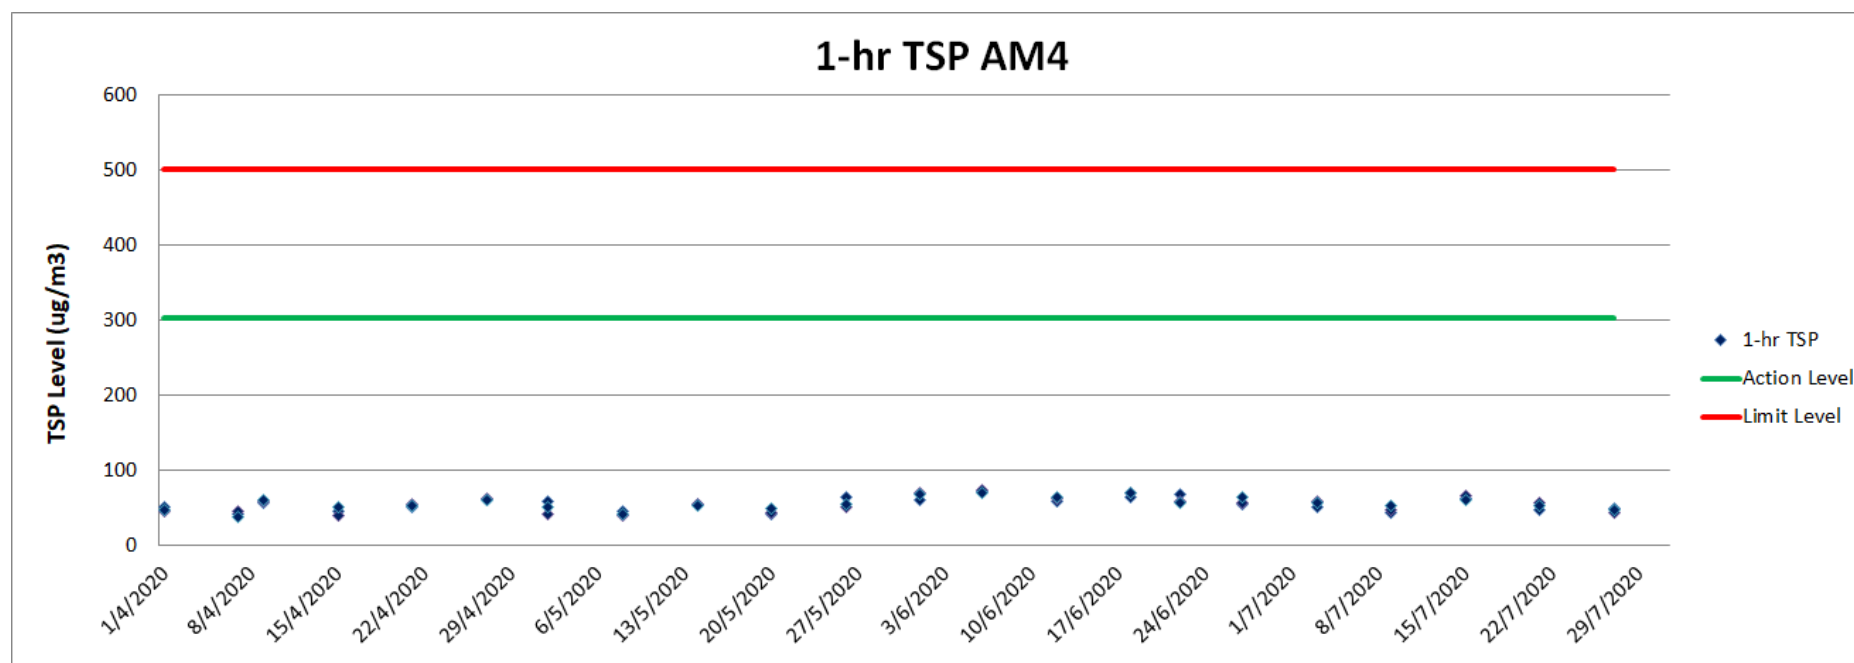
1-hr TSP Monitoring Result for AM4

Date	Weather	Temperature (°C) *	Wind Direction *	Wind Speed (m/s) *	Sampling Time			Reading (µg/m³)			
					1	2	3	1	2	3	Average
3/7/2020	Overcast	28.7 - 32.2	SE	<5m/s	13:10	14:11	15:12	50	58	57	55
9/7/2020	Overcast	24.1 - 29.9	SE	<5m/s	13:10	14:11	15:12	44	48	52	48
15/7/2020	Sunny	27.8 - 35.0	S	<5m/s	13:10	14:11	15:12	62	66	60	63
21/7/2020	Sunny	27.7 - 31.8	S	<5m/s	13:10	14:11	15:12	47	56	52	52
27/7/2020	Overcast	29.2 - 32.6	SE	<5m/s	13:10	14:11	15:12	49	43	48	47

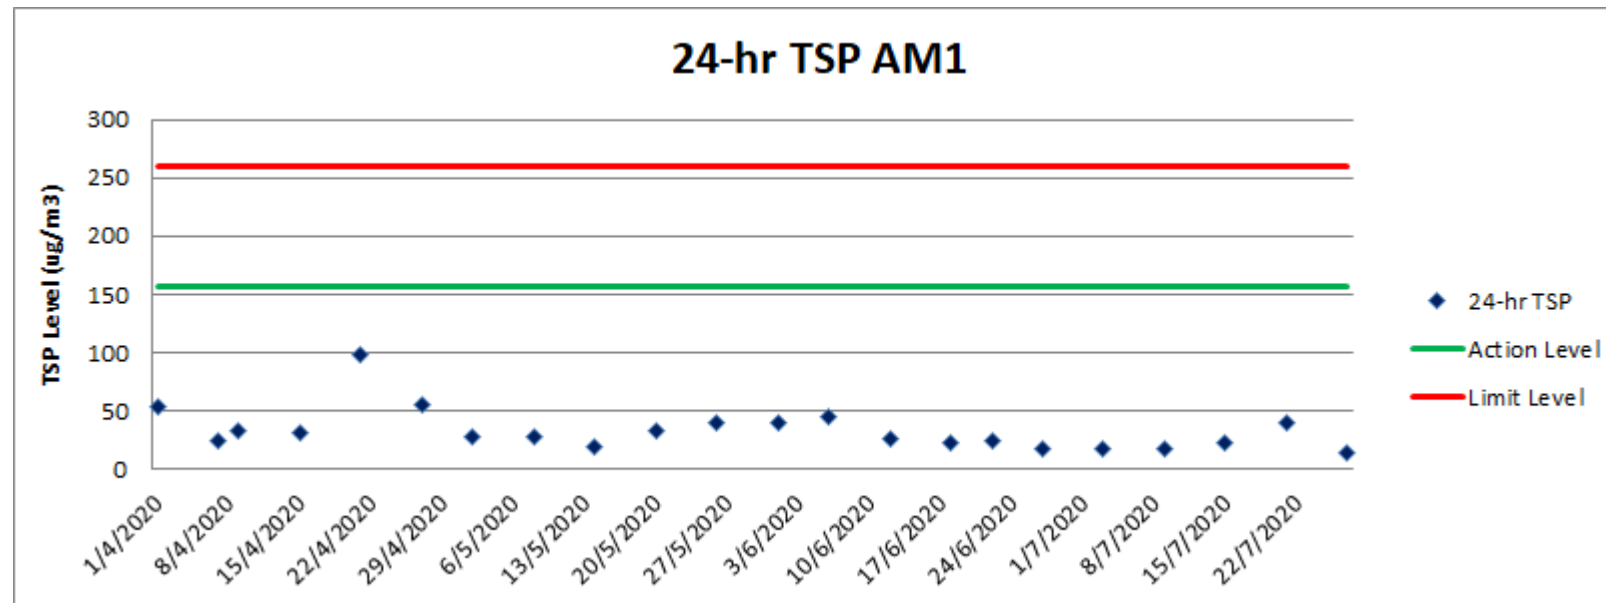
24-hr TSP Monitoring Result for AM1

Sampling ID & Paper No.	Temperature (°C) * ¹	Wind Direction * ¹	Wind Speed (m/s) * ¹	Sampling Date	Wt. of paper (g)			Flow Rate (CFM)	Total Volume * ² (m ³)	TSP Concentration (µg/m ³)
					Initial Wt.	Final Wt.	Wt. of dust			
AM10703 207765	27.3 - 33.1	SE	<5m/s	3/7/2020	2.6804	2.7199	0.0395	50.0	2230.06	18
AM10709 207766	29.0 - 31.9	SE	<5m/s	9/7/2020	2.7025	2.7410	0.0385	50.0	2230.06	17
AM10715 207764	28.8 - 33.9	S	<5m/s	15/7/2020	2.6691	2.7215	0.0524	50.0	2230.06	23
AM10721 207147	28.1 - 34.7	S	<5m/s	21/7/2020	2.7004	2.7882	0.0878	50.0	2230.06	39
AM10727 207148	28.4 - 33.5	SE	<5m/s	27/7/2020	2.7005	2.7323	0.0318	50.0	2230.06	14

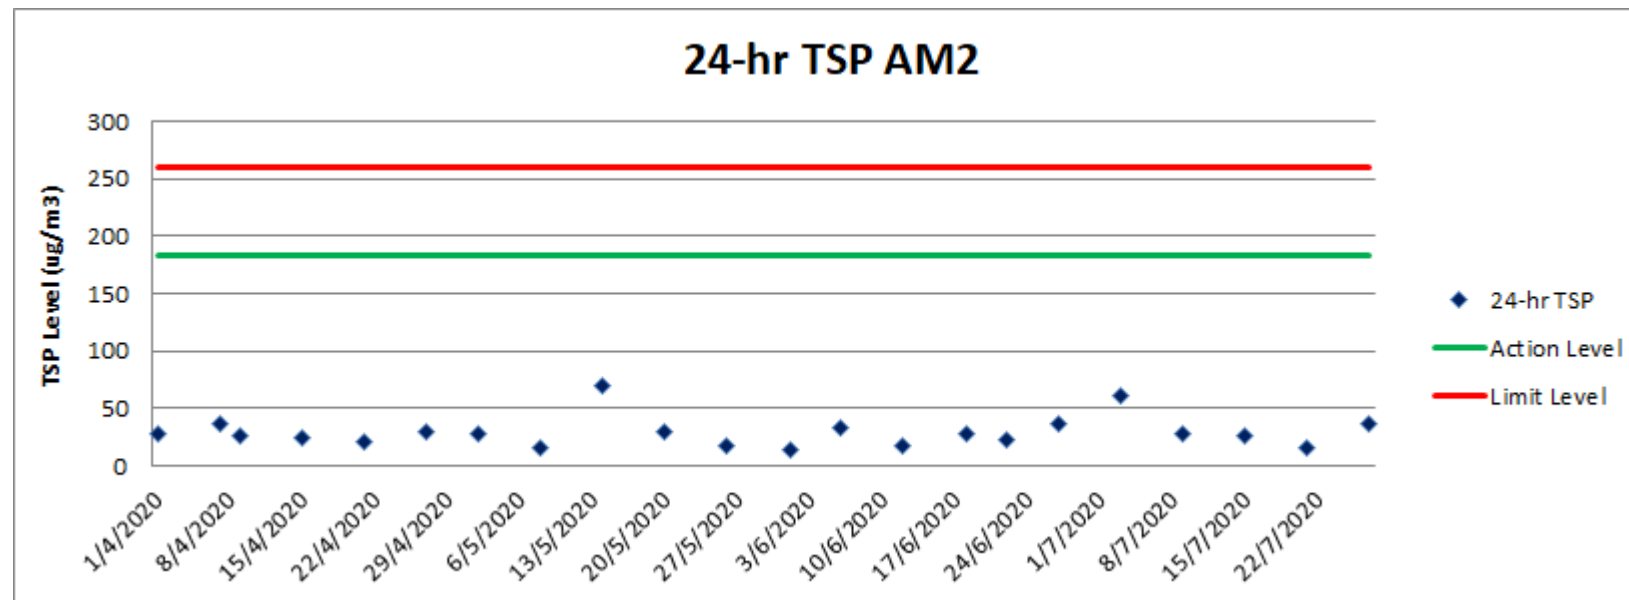
24-hr TSP Monitoring Result for AM2

Sampling ID & Paper No.	Temperature (°C) * ¹	Wind Direction * ¹	Wind Speed (m/s) * ¹	Sampling Date	Wt. of paper (g)			Flow Rate (CFM)	Total Volume * ² (m ³)	TSP Concentration (µg/m ³)
					Initial Wt.	Final Wt.	Wt. of dust			
AM20703 207143	27.3 - 33.1	SE	<5m/s	3/7/2020	2.6565	2.7984	0.1419	50.0	2320.76	61
AM20709 207154	29.0 - 31.9	SE	<5m/s	9/7/2020	2.6927	2.7553	0.0626	50.0	2320.76	27
AM20715 207743	28.8 - 33.9	S	<5m/s	15/7/2020	2.6890	2.7491	0.0601	50.0	2320.76	26
AM20721 207755	28.1 - 34.7	S	<5m/s	21/7/2020	2.6953	2.7306	0.0353	50.0	2320.76	15
AM20727 207739	28.4 - 33.5	SE	<5m/s	27/7/2020	2.6618	2.7452	0.0834	50.0	2320.76	36

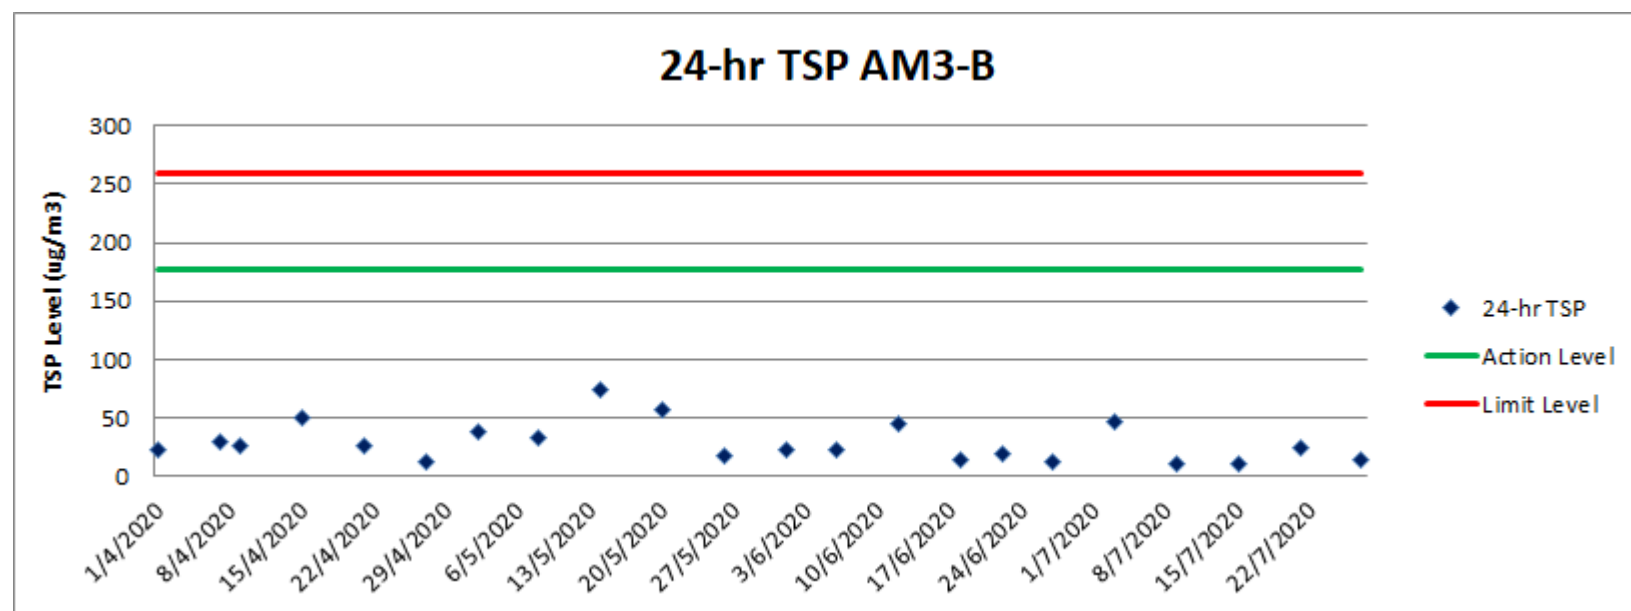
24-hr TSP Monitoring Result for AM3-B

Sampling ID & Paper No.	Temperature (°C) * ¹	Wind Direction * ¹	Wind Speed (m/s) * ¹	Sampling Date	Wt. of paper (g)			Flow Rate (CFM)	Total Volume * ² (m ³)	TSP Concentration (µg/m ³)
					Initial Wt.	Final Wt.	Wt. of dust			
AM3-B0703 207738	27.3 - 33.1	SE	<5m/s	3/7/2020	2.6732	2.7786	0.1054	50.0	2261.90	47
AM3-B0709 207732	29.0 - 31.9	SE	<5m/s	9/7/2020	2.6916	2.7165	0.0249	50.0	2261.90	11
AM3-B0715 207733	28.8 - 33.9	S	<5m/s	15/7/2020	2.6826	2.7075	0.0249	50.0	2261.90	11
AM3-B0721 207397	28.1 - 34.7	S	<5m/s	21/7/2020	2.7739	2.8306	0.0567	50.0	2261.90	25
AM3-B0727 207146	28.4 - 33.5	SE	<5m/s	27/7/2020	2.6970	2.7291	0.0321	50.0	2261.90	14

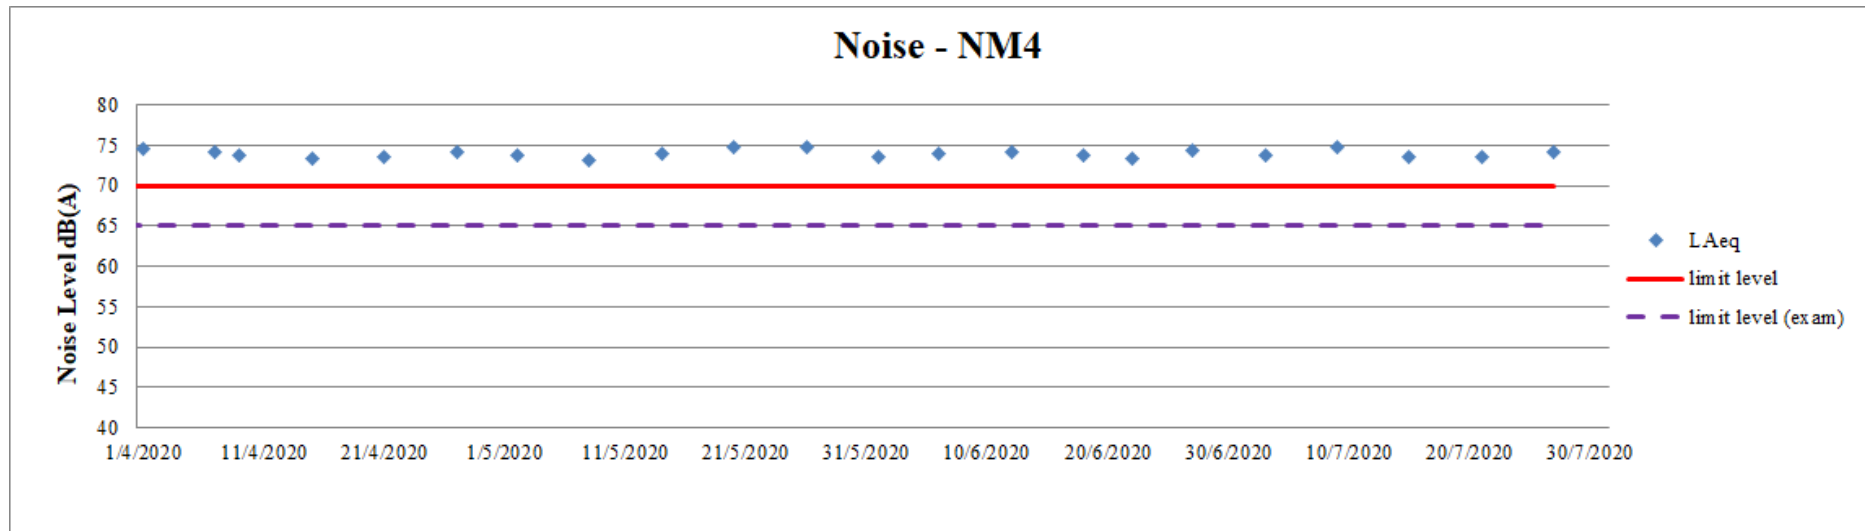
Noise Monitoring Result for NM4

The noise source for causing exceedances at NM4 was from the traffic of Canton Road. The NM4 was directly affected by the noise generated from the traffic. The recorded monitoring results at the NM4 were near the baseline noise level. The exceedances were not caused by the construction works of this project.

Location	NM4					NM4 (Re-measurement) *				
Date	3/7/2020	9/7/2020	15/7/2020	21/7/2020	27/7/2020	3/7/2020	9/7/2020	15/7/2020	21/7/2020	27/7/2020
Weather Condition	Overcast	Overcast	Sunny	Sunny	Overcast	Overcast	Overcast	Sunny	Sunny	Overcast
Start Time	13:00	13:00	13:00	13:00	13:00	13:30	13:30	13:30	13:30	13:30
Measurement Period	30min	30min	30min	30min	30min	30min	30min	30min	30min	30min
Baseline Level	73.3					73.3				
L _{Aeq}	73.7	74.8	73.5	73.6	74.2	73.9	74.6	74.1	73.8	74.0
L ₁₀	75.8	76.7	76.3	76.5	76.8	75.9	76.5	76.8	76.9	77.1
L ₉₀	68.1	68.5	68.9	67.8	69.1	68.2	68.5	69.0	68.0	68.4

* Repeat noise measurement when exceedance is recorded. The result is used to confirm the findings and it would not be showed on the graph plot
