**ATAL-DEGREMONT-CHINA HARBOUR
JOINT VENTURE**

**CONTRACT NO. DC/2013/10 - DESIGN,
BUILD AND OPERATE SAN WAI
SEWAGE TREATMENT WORKS –
PHASE 1**

**MONTHLY EM&A REPORT
NO. 35**

(01 MARCH – 31 MARCH 2020)

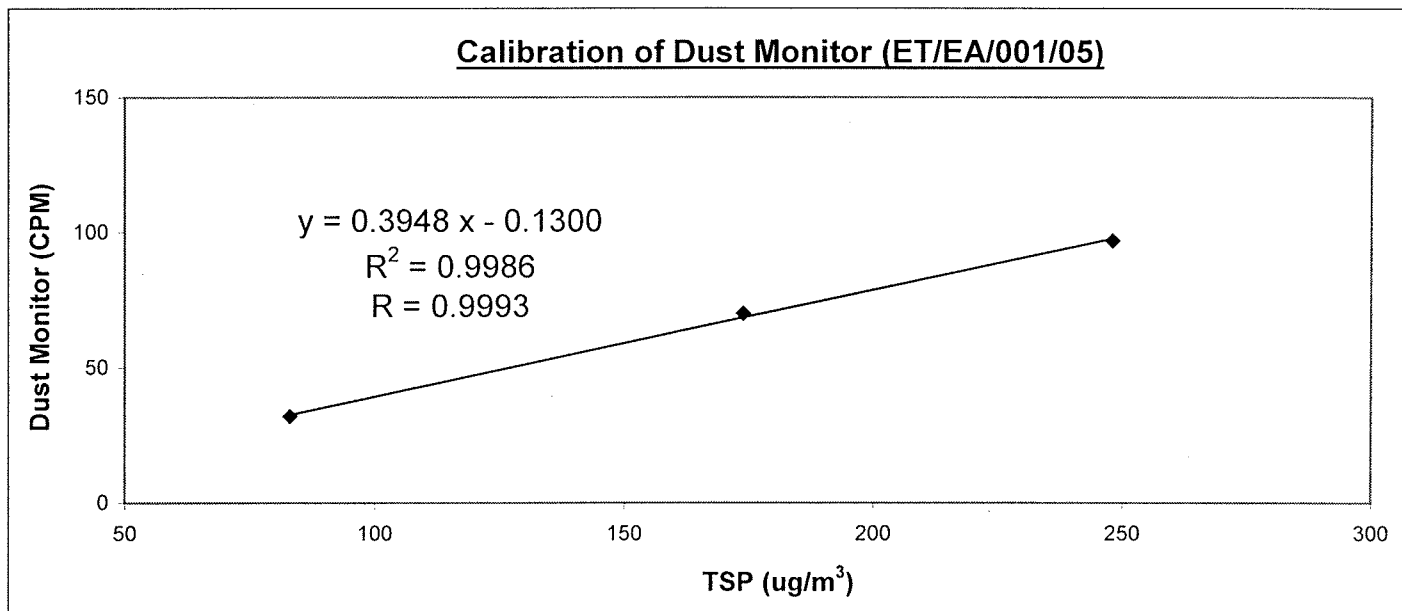
Method : Parallel measurement (Three-point calibration) by placing the Dust Monitor and High Volume Air Sampler together under the same environmental condition

Results :	Dust Monitor (CPM)	32	70	97
	TSP (ug/m ³)	83	174	248
	High Volume Air Sampler Serial No.: 1177	Calibration Due Date: 29 Nov 2019

Acceptance Criteria : Correlation coefficient (r) of the calibration curve greater than 0.990 after three-point calibration

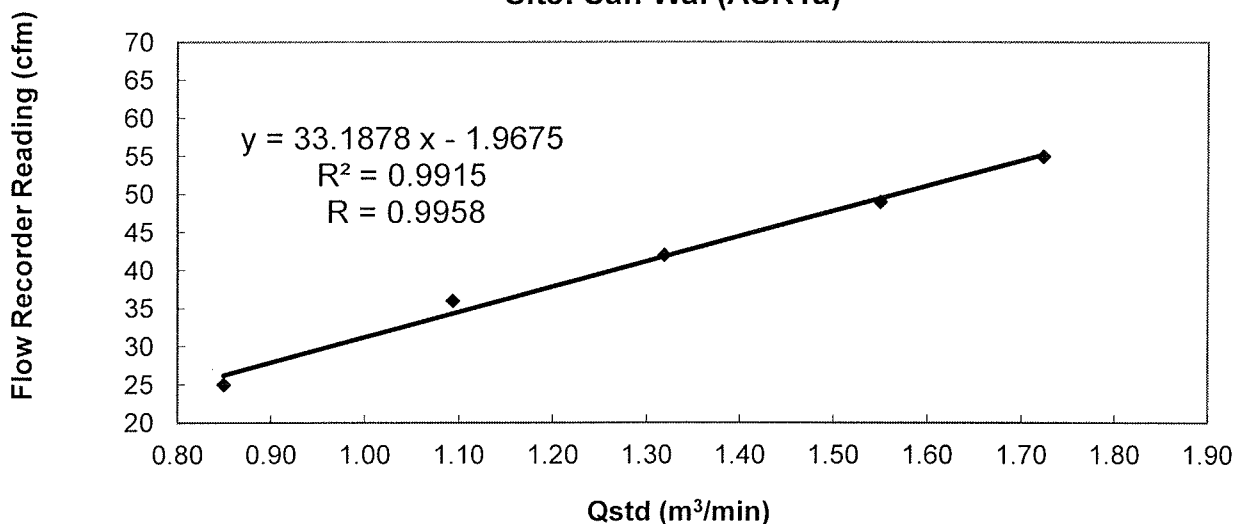
Sampler 1934 Calibration Curve
Site: San Wai (ASR1a)

Flow recorder reading (cfm)	55	49	42	36	25
Qstd (Actual flow rate, m ³ /min)	1.72	1.55	1.32	1.09	0.85
Pressure :	767.31 mm Hg			Temp. : 297 K

Acceptance Criteria : Correlation coefficient (r) of the calibration curve greater than 0.990 after a 5-point calibration.

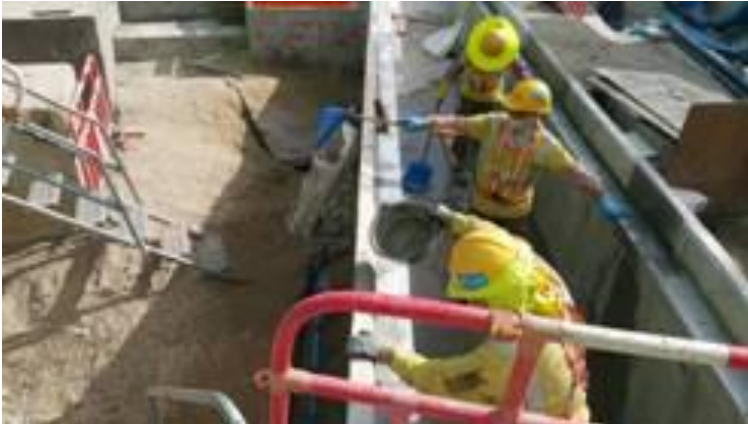
<p>Follow up action to item 1 on 05/03/2020, stagnant water was cleared near CB area.</p>	---	200305_001	No	---
1

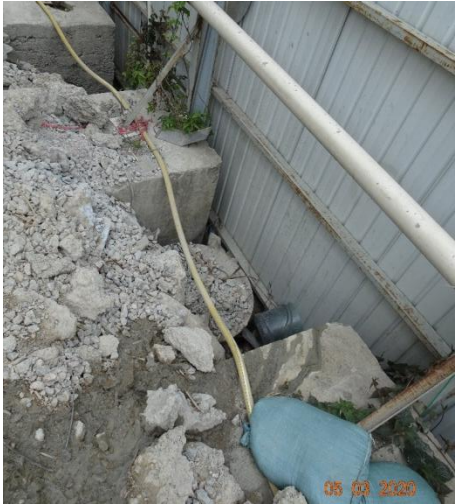
<p>General refuse and C&D materials were observed near AB.</p>	To collect general refuse and C&D materials properly	200305_002	Yes	13/03/2020

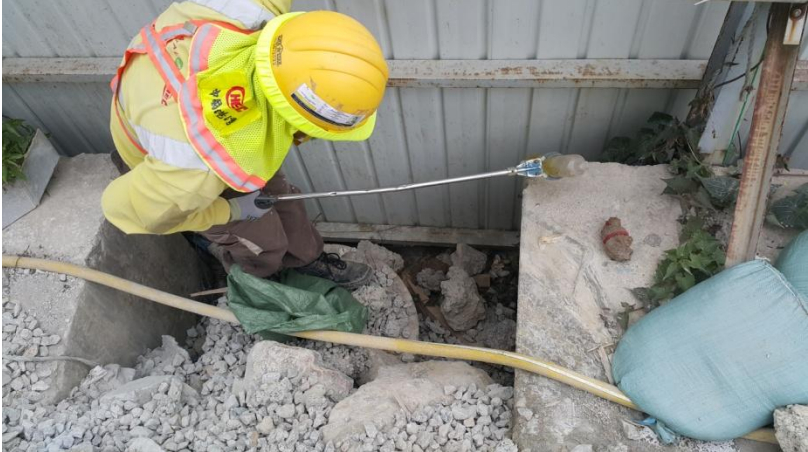
<p>Follow up action to item 1 on 05/03/2020, general refuse and C&D materials were collected.</p>	---	200313_001	No	---
1

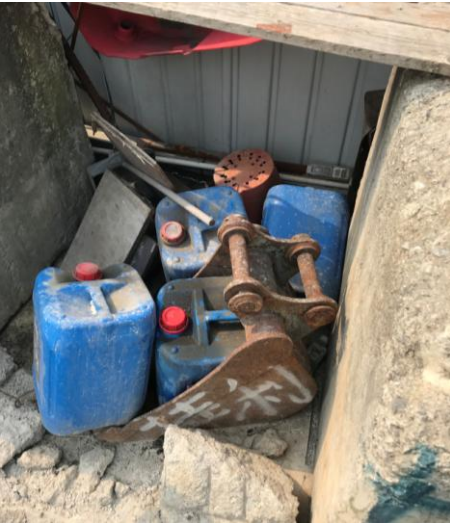
<p>Chemical containers without drip tray were observed at Portion P8.</p>	To provide drip tray for chemical containers	200313_002	Yes	20/03/2020

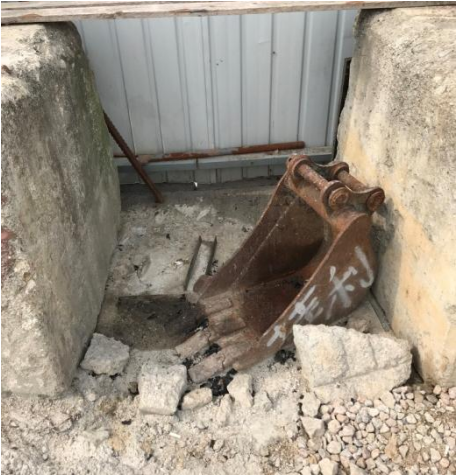
<p>Follow up action to item 1 on 13/03/2020, chemical containers were removed.</p>	---	200320_001	No	---
1

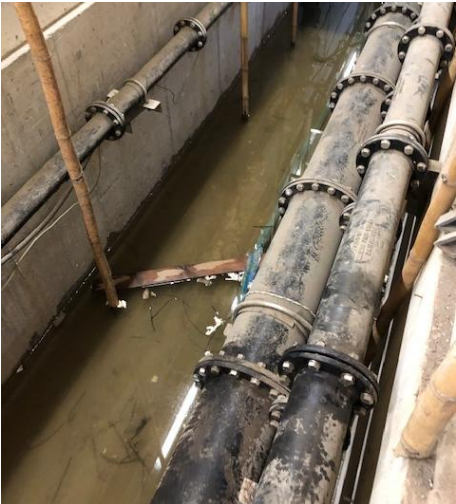
<p>Stagnant water was observed near CEPT.</p>	To clear the stagnant water properly	200320_002	Yes	27/03/2020

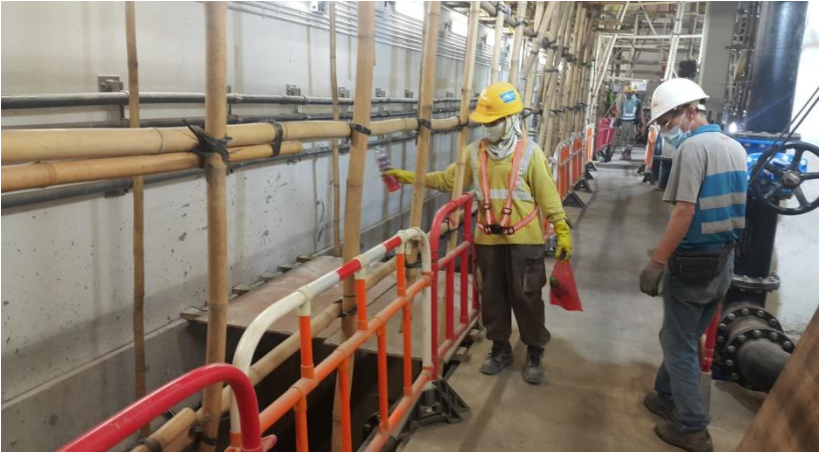
<p data-bbox="181 852 1093 924">Follow up action to item 1 on 20/03/2020, larvicidal oil was applied to stagnant water.</p>	---	200327_001	No	---

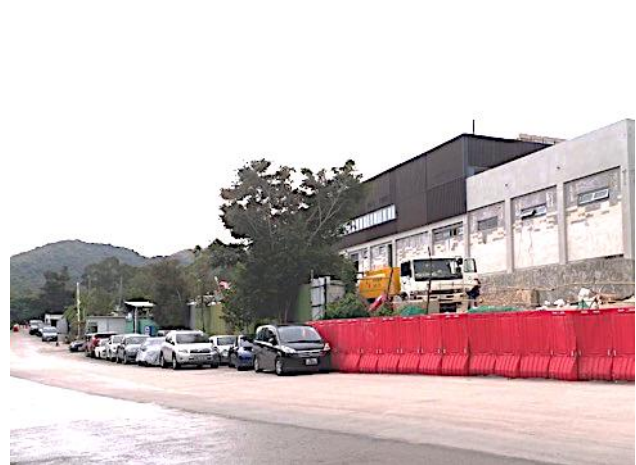
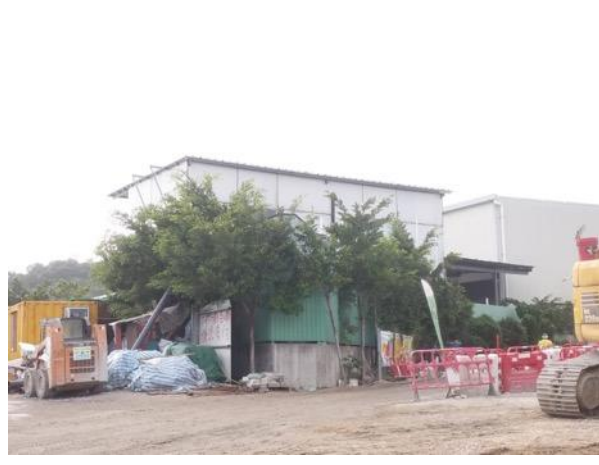
Figure 1	Figure 2

<p>Most of the trees are removed at the eastern boundary</p>	<p>Trees located adjacent to our site (outside site)</p>

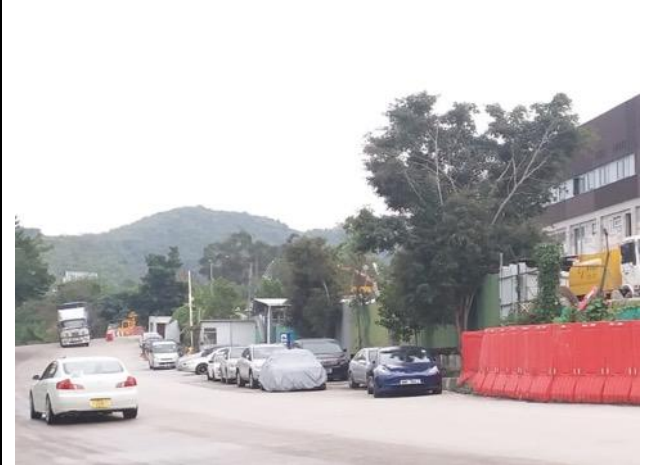
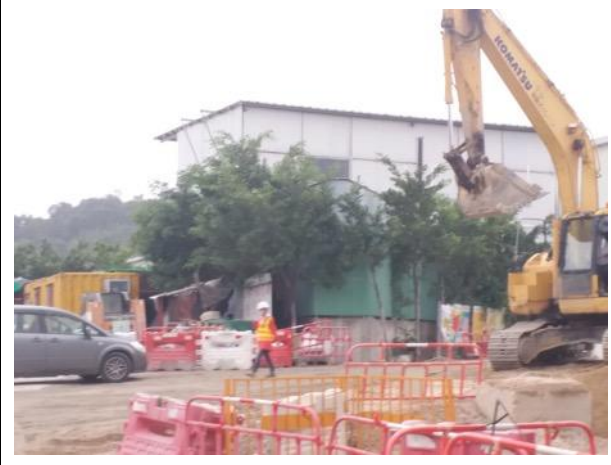
Figure 1	Figure 2

<p>Most of the trees are removed at the eastern boundary</p>	<p>Trees located adjacent to our site (outside site)</p>
