Expansion of Hong Kong International Airport into a Three-Runway System

Construction Phase Monthly EM&A
Report No. 92
(For August 2023)

September 2023

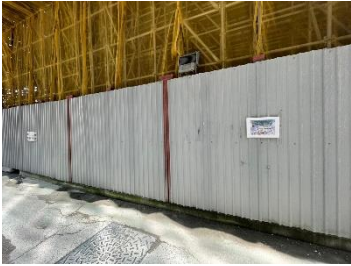
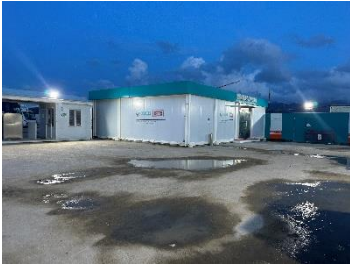
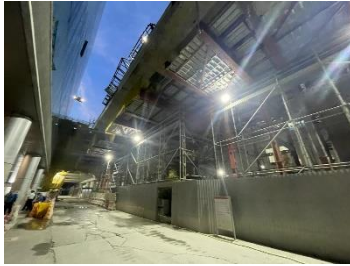
Table 7.2: Examples of Landscape and Visual Mitigation Measures in the Reporting Periods

<p>Erection of site hoardings around works area in unobtrusive colours (CM5)</p>	<p>Avoidance of excessive height and bulk of site buildings (CM6)</p>	<p>Control of night-time lighting using light hooding and minimisation of night working period (CM7)</p>

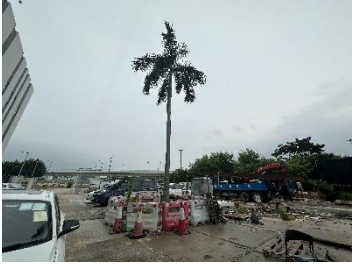
General view of tree protection zone for retained tree (CM8)	General view of transplanted trees (CM9)	General view of compensatory tree planting (OM7)

In accordance with the Updated EM&A Manual, all existing trees shall be protected carefully during construction. Trees unavoidably affected by the works shall be transplanted where practical. In this reporting period, the cumulative total number of retained trees and transplanted trees under the Project remained unchanged (i.e. 46 and 26 respectively) comparing to the previous reporting period.
