**ENVIRONMENTAL TEAM FOR
DEVELOPMENT OF
ANDERSON ROAD QUARRY SITE -
ROAD IMPROVEMENT WORKS**

UNDER ENVIRONMENTAL PERMIT NO. EP-513/2016

MONTHLY ENVIRONMENTAL MONITORING & AUDIT REPORT

SEPTEMBER 2019

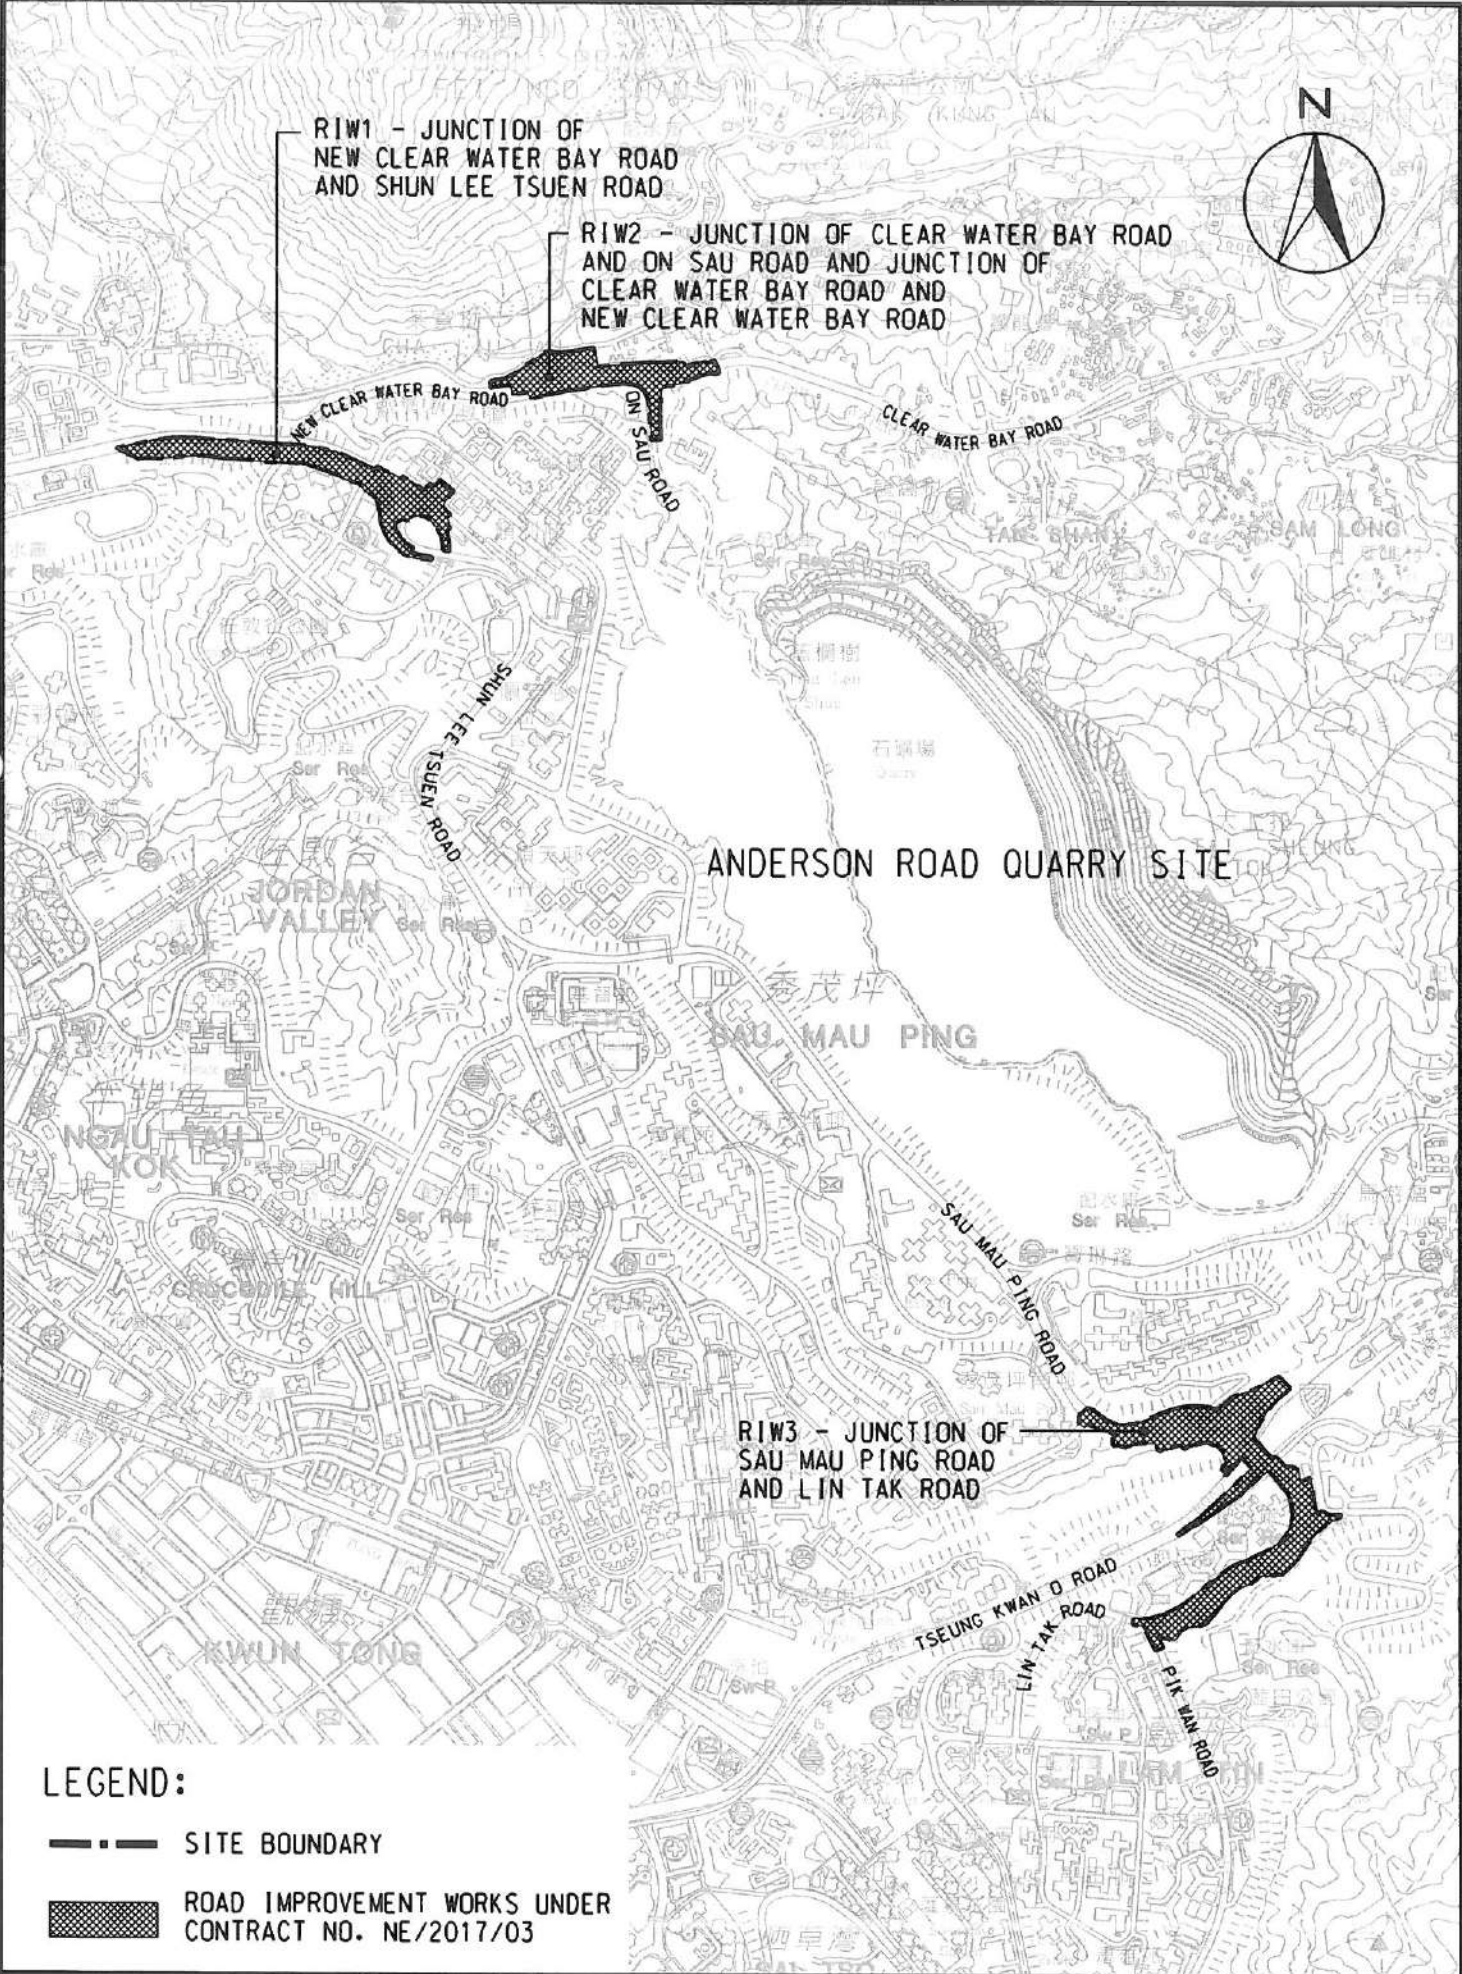
GENERAL LAYOUT PLAN OF ROAD IMPROVEMENT WORKS UNDER CONTRACT NO. NE/2017/03

Figure 2.1 Project Layout

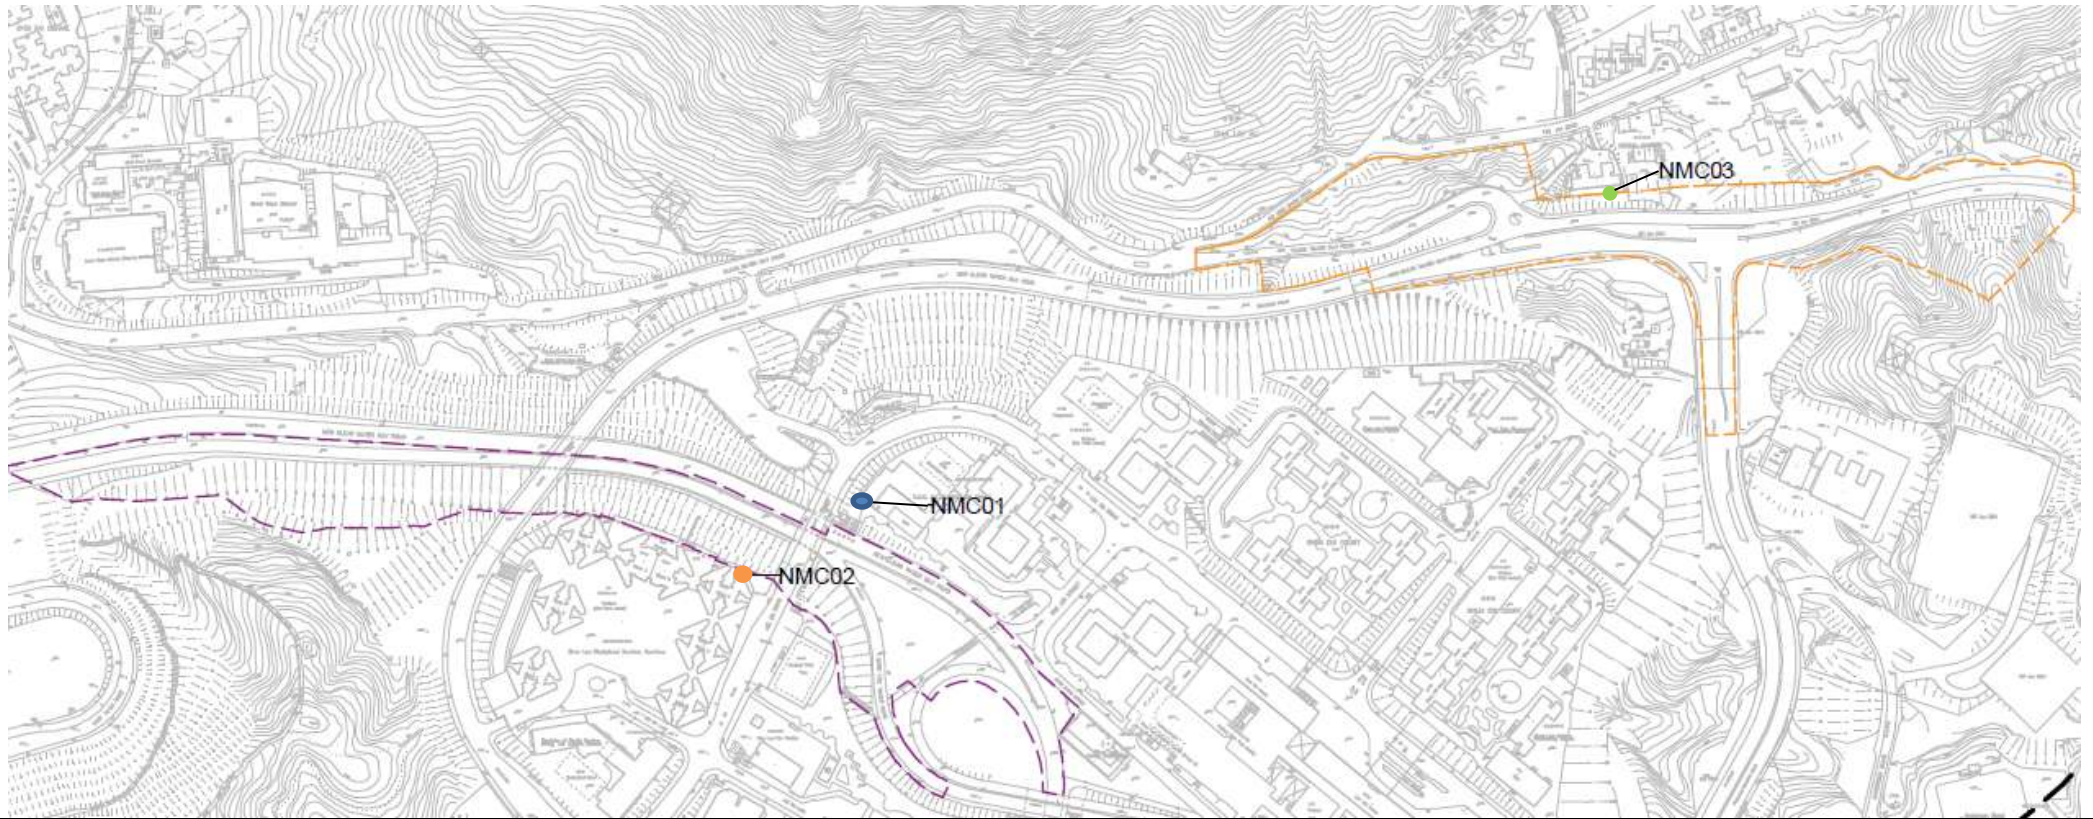
Figure 4.1
 Location of Noise Monitoring Station
 (Construction Phase)
 (for Road Improvement Work 1 & 2)

Monitoring Location ID	Description
<i>Noise Monitoring Station (Construction Phase)</i>	
NMC01	Kei Shun Special School
NMC02	Shun Lee Disciplined Services Quarters Block 6
NMC03	Sienna Garden Block 6

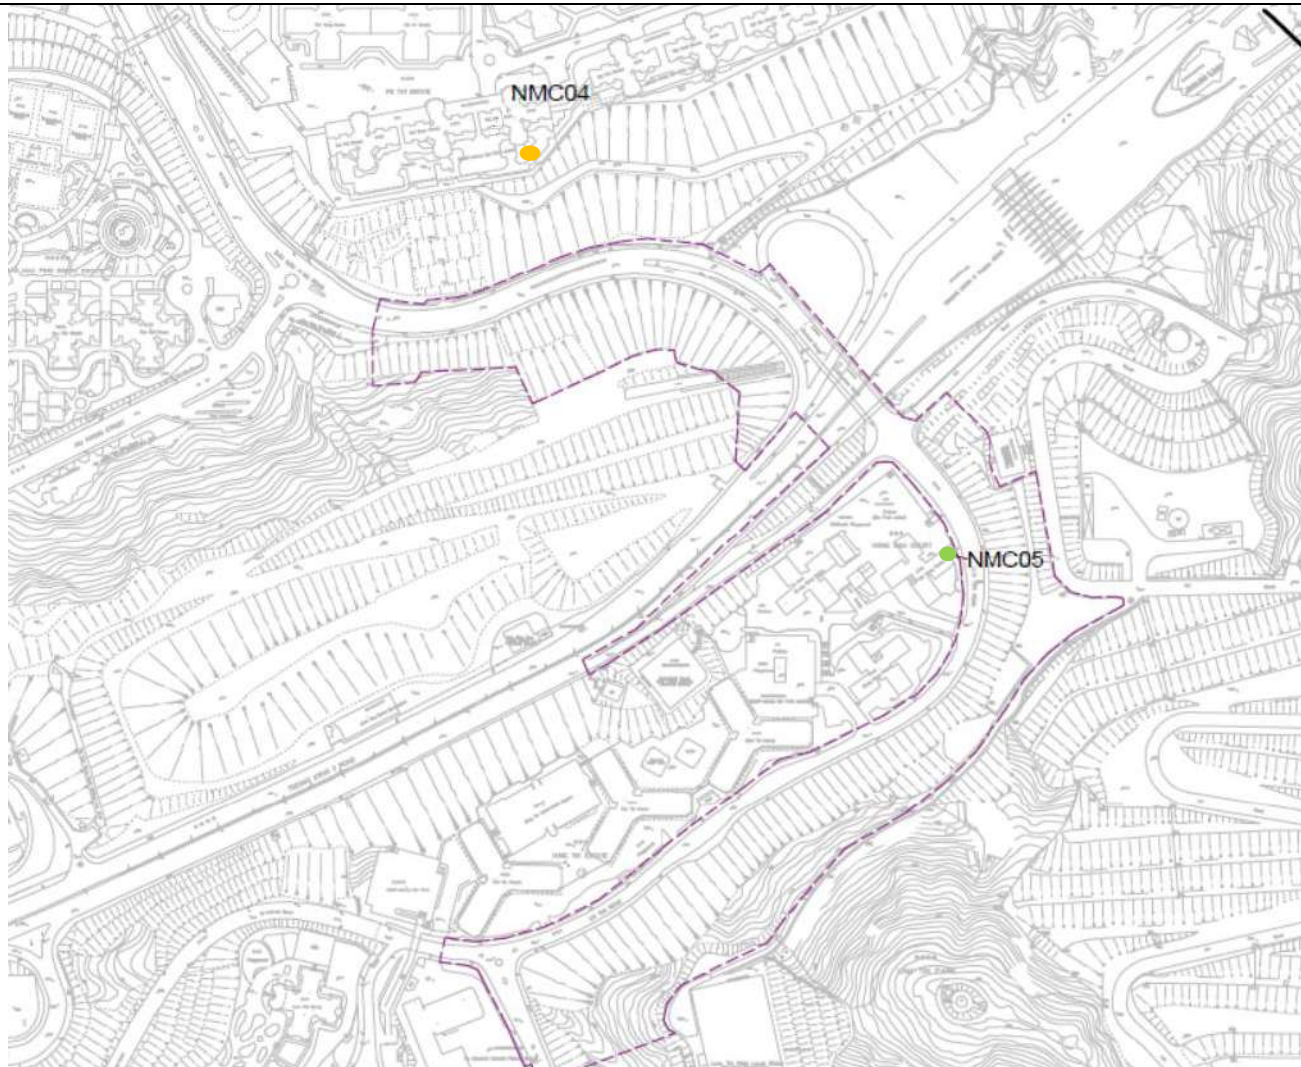
Figure 4.2
 Location of Noise Monitoring Station
 (Construction Phase)
 (for Road Improvement Work 3)

Monitoring Location ID	Description
NMC04	Po Tat Estate Tat Kai House
NMC05	Hong Wah Court Block B Yee Hong House

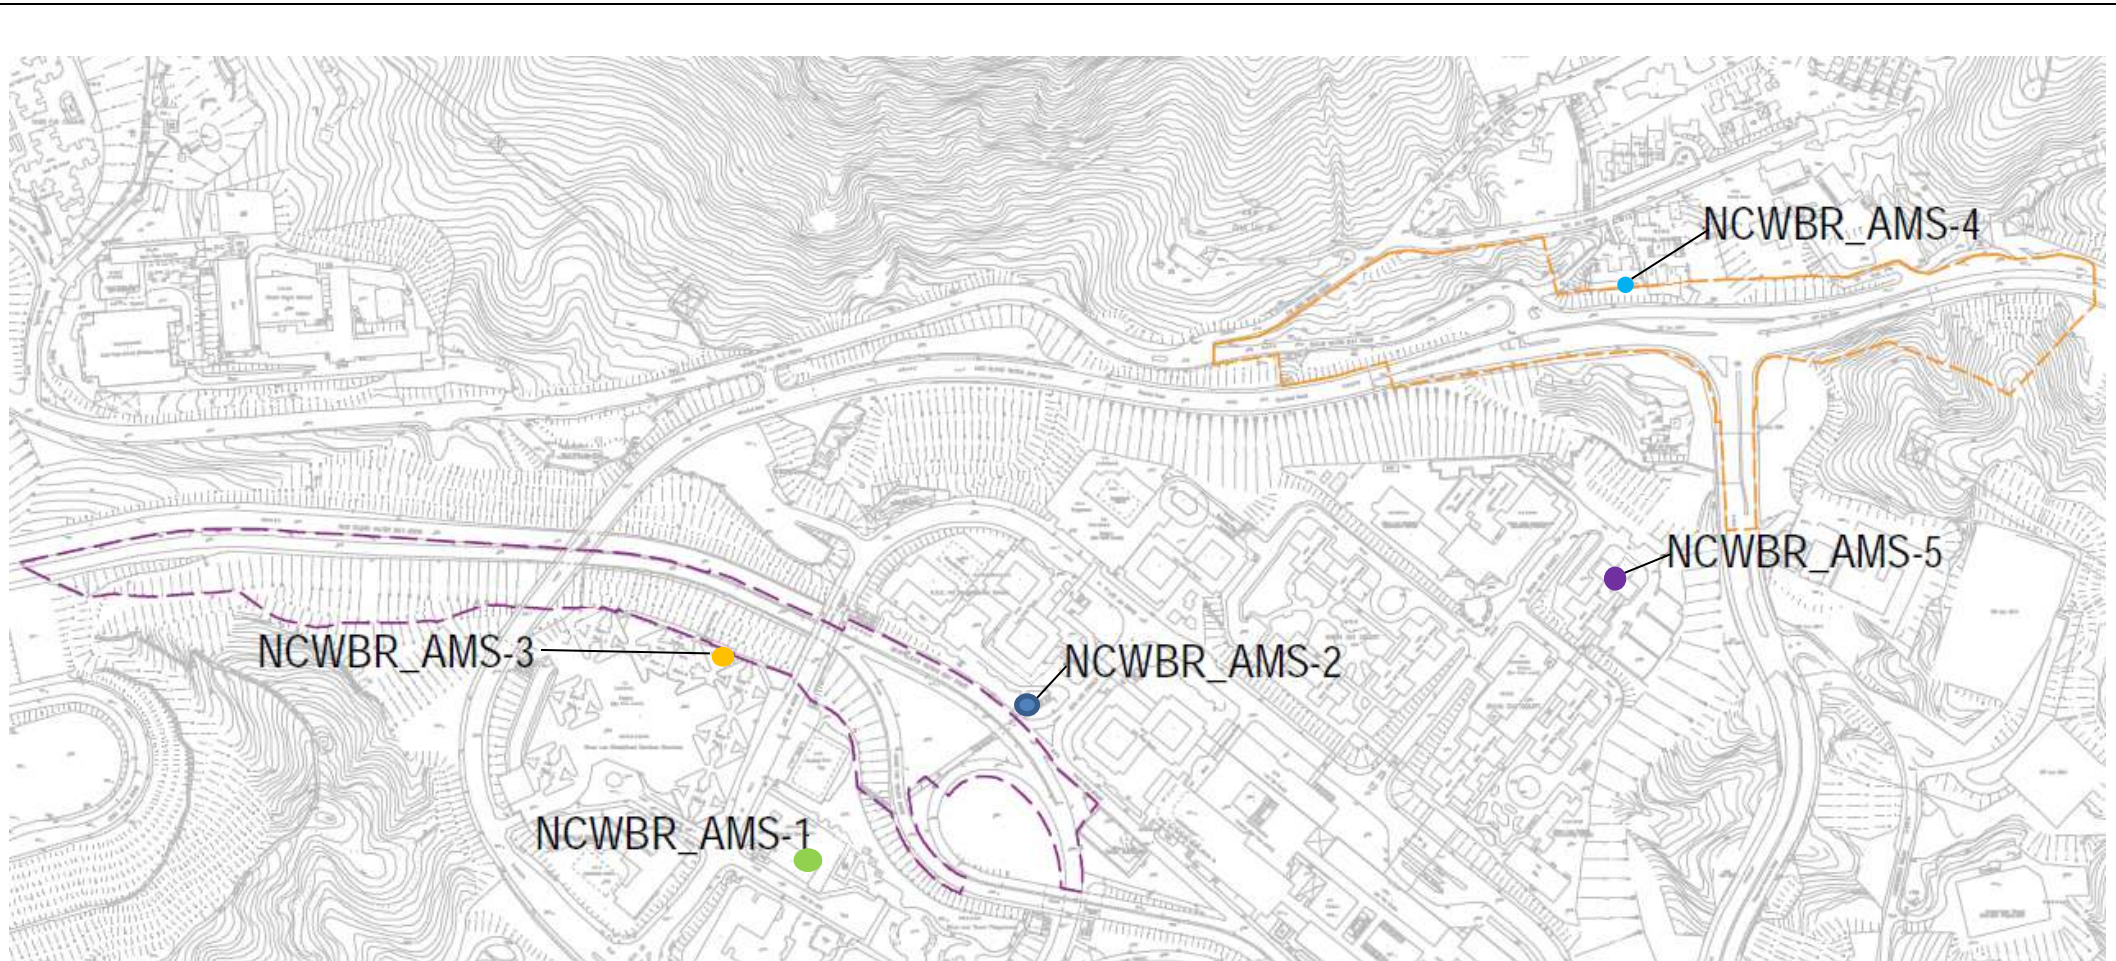
Figure 4.3
Location of Air Quality Monitoring Station
(for Road Improvement Work 1 & 2)

Monitoring Station ID	EIA ID	Location
NCWBR RIW		
NCWBR_AMS-1	ASLF-1	Shun Lee Fire Station
NCWBR_AMS-2	ASLE-21	Shun Lee Estate Lee Hang House
NCWBR_AMS-3	ASLD-10	Shun Lee Disciplined Services Quarters (Block 6)
NCWBR_AMS-4	AFNS-3	Sienna Garden
NCWBR_AMS-5	ASCC-05	Shun Chi Court Shun Fung House

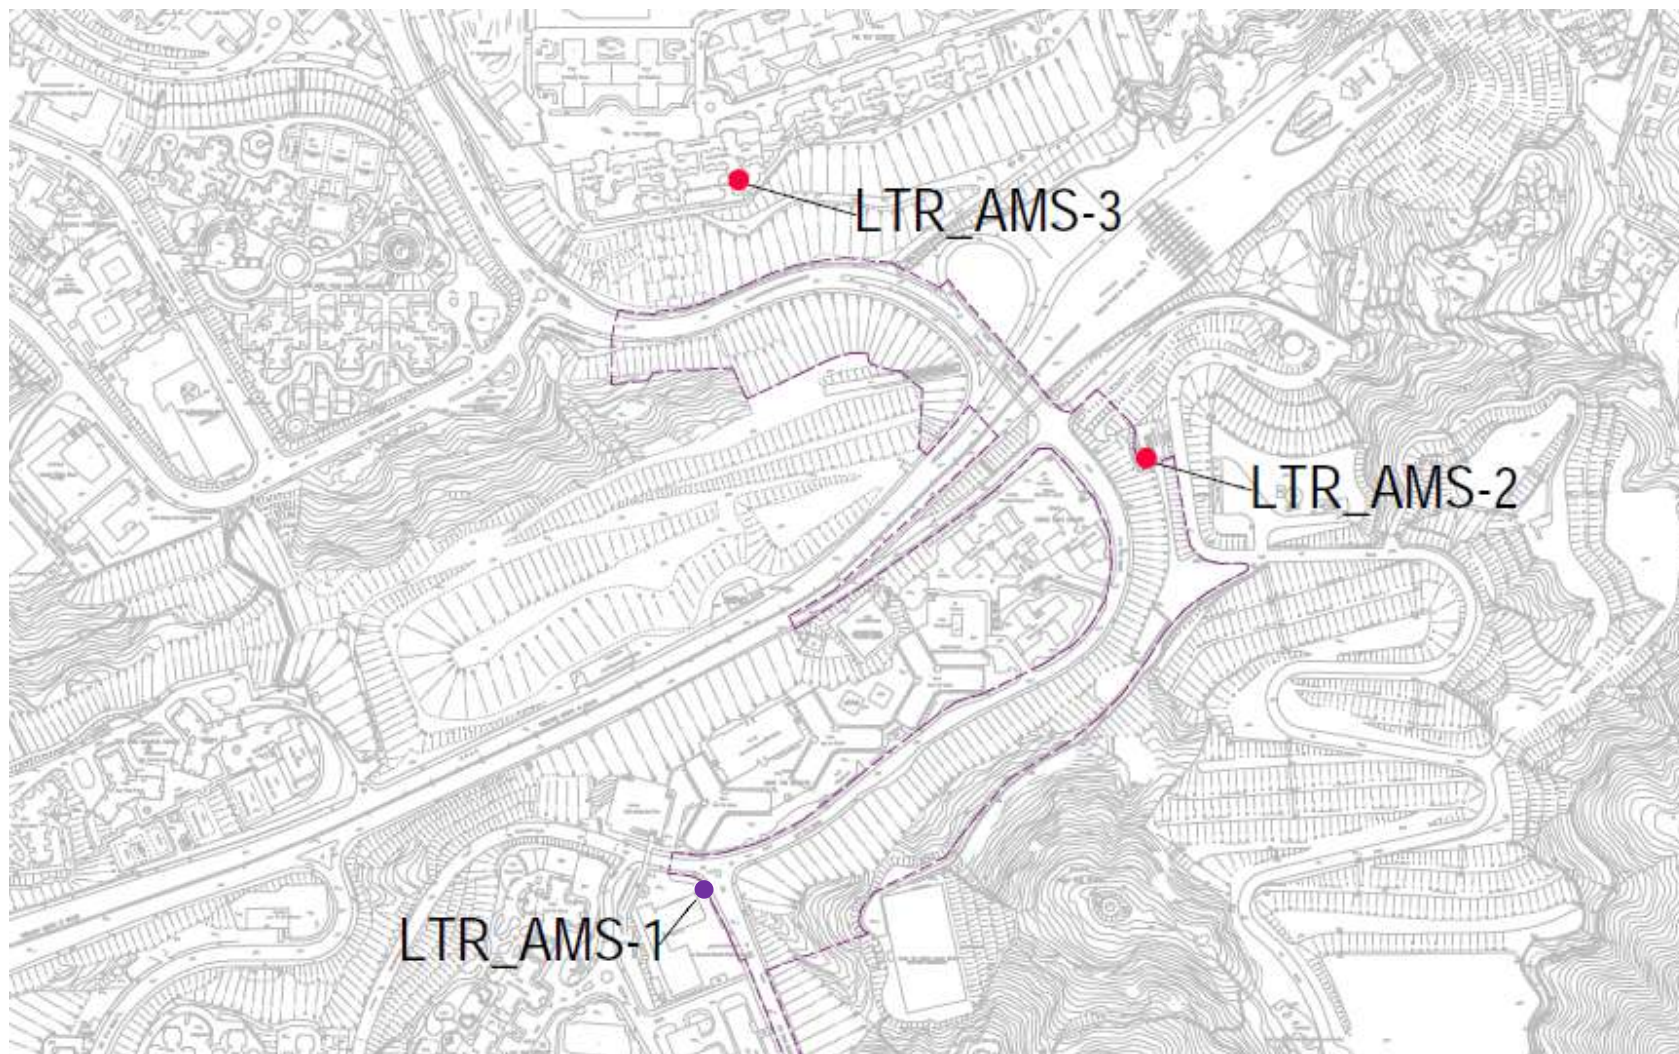
Figure 4.4
Location of Air Quality Monitoring Station
(for Road Improvement Work 3)

Monitoring Station ID	EIA ID	Location
LTR RIW		
LTR_AMS-1	ASECP-2	St Edward's Catholic Primary School
LTR_AMS-2	AEPD-01	Environmental Protection Department's Restored Landfill Site Office
LTR_AMS-3	APTE-14	Po Tat Estate Tat Kai House

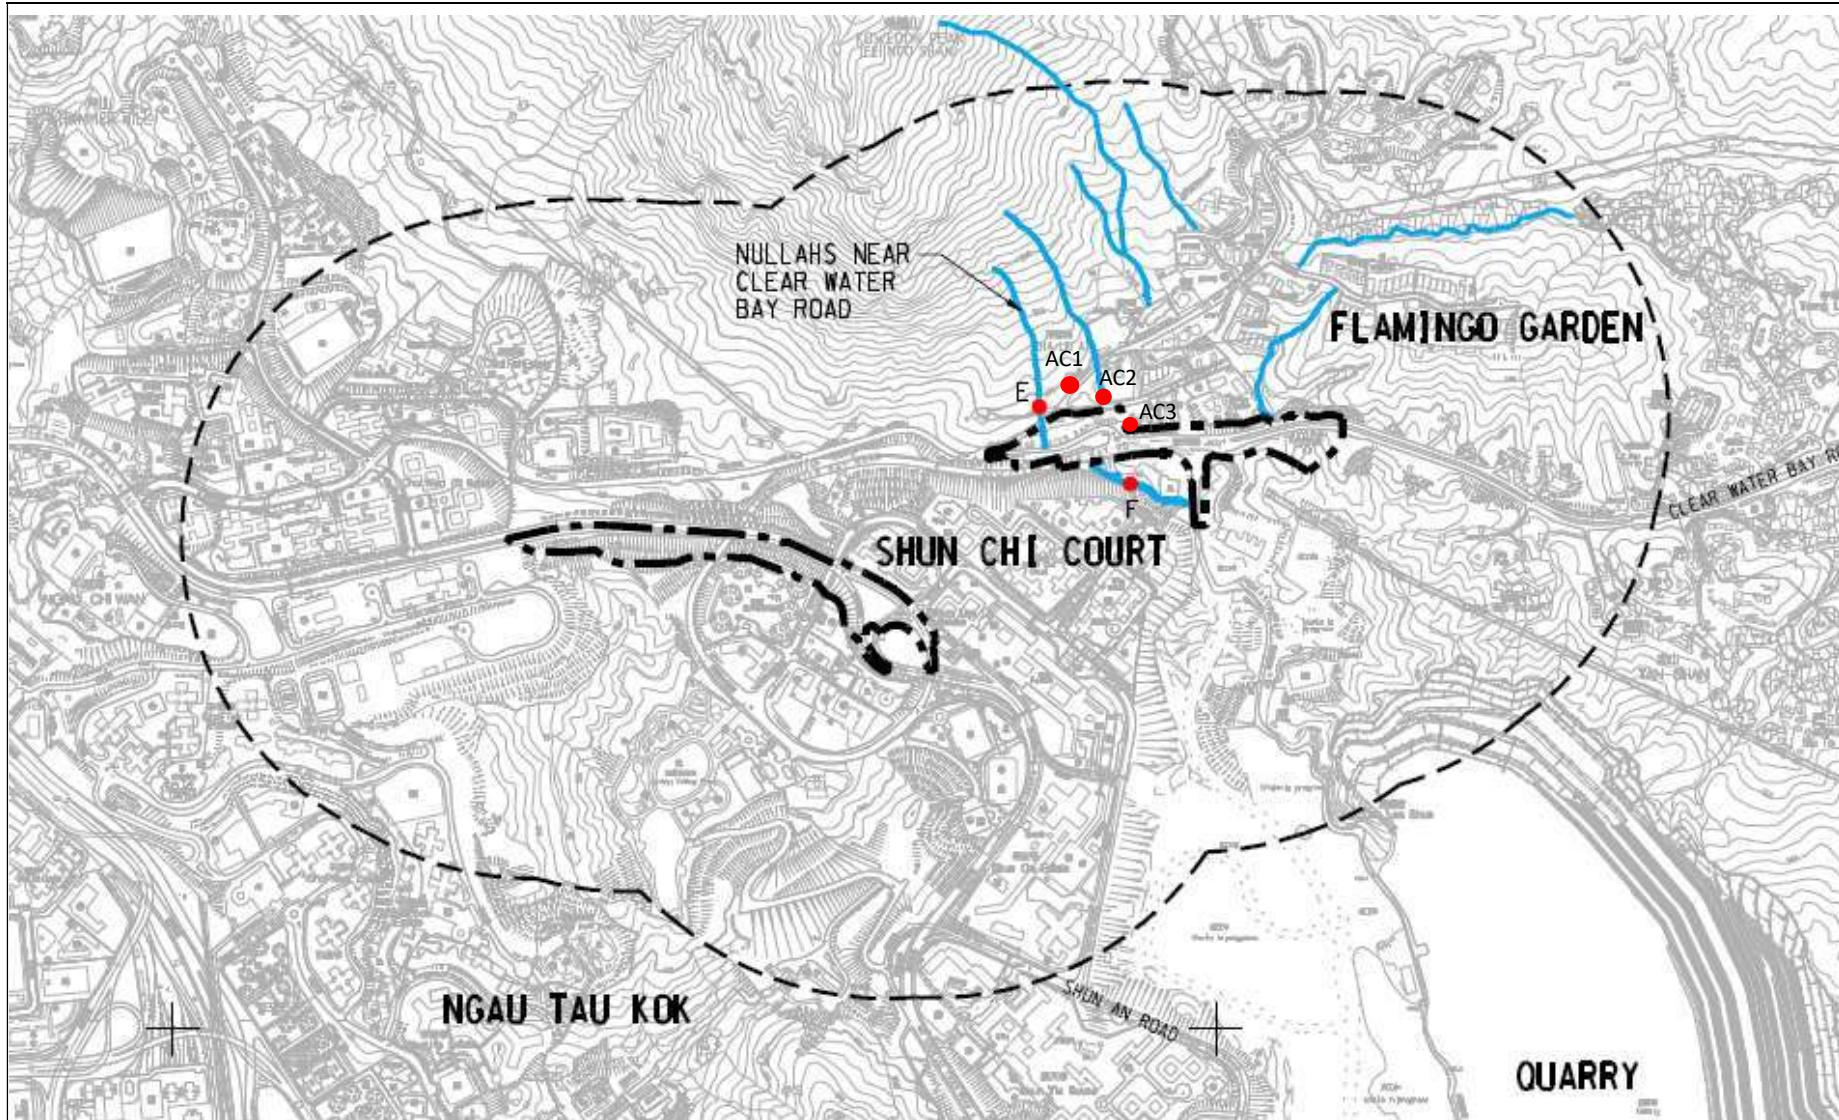
Figure 4.5
Location of Water Quality Monitoring Station
(for Road Improvement Work 1 & 2)

Inland Water	Stations	Description
Channelized nullah across the Project site	E	Upstream Control Station
	F	Downstream Impact Station
	AC1	Upstream Reference Station
	AC2	Upstream Reference Station
	AC3	Upstream Reference Station

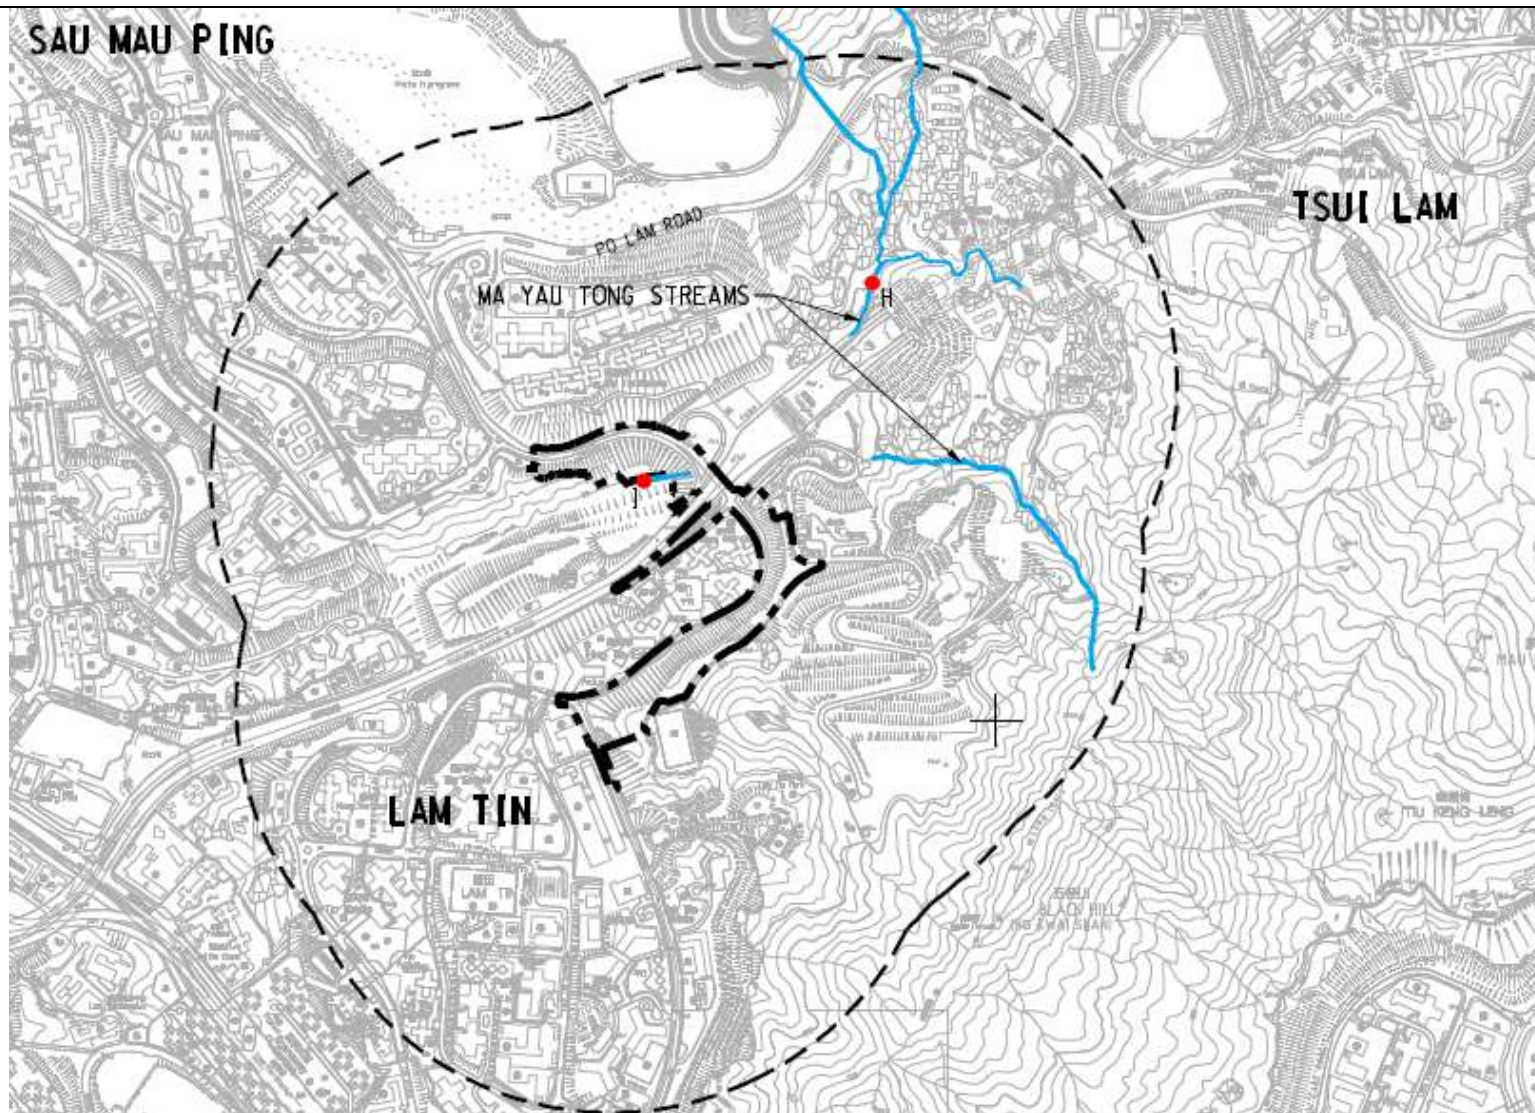
Figure 4.6
Location of Water Quality Monitoring Station
(for Road Improvement Work 3)

Inland Water	Stations	Description
Ma Yau Tong Stream	H	Upstream Control Station
	I	Downstream Impact Station

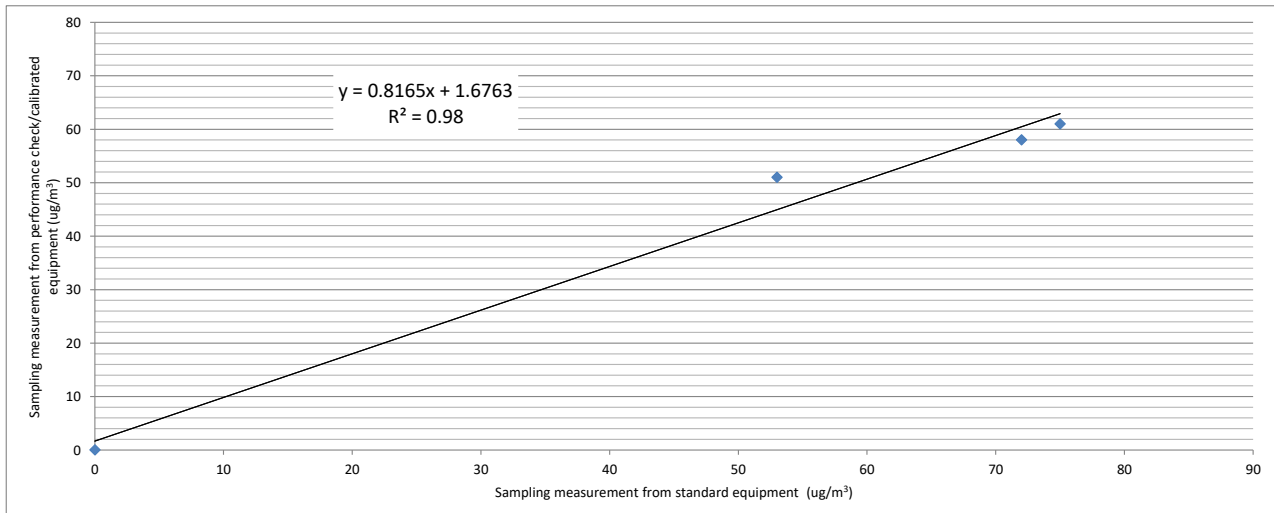
Linear Regression of Y on X

Slope (K- factor) : 1.3000
Correlation Coefficient : 0.9900
Validity of Performance Check / Calibration Record : 27/2/2020

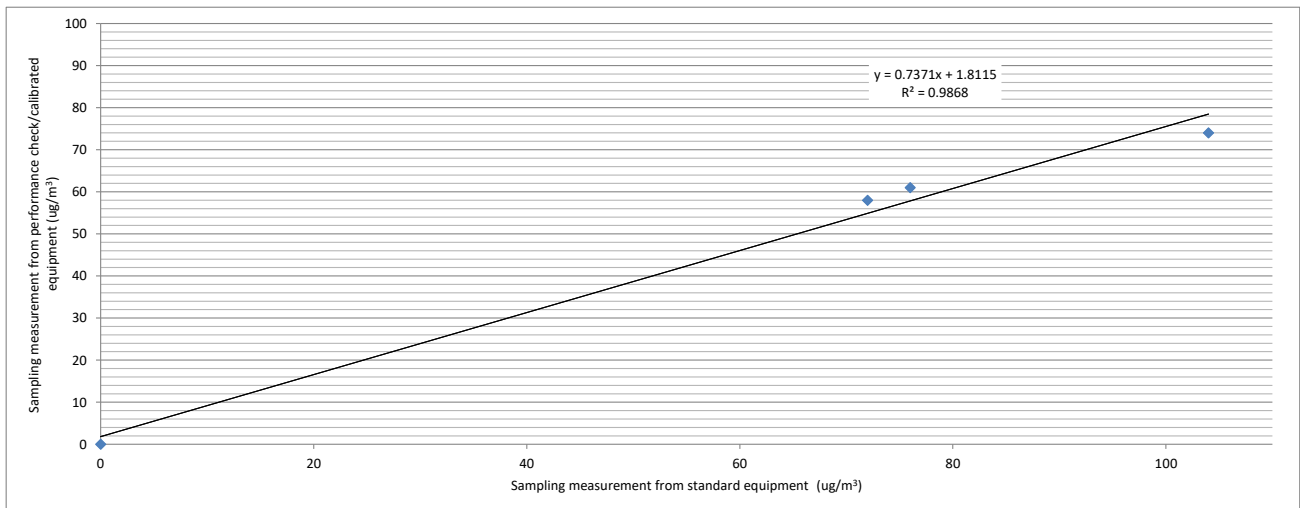
Linear Regression of Y on X

Slope (K- factor) : 1.4000
Correlation Coefficient : 0.9934
Validity of Performance Check / Calibration Record : 13/3/2020

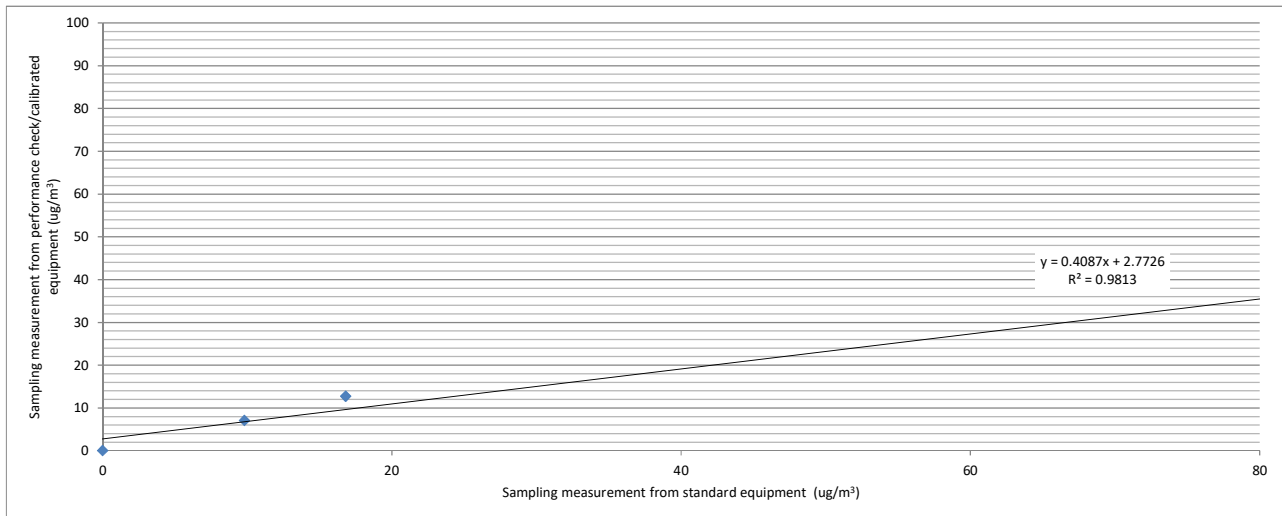
Linear Regression of Y on X

Slope (K- factor) : 2.5000
Correlation Coefficient : 0.9906
Validity of Performance Check / Calibration Record : 28/7/2020

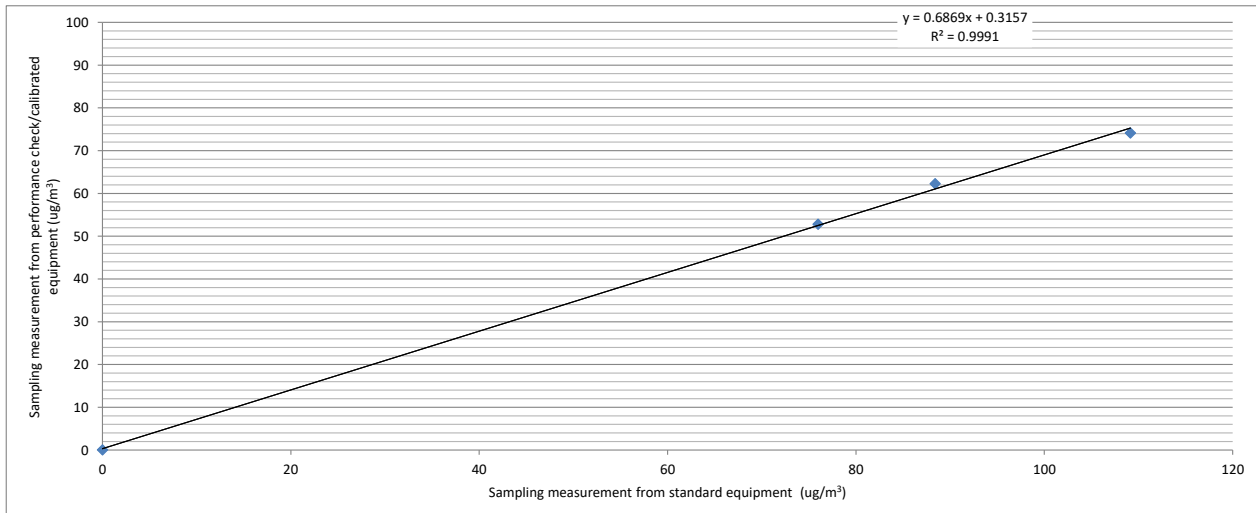
Linear Regression of Y on X

Slope (K- factor) : 1.5000
Correlation Coefficient : 0.9995
Validity of Performance Check / Calibration Record : 10/1/2020

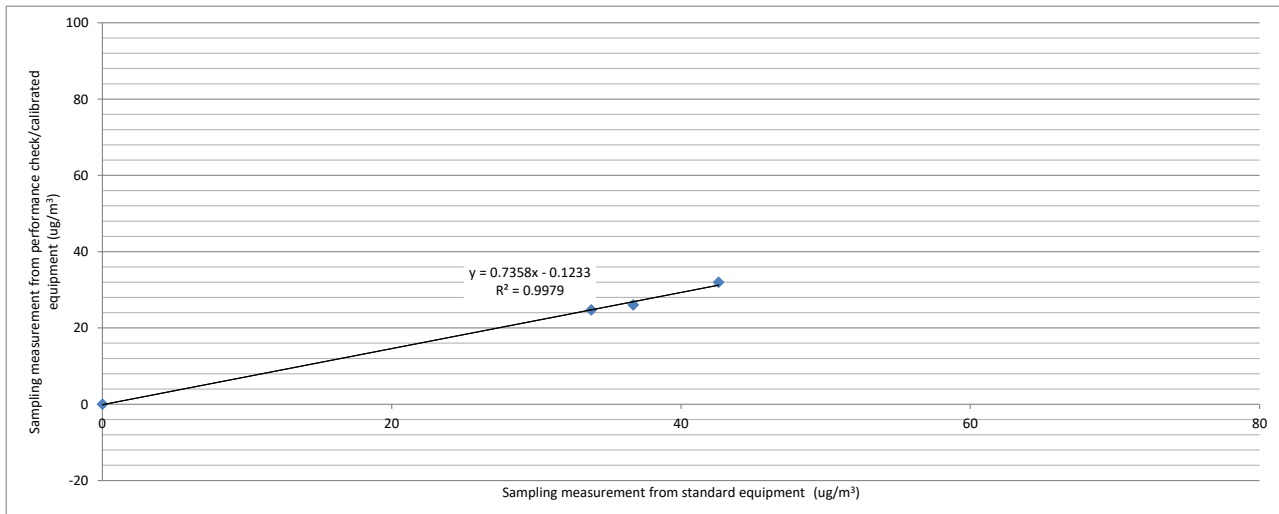
Linear Regression of Y on X

Slope (K- factor) : 1.4000
 Correlation Coefficient : 0.9989
 Validity of Performance Check / Calibration Record : 7/7/2020

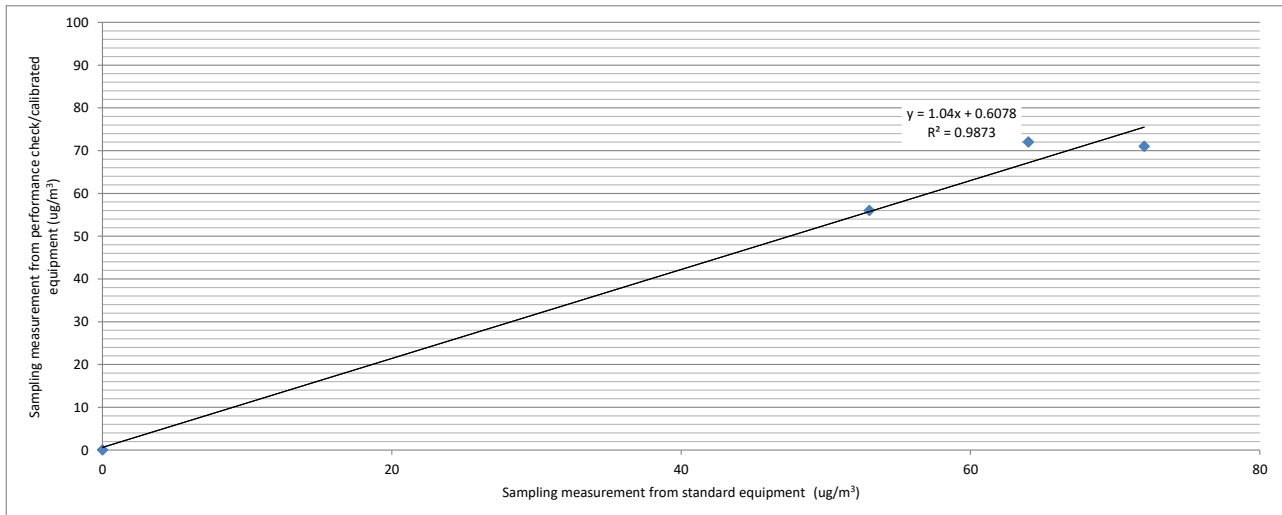
Linear Regression of Y on X

Slope (K- factor) : 1.0000
Correlation Coefficient : 0.9936
Validity of Performance Check / Calibration Record : 13/3/2020

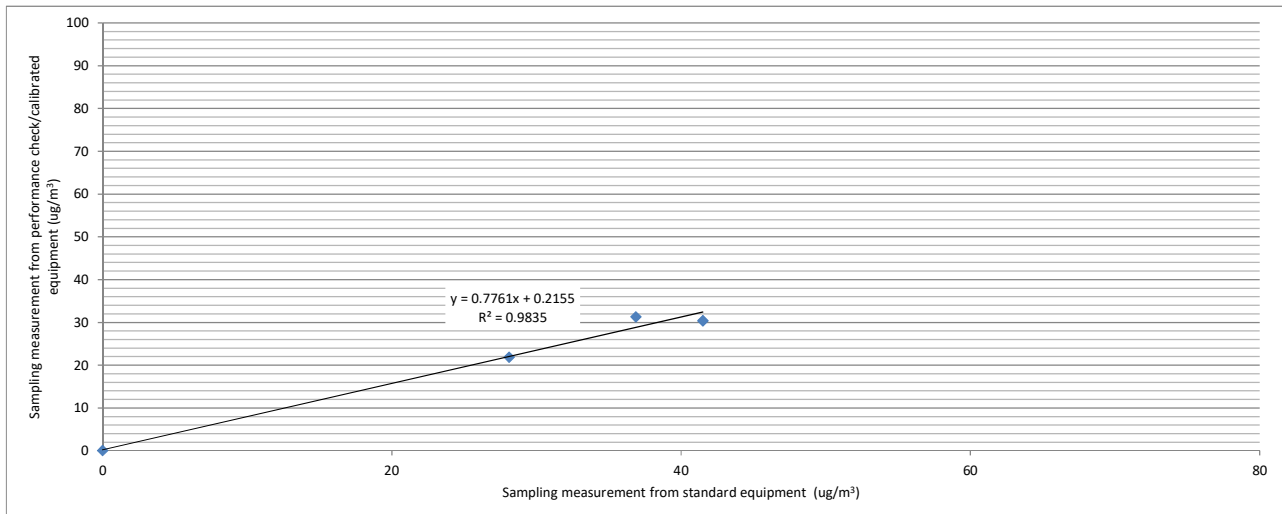
Linear Regression of Y on X

Slope (K- factor) : 1.3000
 Correlation Coefficient : 0.9917
 Validity of Performance Check / Calibration Record : 19/6/2020

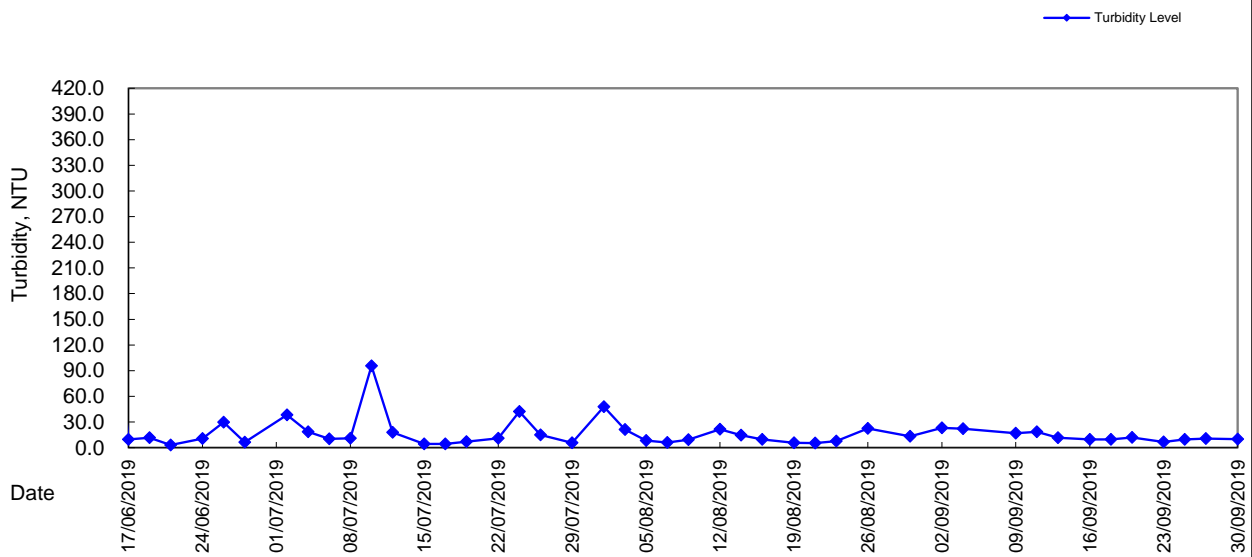
Station AC2 - Upstream reference station - Turbidity

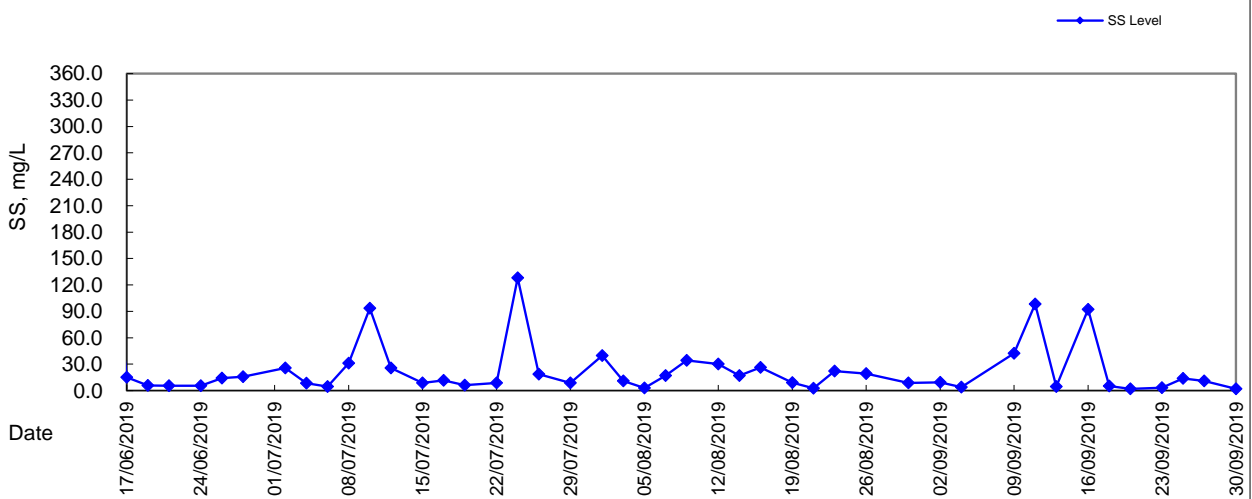
Station AC2 - Upstream reference station - Suspended Solid

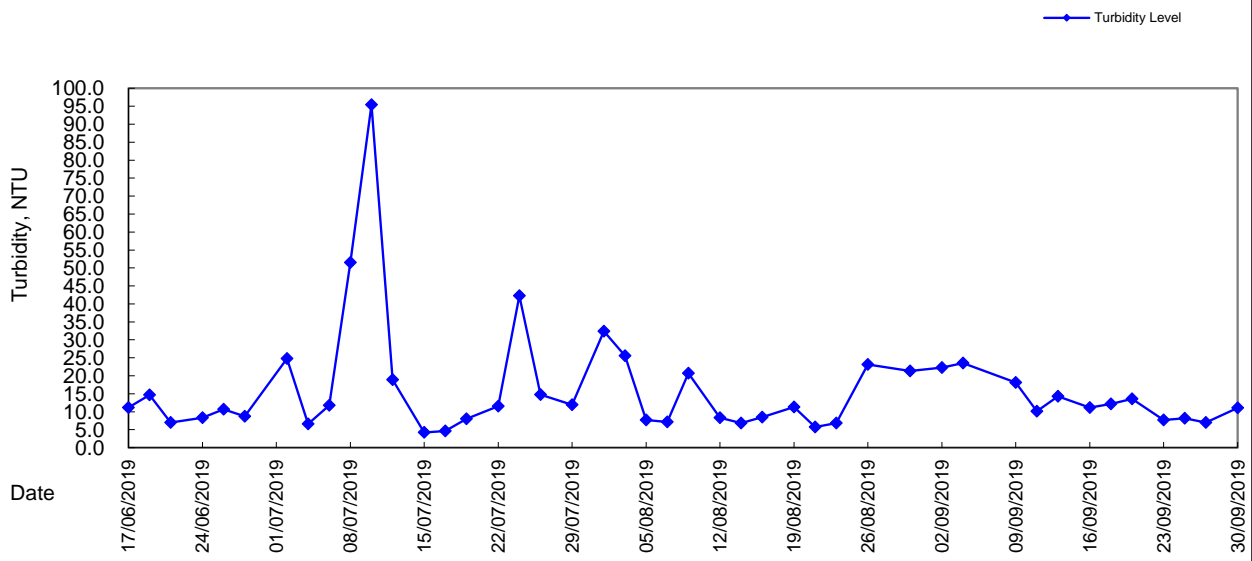
Station AC3 - Upstream reference station - Turbidity

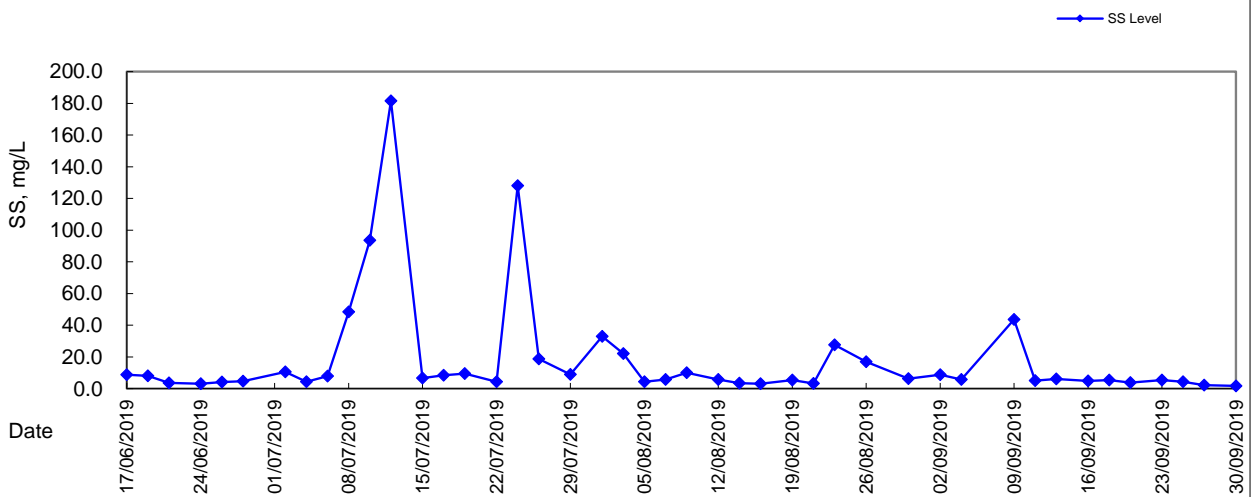
Station AC3 - Upstream reference station - Suspended Solid
