**ENVIRONMENTAL TEAM FOR
DEVELOPMENT OF
ANDERSON ROAD QUARRY SITE -
ROAD IMPROVEMENT WORKS**

UNDER ENVIRONMENTAL PERMIT NO. EP-513/2016

MONTHLY ENVIRONMENTAL MONITORING & AUDIT REPORT

AUGUST 2021

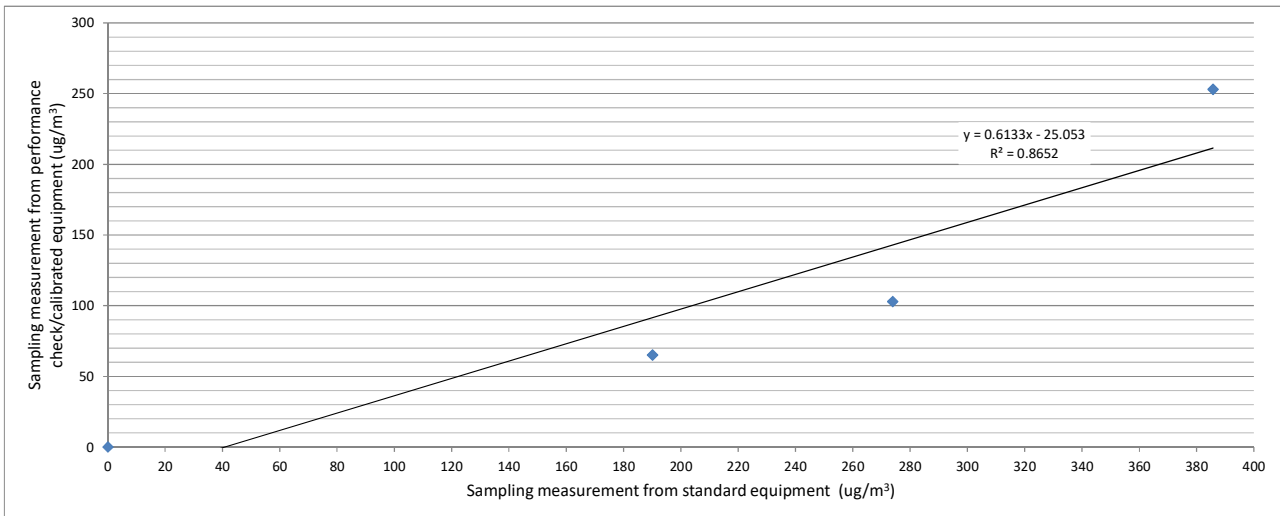
Linear Regression of Y on X

Slope (K- factor) : 1.5000
Correlation Coefficient : 0.9302
Validity of Performance Check / Calibration Record : 20/4/2022
