**SERVICE CONTRACT NO: EDO/01/2017**

**ENVIRONMENTAL TEAM FOR  
DEVELOPMENT OF  
ANDERSON ROAD QUARRY SITE -  
ROAD IMPROVEMENT WORKS**

**MONTHLY ENVIRONMENTAL MONITORING & AUDIT REPORT**

**MARCH 2022**

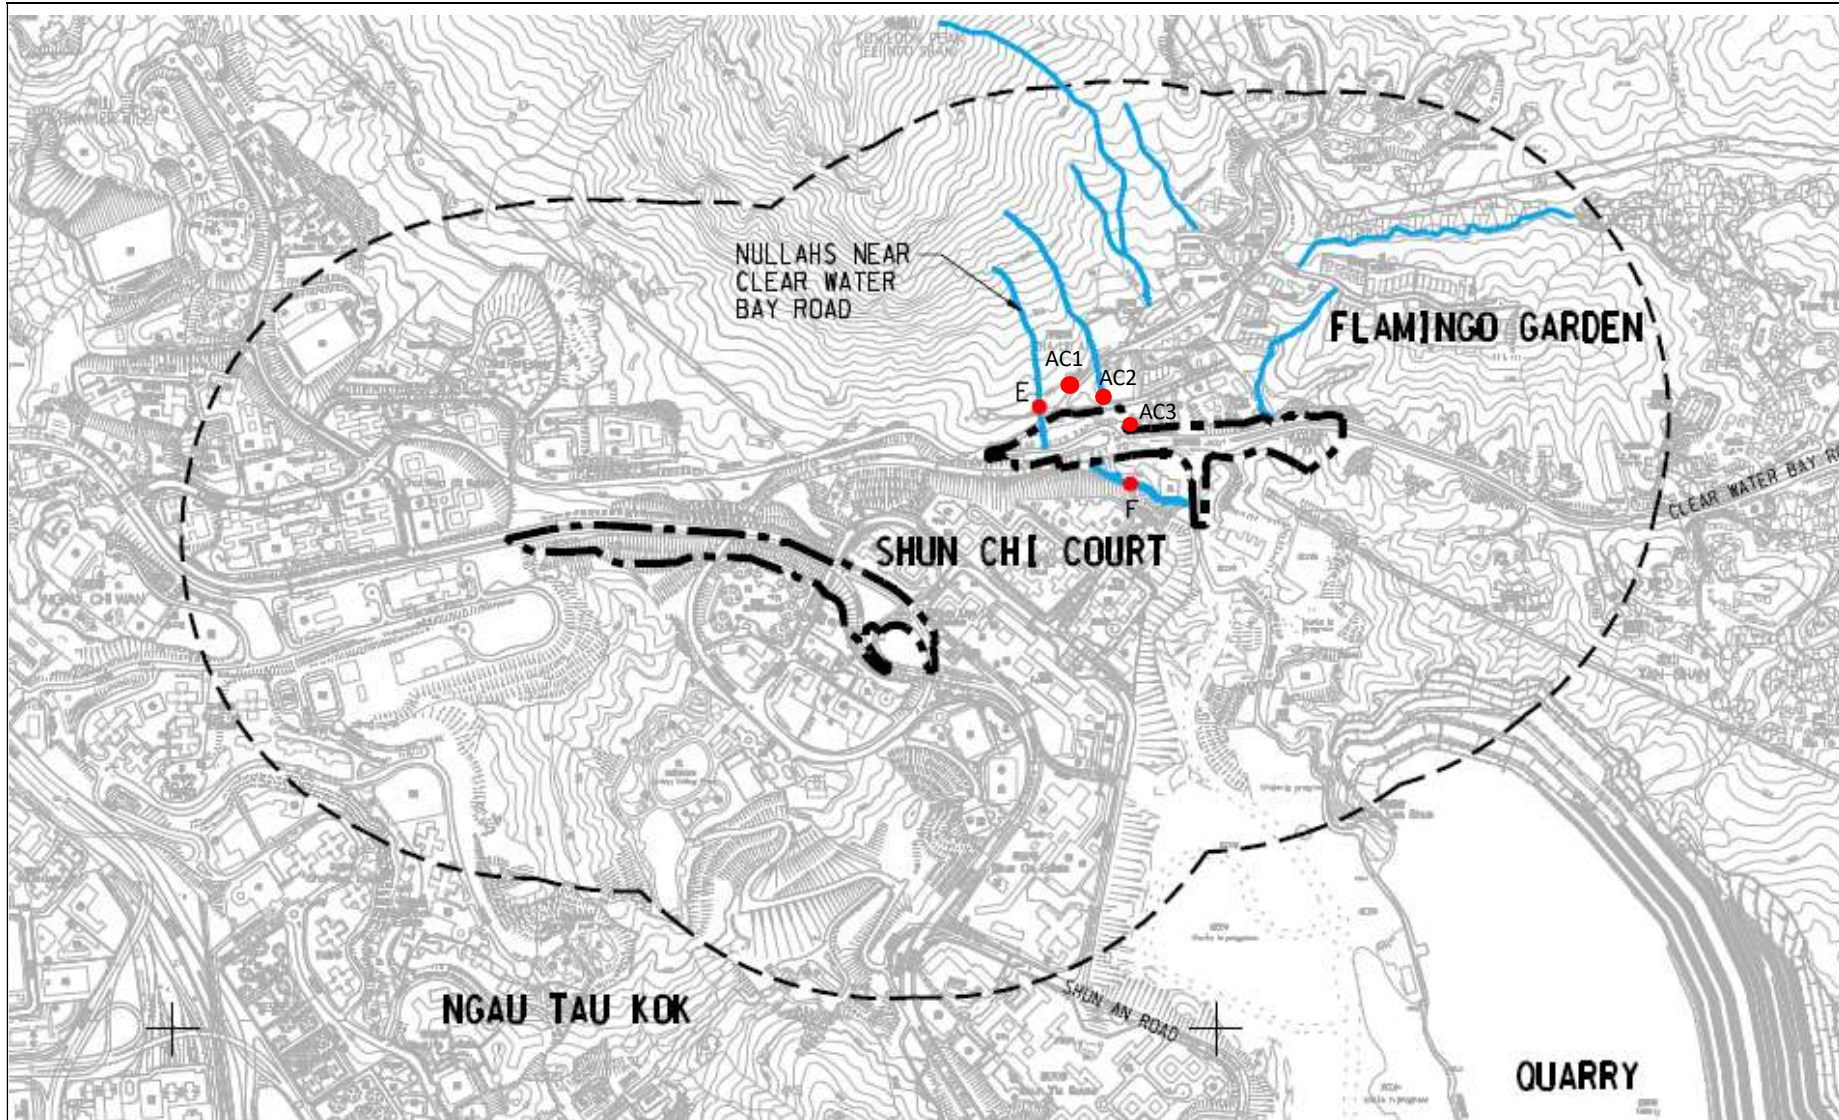
Figure 4.5  
Location of Water Quality Monitoring Station  
(for Road Improvement Work 1 & 2)

Inland Water	Stations	Description
Channelized nullah across the Project site	E	Upstream Control Station
	F	Downstream Impact Station
	AC1	Upstream Reference Station
	AC2	Upstream Reference Station
	AC3	Upstream Reference Station

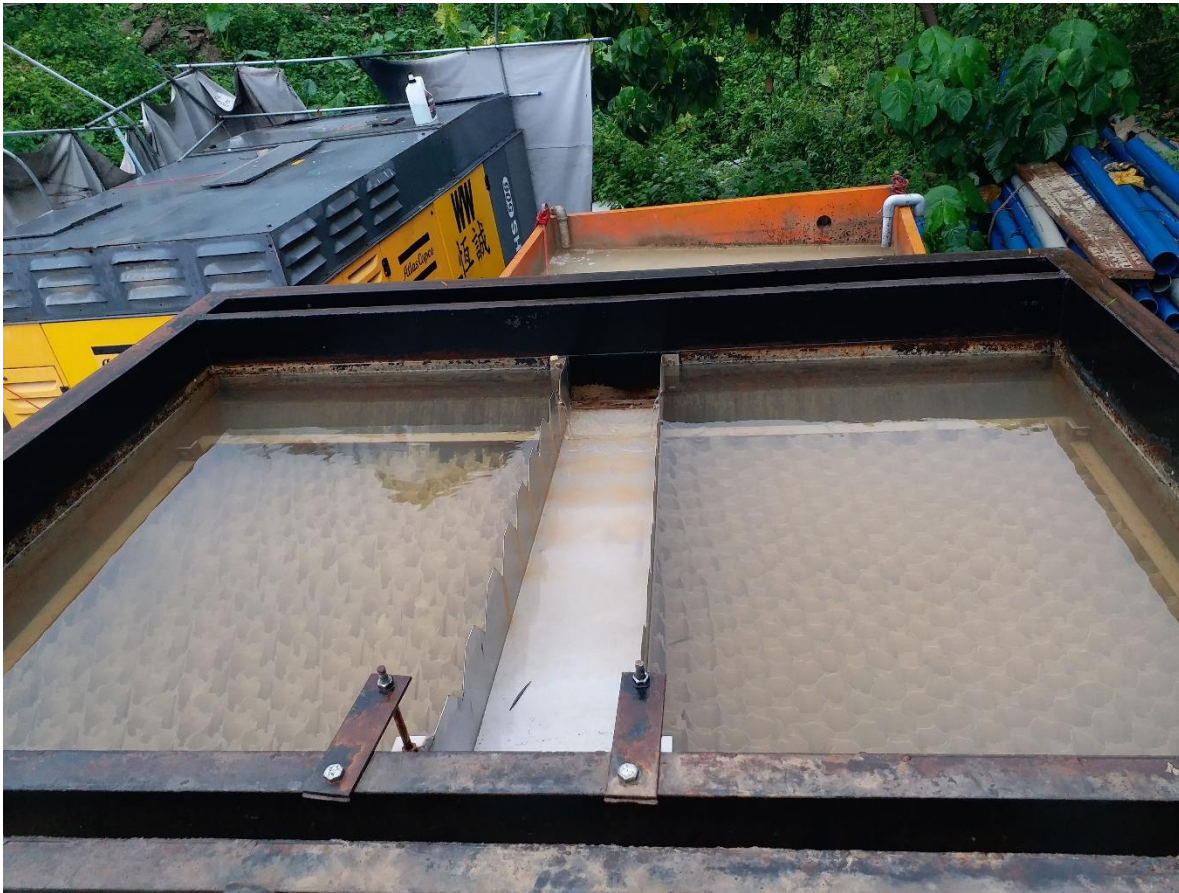
**The Condition of the wastewater treatment facility near Monitoring Station F on 25 March 2022**
