Service Contract No: EDO/01/2017
Environmental Team for
Development of Anderson Road Quarry Site
Road Improvement Works
Monthly EM&A Report (June 2022)

**ENVIRONMENTAL TEAM FOR
DEVELOPMENT OF
ANDERSON ROAD QUARRY SITE -
ROAD IMPROVEMENT WORKS**

MONTHLY ENVIRONMENTAL MONITORING & AUDIT REPORT

JUNE 2022

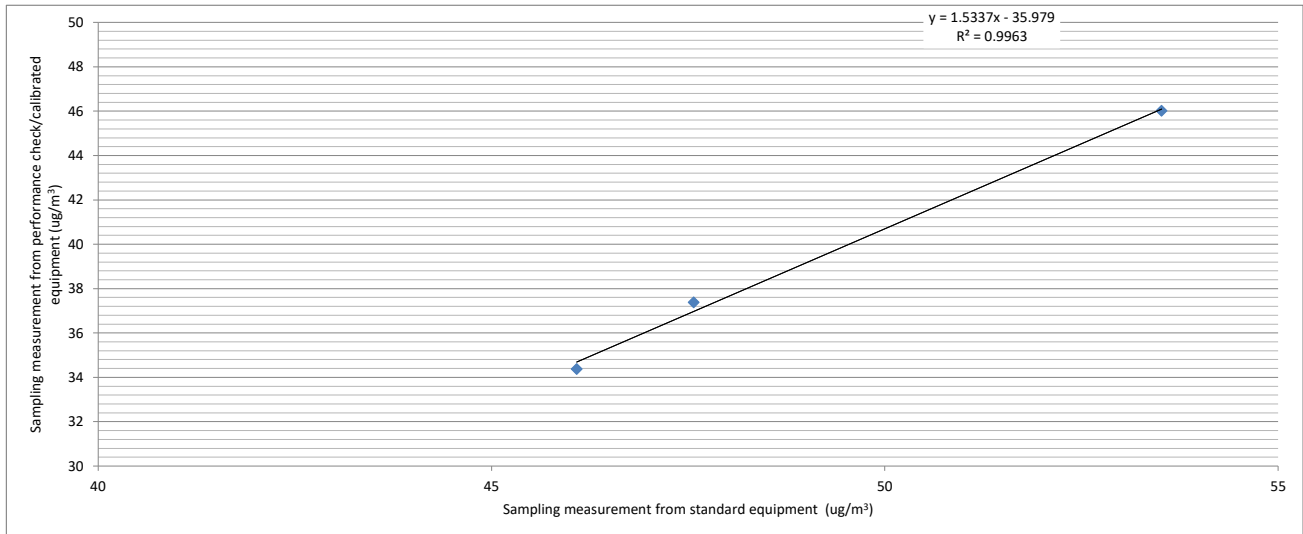
Linear Regression of Y on X

Slope (K- factor) : 0.7000
Correlation Coefficient : 0.9982
Validity of Performance Check / Calibration Record : 30/4/2023

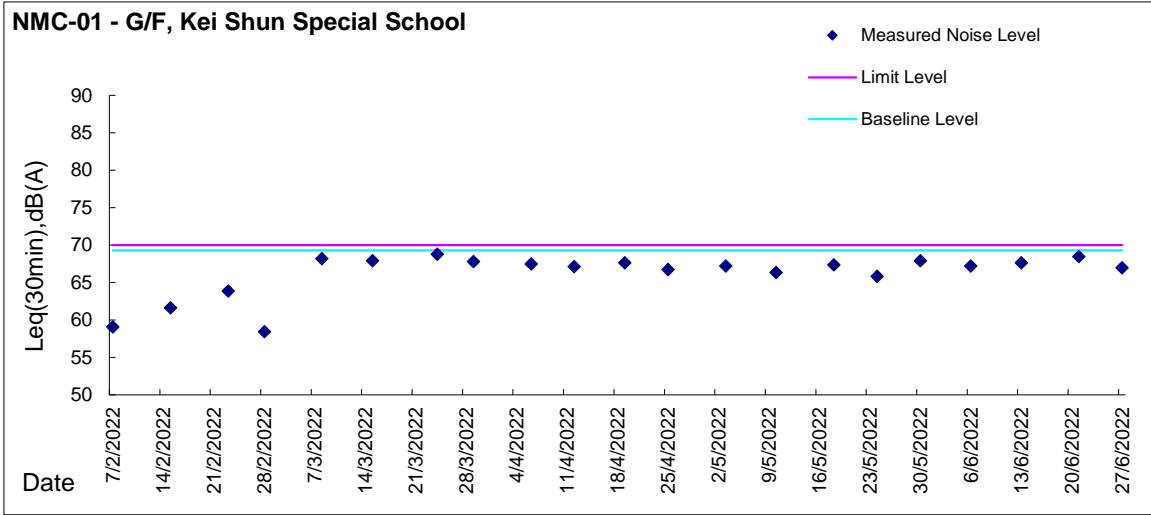
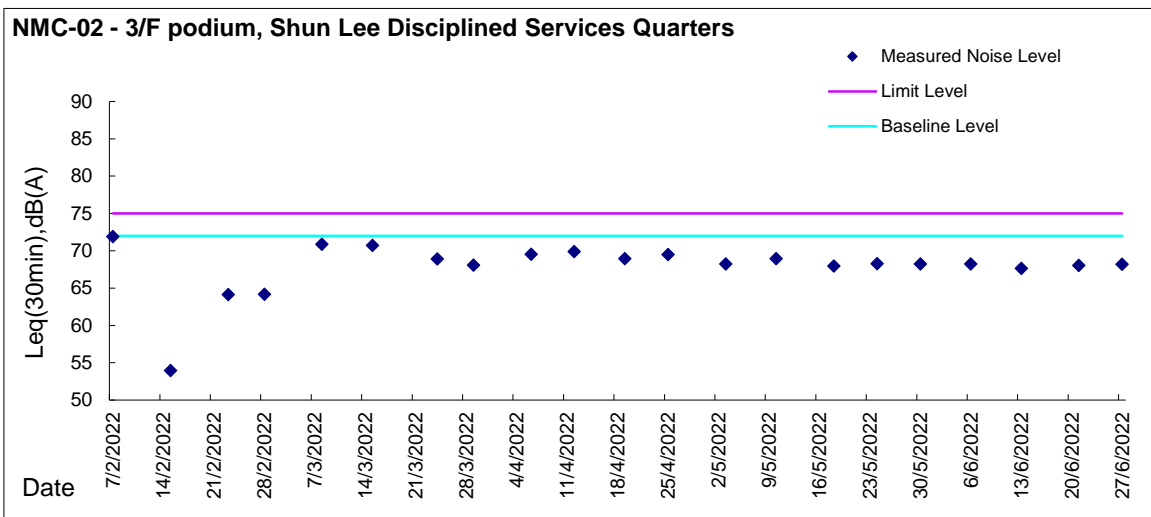
Graphic Presentation of Noise Monitoring Result
Day Time (0700 - 1900hrs on normal weekdays)

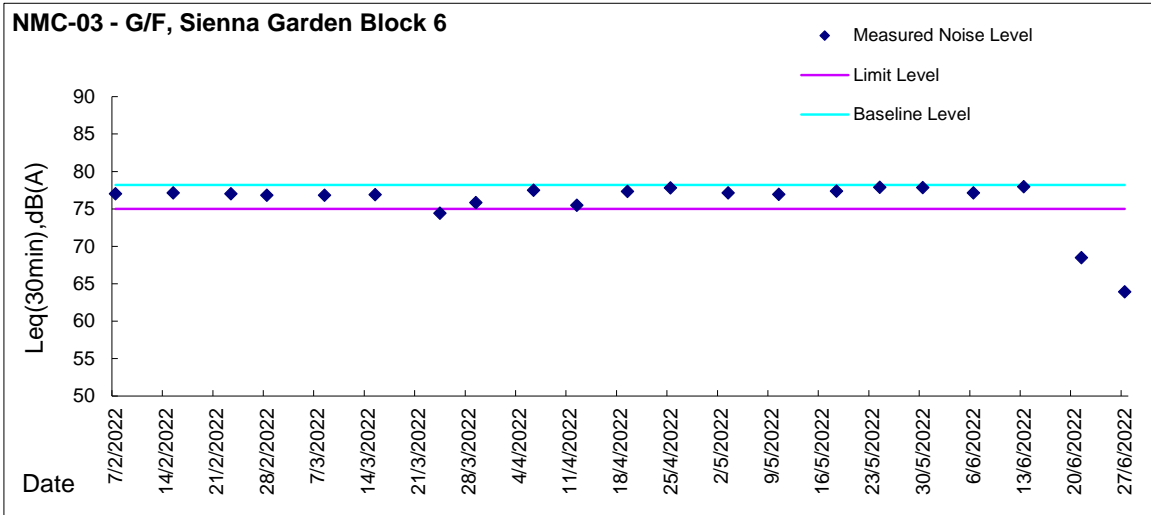
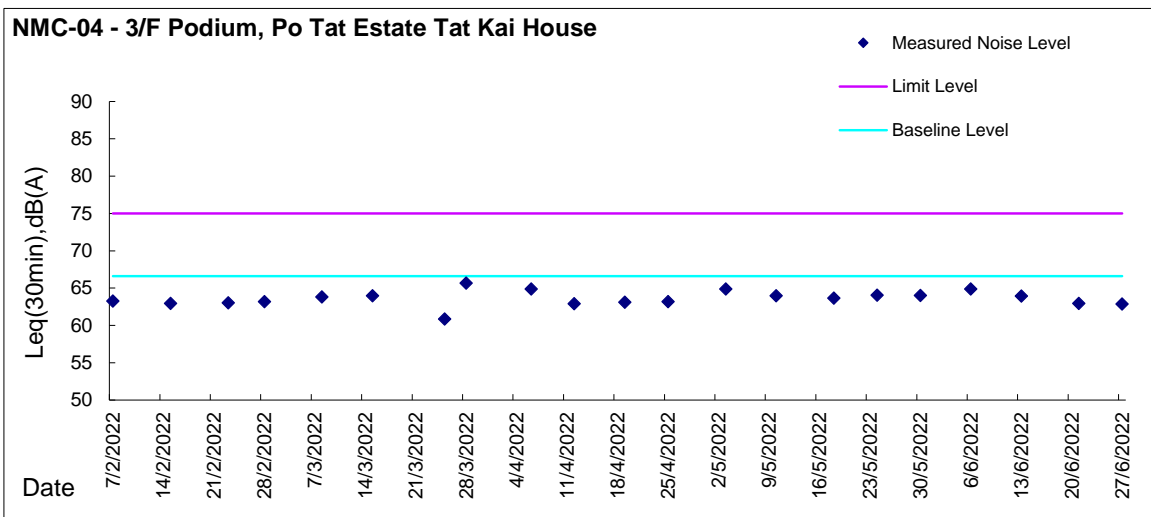
Graphic Presentation of Noise Monitoring Result
Day Time (0700 - 1900hrs on normal weekdays)

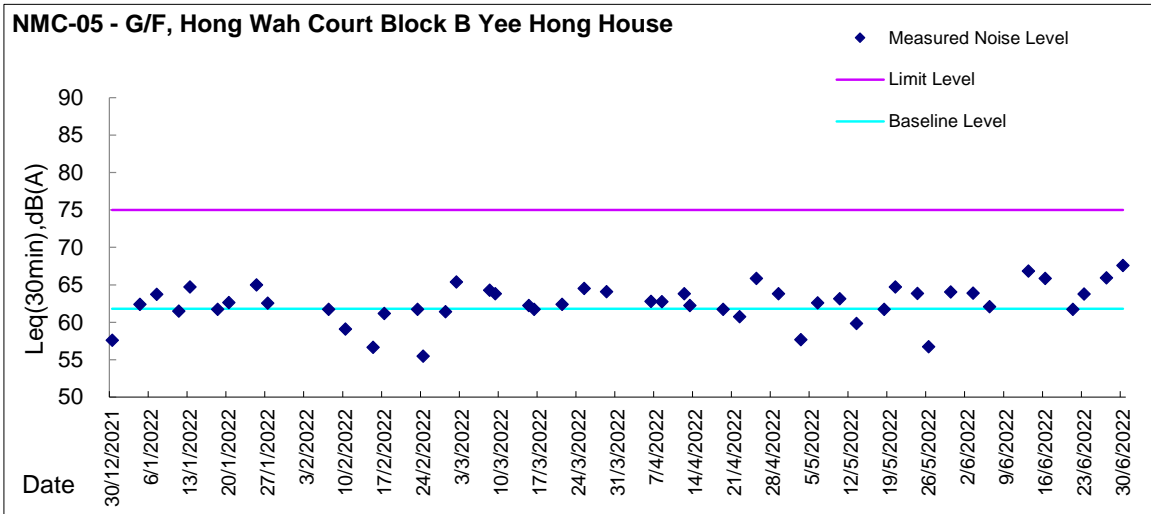
Graphic Presentation of Noise Monitoring Result

Day Time (0700 - 1900hrs on normal weekdays)

NMC-05 - G/F, Hong Wah Court Block B Yee Hong House

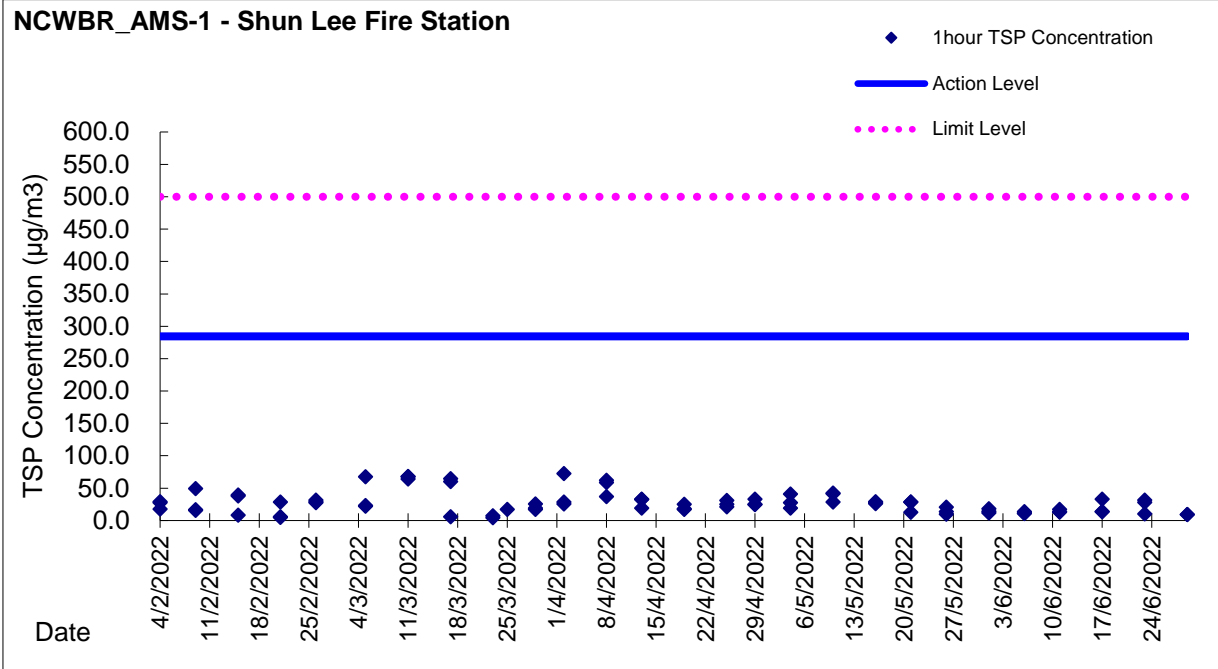
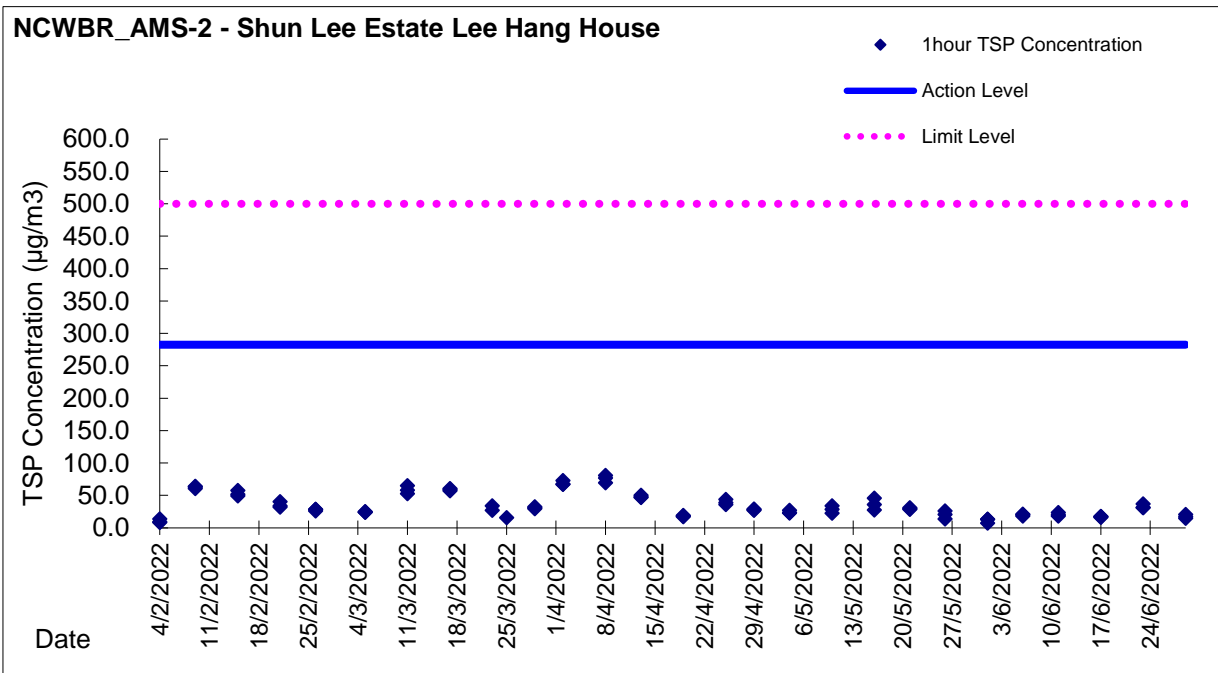
Graphic Presentation of TSP Result

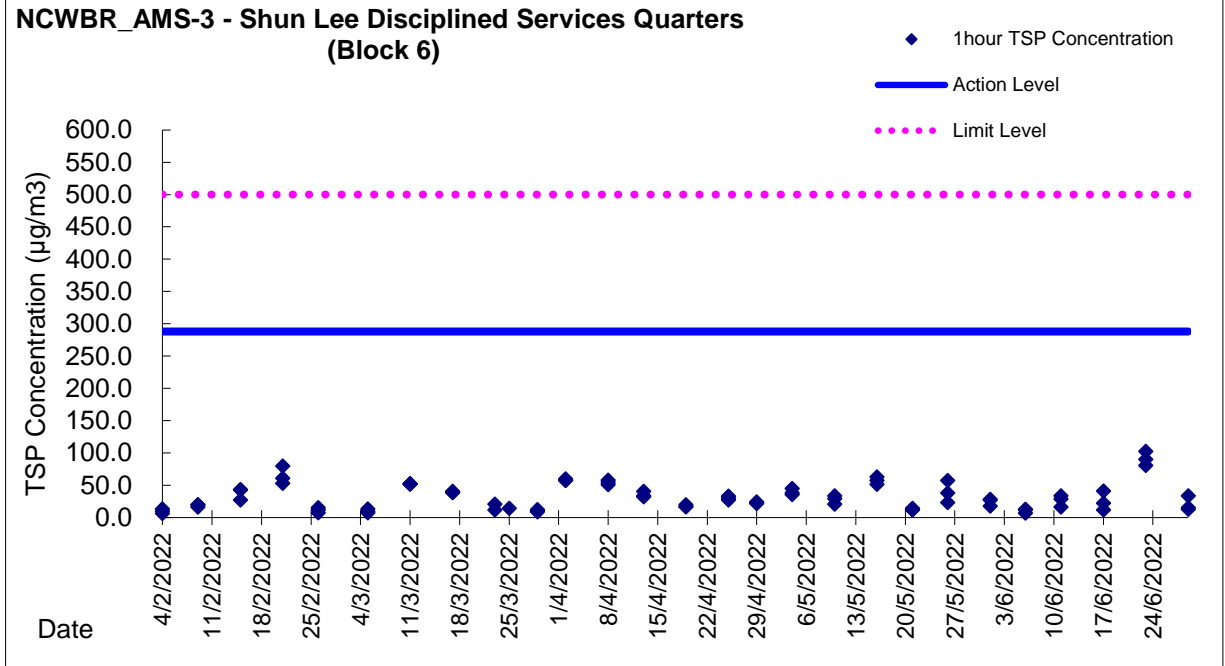
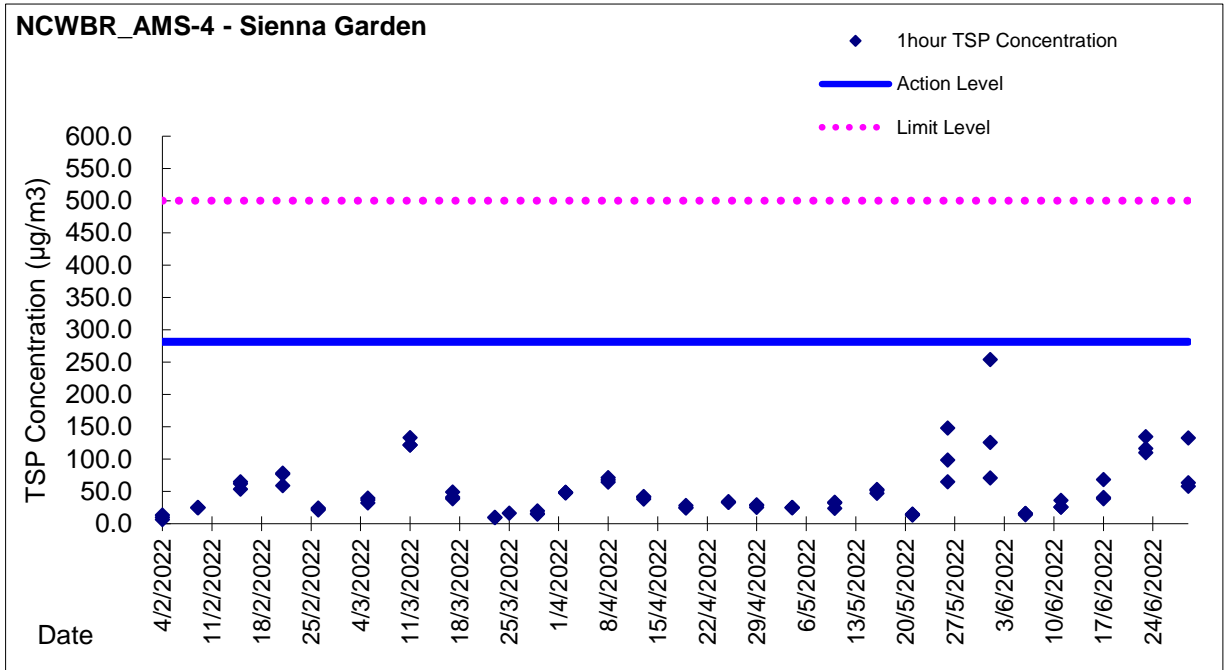
Graphic Presentation of TSP Result

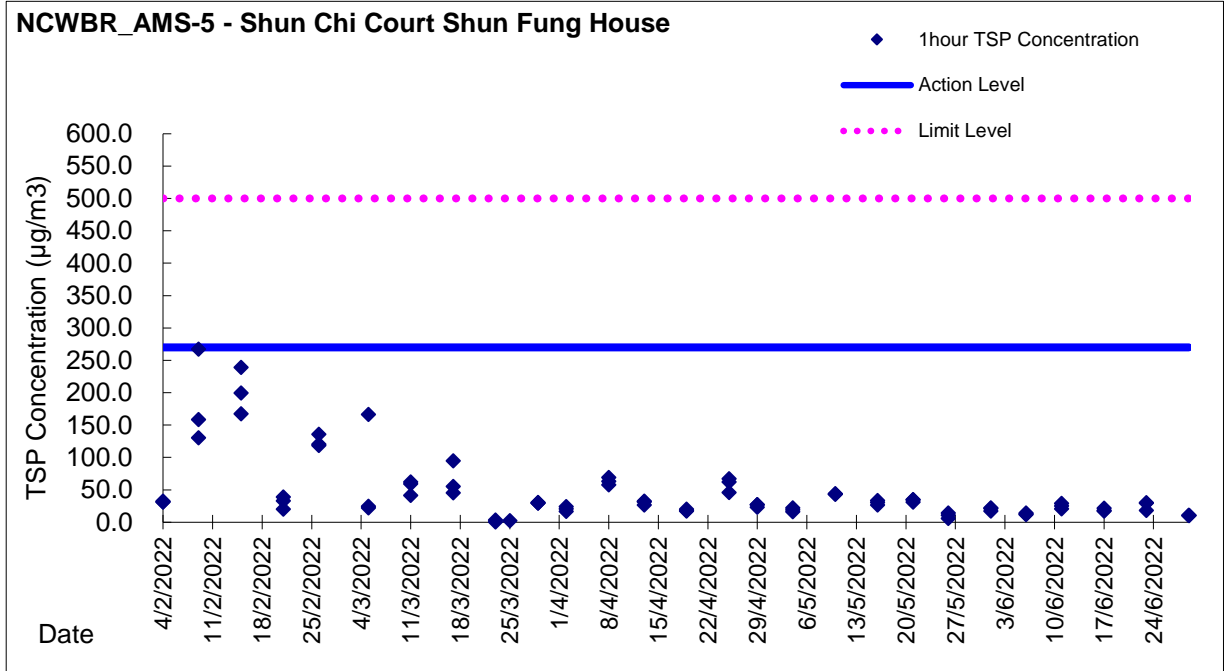
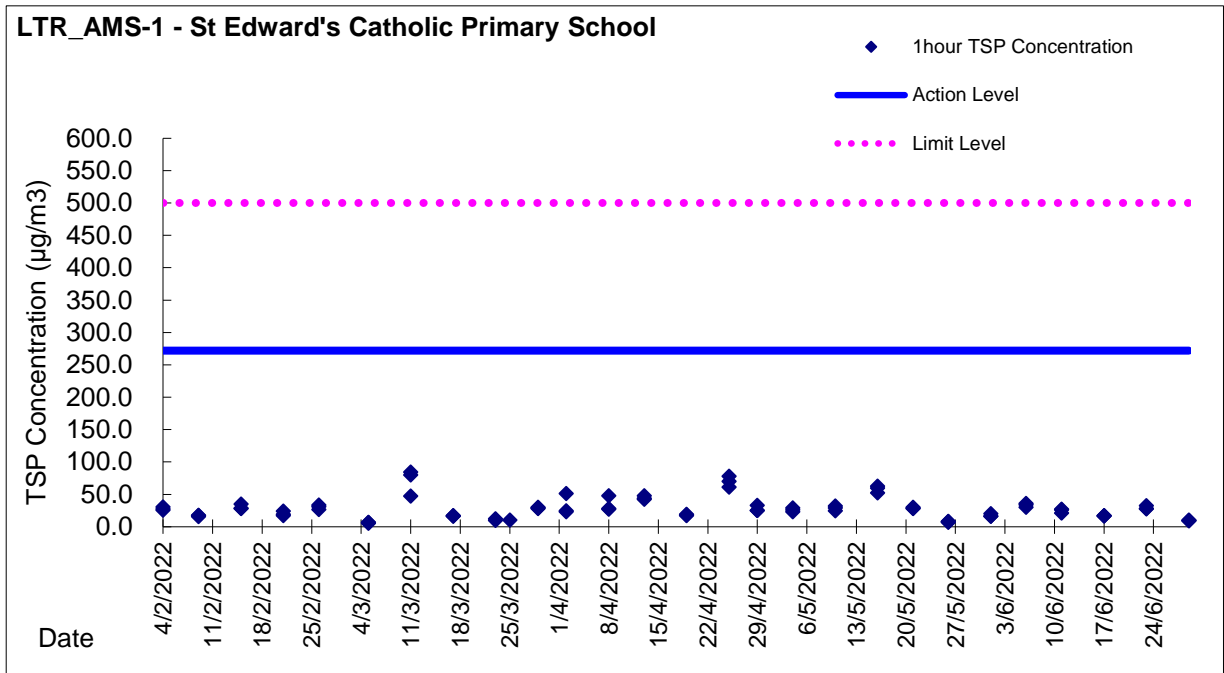
Graphic Presentation of TSP Result

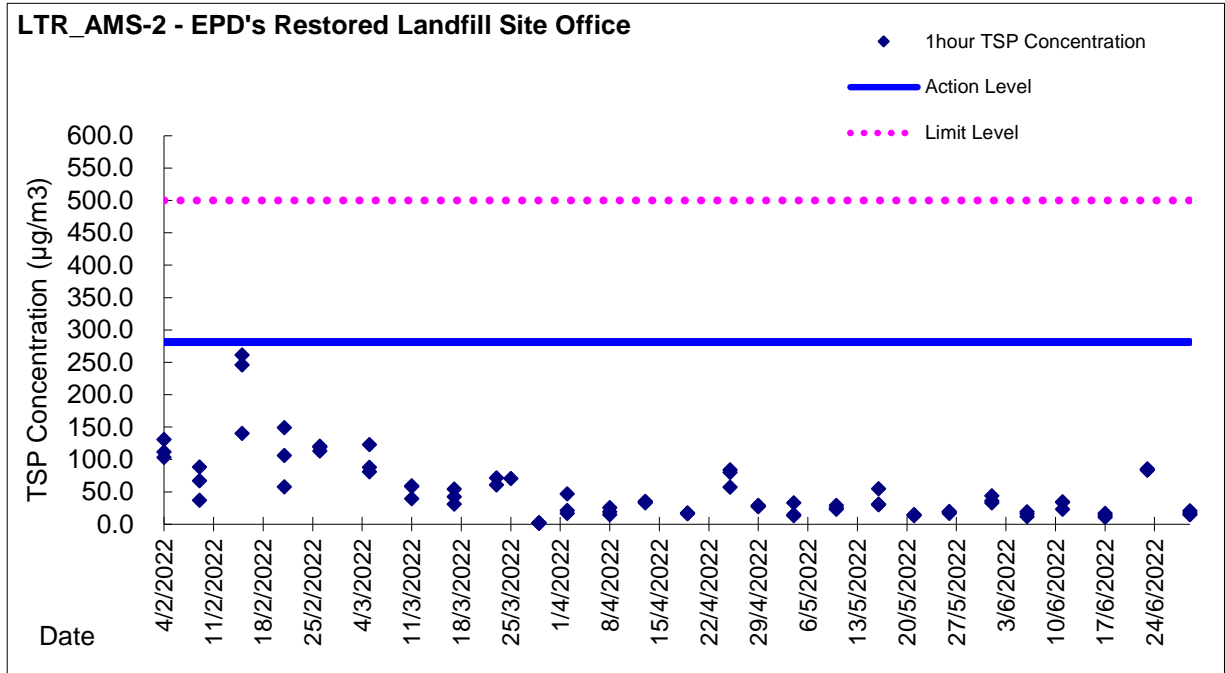
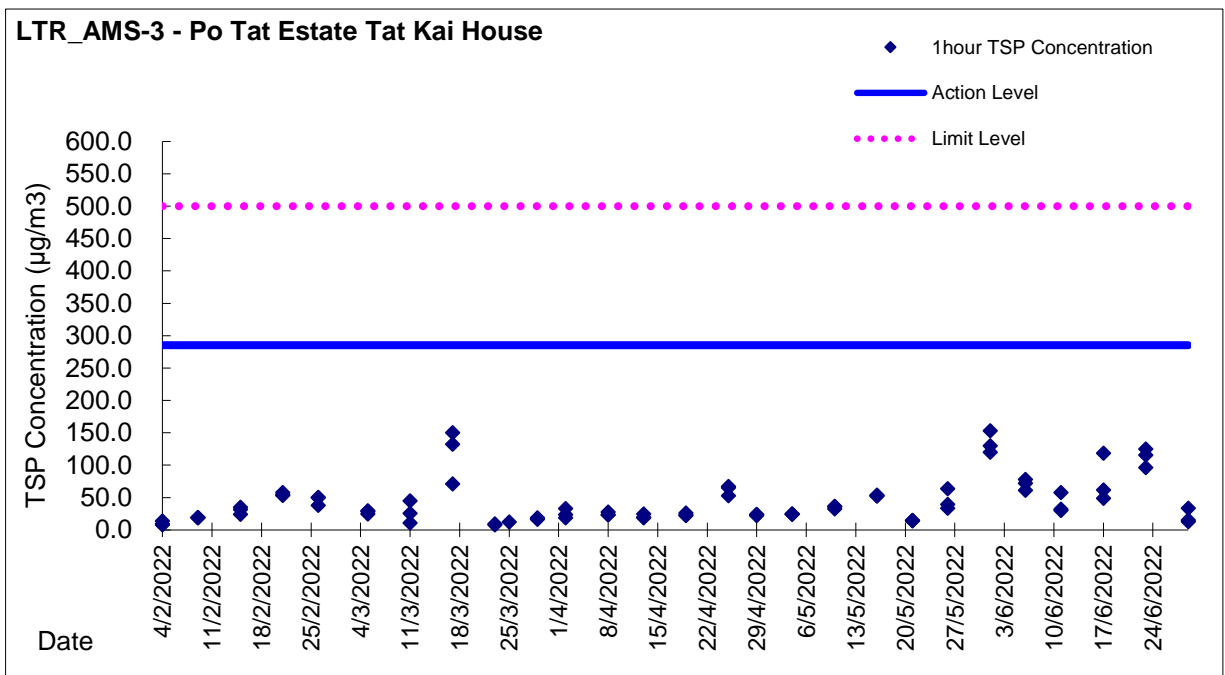
Graphic Presentation of TSP Result
