**ENVIRONMENTAL TEAM FOR
DEVELOPMENT OF
ANDERSON ROAD QUARRY SITE -
ROAD IMPROVEMENT WORKS**

UNDER ENVIRONMENTAL PERMIT NO. EP-513/2016

MONTHLY ENVIRONMENTAL MONITORING & AUDIT REPORT

JULY 2022

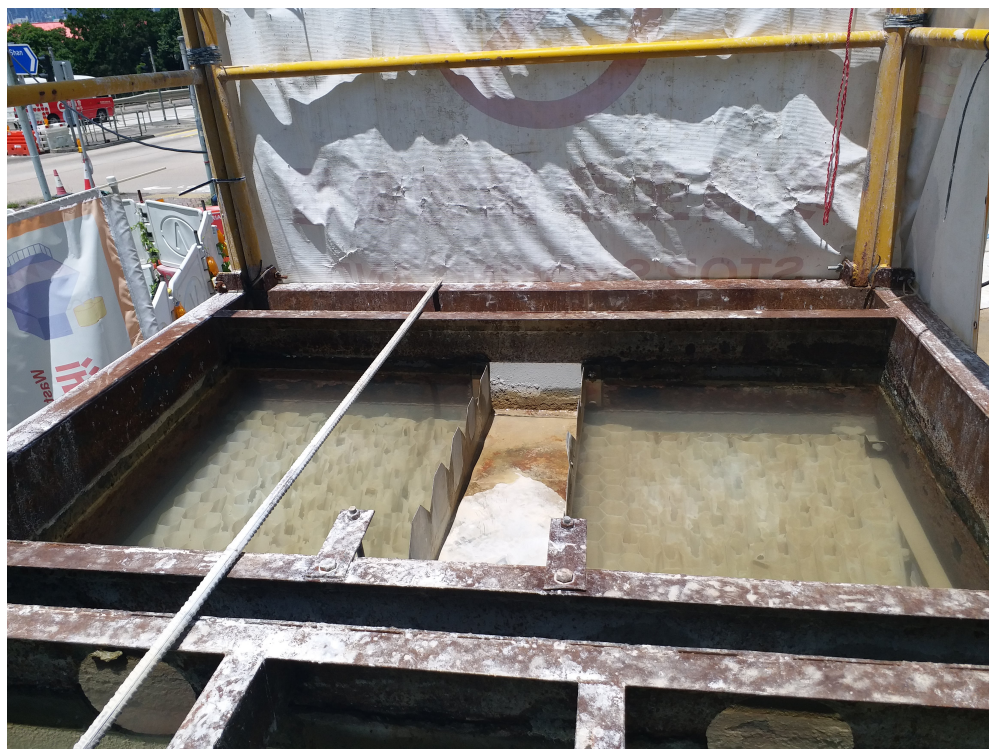
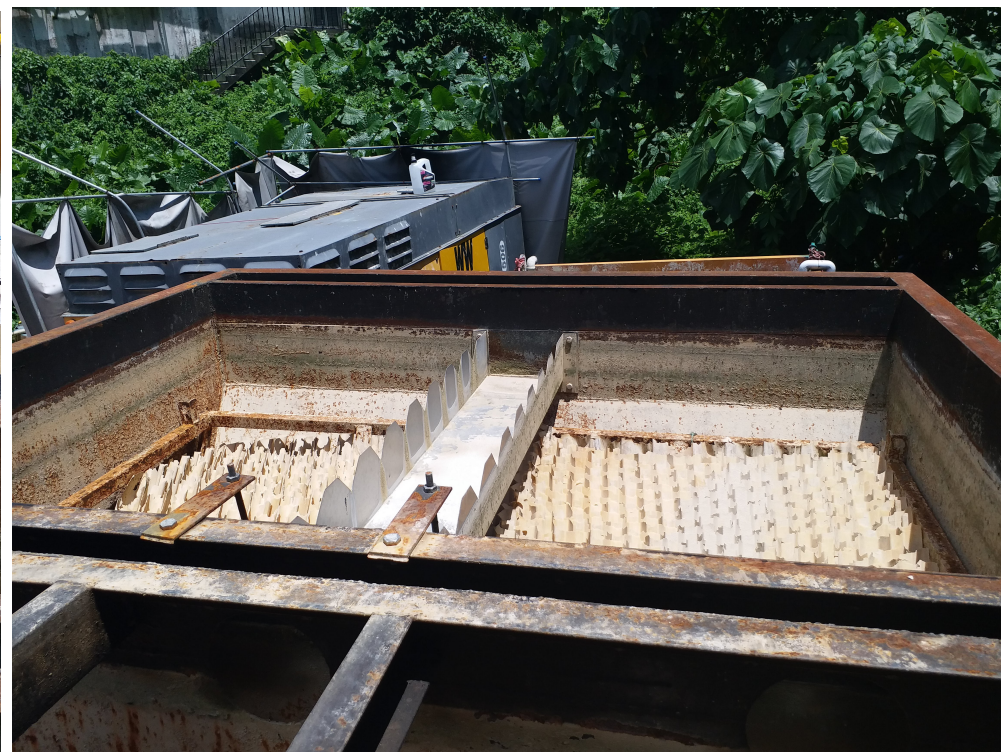
The condition of the RIW2 wastewater treatment facilities near Monitoring Station F on 11 July 2022, 11:30am
