**ENVIRONMENTAL TEAM FOR
DEVELOPMENT OF
ANDERSON ROAD QUARRY SITE -
ROAD IMPROVEMENT WORKS**

UNDER ENVIRONMENTAL PERMIT NO. EP-513/2016

MONTHLY ENVIRONMENTAL MONITORING & AUDIT REPORT

DECEMBER 2022

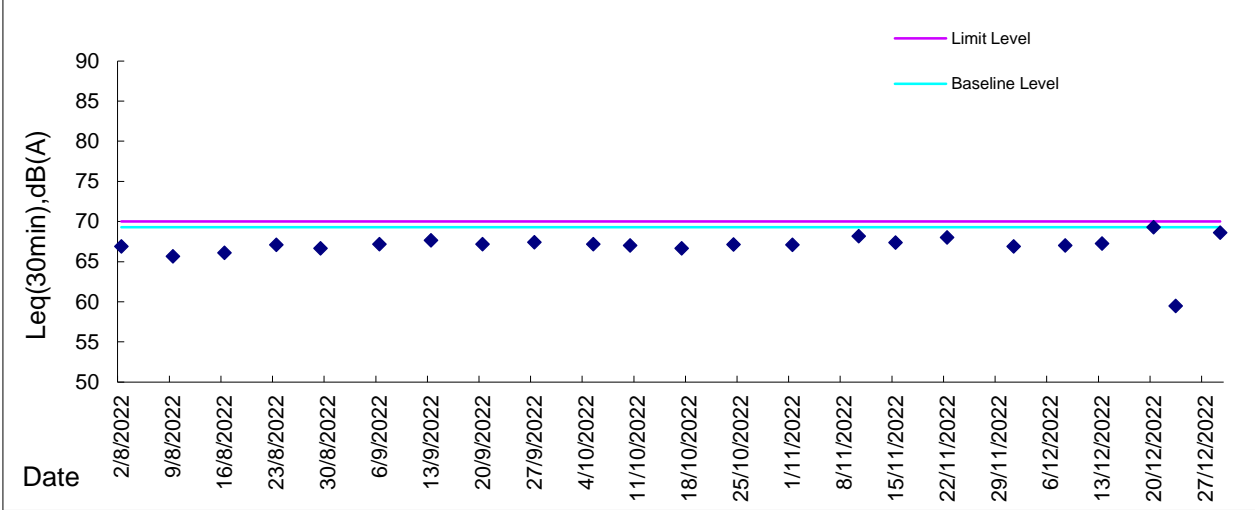
NMC-01 - G/F, Kei Shun Special School

Day Time (0700 - 1900hrs on normal weekdays)

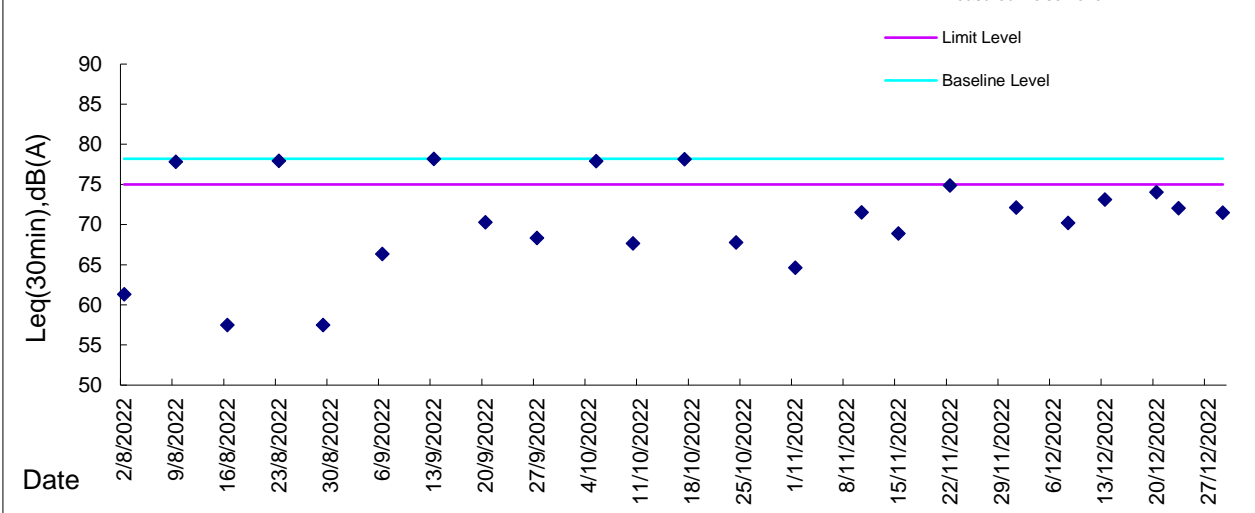
NMC-03 - G/F, Sienna Garden Block 6

Graphic Presentation of Noise Monitoring Result

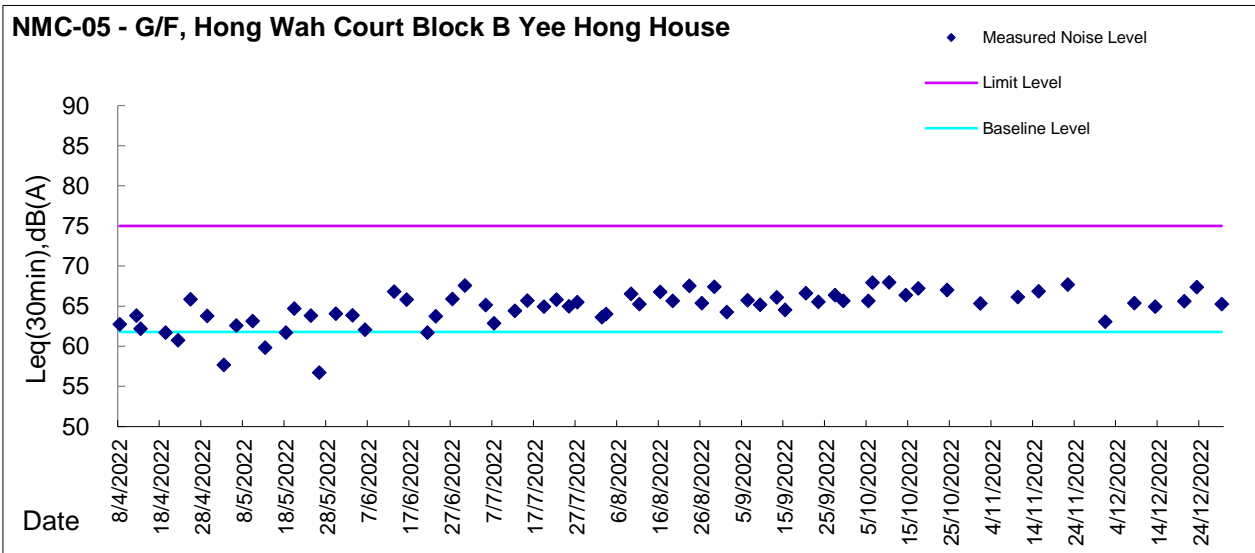
NMC-05 - G/F, Hong Wah Court Block B Yee Hong House

Graphic Presentation of Noise Monitoring Result
Day Time (0700 - 1900hrs on normal weekdays)

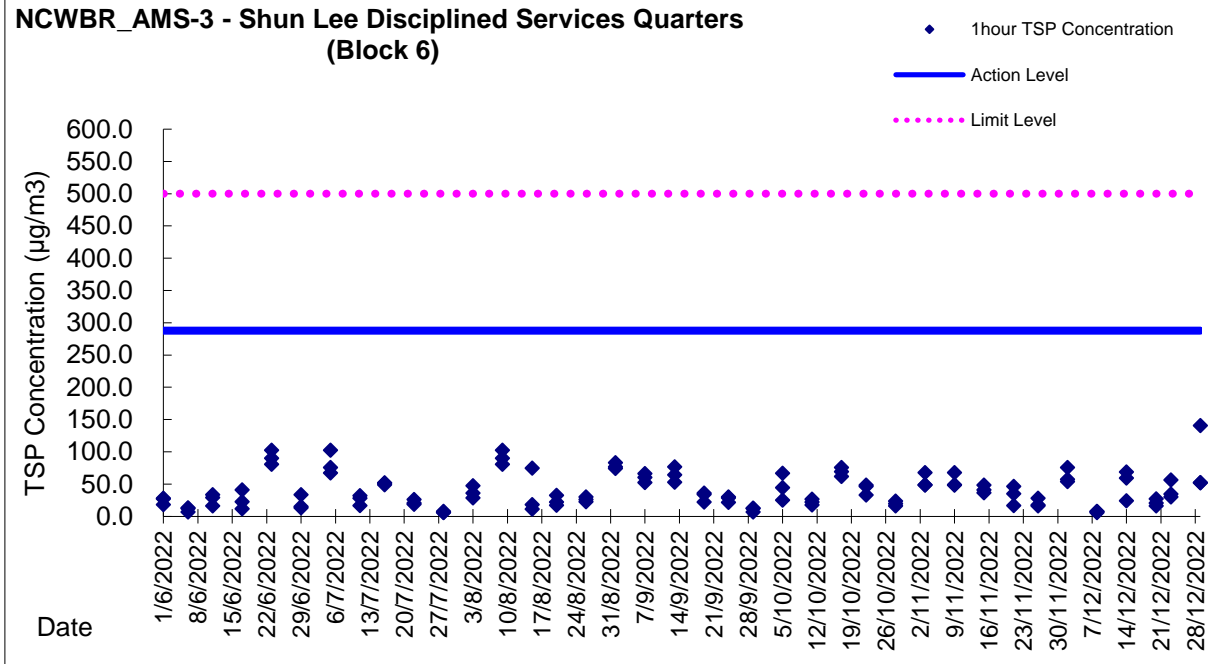
NCWBR_AMS-3 - Shun Lee Disciplined Services Quarters (Block 6)

Graphic Presentation of TSP Result
