Service Contract No: EDO/01/2017
Environmental Team for
Development of Anderson Road Quarry Site
Road Improvement Works
Monthly EM&A Report (December 2023)

**ENVIRONMENTAL TEAM FOR
DEVELOPMENT OF
ANDERSON ROAD QUARRY SITE -
ROAD IMPROVEMENT WORKS**

UNDER ENVIRONMENTAL PERMIT NO. EP-513/2016

MONTHLY ENVIRONMENTAL MONITORING & AUDIT REPORT

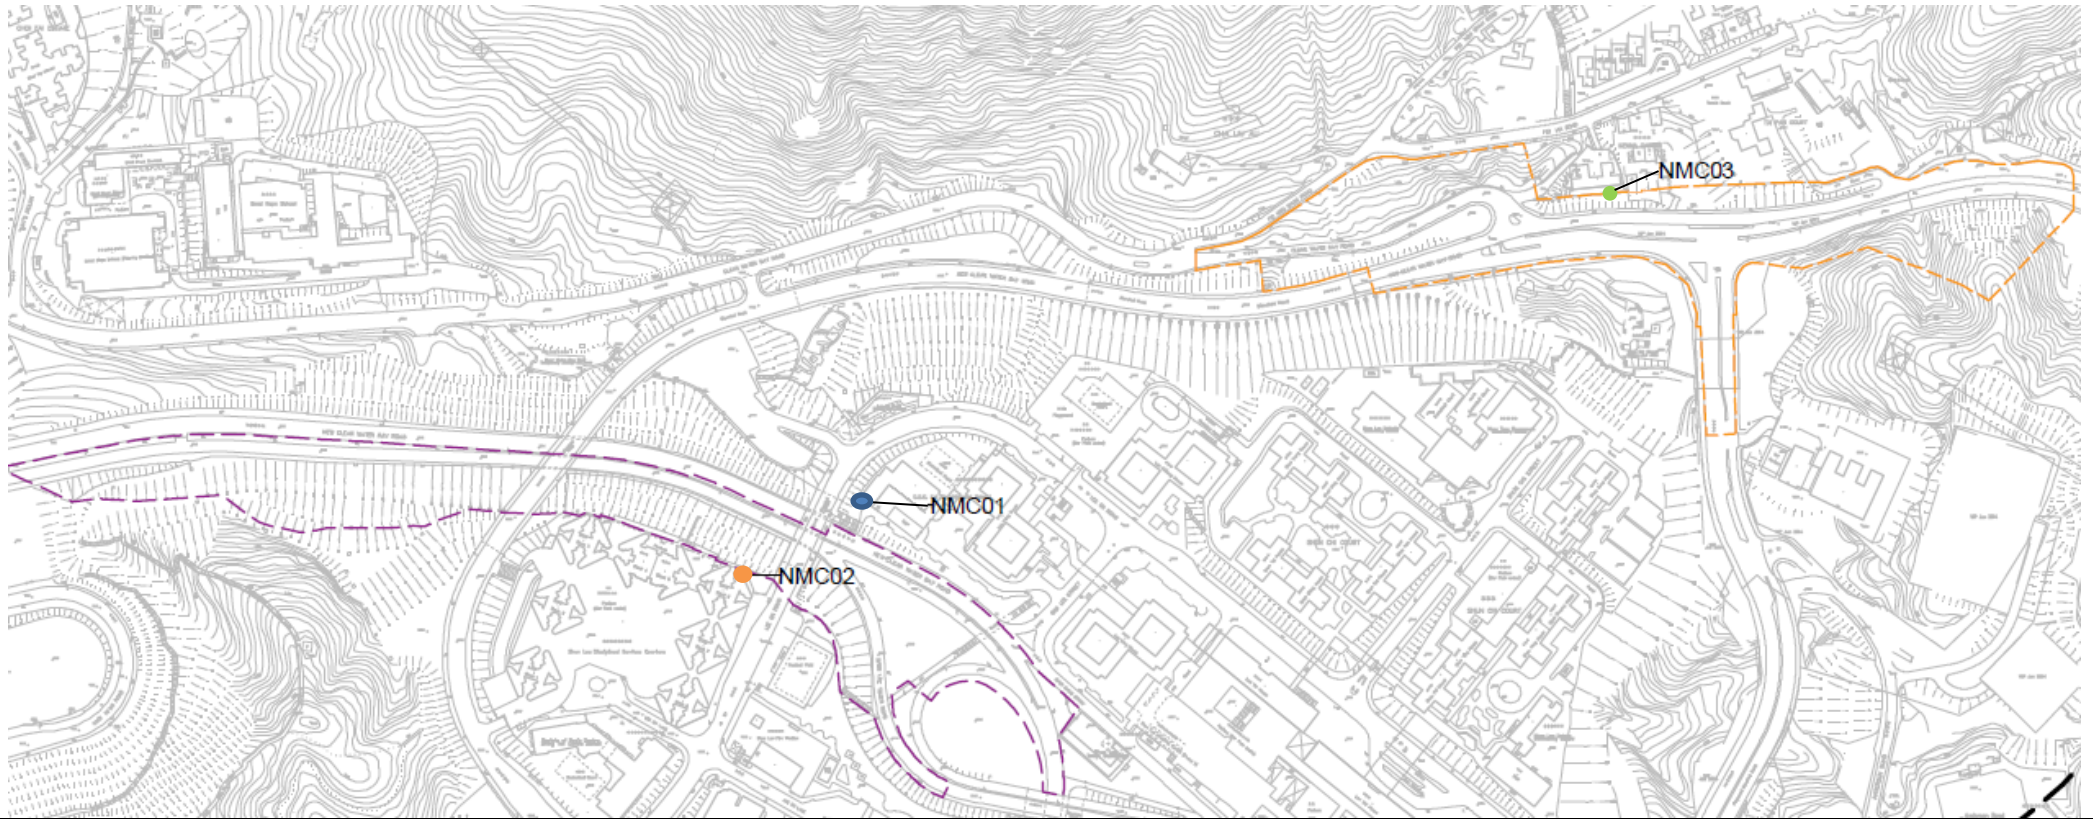
Figure 4.6
Location of Water Quality Monitoring Station
(for Road Improvement Work 3)

Inland Water	Stations	Description
Ma Yau Tong Stream	H	Upstream Control Station
	I	Downstream Impact Station

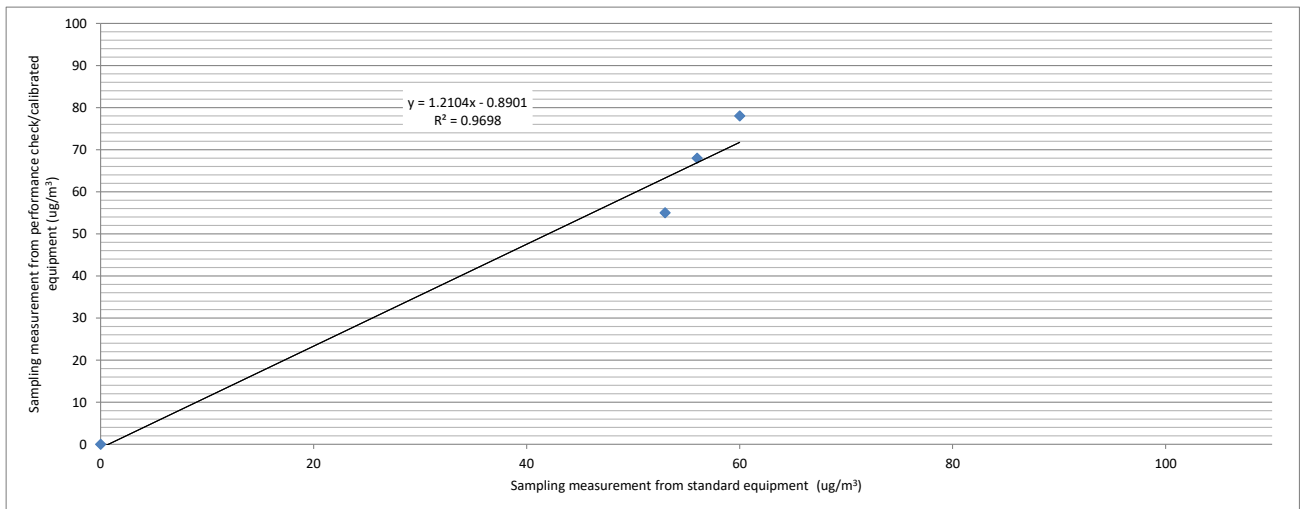
Linear Regression of Y on X

Slope (K- factor) : 1.3000
Correlation Coefficient : 0.9876
Validity of Performance Check / Calibration Record : 30/3/2023

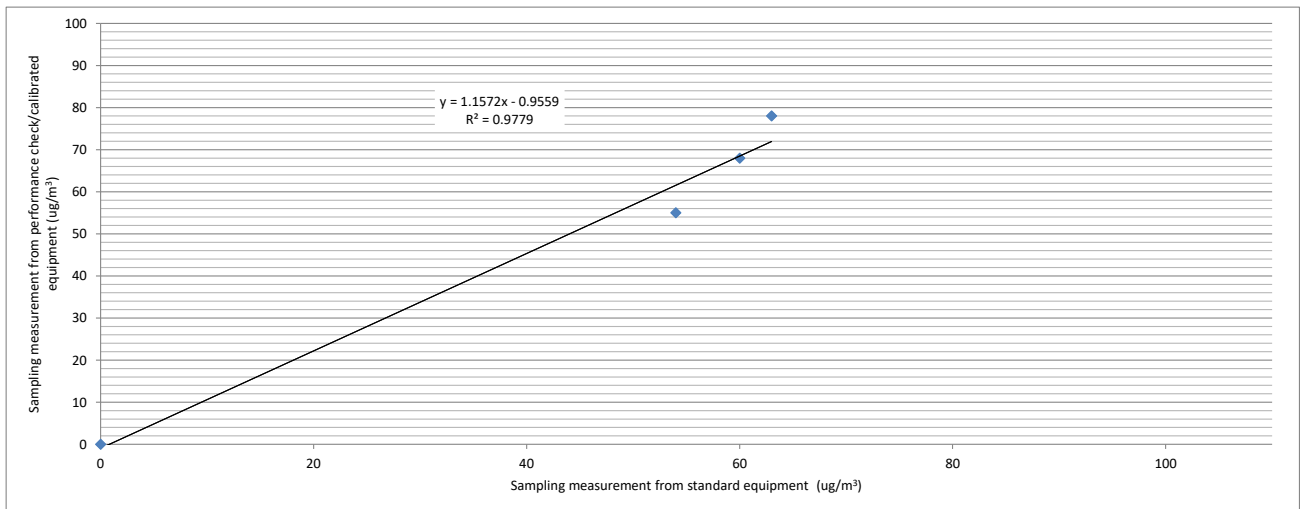
Linear Regression of Y on X

Slope (K- factor) : 1.2000
Correlation Coefficient : 0.9934
Validity of Performance Check / Calibration Record : 30/3/2023

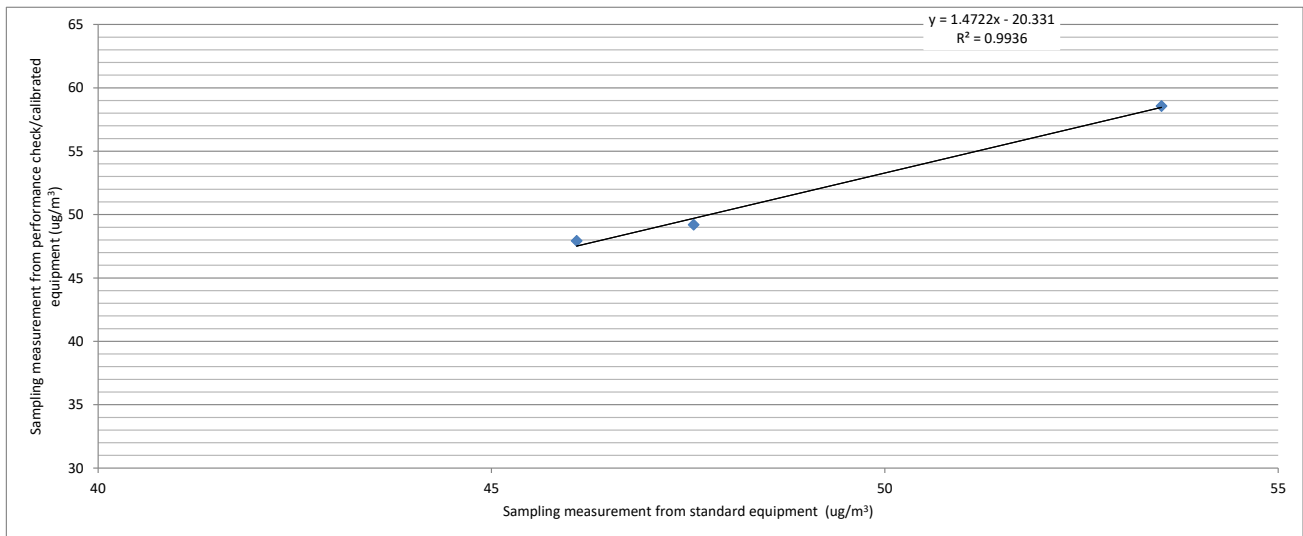
Linear Regression of Y on X

Slope (K- factor) : 0.7000
Correlation Coefficient : 0.9968
Validity of Performance Check / Calibration Record : 30/4/2023

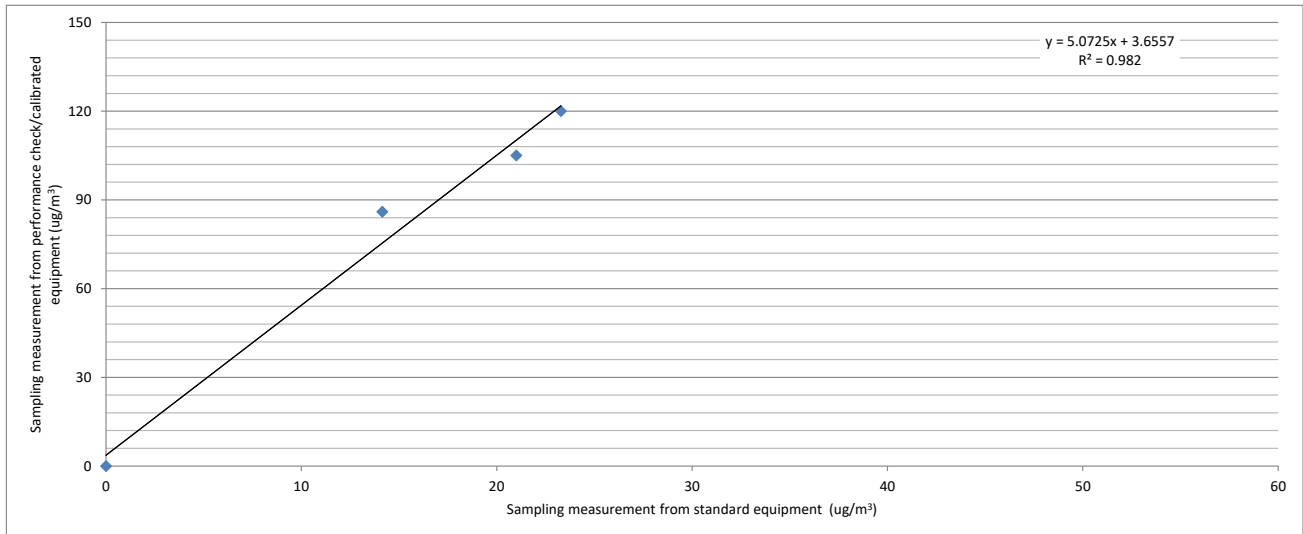
Linear Regression of Y on X

Slope (K- factor) : 5.1000
Correlation Coefficient : 0.9909
Validity of Performance Check / Calibration Record : 8/6/2024

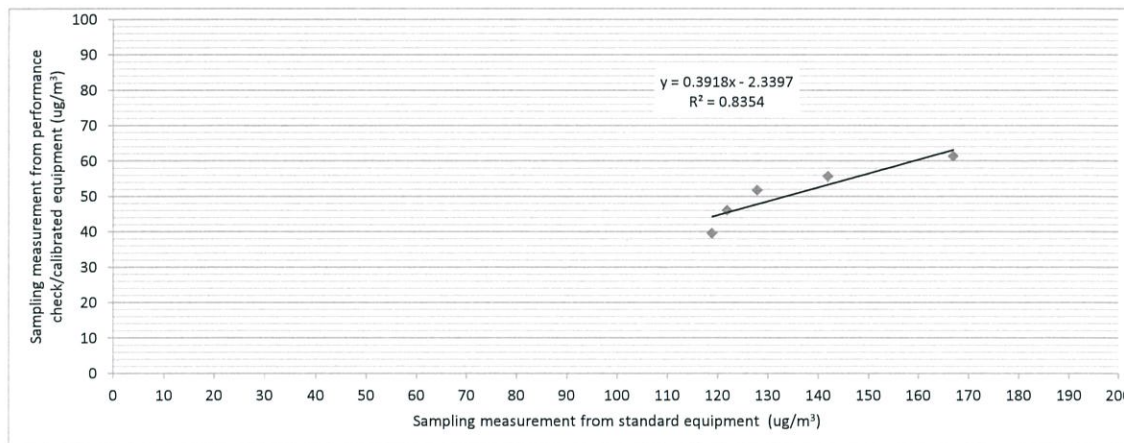
Linear Regression of Y on X

Slope (K- factor) : 2.2000
 Correlation Coefficient : 0.9140
 Validity of Performance Check / Calibration Record : 3/2/2024

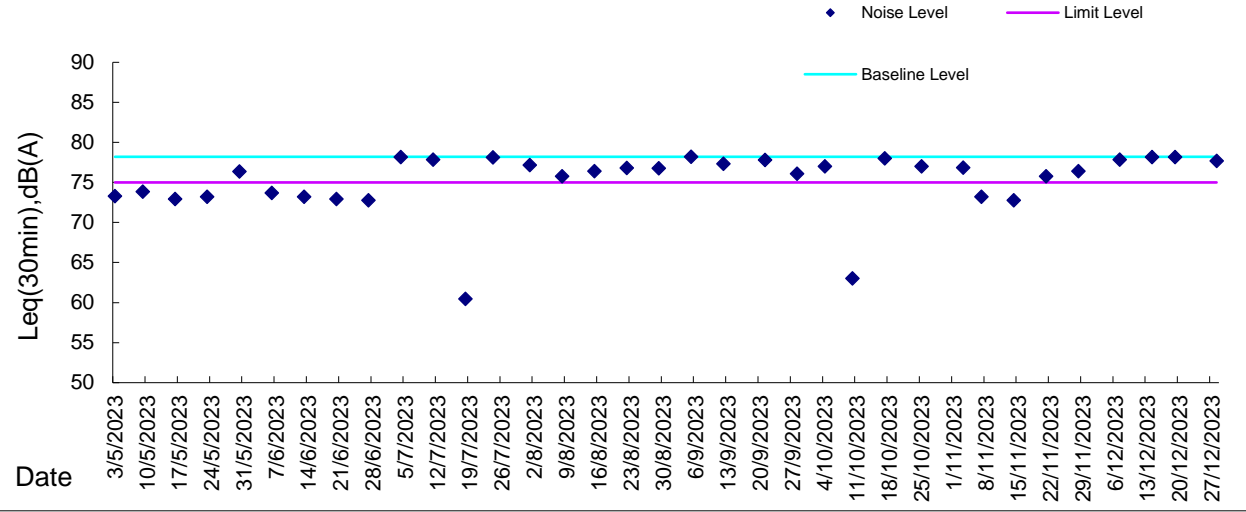
NMC-03 - G/F, Sienna Garden Block 6

Graphic Presentation of Noise Monitoring Result
Day Time (0700 - 1900hrs on normal weekdays)

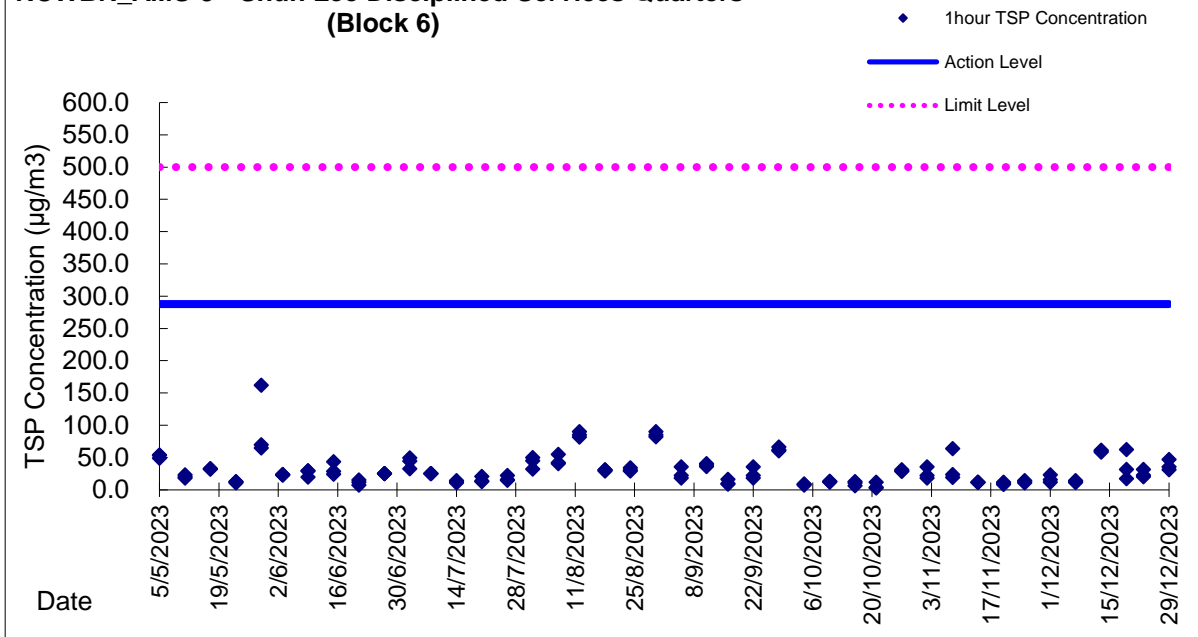
NCWBR_AMS-3 - Shun Lee Disciplined Services Quarters (Block 6)

Graphic Presentation of TSP Result

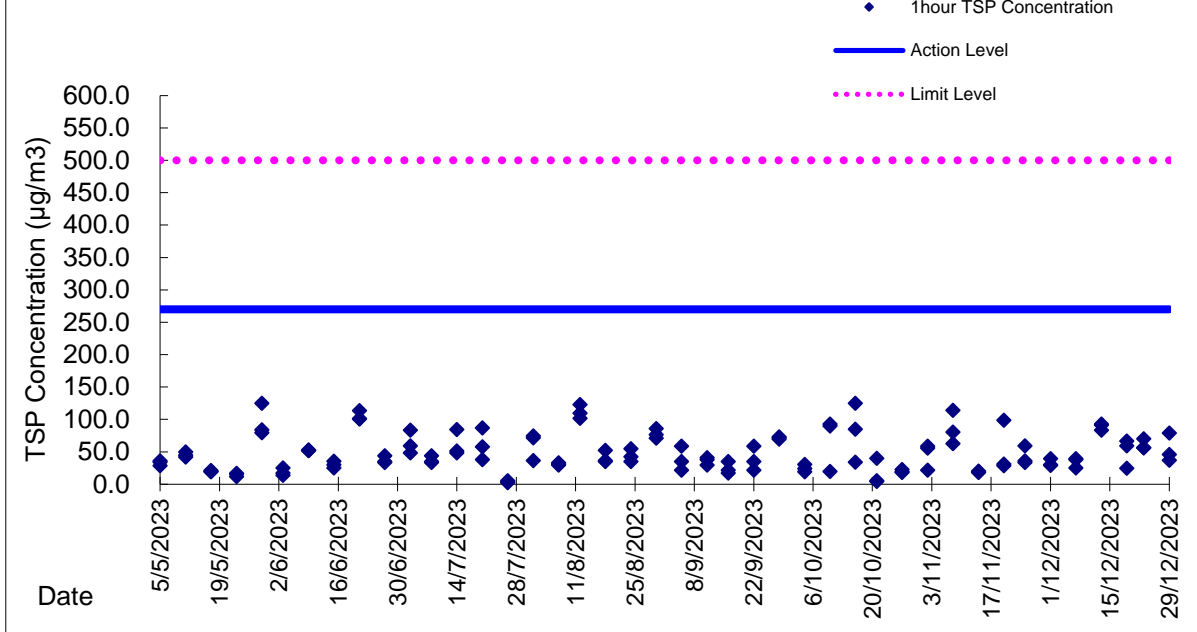
NCWBR_AMS-5 - Shun Chi Court Shun Fung House

Graphic Presentation of TSP Result

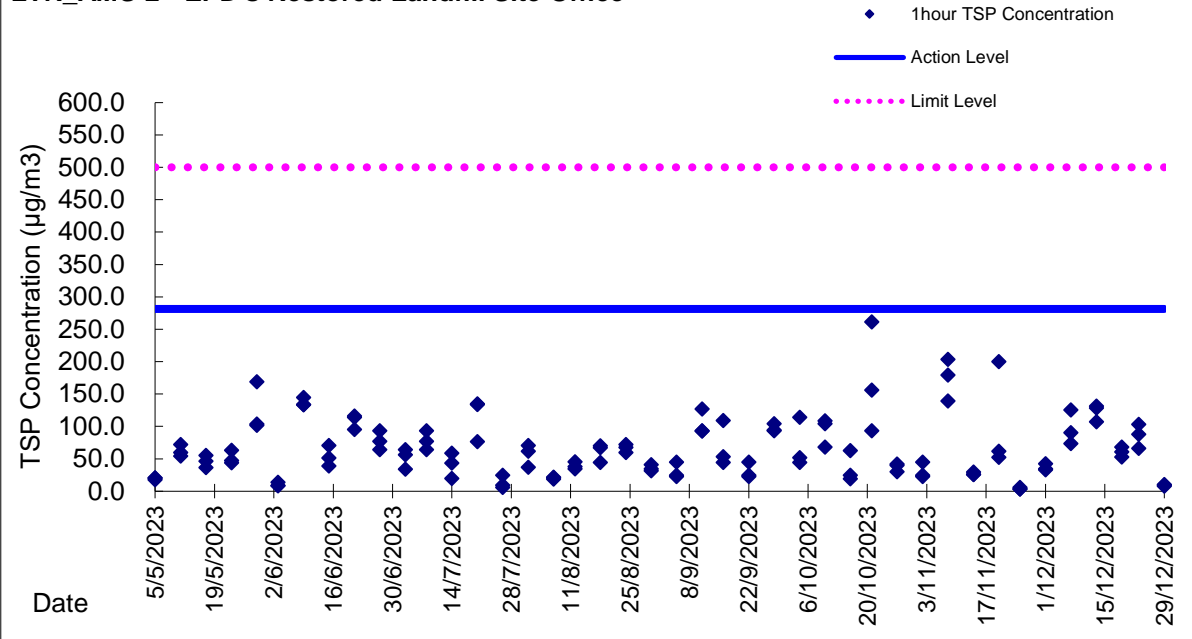
LTR_AMS-2 - EPD's Restored Landfill Site Office

Graphic Presentation of TSP Result
