Service Contract No: EDO/01/2017
Environmental Team for
Development of Anderson Road Quarry Site
Road Improvement Works
Monthly EM&A Report (February 2024)

**ENVIRONMENTAL TEAM FOR
DEVELOPMENT OF
ANDERSON ROAD QUARRY SITE -
ROAD IMPROVEMENT WORKS**

UNDER ENVIRONMENTAL PERMIT NO. EP-513/2016

MONTHLY ENVIRONMENTAL MONITORING & AUDIT REPORT

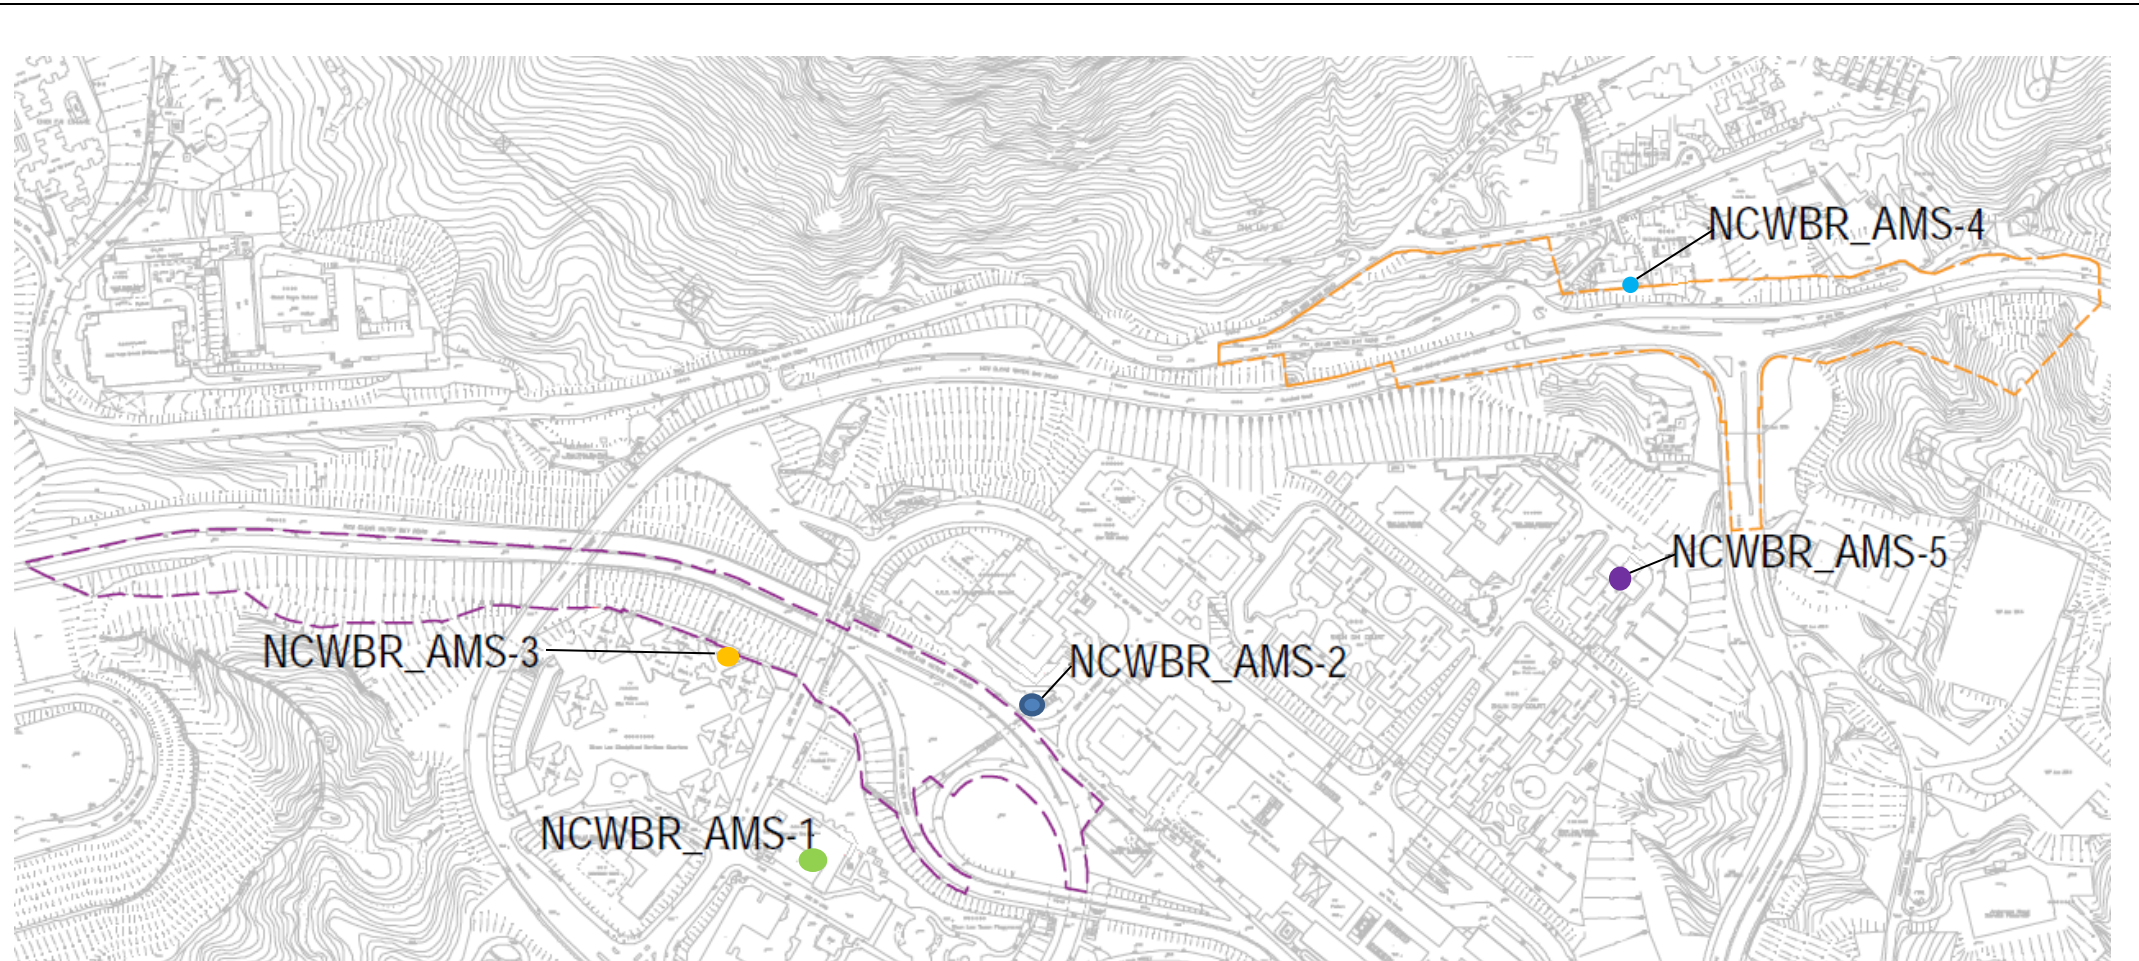
Figure 4.3
Location of Air Quality Monitoring Station
(for Road Improvement Work 1 & 2)

Monitoring Station ID	EIA ID	Location
NCWBR RIW		
NCWBR_AMS-1	ASLF-1	Shun Lee Fire Station
NCWBR_AMS-2	ASLE-21	Shun Lee Estate Lee Hang House
NCWBR_AMS-3	ASLD-10	Shun Lee Disciplined Services Quarters (Block 6)
NCWBR_AMS-4	AFNS-3	Sienna Garden
NCWBR_AMS-5	ASCC-05	Shun Chi Court Shun Fung House

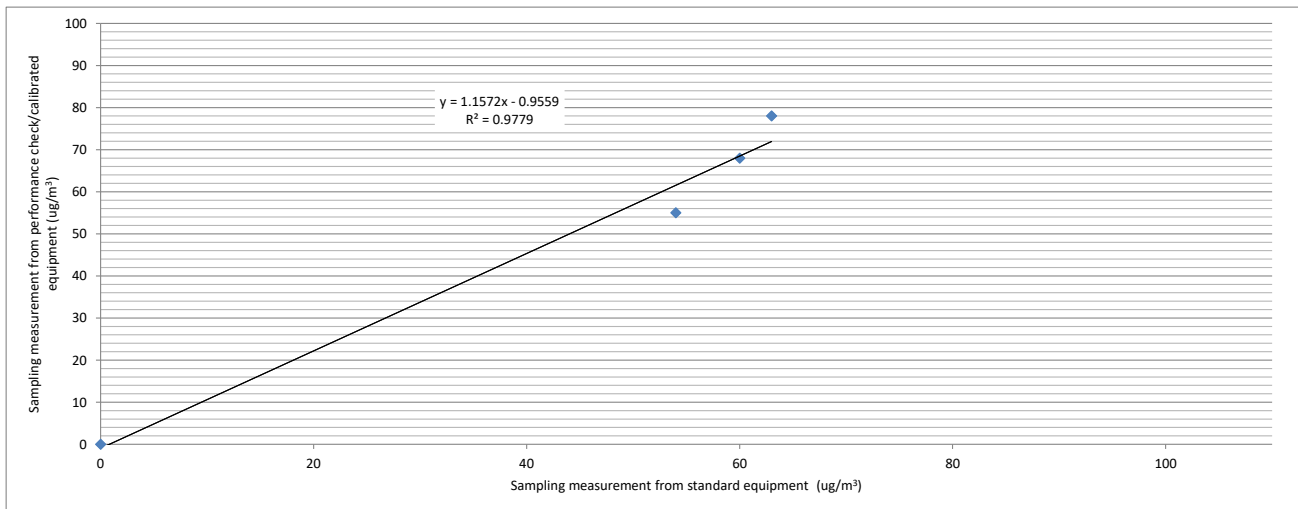
Linear Regression of Y on X

Slope (K- factor) : 1.2000
Correlation Coefficient : 0.9934
Validity of Performance Check / Calibration Record : 30/3/2023

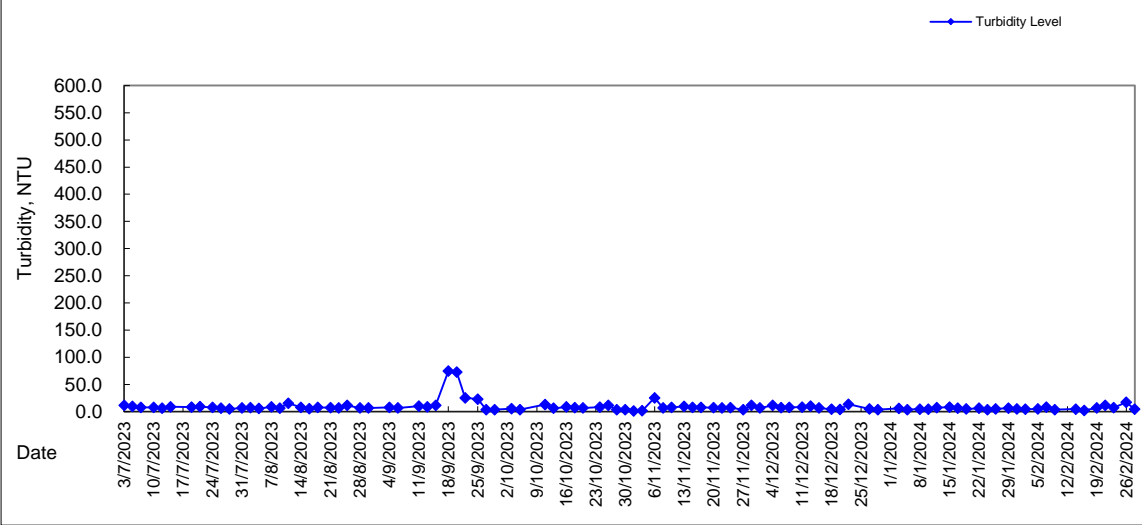
Station H - Ma You Tong Stream (Upstream Control Station) - Turbidity

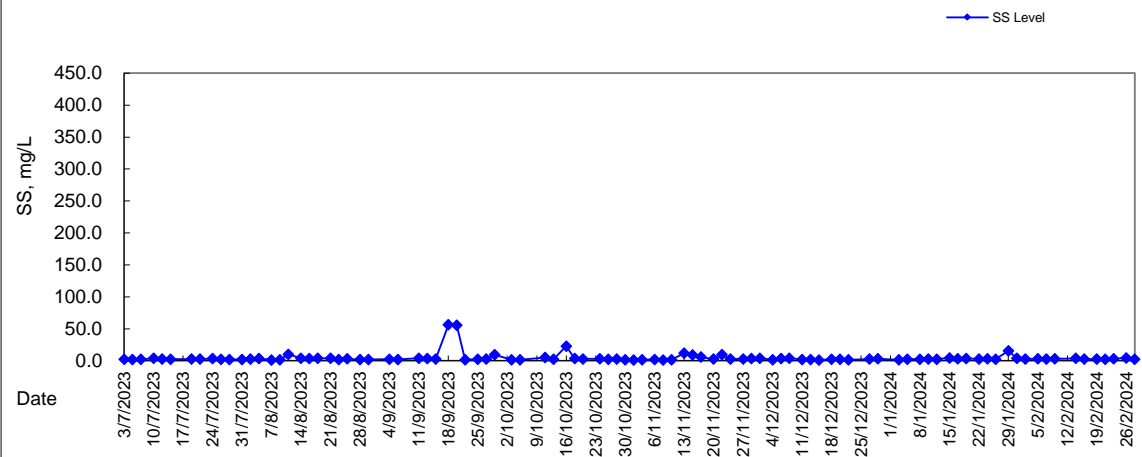
Station H - Ma You Tong Stream (Upstream Control Station) - Suspended Solid
