**CONVERSION OF THE FORMER FRENCH MISSION  
BUILDING FOR ACCOMMODATION USE BY LAW-RELATED  
ORGANISATIONS AND RELATED PURPOSES**

**IEC MONTHLY AUDIT REPORT (MARCH 2019)**

## IEC MONTHLY AUDIT REPORT FOR MARCH 2019

Revision **1.0**  
Date **12/04/2019**  
Made by **Harris Wong**  
Checked by **Simon Cheung**

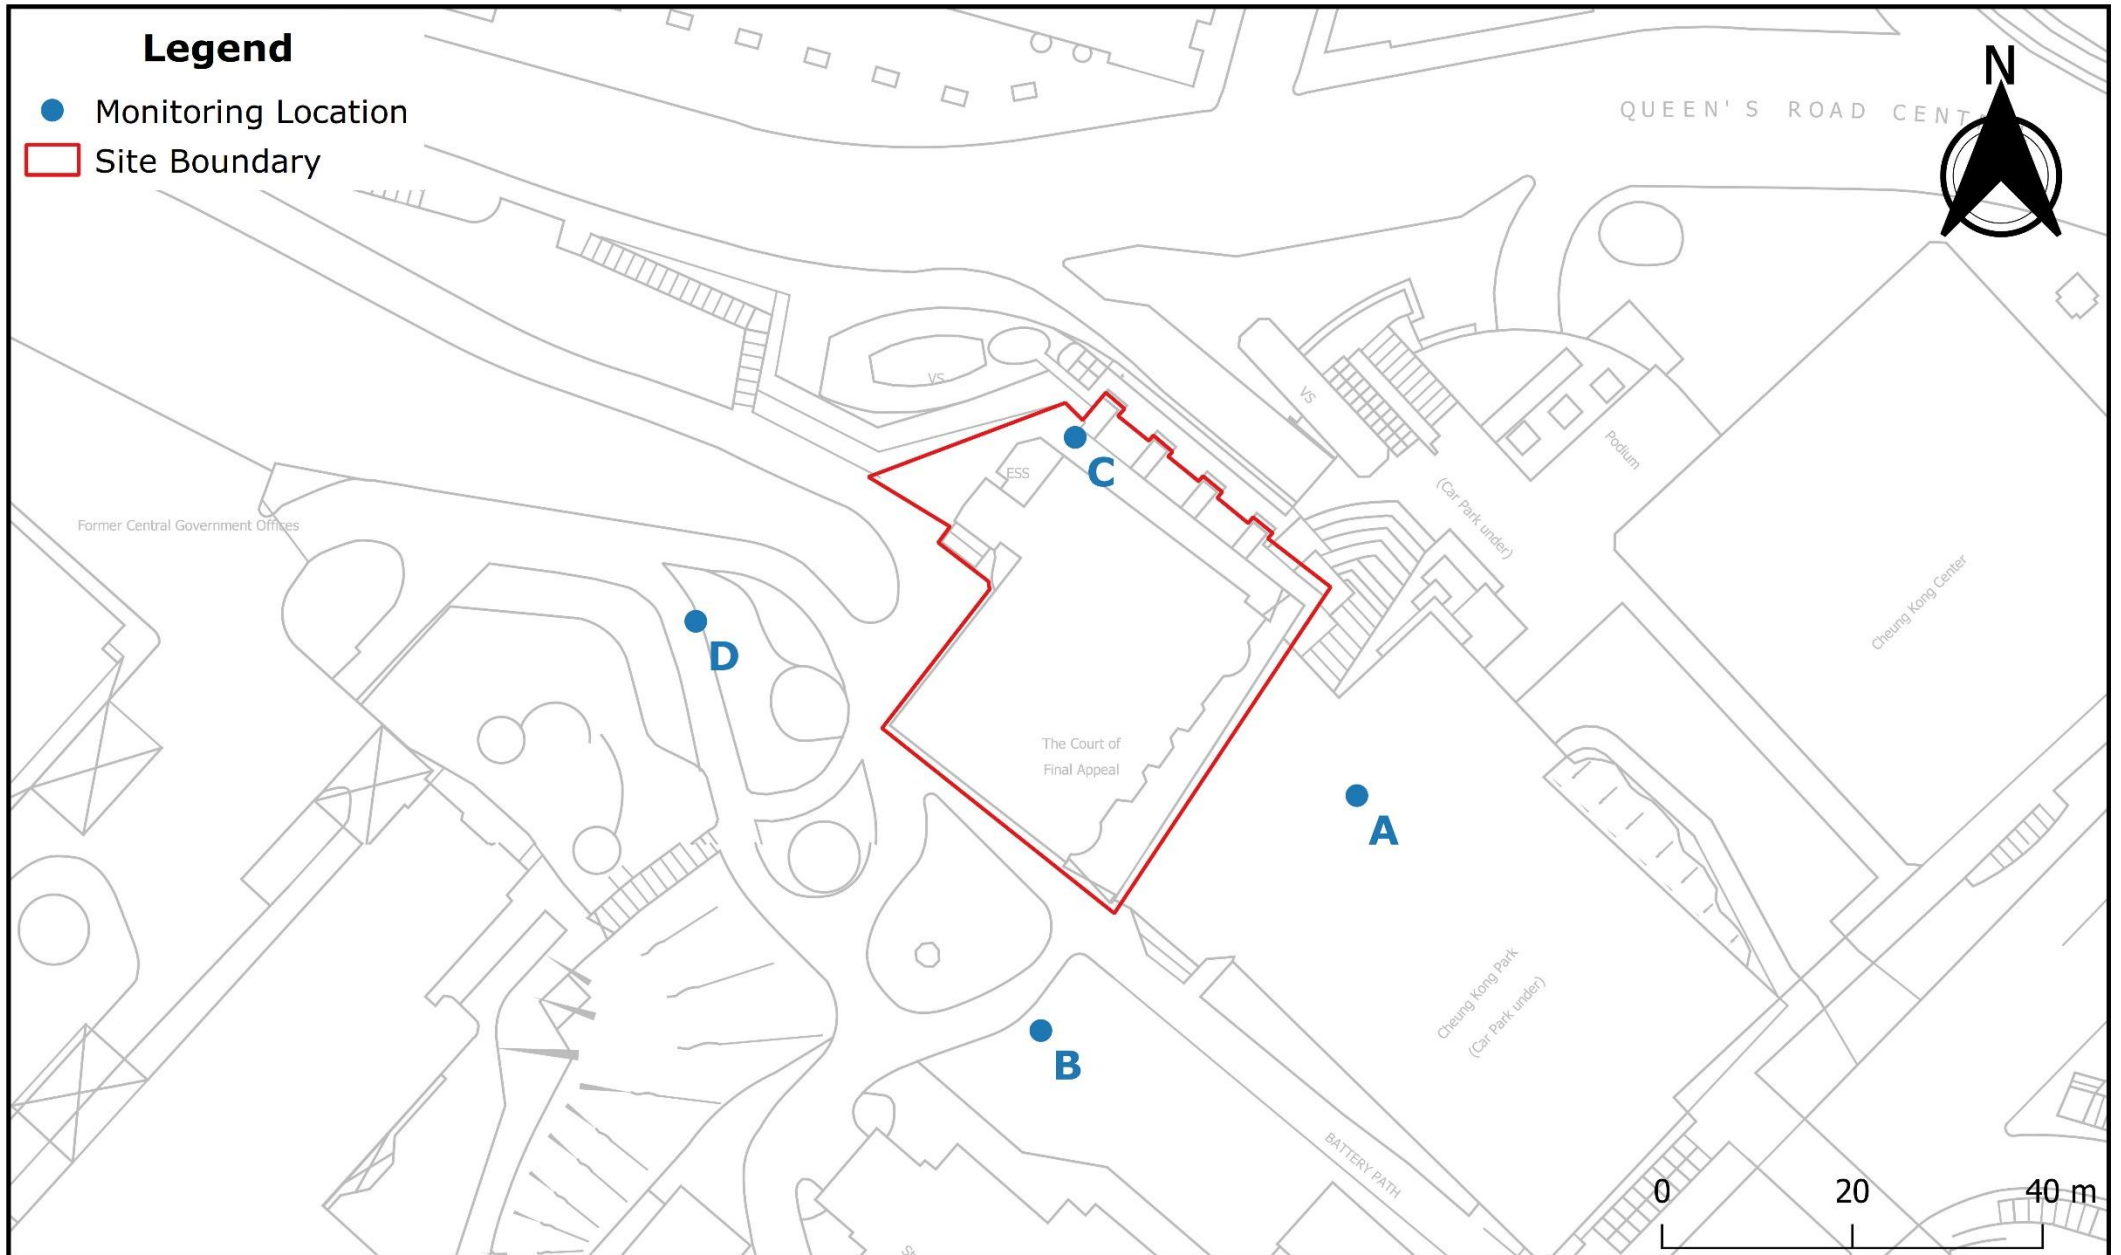
- 1.1.8 The site location of the Project is presented in **Figure 1**.

- 2.2.1 Four locations were proposed as the air quality and noise monitoring stations during the construction phase of the Project. **Table 2.2** summarizes the details of these monitoring stations.

Monitoring Station	Location	Type of Noise Monitoring Measurement
A	Cheung Kong Park	Free-field
B	Battery Path	Free-field
C	North corner of the Project site with the site boundary	Façade
D	West side of Battery Path	Free-field
