# Agreement No. CE 64/2020 (EP) Environmental Team for Tung Chung New Town Extension (West) – Design and Construction

Monthly Environmental Monitoring & Audit Report for June 2022

Environmental Permit No. EP-519/2016

**Tung Chung New Town Extension (West)**

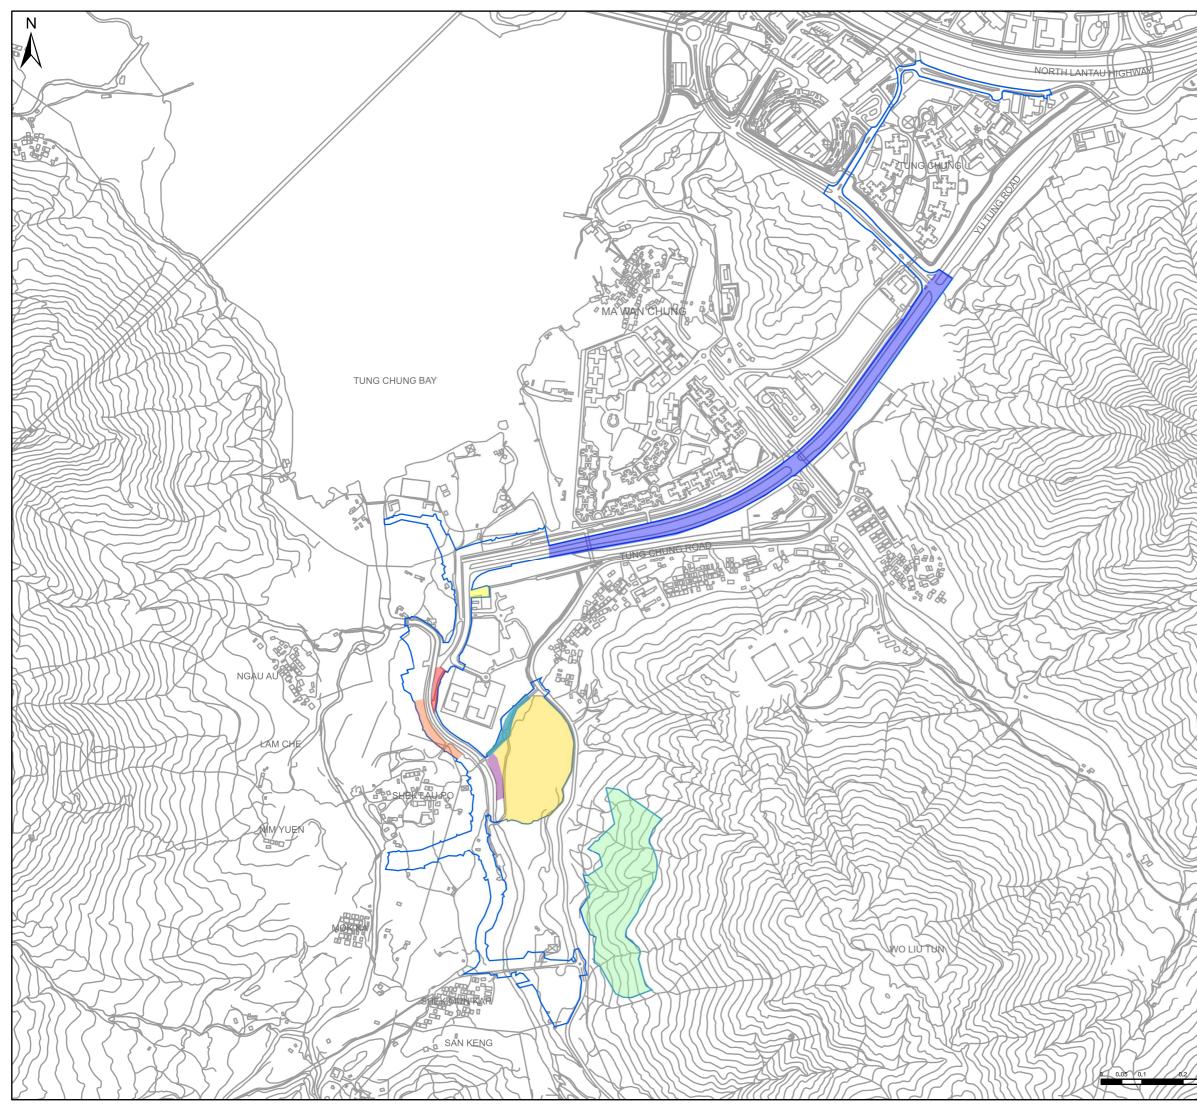
Key Plan: 1:140,000         Image: I
	Key to symbols:
	LEGEND
I A	PROJECT AREA
	YU TUNG ROAD
	AREA 42
	SEWAGE PUMPING STATION-A
	COMPENSATORY WOODLAND AREA
	ROAD L29
	ROAD L30
	VISITOR CENTRE
FT (   { { { { { { { { { } } } } } }	
2111492	
1 MARILE	P1         JUL 2021         KN         LL         TC
	Rev Date Drawn Description Ch'k'd App'd
	M 3/F International Trade Tower 348 Kwun Tung Road Kwun Tung, Kowloon Hong Kong T +852 2828 5757 T +852 2827 1823 W mottmac.com
AL	Client
	AGREEMENT NO. CE 64/2020(EP) ENVIRONMENTAL TEAM FOR TUNG CHUNG NEW TOWN EXTENSION (WEST) – DESIGN AND CONSTRUCTION
	Title
	Location of Contract No. NL/2020/06 ("Contract 6")
	Designed Eng check Drawn Coordination
NY CARANT	Dwg check Approved
kilometers	Drawing Number FIGURE 1.2

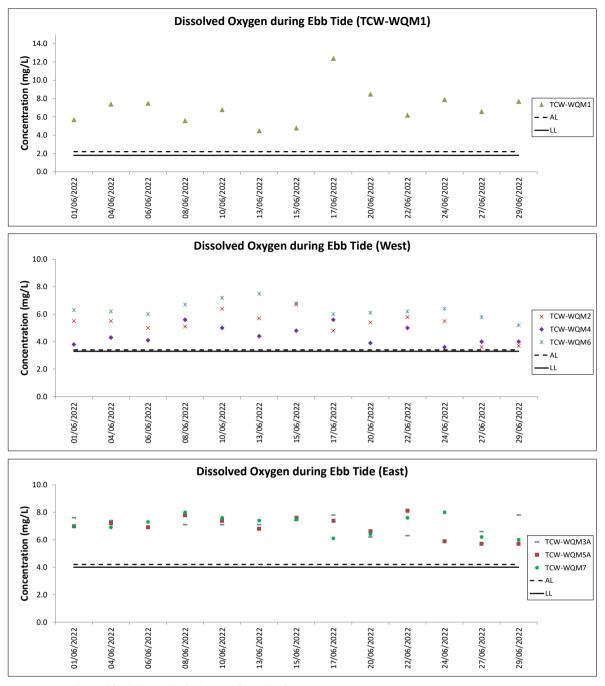
The Action and Limit Level of dissolved oxygen can be referred to Table 4.3 of the monthly EM&A report. Major site activities carried out during the reporting period are summarized in Section 1.4 of the monthly EM&A report. Weather conditions during monitoring are presented in the data tables above. QA/ QC requirements as stipulated in the EM&A Manual were carried out during measurement. Note:

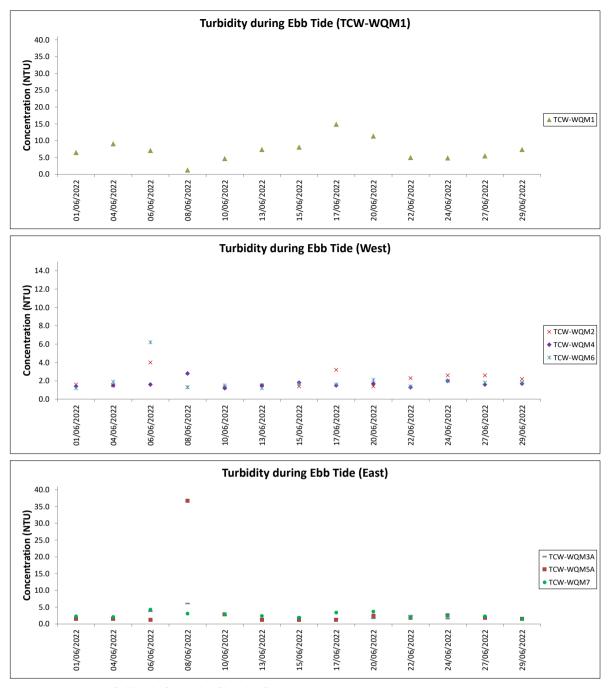
The Action and Limit Level of turbidity can be referred to Table 4.3 of the monthly EM&A report. Note: Major site activities carried out during the reporting period are summarized in Section 1.4 of the monthly EM&A report. Weather conditions during monitoring are presented in the data tables above. QA/ QC requirements as stipulated in the EM&A Manual were carried out during measurement.

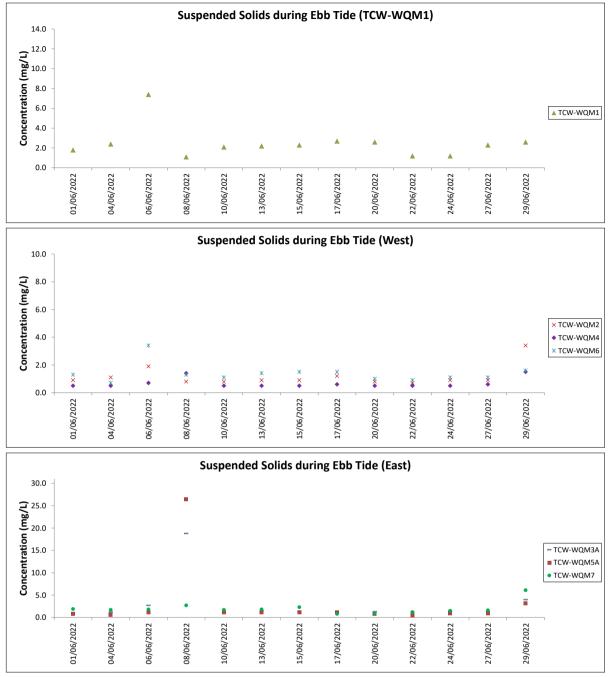
The Action and Limit Level of suspended solids can be referred to Table 4.3 of the monthly EM&A report. Major site activities carried out during the reporting period are summarized in Section 1.4 of the monthly EM&A report. Weather conditions during monitoring are presented in the data tables above. QA/ QC requirements as stipulated in the EM&A Manual were carried out during measurement. Note
