**Agreement No. CE 64/2020 (EP)
Environmental Team for
Tung Chung New Town
Extension (West) –
Design and Construction**

Monthly Environmental Monitoring & Audit Report
for February 2022

March 2022

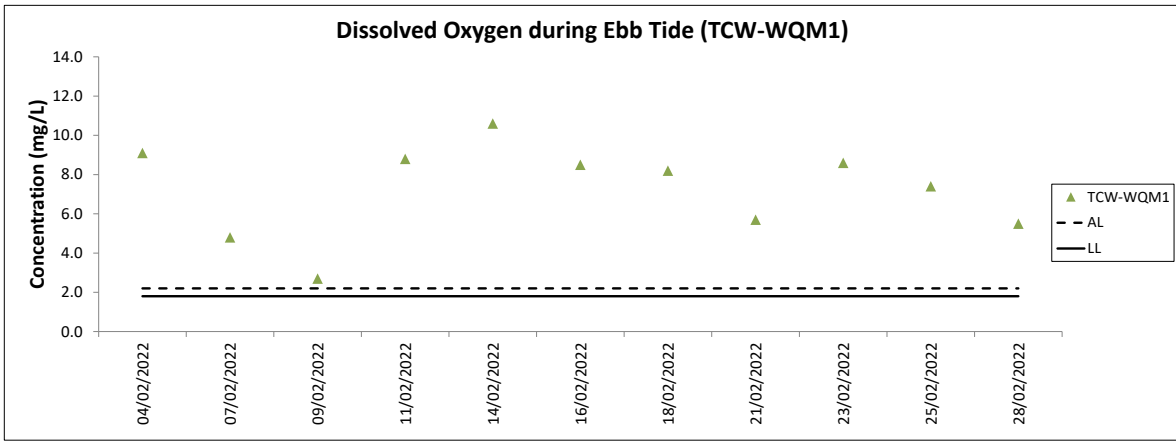
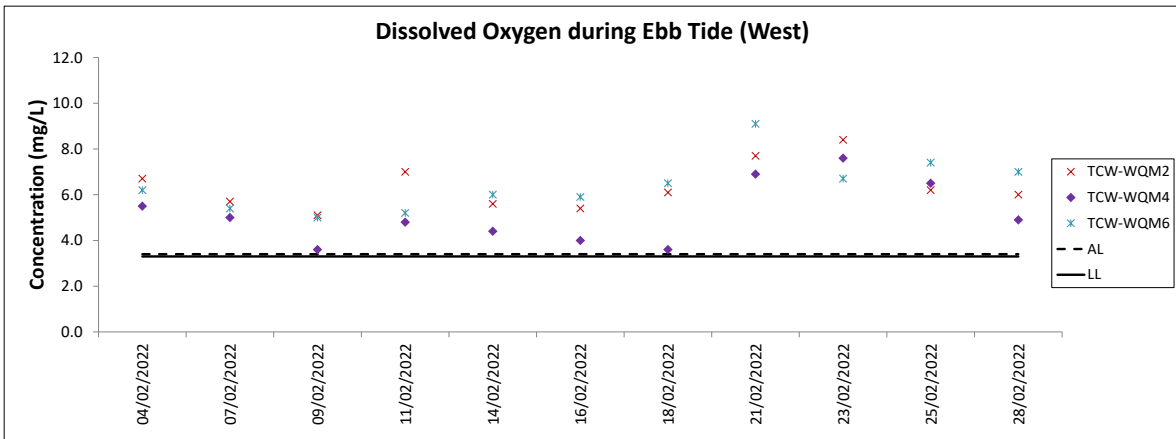
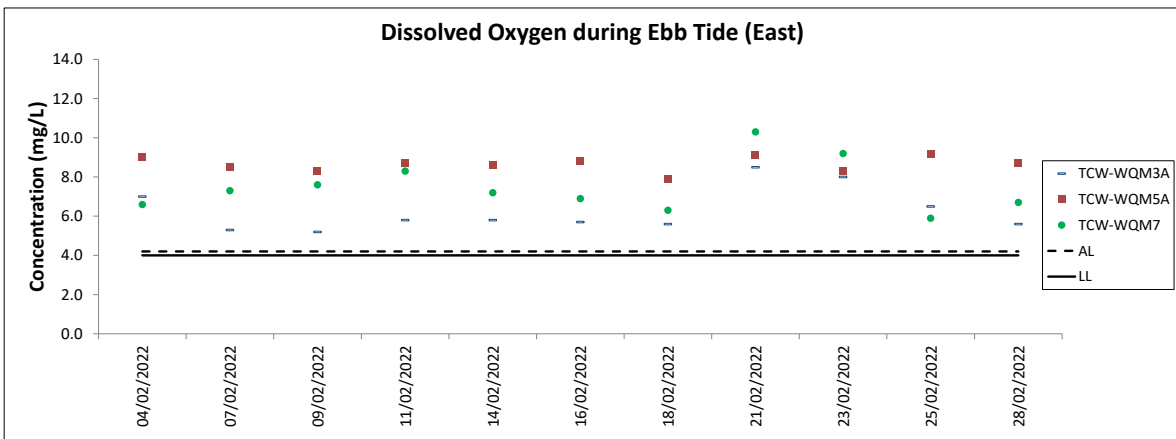
H4. Water Quality Monitoring Results

Note: The Action and Limit Level of dissolved oxygen can be referred to Table 4.3 of the monthly EM&A report.
 Major site activities carried out during the reporting period are summarized in Section 1.4 of the monthly EM&A report.
 Weather conditions during monitoring are presented in the data tables above.
 QA/ QC requirements as stipulated in the EM&A Manual were carried out during measurement.

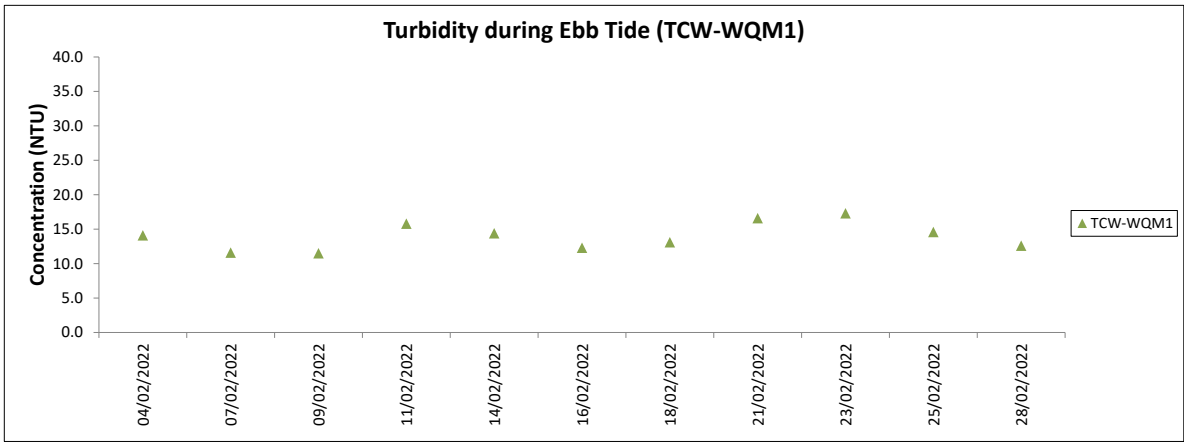
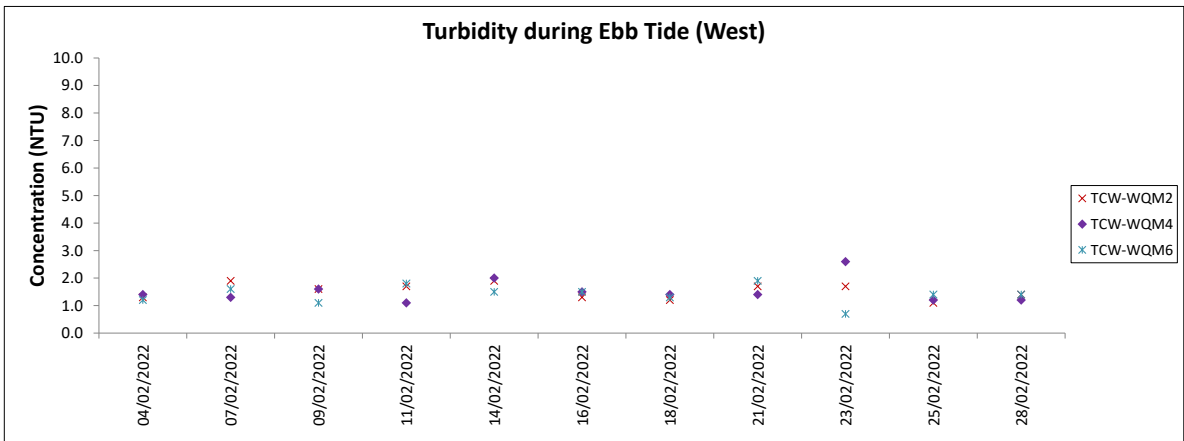
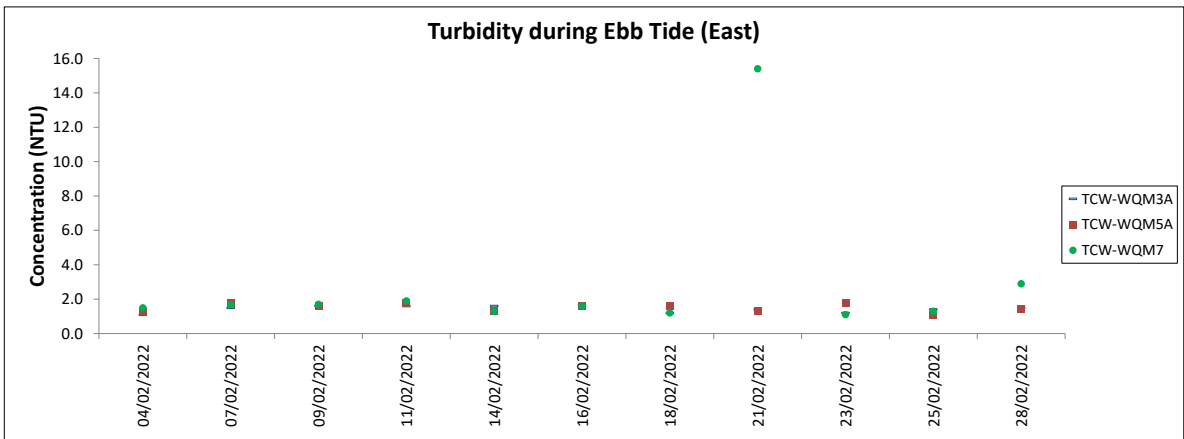
Note: The Action and Limit Level of turbidity can be referred to Table 4.3 of the monthly EM&A report.
 Major site activities carried out during the reporting period are summarized in Section 1.4 of the monthly EM&A report.
 Weather conditions during monitoring are presented in the data tables above.
 QA/ QC requirements as stipulated in the EM&A Manual were carried out during measurement.

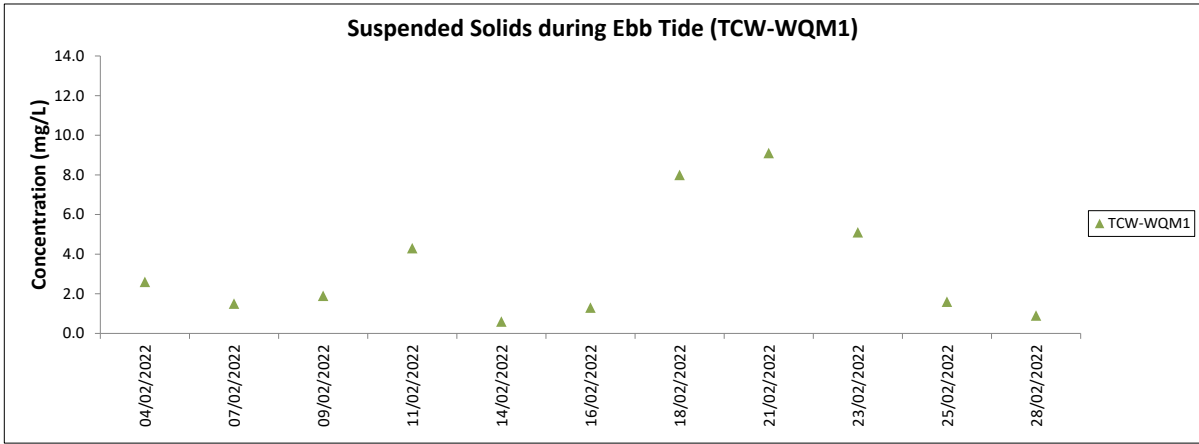
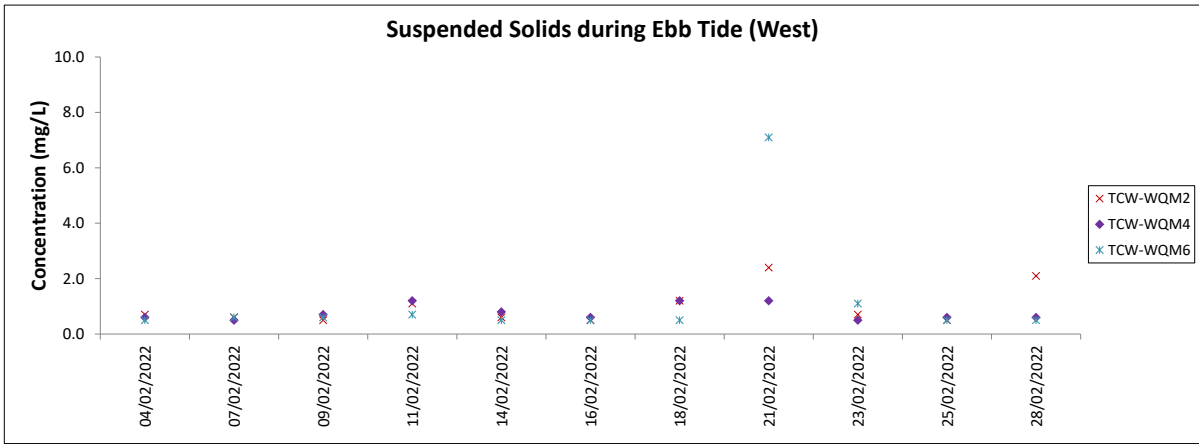
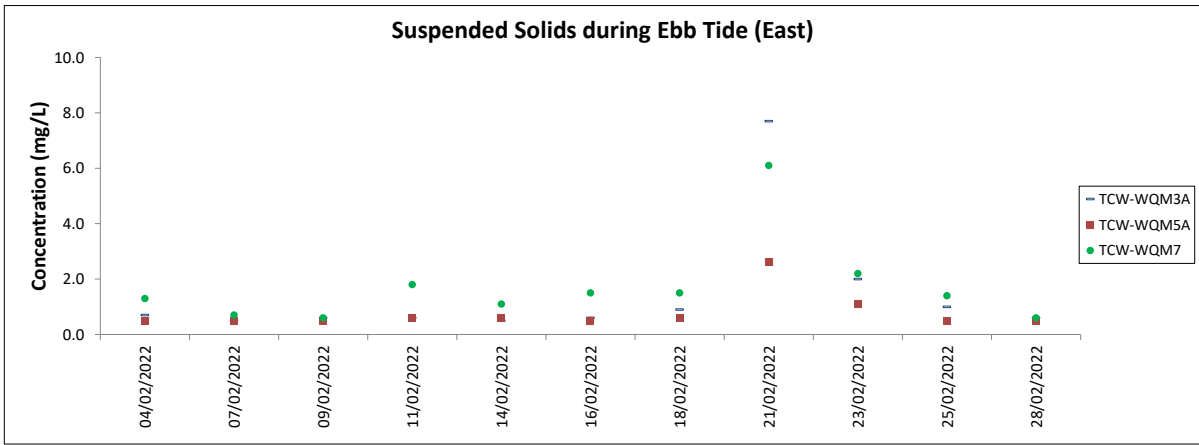
Note: The Action and Limit Level of suspended solids can be referred to Table 4.3 of the monthly EM&A report.
 Major site activities carried out during the reporting period are summarized in Section 1.4 of the monthly EM&A report.
 Weather conditions during monitoring are presented in the data tables above.
 QA/ QC requirements as stipulated in the EM&A Manual were carried out during measurement.
