Agreement No. CE 64/2020 (EP) Environmental Team for Tung Chung New Town Extension (West) – Design and Construction

Monthly Environmental Monitoring & Audit Report for August 2022

Tung Chung New Town Extension (West)

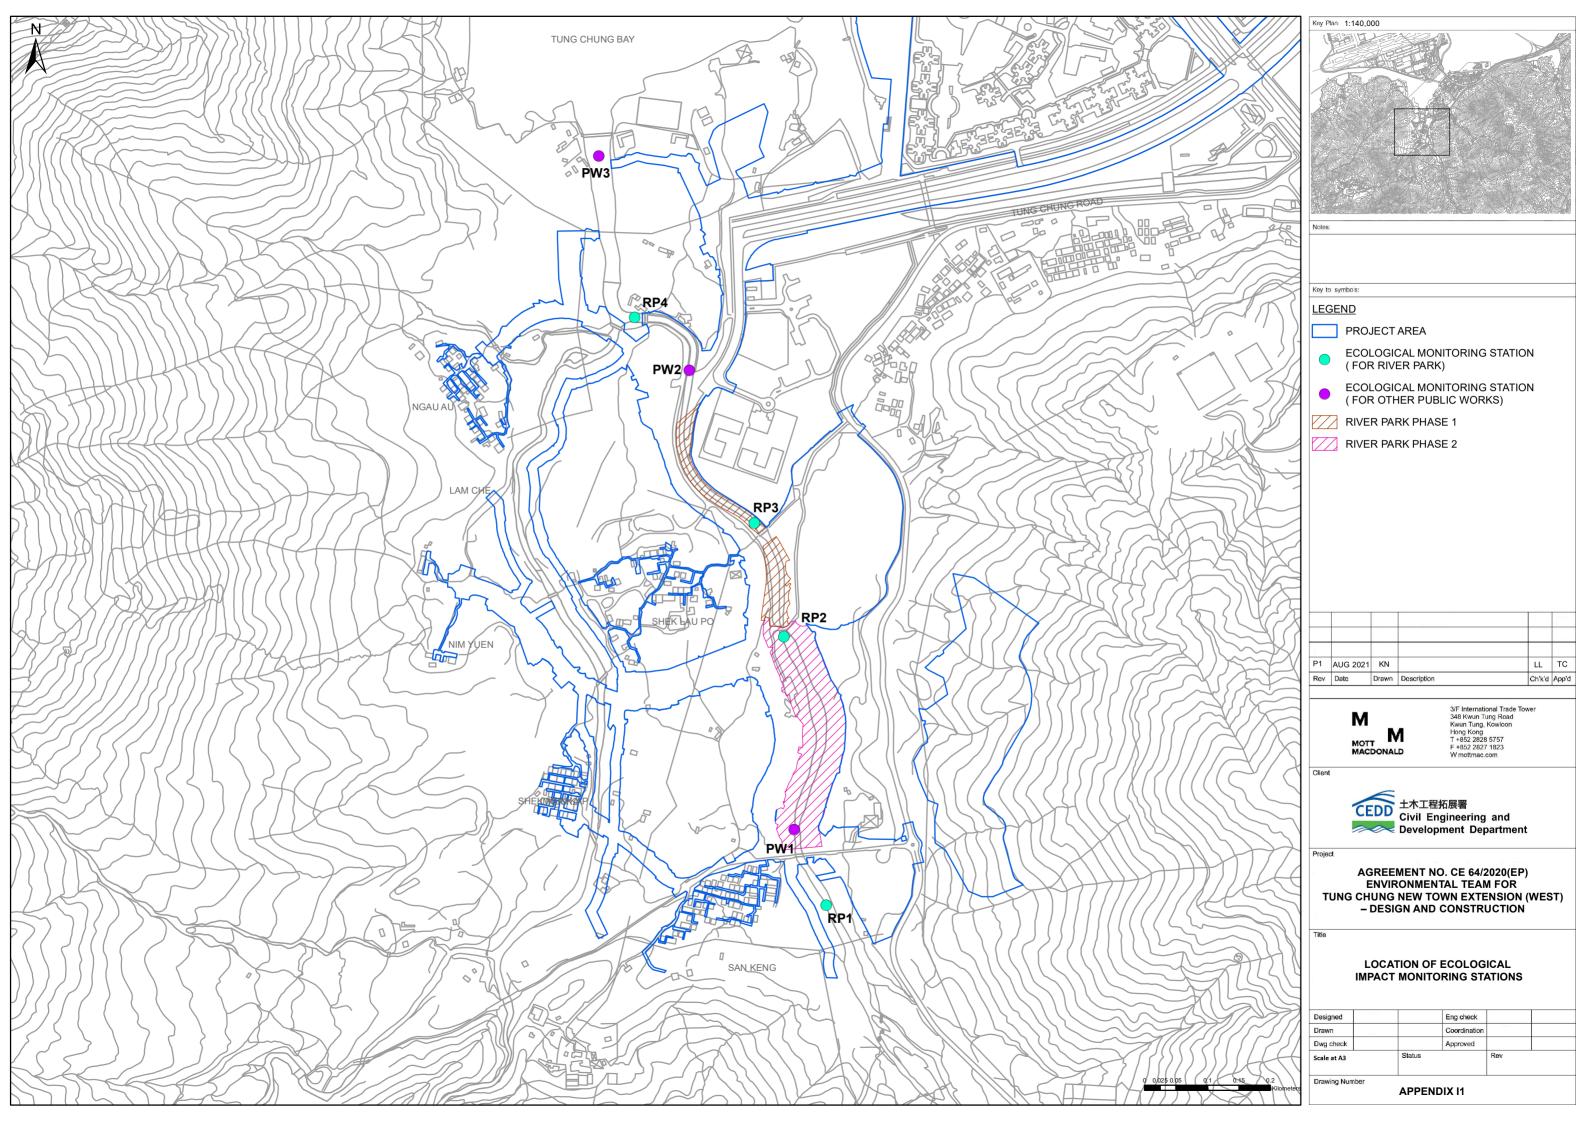
I1. Location of Ecological Impact Monitoring Stations

The locations of the monitoring stations are presented in **Table 5.1** and **Appendix I1**. Note that the exact monitoring locations were subject to fine adjustment based on site conditions (e.g. adverse weather conditions, blockage by plants, rocks or other obstacles).
