Agreement No. CE 60/2017 (EP)

Environmental Team for Tung Chung New Town Extension (East) - Design and Construction

**Monthly Environmental Monitoring & Audit Report
for June 2023**

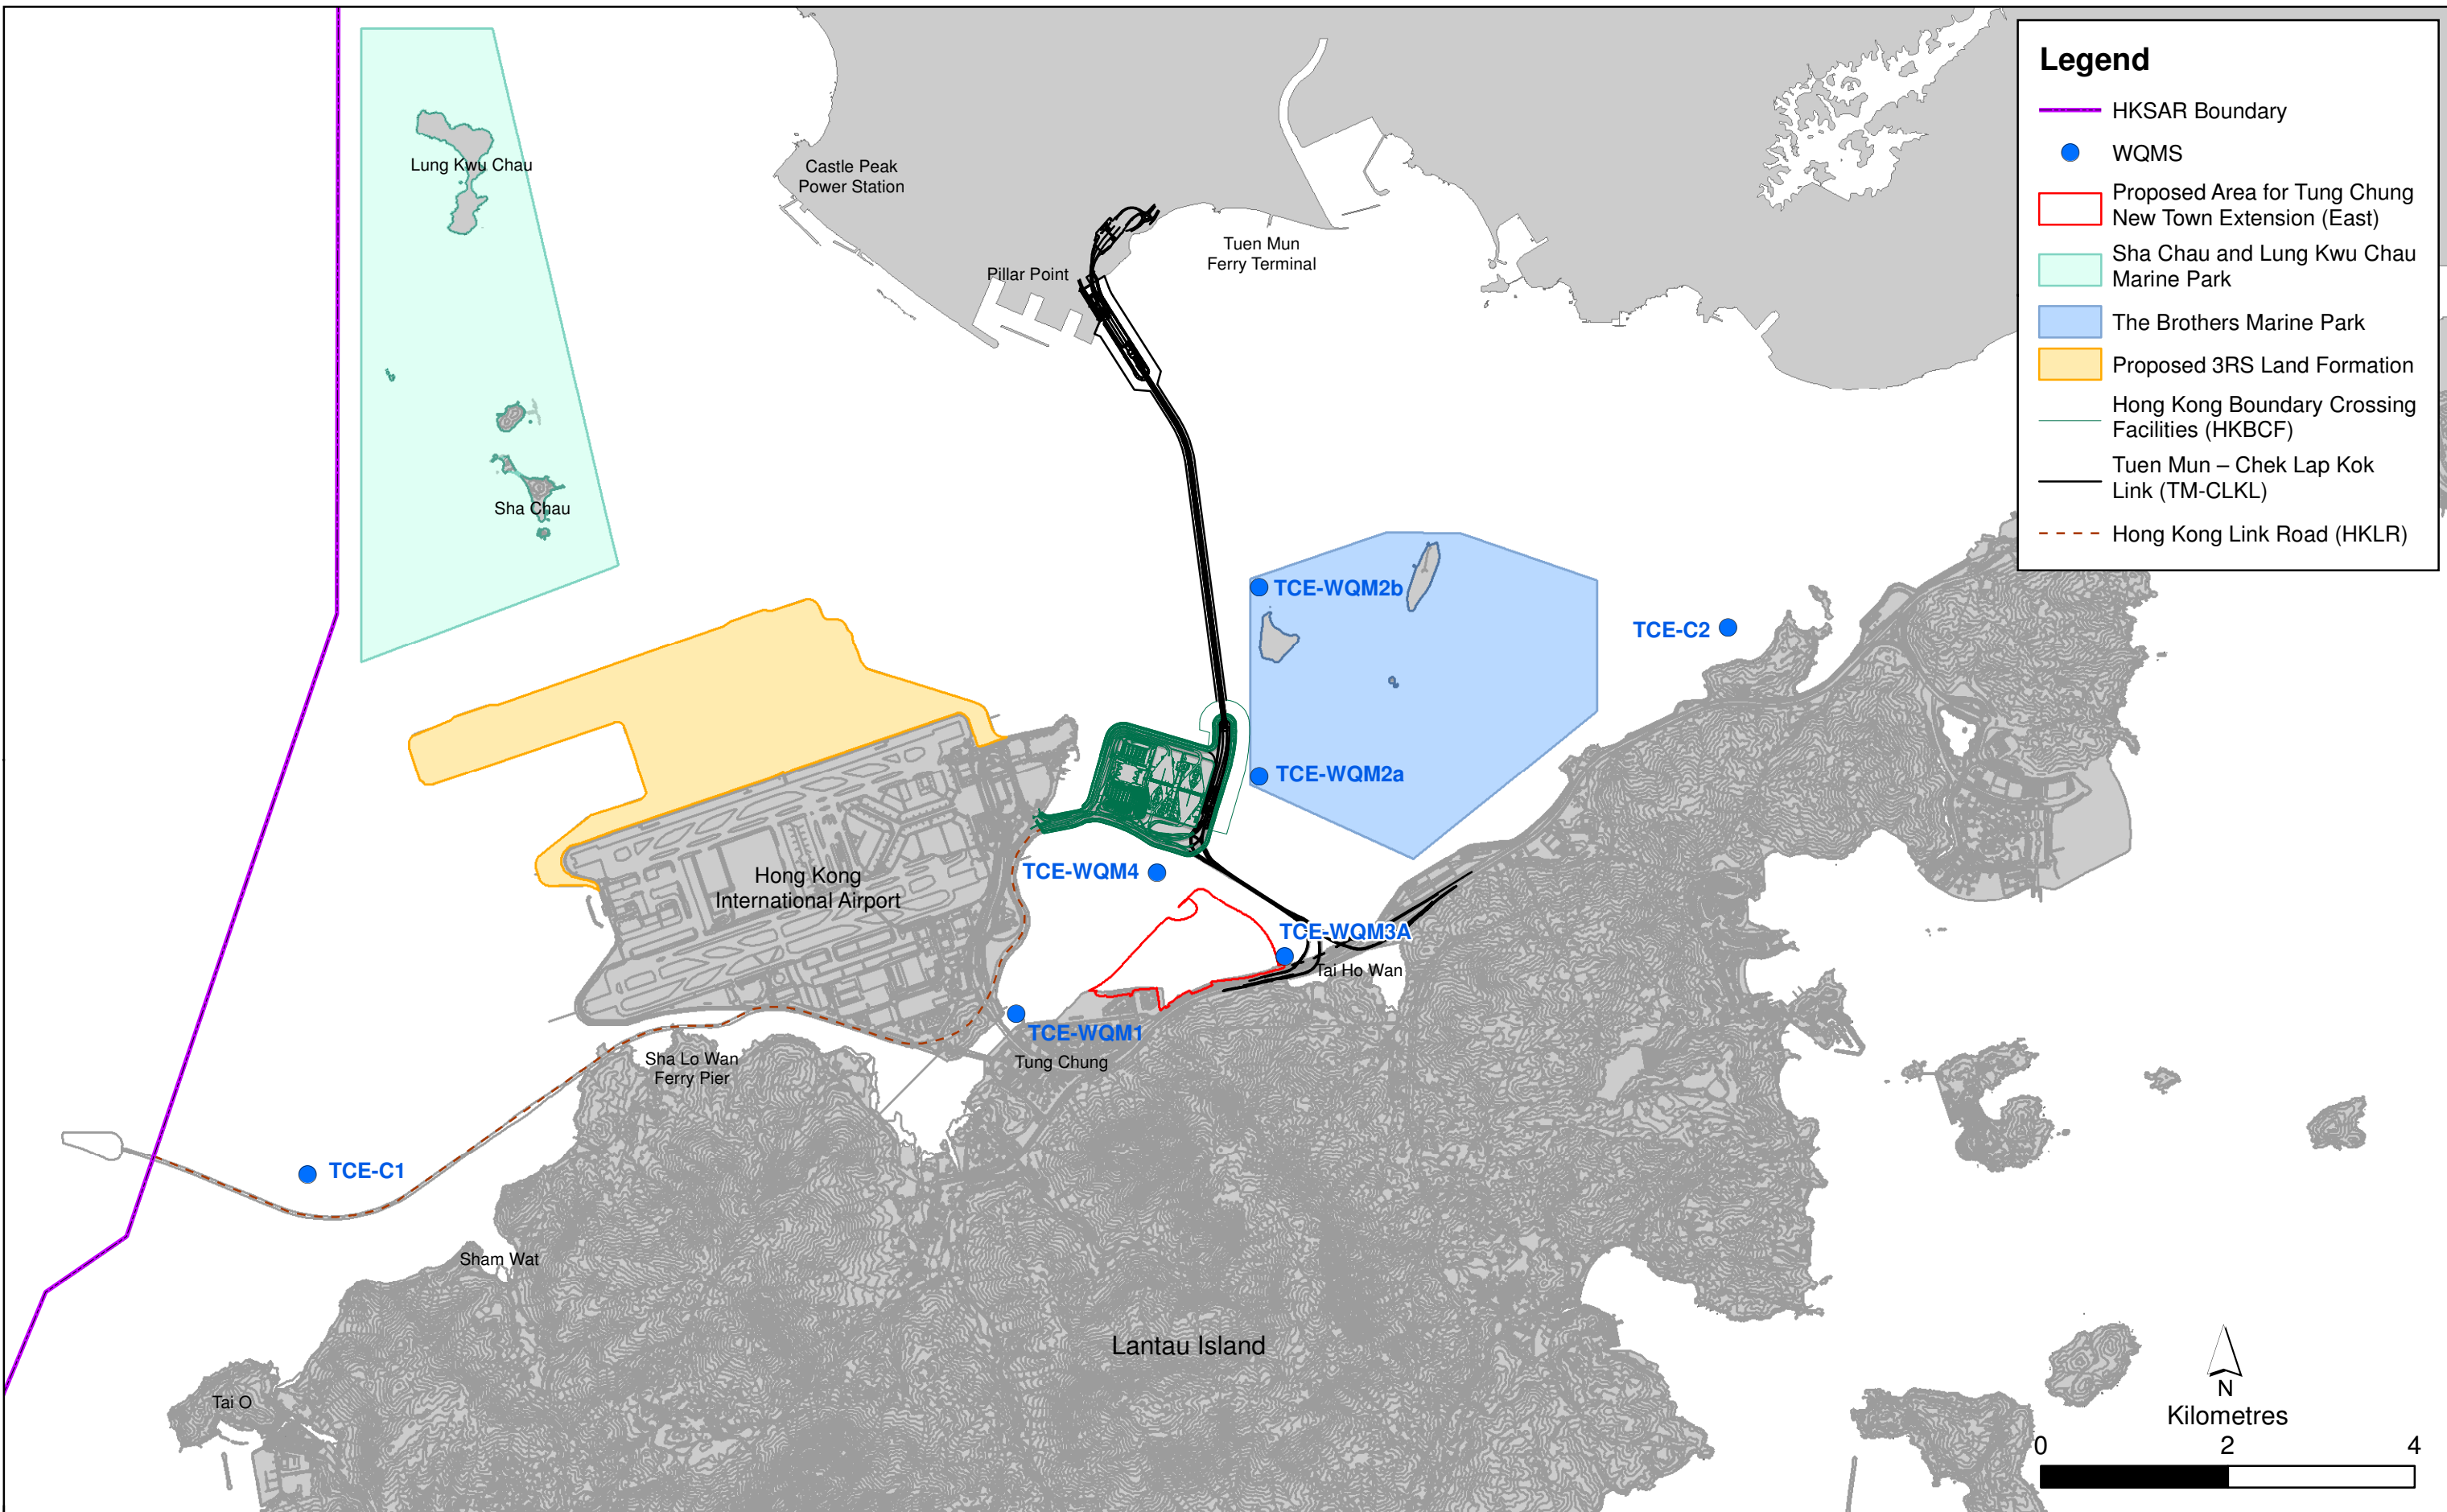
Figure 2.3

Water Quality Monitoring Locations

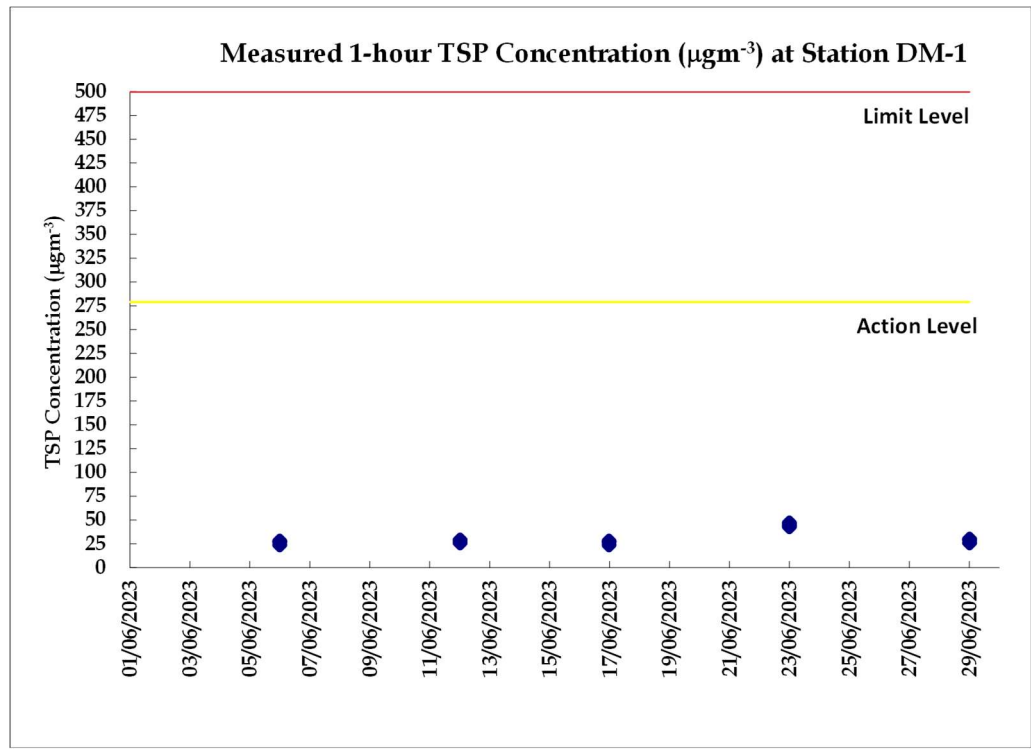
Figure E3 Graphical Presentation for 1-hr TSP Monitoring at Station DM-1

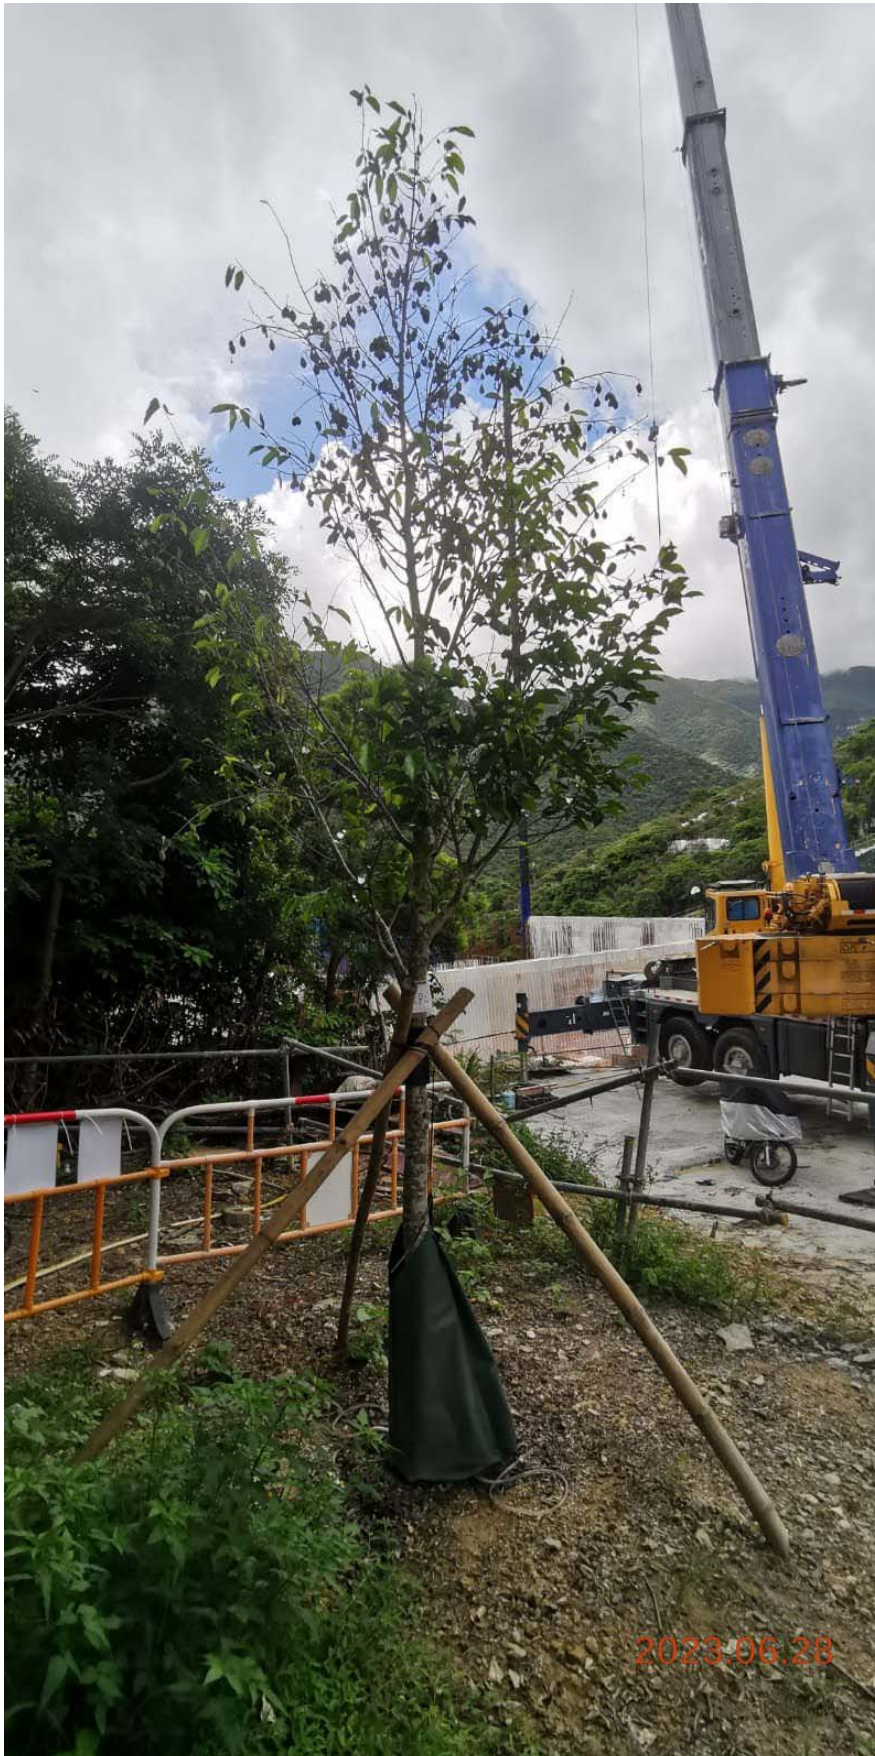
Monitoring of the replacement planting of *Aquilaria sinensis* was carried out on 28 June 2023. Two (2) individuals of the replacement planting trees were in fair health condition while one (1) individual was in poor health condition with no signs of blooming. Photographic record of *Aquilaria sinensis* monitoring are provided in *Annex I2*.

The transplanted plant species of conservation importance were watered twice a week to keep the soil moist except in days with heavy rainfall. The ET will continue to monitor the implementation of monitoring of *in-situ* preserved/transplanted plant species of conservation importance.
