Agreement No. CE 60/2017 (EP)

Environmental Team for Tung Chung New Town Extension (East) - Design and Construction

**Monthly Environmental Monitoring & Audit Report
for July 2023**

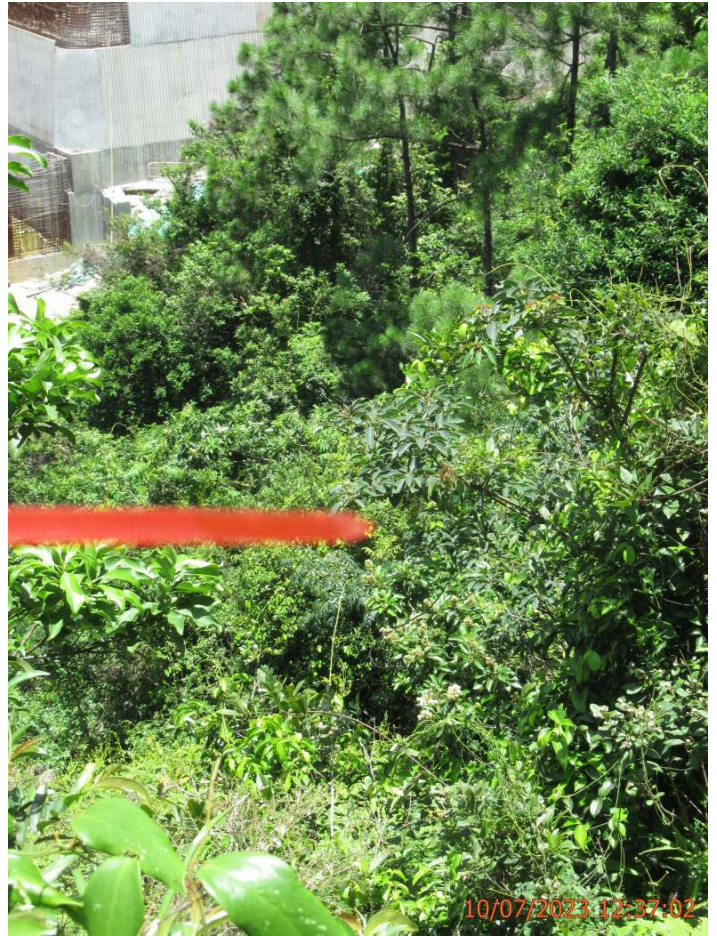
G01_39-R01_Inaccessible

importance, of which two individuals of *Gmelina chinensis* could not be monitored as a result of unsafe access to the locations, as recorded during the monitoring carried out on 10 July 2023.

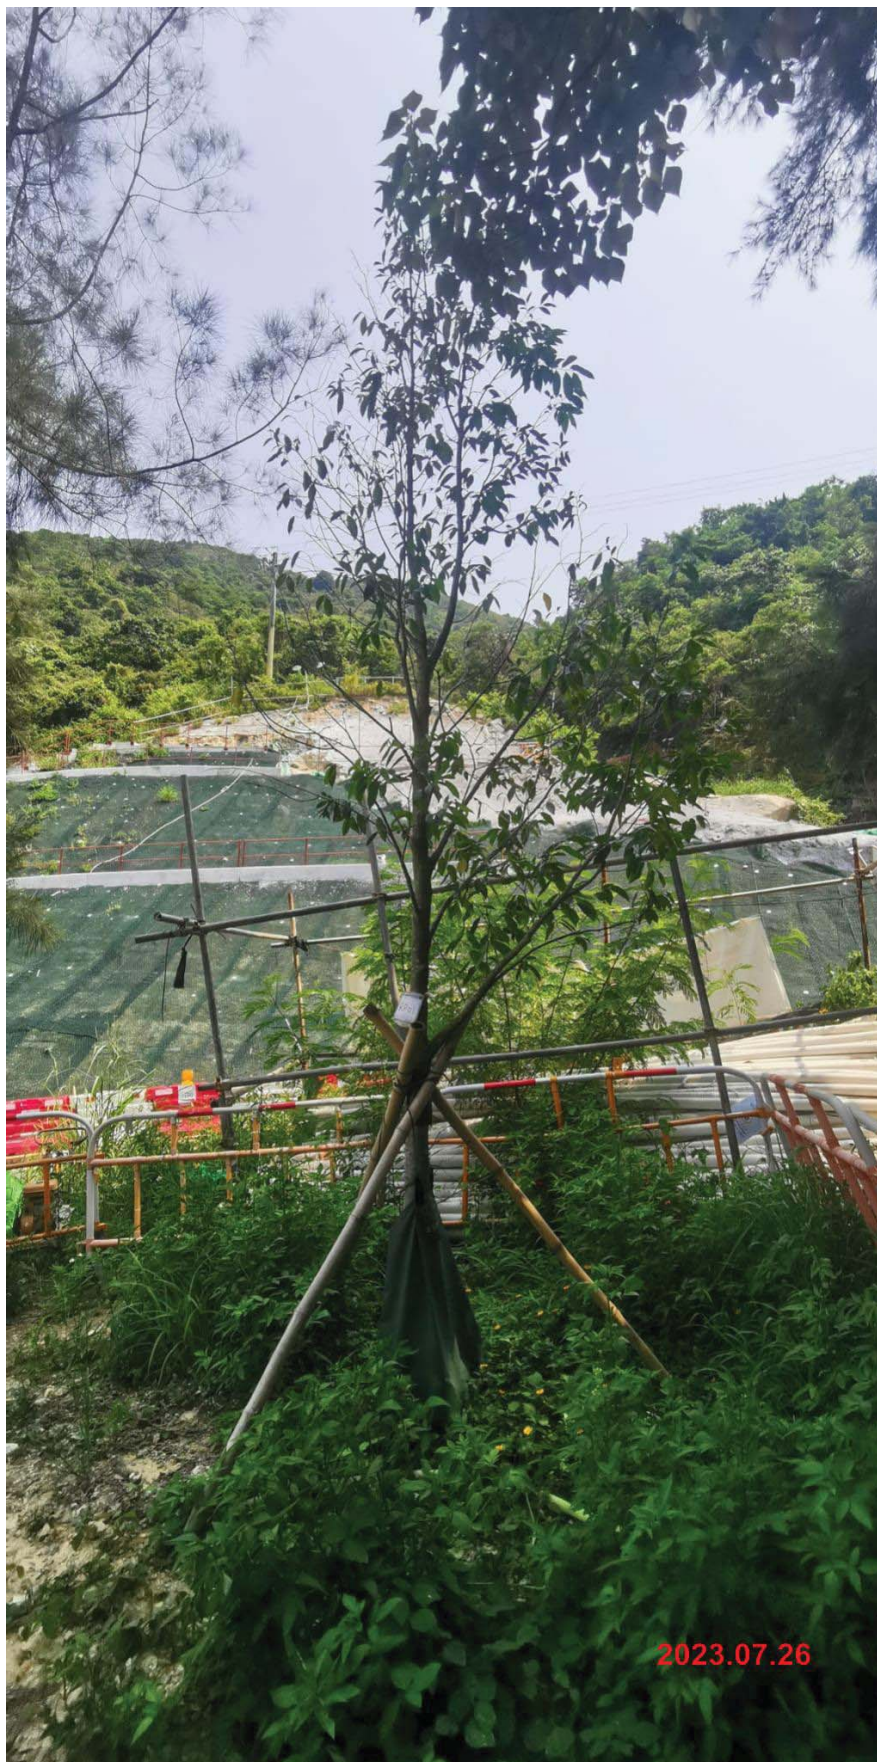
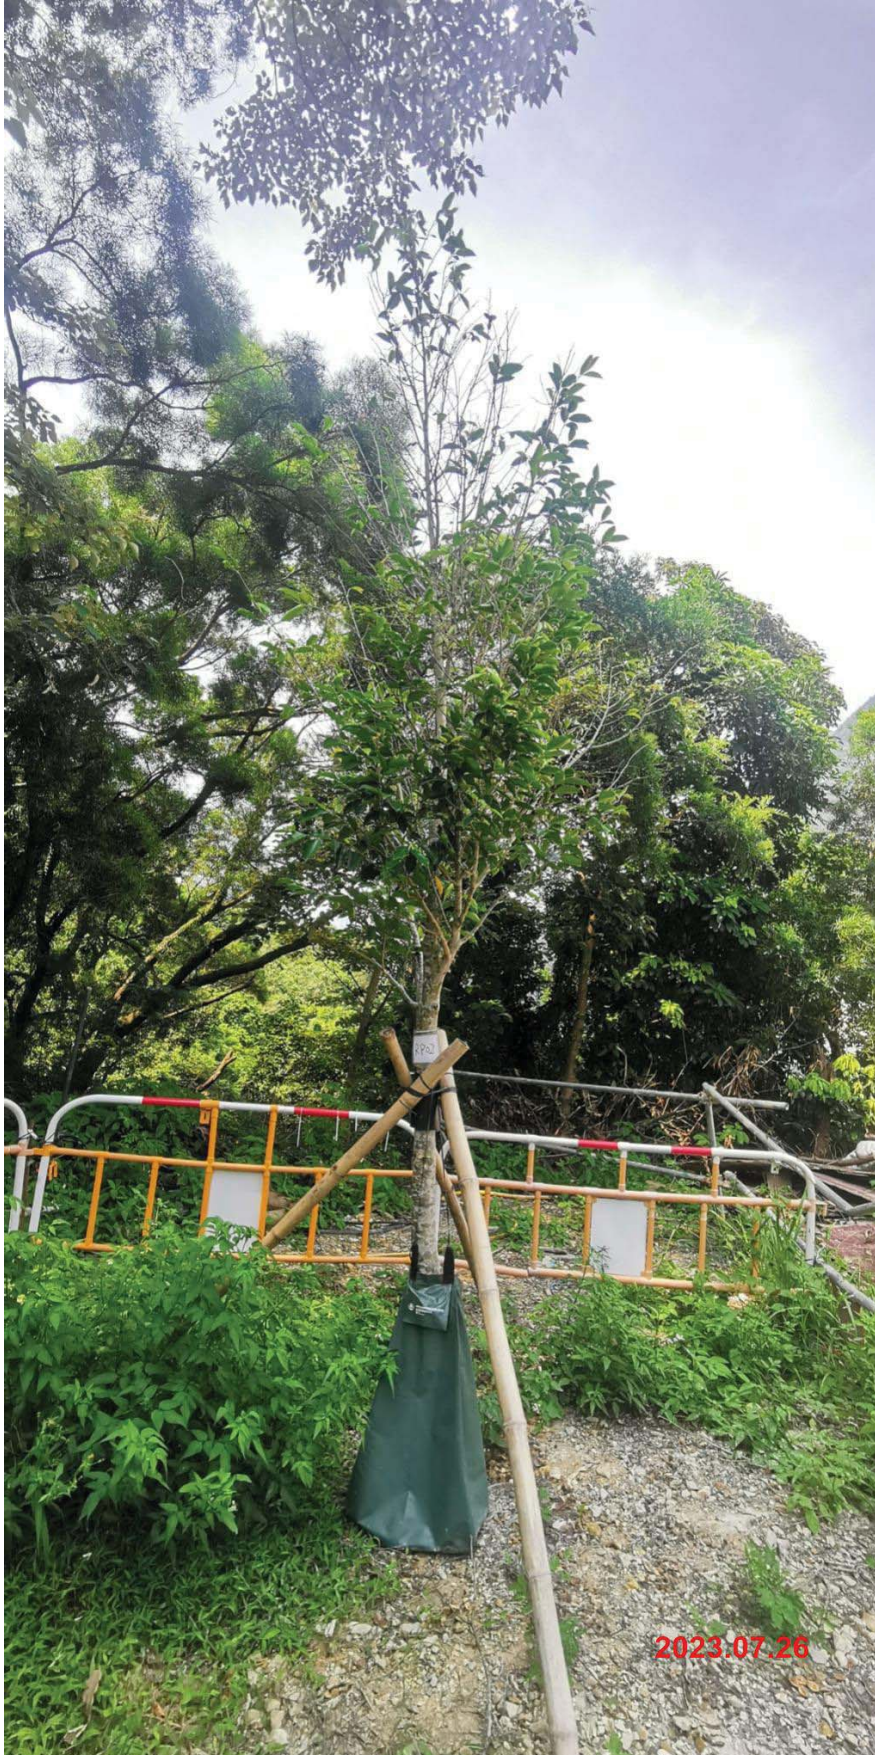
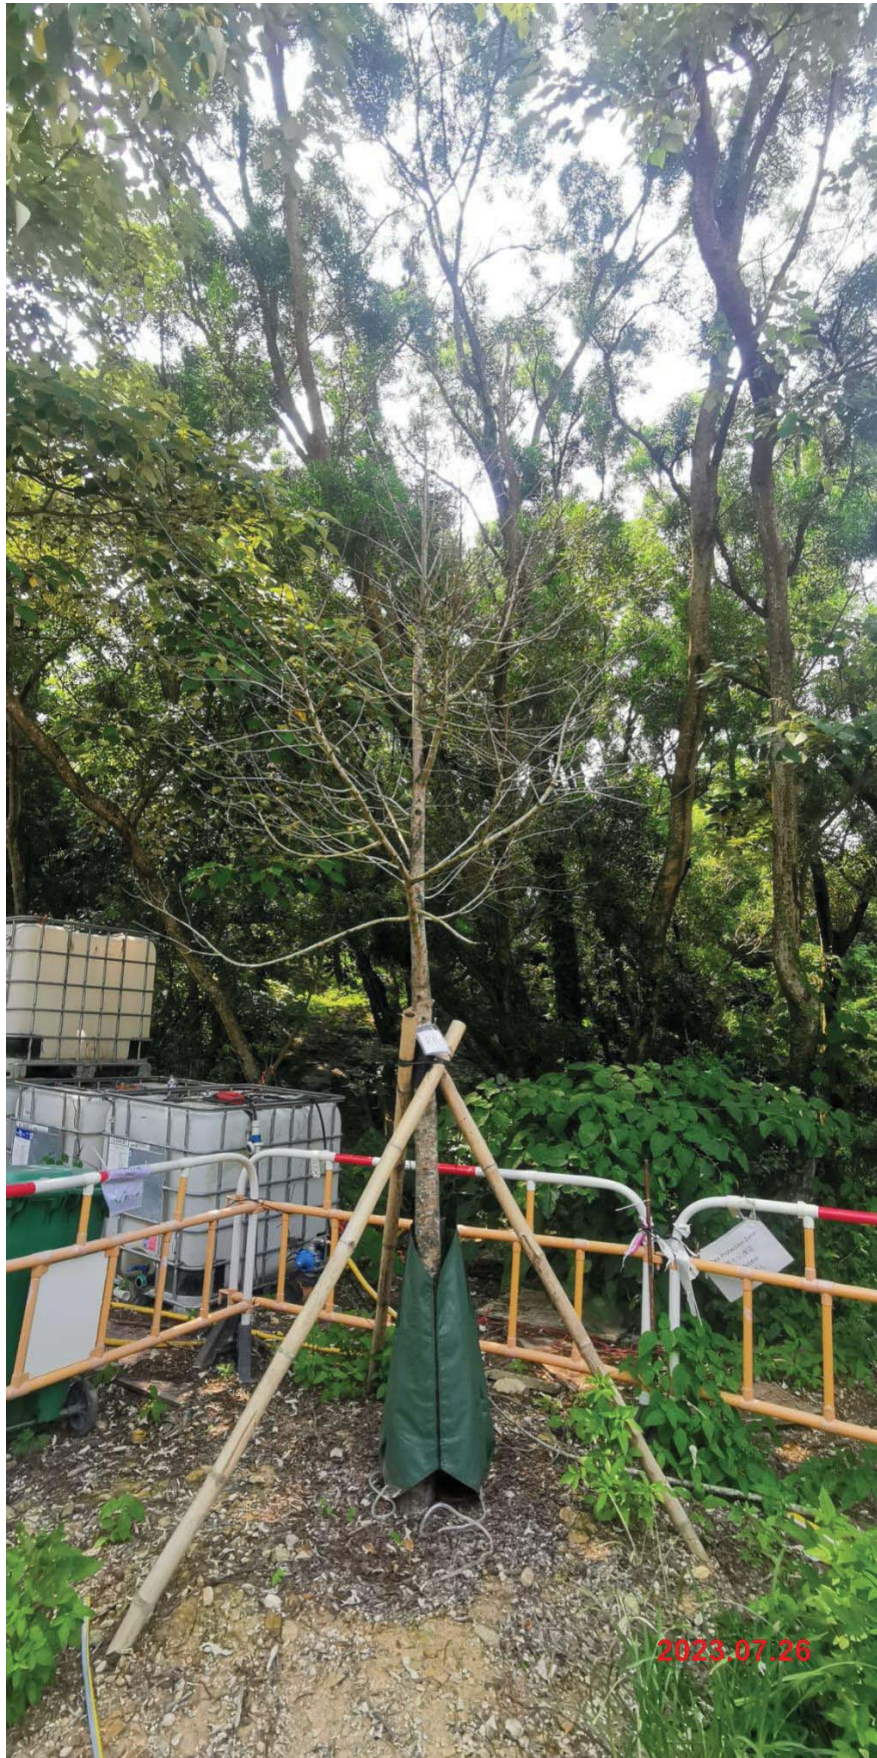
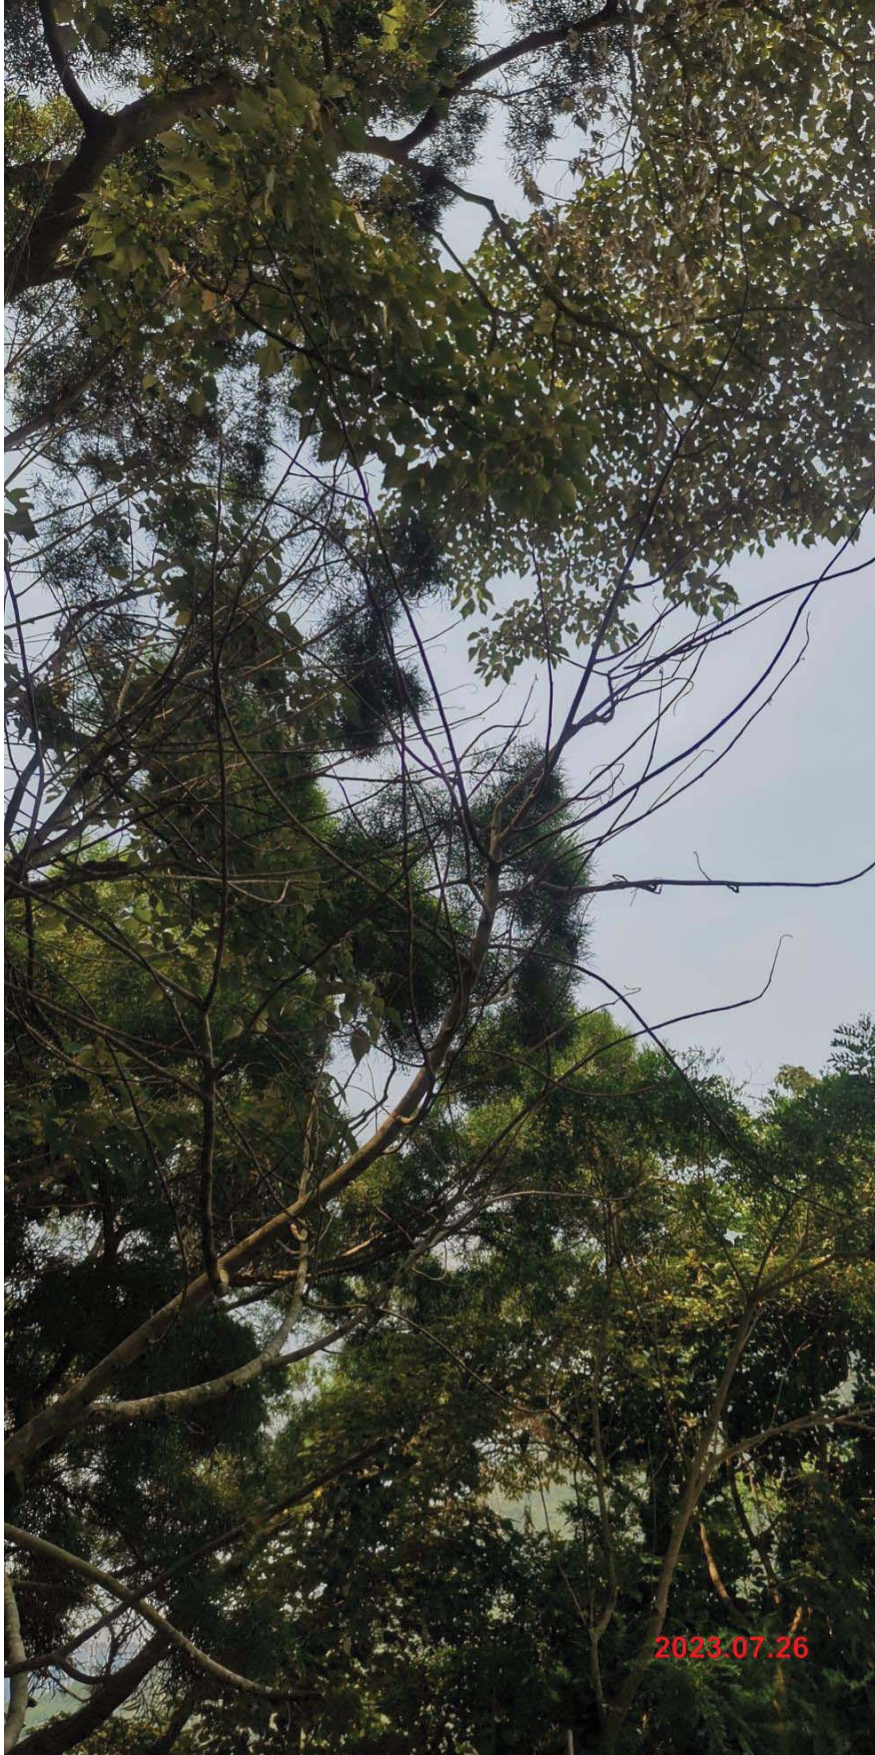
Monitoring of the replacement planting of *Aquilaria sinensis* was carried out on 26 July 2023. Two (2) individuals of the replacement planting trees were in fair health condition while one (1) individual was certified dead by the QP as no living signs were observed. Removal of the dead tree and replacement planting of new tree will be arranged accordingly. Photographic record of *Aquilaria sinensis* monitoring are provided in *Annex I2*.

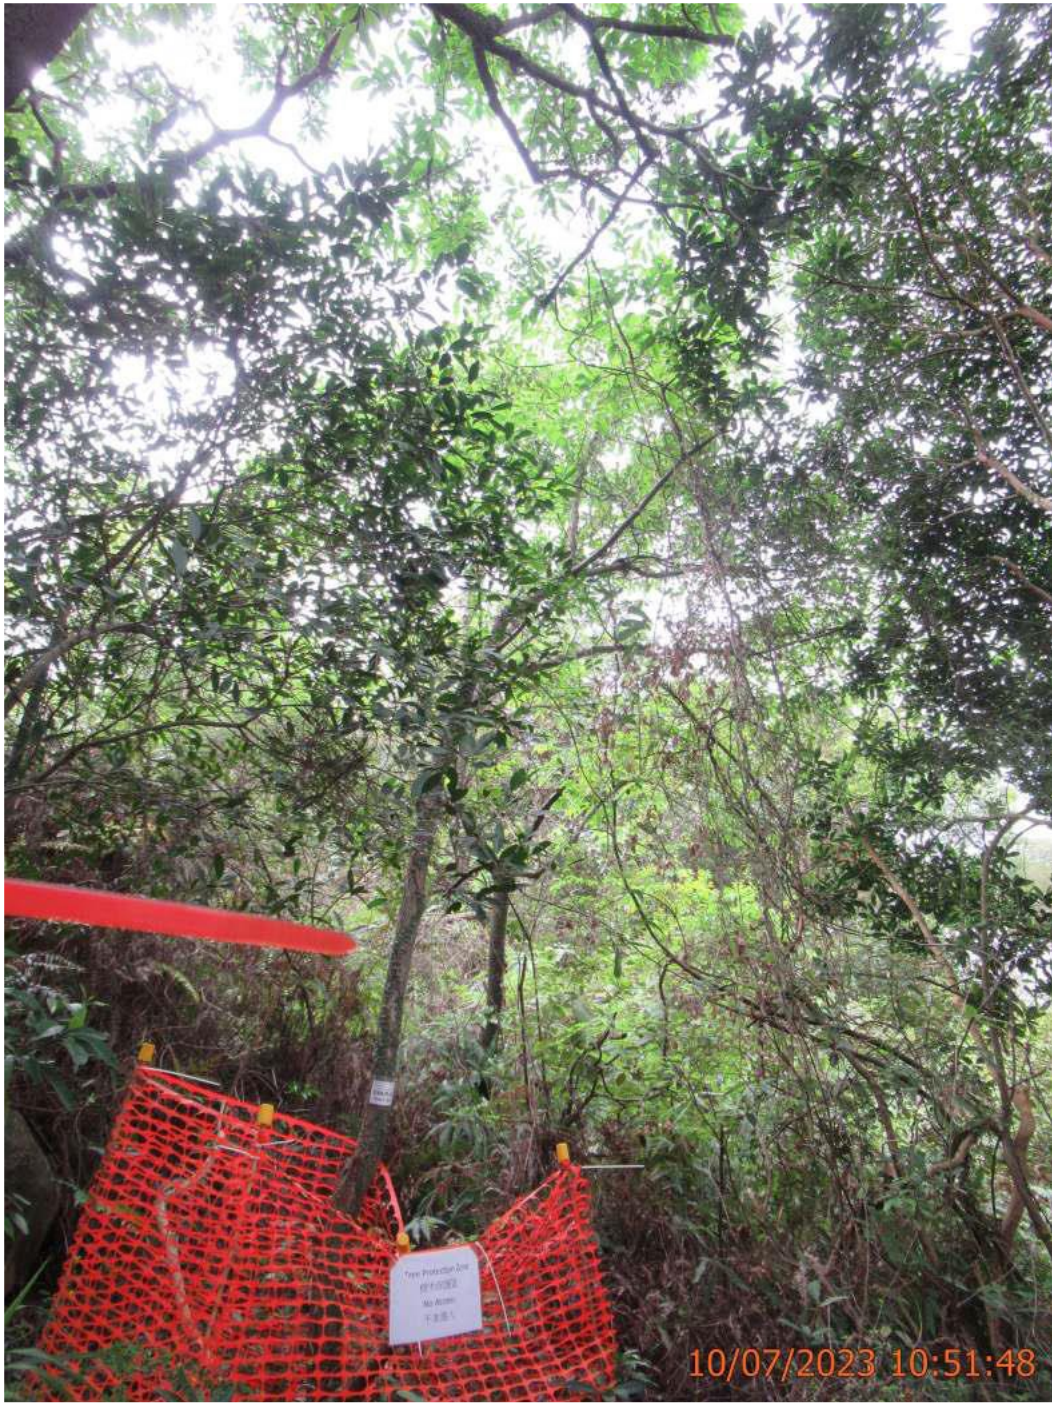
Photo 1 - Tree protection zone for preserved plant species of conservation importance

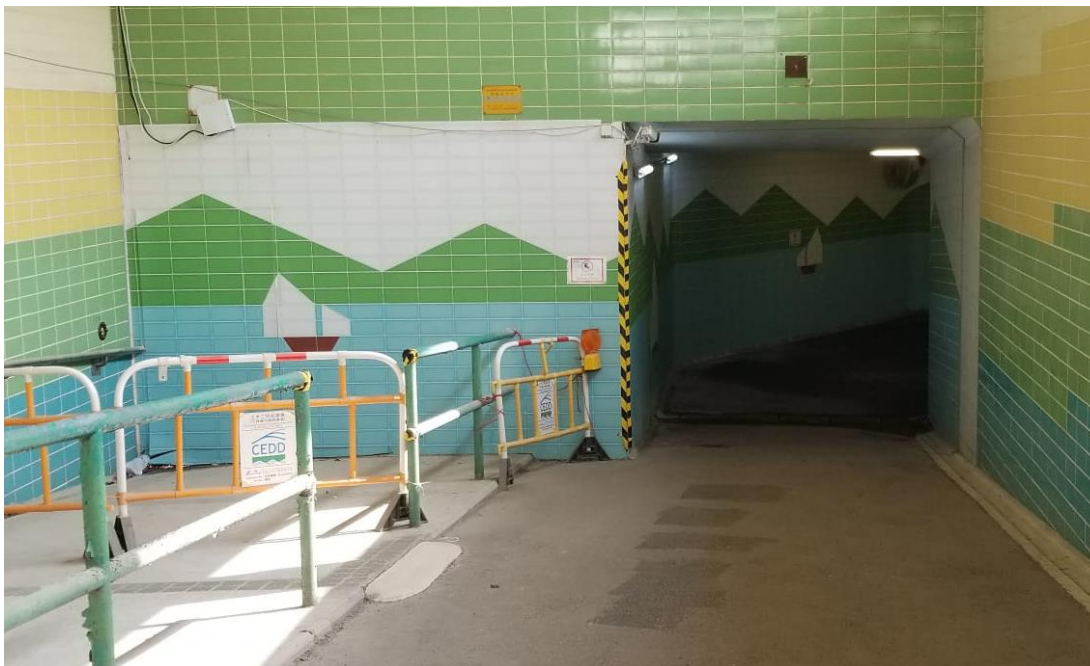
Photo 3 – Erection of site hoardings in unobtrusive colours

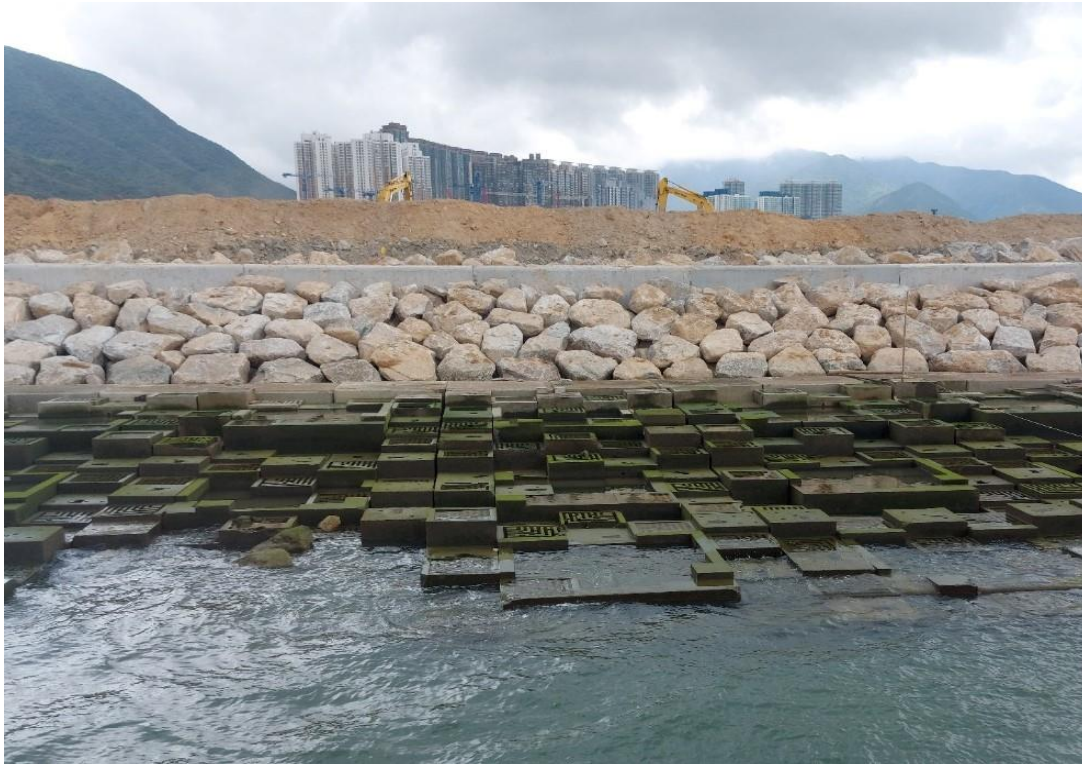
Photo 4 – Natural Rock Material/Planting for Artificial Seawall
