**ENVIRONMENTAL TEAM FOR  
RELOCATION OF SHA TIN SEWAGE TREATMENT  
WORKS TO CAVERNS – SITE PREPARATION  
AND ACCESS TUNNEL CONSTRUCTION**

**UNDER ENVIRONMENTAL PERMIT NO. EP-533/2017**

**MONTHLY ENVIRONMENTAL MONITORING & AUDIT  
REPORT**

**AUGUST 2019**

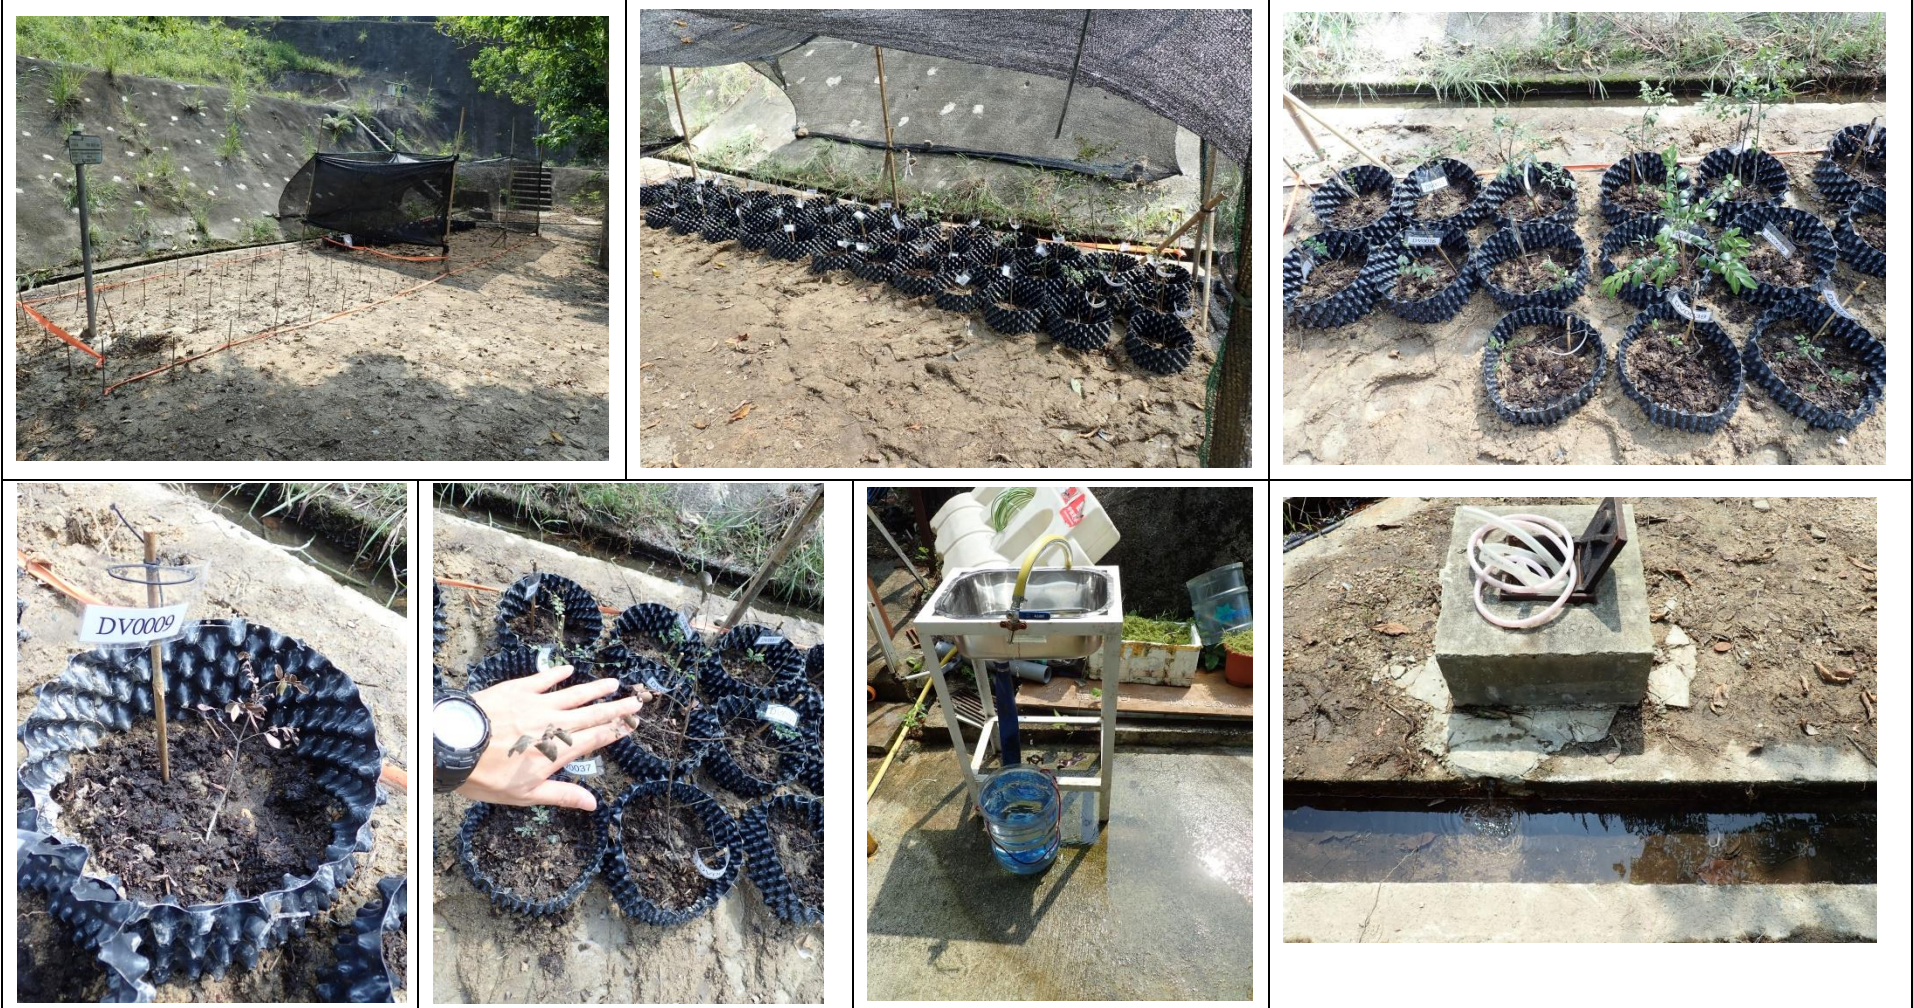
Plant conditions of DV0001-DV0040 were listed in **Table 2**. Most seedlings were generally tiny (about 10cm in height) aiming at smaller root zone and better survival. However, some of them have yet developed sufficient leaves. Sign of leave drop and dehydration has been observed (**Plate 1**), despite provision of shelter and irrigation. Although tiny new branch or leaf buds were observed, seedlings may struggle for survival against environmental stress. Next few monitoring will be importance to assess their progress in plant condition.

**Plate 1.** The 1<sup>st</sup> batch of 40 nos. of *Diospyros vaccinioides* transplanted from Site 1; and stored by Landscape Specialist Contractor at the on-site nursery, which has water supply for irrigation.

According to environmental condition and location of the receptor sites/ nursery, watering frequency was recommended in a daily practice for at least the first 3 months as the transplant time is in summer months with strong sunlight and high temperature; except the days with fog and rain. Water frequency may be reduced based on the plant condition after monitoring in the first 3 months.

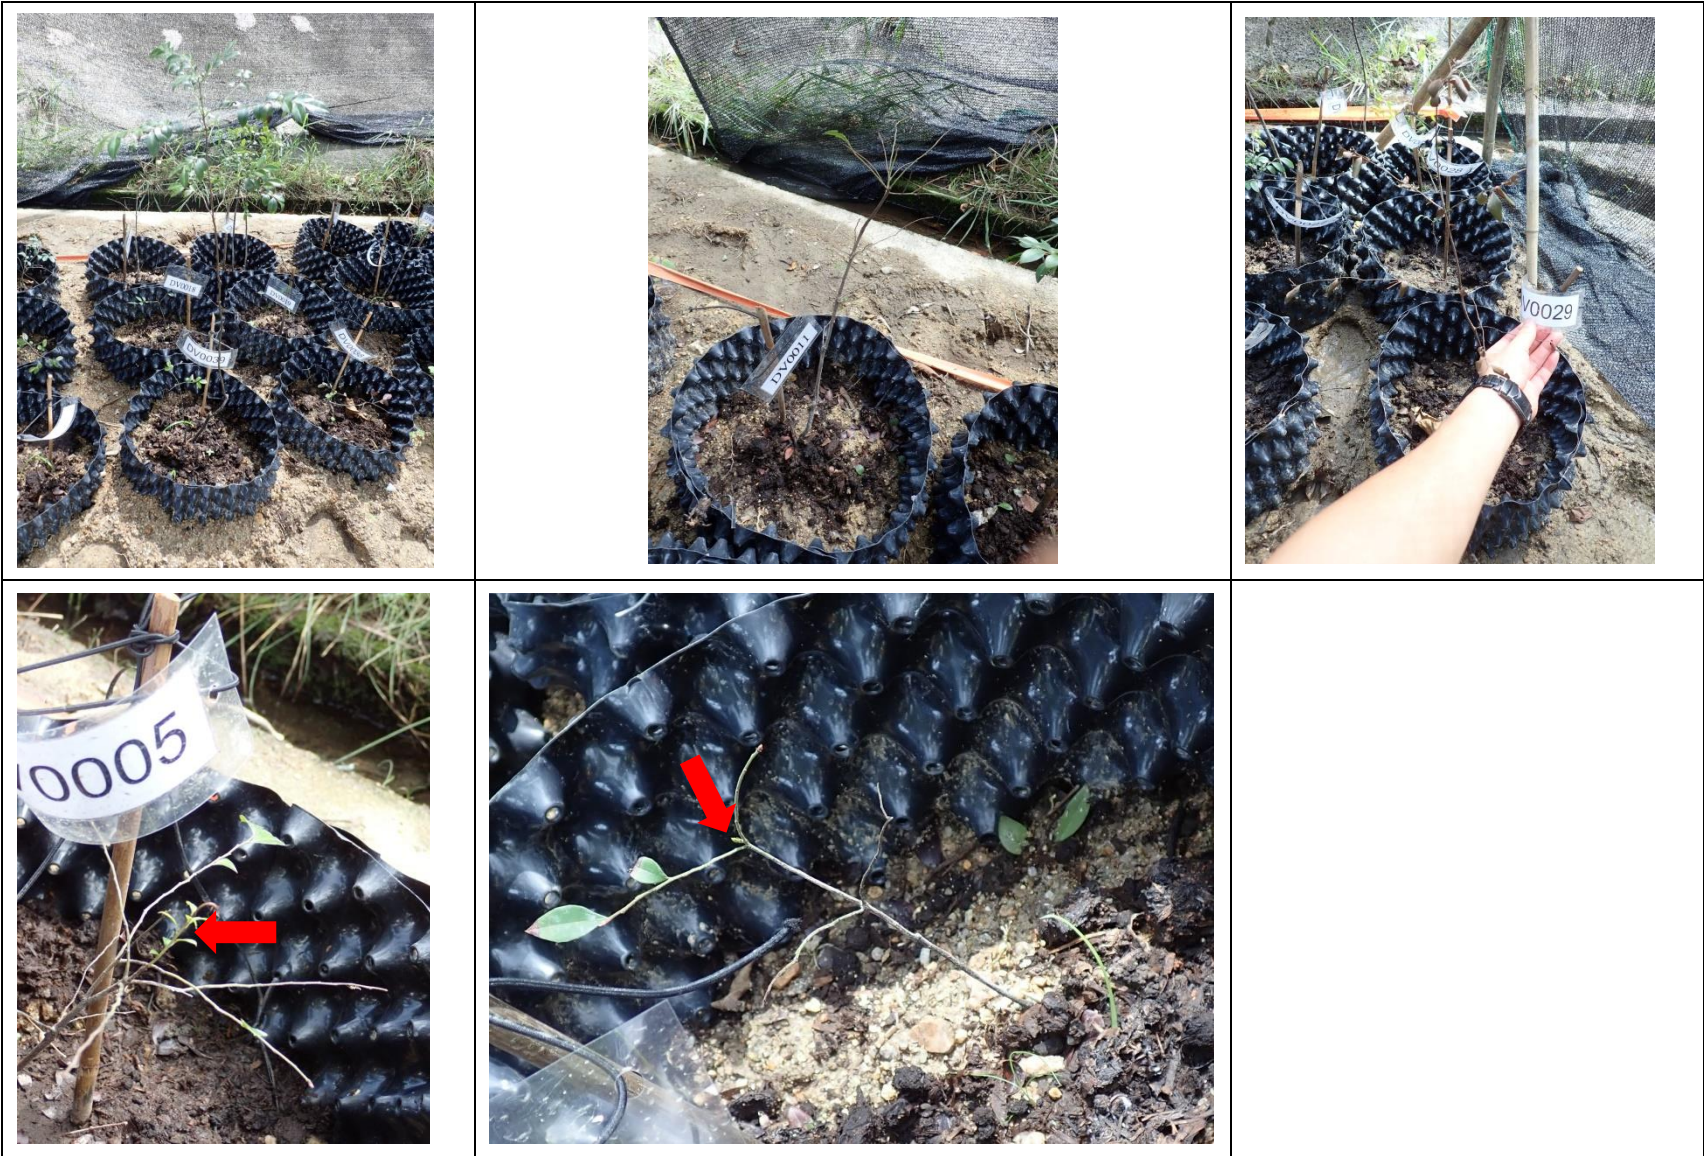
**Plate 1 (cont'd).** The 1<sup>st</sup> batch of 40 nos. of *Diospyros vaccinioides* transplanted from Site 1. Example of *Diospyros vaccinioides* in good condition (top left). Sign of leaf drop and dehydration (top middle & right). Growing of tiny new branch and leaf bud (bottom).

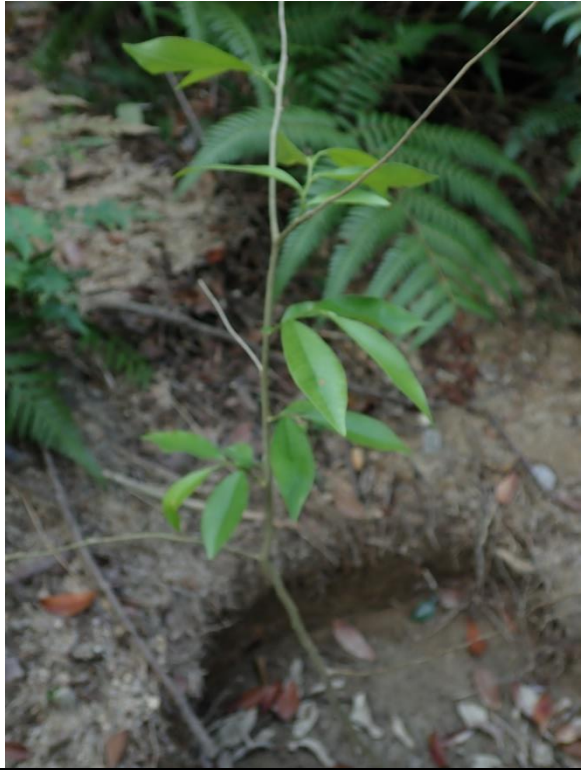
For C0001, E0004 and H0002, plant conditions were listed in **Table 3**, and corresponding photographic records were shown in **Appendix 1**. Despite rootballs were maintained intact as far as possible, transplanted plants need time to grow into new soil of the receptor site. Therefore, sign of dehydration, leaf yellowing/ wilting, or even die-off were expected. Next few monitoring would be important to access their progress of recovery and establishment of new root system at the receptor site.

No.	Form	Health condition	Structural condition	Amenity value	Remarks
C0001	Fair	Fair	Fair	Poor	Young leaves kept growing
E0004-1	Fair	Fair	Fair	Fair	
E0004-2	Fair	Fair	Fair	Fair	
E0004-3	Fair	Fair	Fair	Fair	
E0004-4	Fair	Fair	Fair	Fair	
E0004-5	Fair	Fair	Fair	Fair	
E0004-6	Fair	Fair	Fair	Fair	Some leave drop
E0004-7	Fair	Fair	Fair	Fair	
H0002	Fair	Fair	Fair	Fair	A young leave is growing
