**ENVIRONMENTAL TEAM FOR  
RELOCATION OF SHA TIN SEWAGE TREATMENT  
WORKS TO CAVERNS – SITE PREPARATION  
AND ACCESS TUNNEL CONSTRUCTION**

**UNDER ENVIRONMENTAL PERMIT NO. EP-533/2017**

**MONTHLY ENVIRONMENTAL MONITORING & AUDIT  
REPORT**

**OCTOBER 2019**

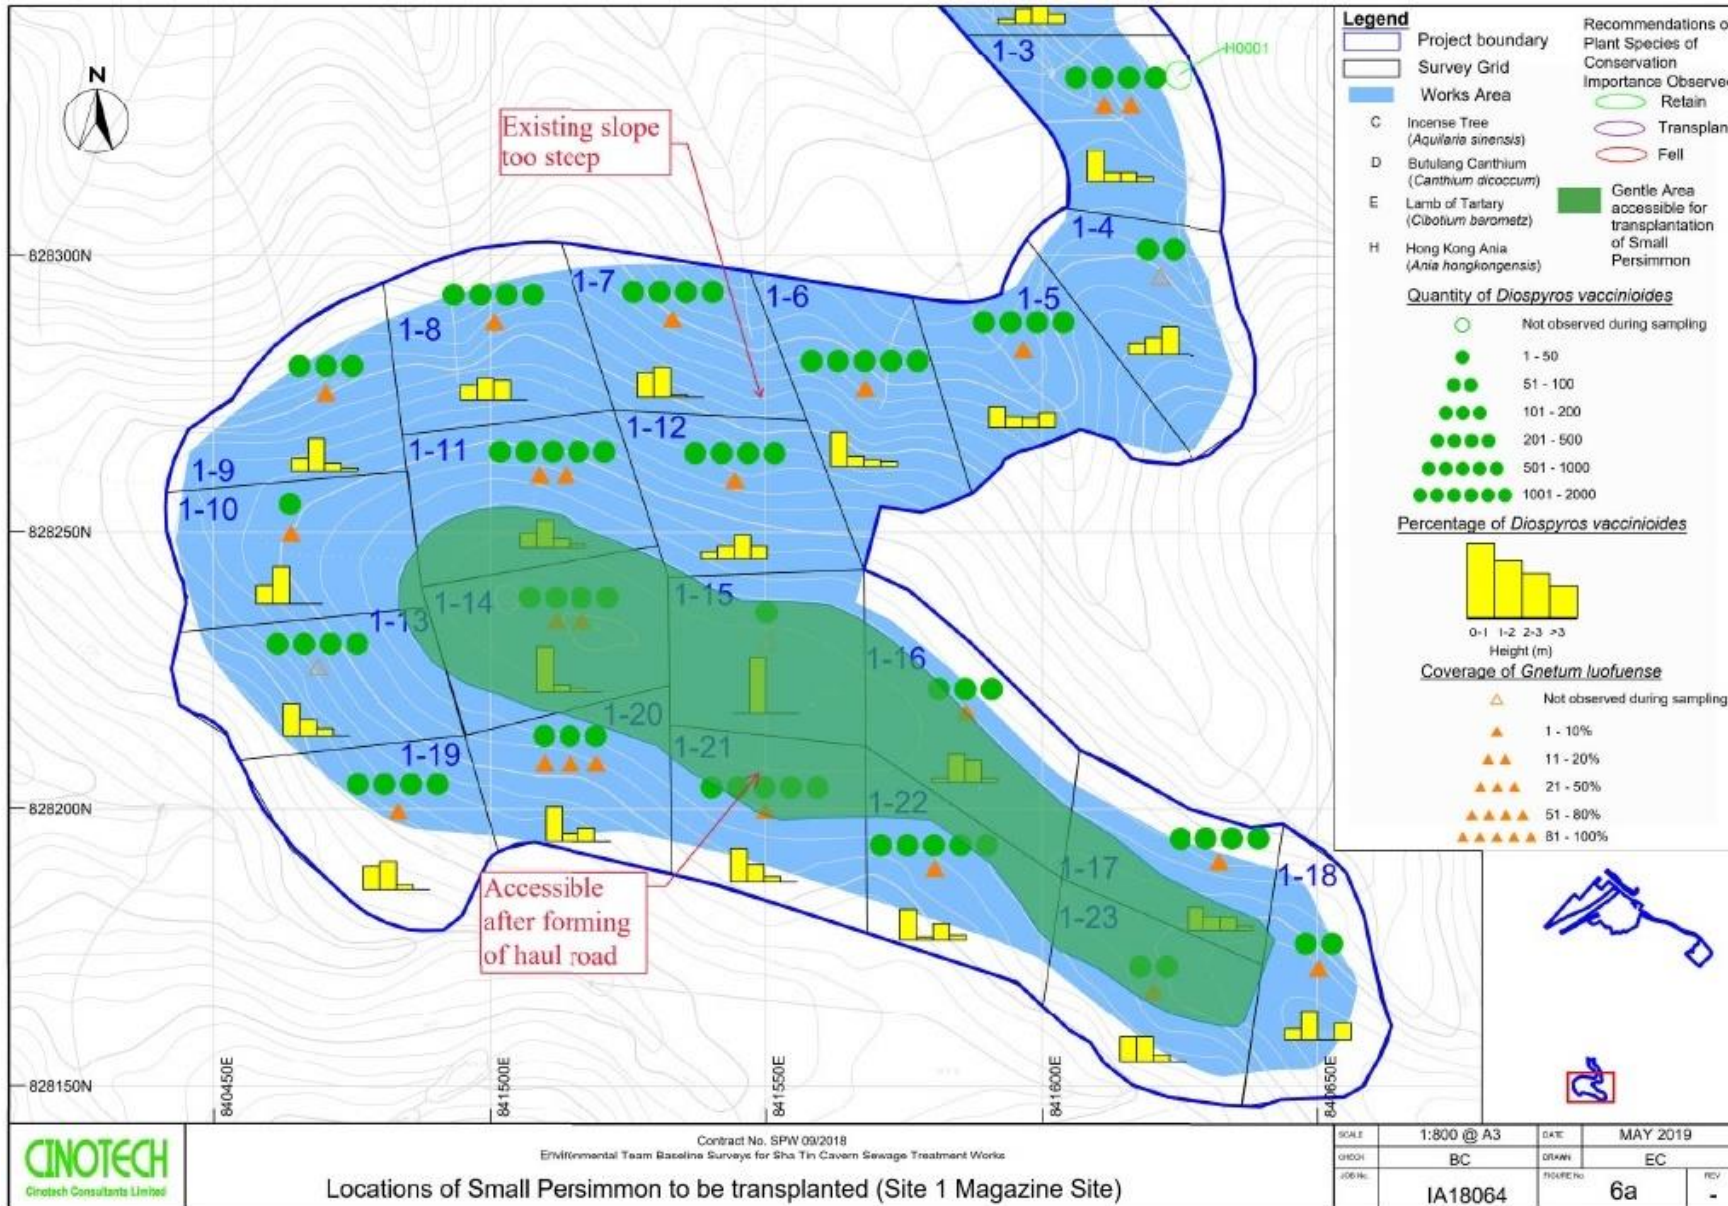
**Figure 1.** Original location of DV0001-DV0040 at Site 1 to be transplanted to the nursery.

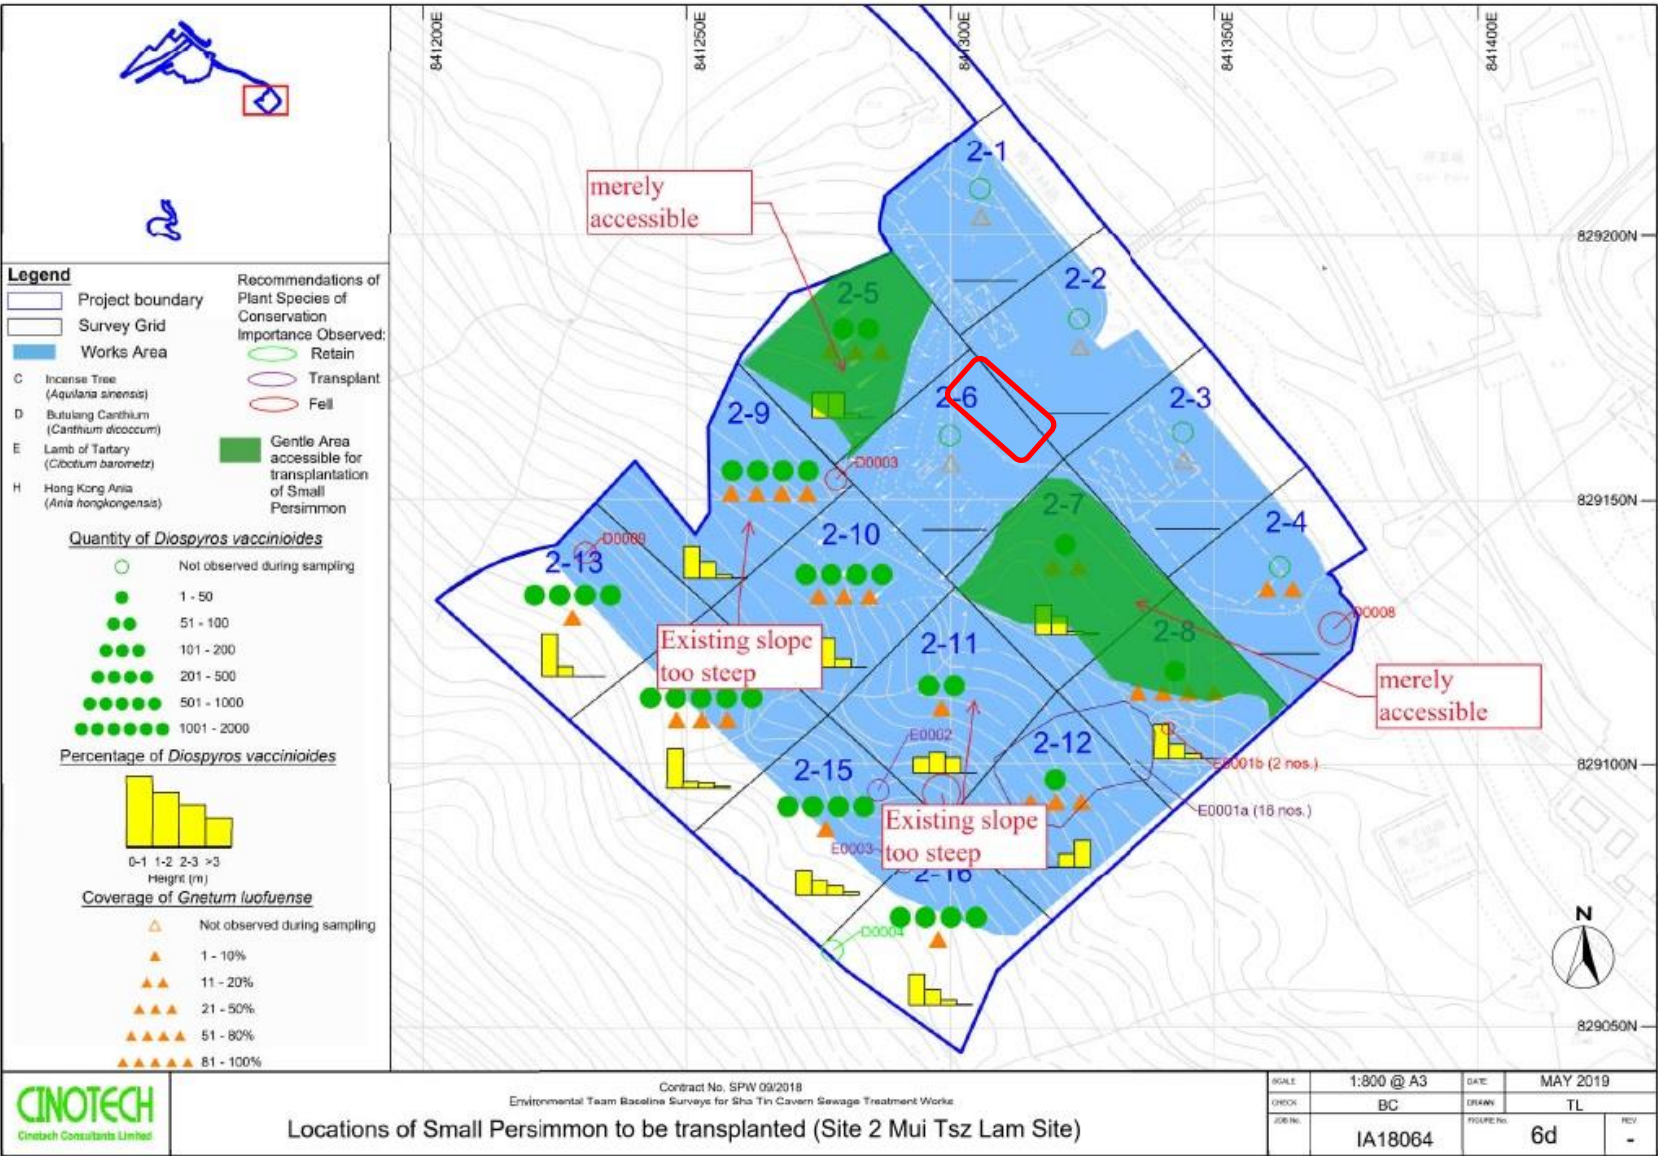
Figure 2. Nursery site highlighted in red frame for DV0001-DV0040 at Site 2.

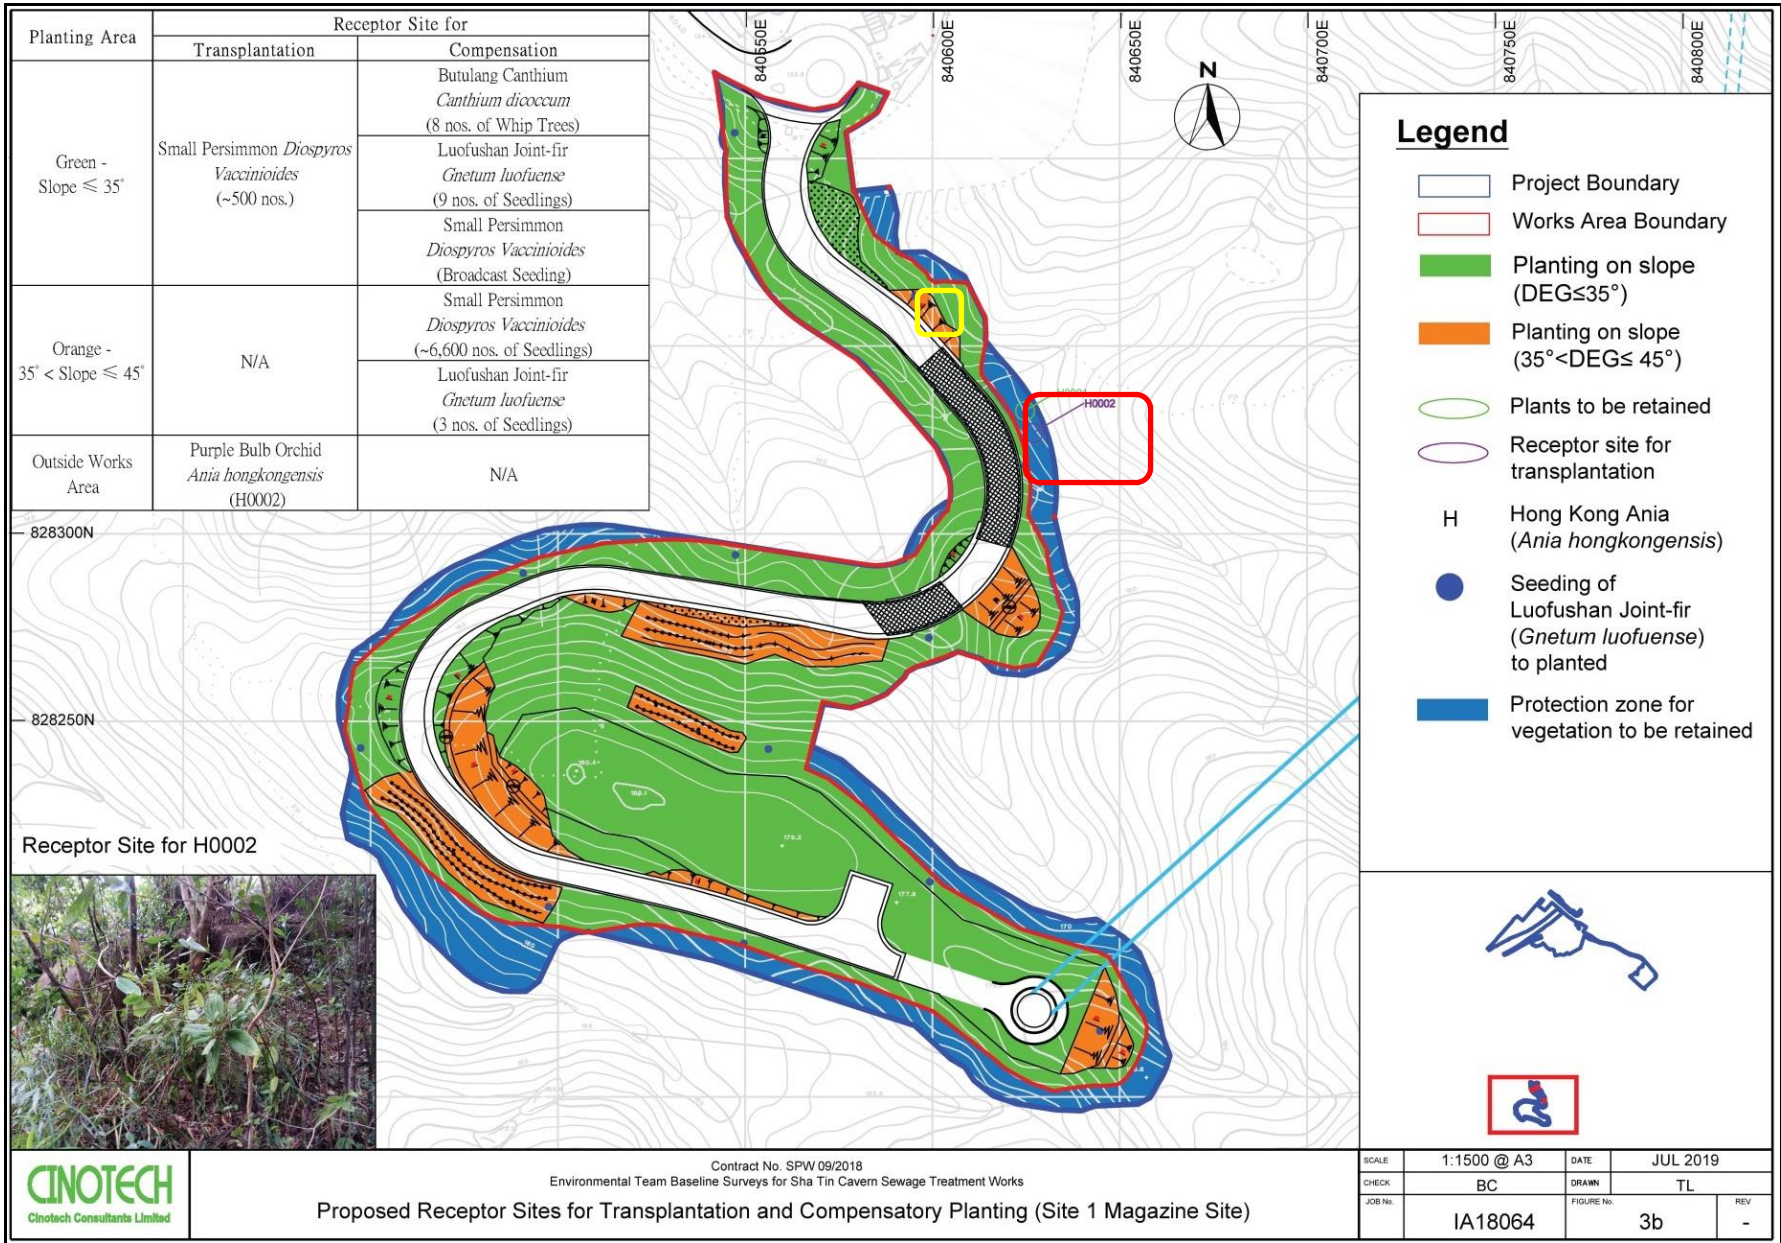
Figure 3. Original location of H0002 highlighted in yellow frame and its receptor site highlighted in red frame.

woodland surrounding receptor sites of H0002. Landscape Contractor was recommended to provide shelter to the transplanted plants to provide similar shading against adverse environmental condition (e.g. strong sunlight, rainstorm and construction dust). Next few monitoring would be important to access their progress of recovery and establishment of new root system at the receptor site.

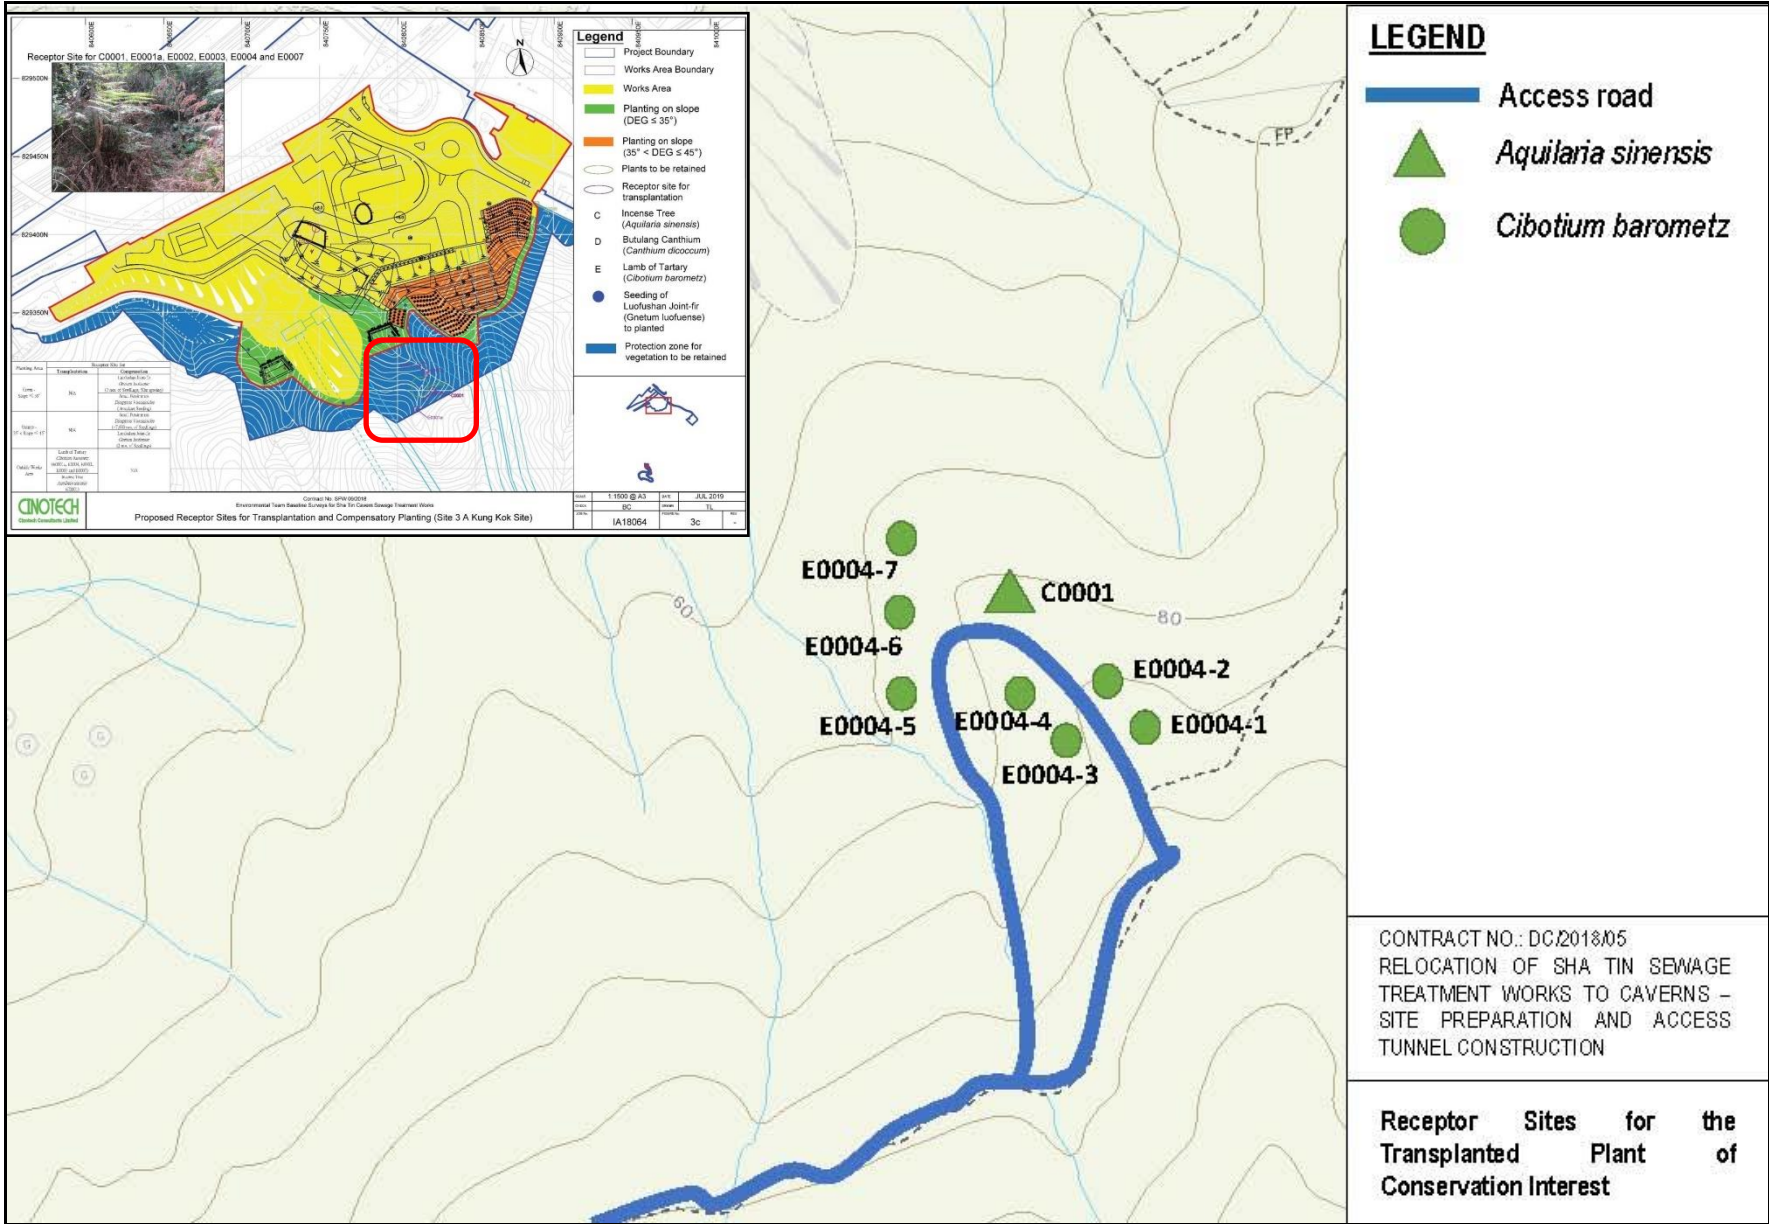
Figure 4. Receptor site for C0001 and E0004, the area highlighted in red frame is enlarged.

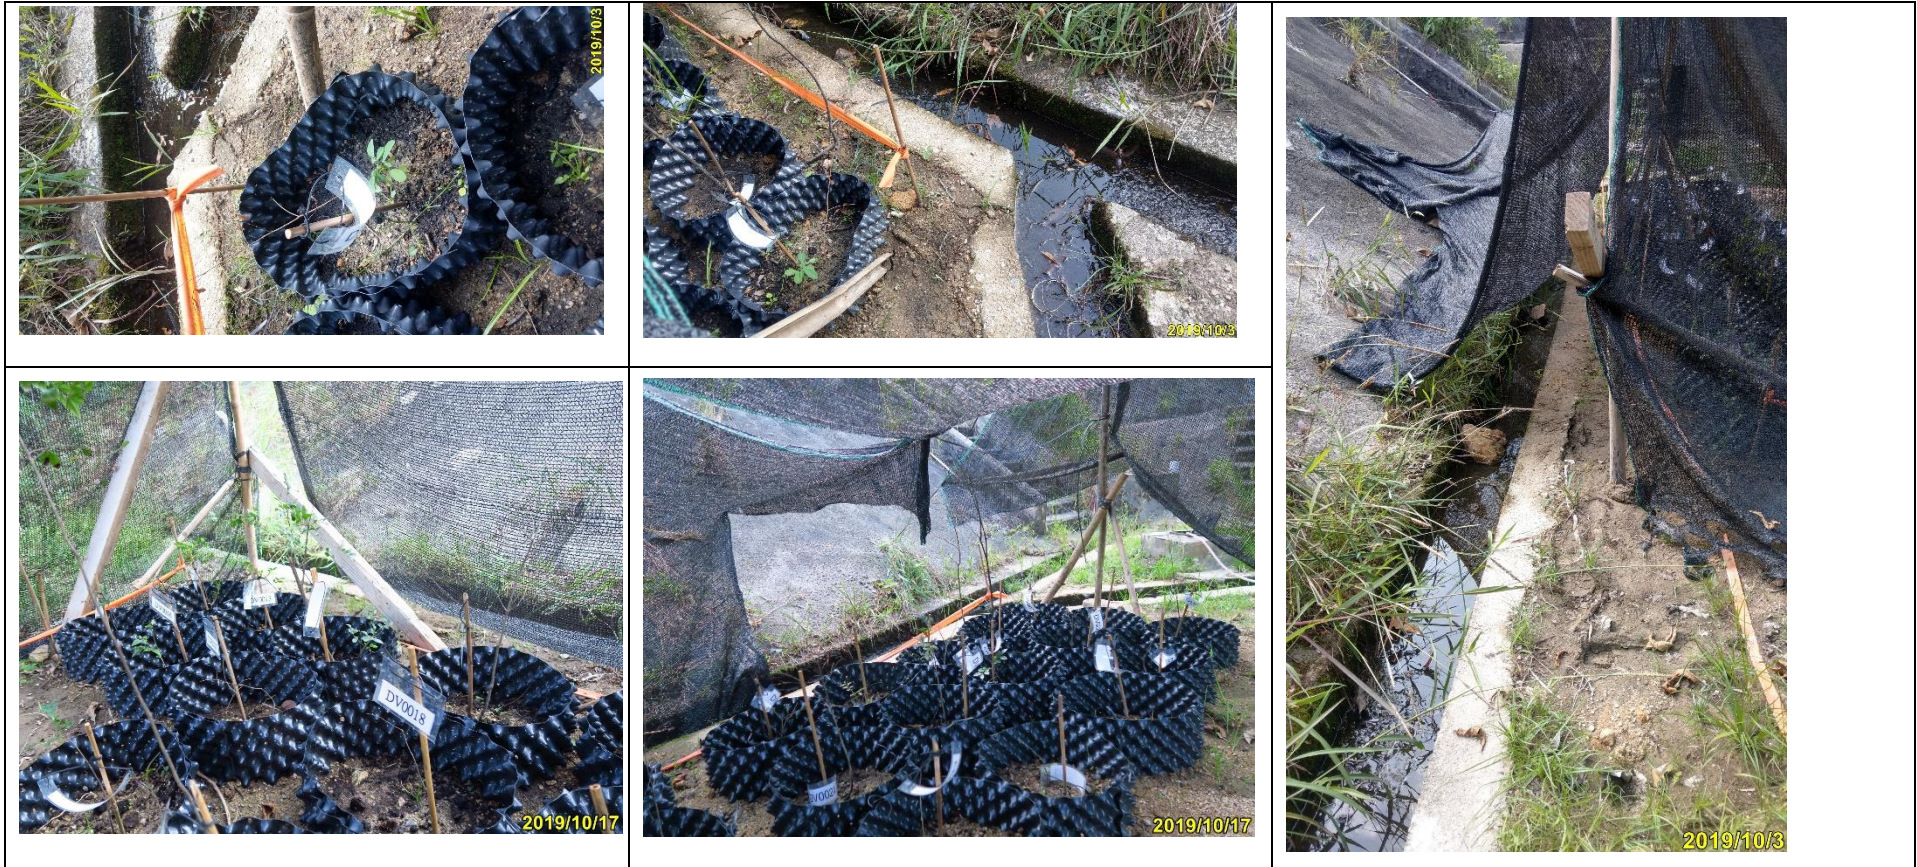
Most seedlings were generally tiny (about 10cm in height) aiming at smaller root zone and better survival. However, some of them have yet developed sufficient leaves. Sign of leaf drop and dehydration has been observed (**Plate 1**), despite provision of shelter and irrigation. Although tiny new branch or leaf buds were observed, seedlings may struggle for survival against environmental stress.

Nursery ground was found waterlogged and the drainage nearby was blocked by soil and debris; due to the same reason of recent rains (**Plate 1**). Watering problem has been rectified by the Landscape Specialist Contractor as observed on 17 October 2019.

In contrast, the Landscape Contractor was recommended to check all transplanted plants after heavy rains/ typhoon under safe condition, in order to carry out any stabilization/ maintenance work. Blocked drainage shall be cleared; excessive water shall be pumped or diverged from nursery ground; saturated soil shall be aerated.

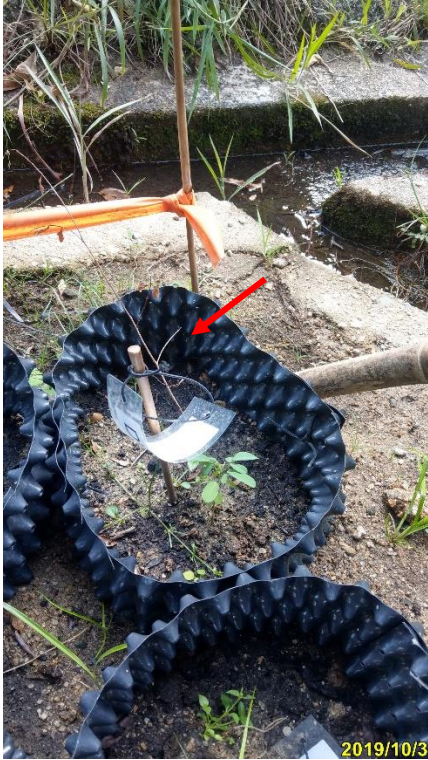
Plant conditions of DV0001-DV0040 were listed in **Table 2**. DV0001 is actually a *Syzygium buxifolium* rather than targeted *Diospyros vaccinioides*. It shall be replaced during next transplantation.

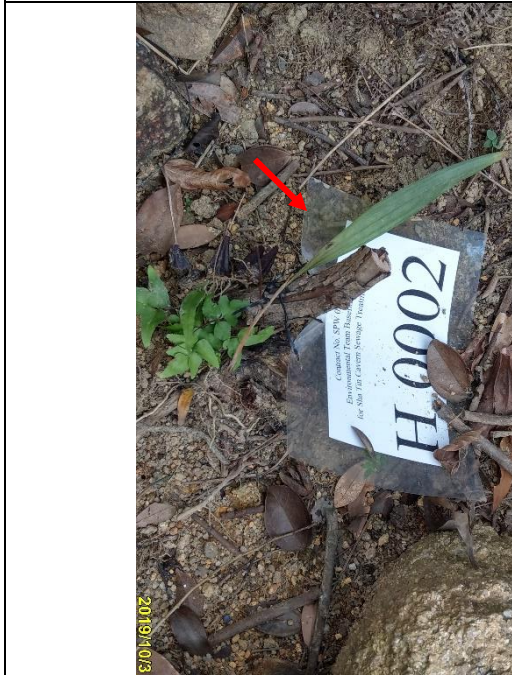
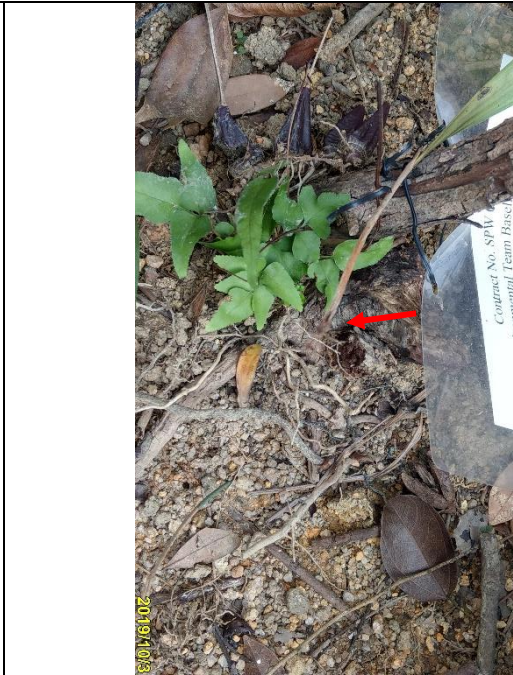
H0002

For C0001, E0004 and H0002, plant conditions were listed in **Table 3**, and corresponding photographic records were shown in **Appendix 2**. Despite root balls were maintained intact as far as possible, transplanted plants need time to grow into new soil of the receptor site. Therefore, sign of dehydration, leaf yellowing/ wilting, or even die-off were expected. Meanwhile, it is observed that site clearance was carried out in the continue patch of
