CONTRACT NO. SPW 25/2018

**ENVIRONMENTAL TEAM FOR
RELOCATION OF SHA TIN SEWAGE TREATMENT
WORKS TO CAVERNS – SITE PREPARATION
AND ACCESS TUNNEL CONSTRUCTION**

**MONTHLY ENVIRONMENTAL MONITORING & AUDIT
REPORT**

MARCH 2020

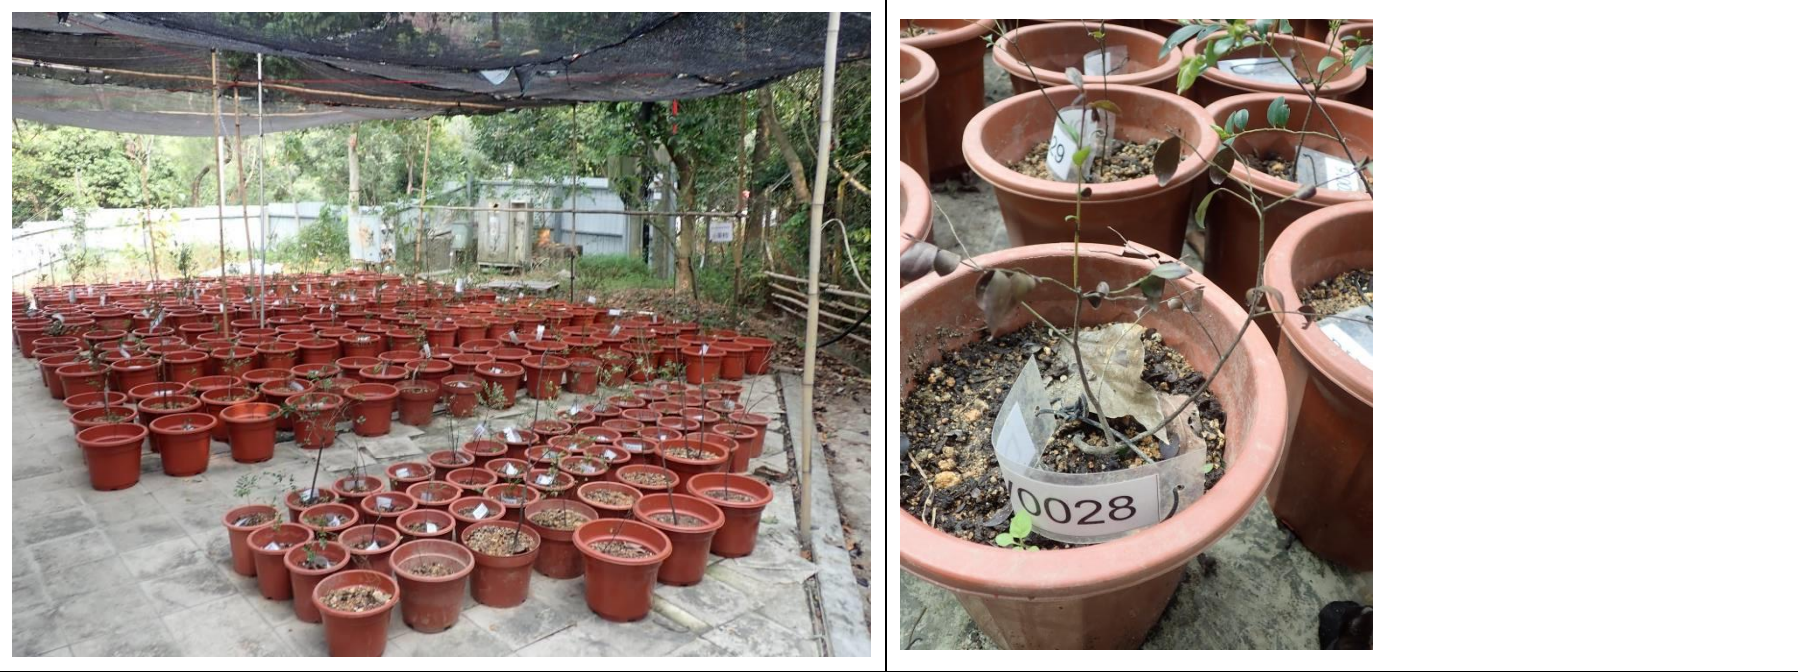
Plate 1. The 2 batches of *Diospyros vaccinioides* transplanted from Site 1; stored by Landscape Specialist Contractor at the on-site nursery.

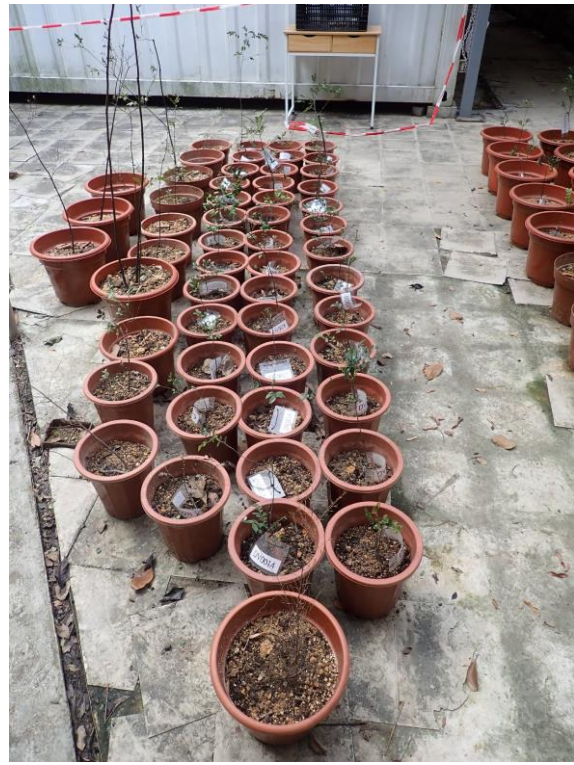
1st Batch of *Diospyros vaccinioides*

Plant conditions of 1st batch DV0001-DV0040 and 2nd batch DV0001-DV0228 were listed in **Table 2a, 2b** and illustrated in **Appendix 1**. Some seedlings were generally tiny (about 10cm in height) aiming at smaller root zone and better survival. However, some of them have yet developed sufficient leaves. Sign of leaf drop and dehydration has been observed (**Plate 1**), despite provision of shelter and irrigation. Although tiny new branch or leaf buds were observed, seedlings may struggle for survival against environmental stress.

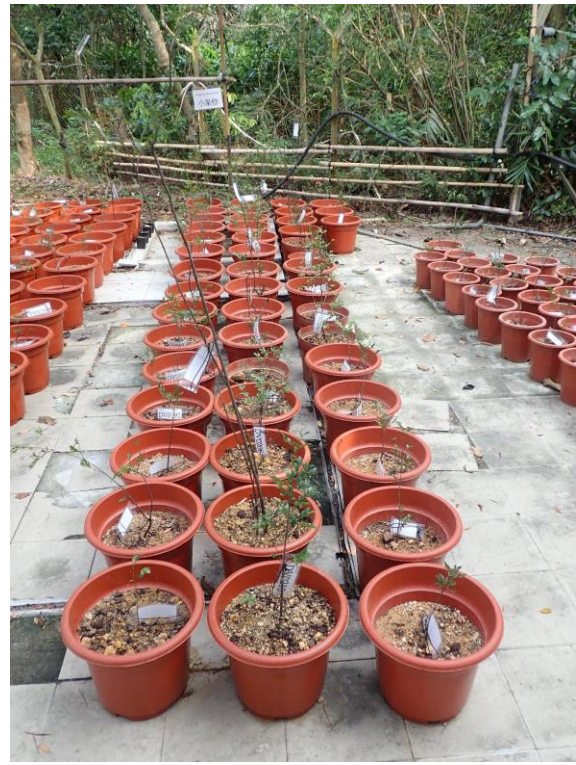
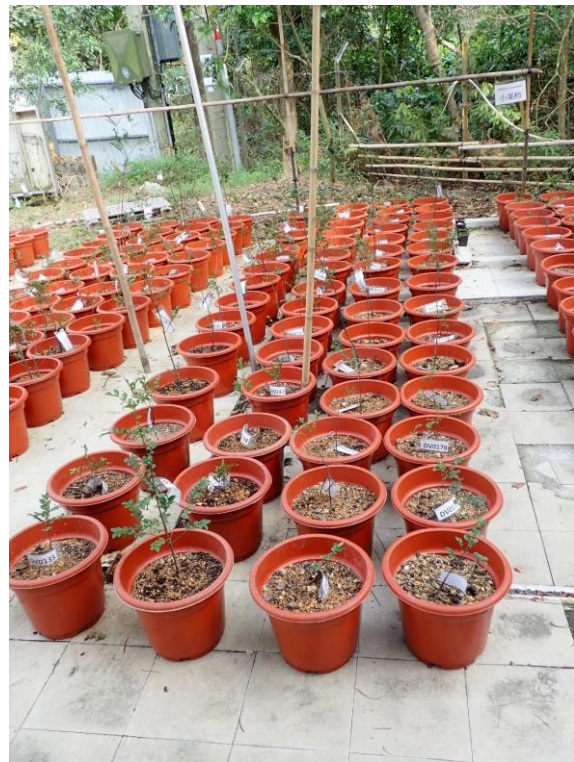
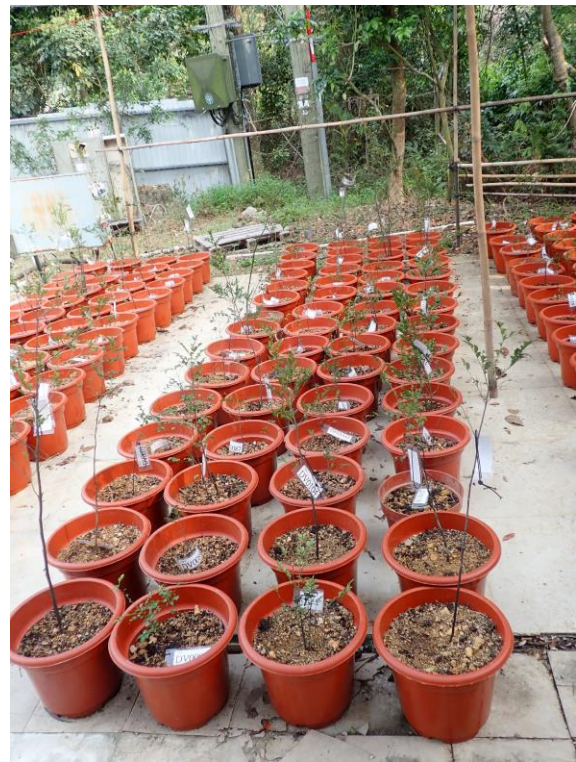
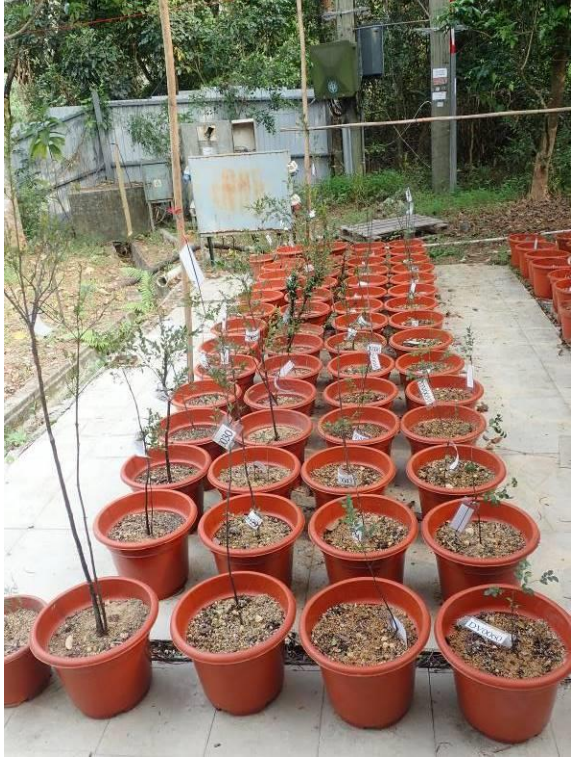
2nd batch of *Diospyros vaccinioides*

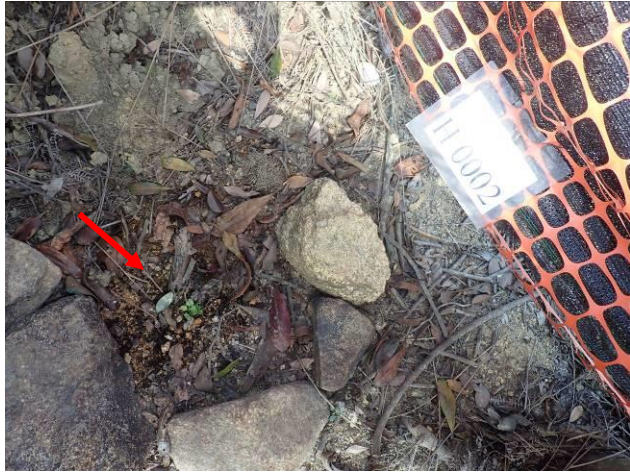
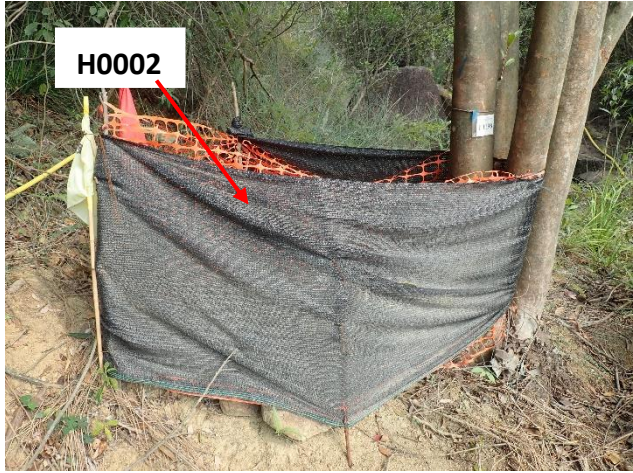
Therefore, sign of dehydration, leaf yellowing/ wilting, or even die-off were expected. Meanwhile, it is observed that site clearance was carried out in the continue patch of woodland surrounding receptor sites of H0002. A shelter has been set up for the transplanted plants to provide similar shading against adverse environmental condition (e.g. strong sunlight, rainstorm and construction dust). It is observed that organic soil conditioner was applied by the Contractor to H0002 in order to retain water moisture in the soil. On the other hand, mulching/ soil condition is suggested to be added by the landscape contractor for C0001.

The patch of retained *Ania hongkongensis* (named as H0001) was observed in a fair condition during reporting period. Flowers were observed from the individuals of *Ania hongkongensis* with corresponding photos presented in **Appendix 3**. The protection zone of H0001 has been expanded due to additional individuals were observed. Close monitoring should be carried out on H0002 due to the poor health condition.

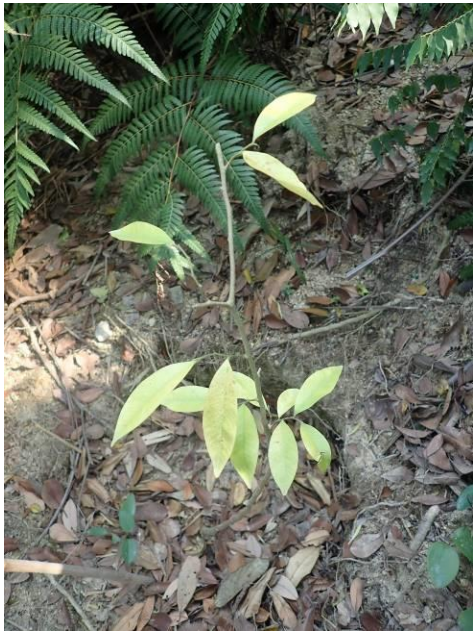
C0001

Item	Date	Reminders/Observations	Action taken by Contractor	Outcome
20200316_01Eco	16-3-2020	Yellow foliage is observe in C0001. Mulching/Soil conditioner to be provided	Mulching/Soil conditioner provided	Keep in view
20200316_02Eco	16-3-2020	H0002 is in poor health	Keep in view	Keep in view

For C0001, E0004 and H0002, plant conditions were listed in **Table 3**, and corresponding photographic records were shown in **Appendix 2**. Despite root balls were maintained intact as far as possible, transplanted plants need time to grow into new soil of the receptor site.
