**ENVIRONMENTAL TEAM FOR
RELOCATION OF SHA TIN SEWAGE TREATMENT
WORKS TO CAVERNS – SITE PREPARATION
AND ACCESS TUNNEL CONSTRUCTION**

UNDER ENVIRONMENTAL PERMIT NO. EP-533/2017

**MONTHLY ENVIRONMENTAL MONITORING & AUDIT
REPORT**

JULY 2020

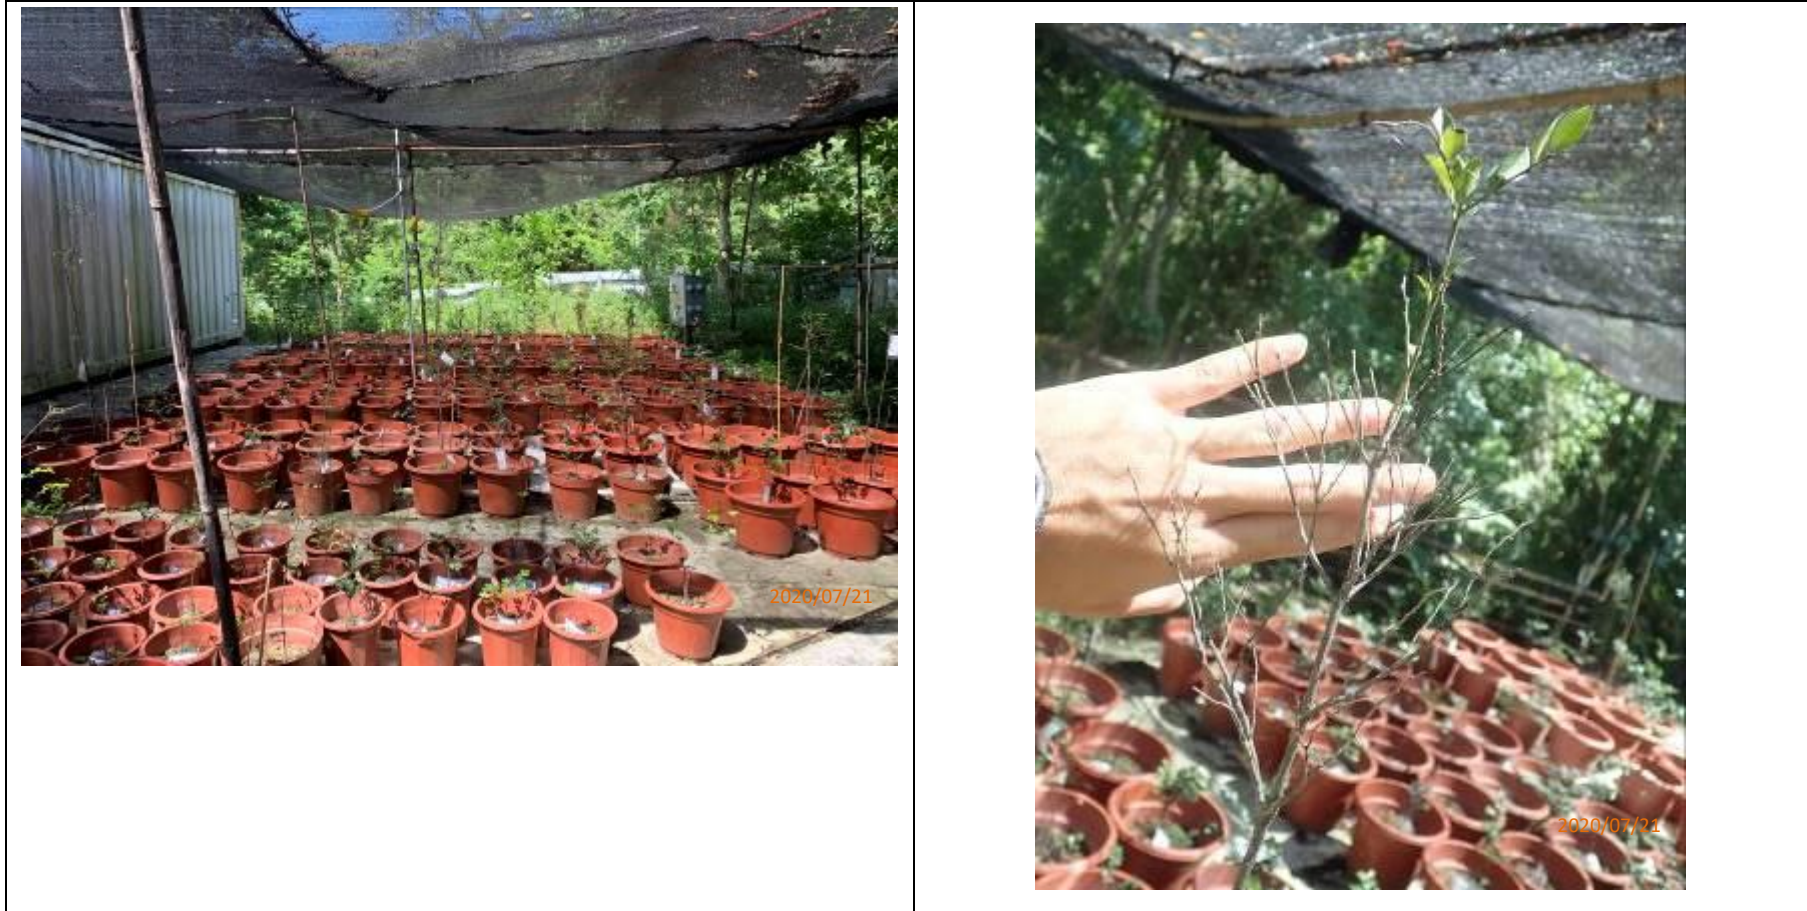
Plate 1. The 2 batches of *Diospyros vaccinioides* transplanted from Site 1; stored by Landscape Specialist Contractor at the on-site nursery (left). Sign of leaf drop has been observed in some transplanted individuals (right).

Plant conditions of 1st batch DV0001-DV0040 and 2nd batch DV0001-DV0228 were listed in **Table 2a, 2b** and illustrated in **Appendix 1**. Some seedlings were generally tiny (about 10cm in height) aiming at smaller root zone and better survival. However, some of them have yet developed sufficient leaves. Sign of leaf drop and dehydration has been observed, despite provision of shelter and irrigation (**Plate 1**). Although tiny new branch or leaf buds were observed, seedlings may struggle for survival against environmental stress.

According to environmental condition and location of the receptor sites/ nursery, watering frequency was recommended in daily practice for at least the first 3 months as the transplant time is in summer months with strong sunlight and high temperature; except the days with fog and rain. Water frequency may be reduced based on the plant condition after monitoring in the first 3 months.

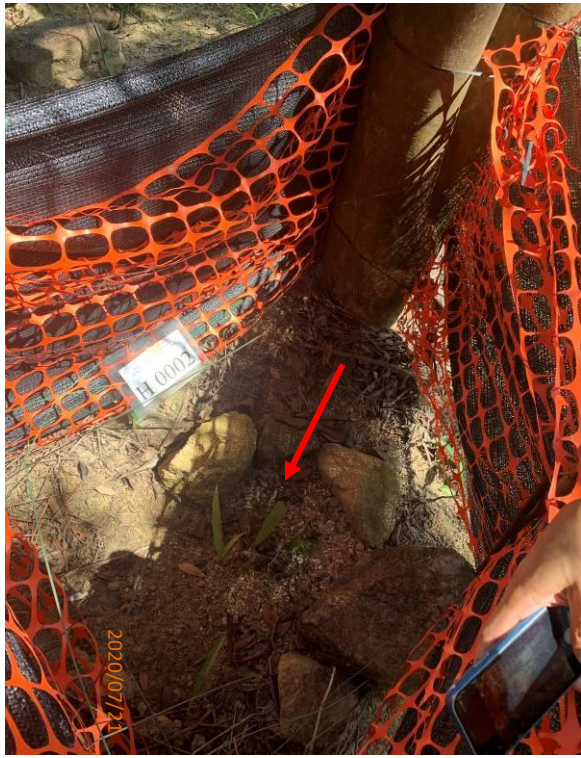
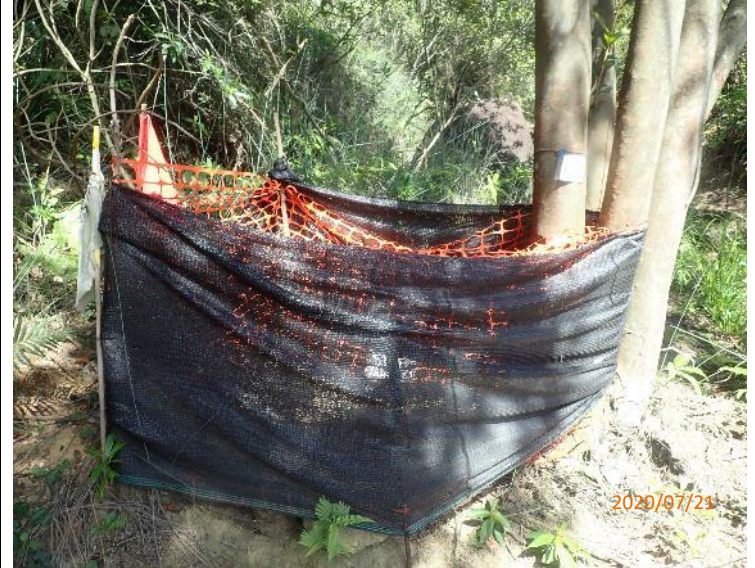
For C0001, E0004 and H0002, plant conditions were listed in **Table 3**, and corresponding photographic records were shown in **Appendix 2**. Despite root balls were maintained intact as far as possible, transplanted plants need time to grow into new soil of the receptor site. Therefore, sign of dehydration, leaf yellowing/ wilting, or even die-off were expected. Meanwhile, it is observed that site clearance was carried out in the continue patch of woodland surrounding receptor sites of H0002. A shelter has been set up for the transplanted plants to

provide similar shading against adverse environmental condition (e.g. strong sunlight, rainstorm and construction dust). It is observed that organic soil conditioner was applied by the Contractor to H0002 in order to retain water moisture in the soil. On the other hand, sign of damage by insect was observed on E0004.

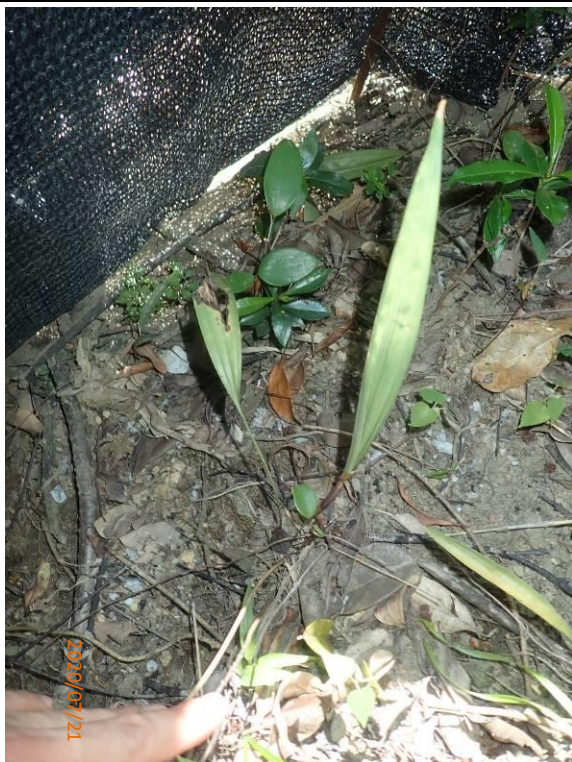
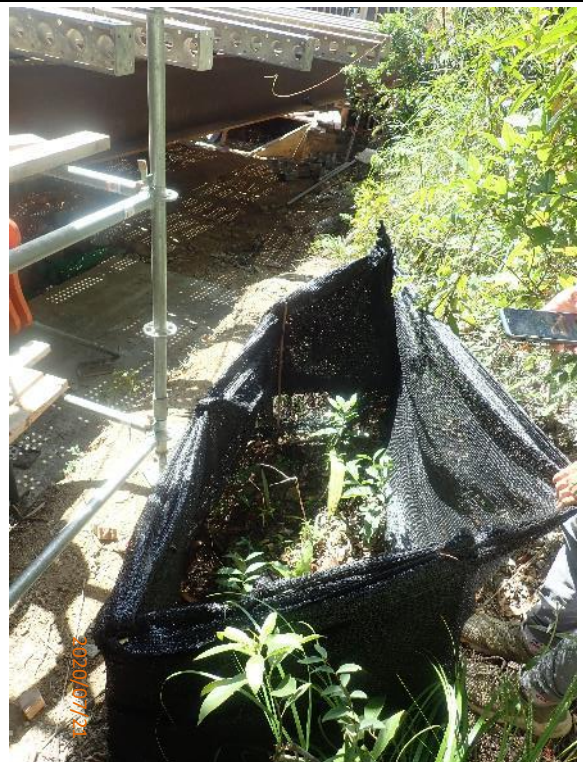
The patch of retained *Ania hongkongensis* (named as H0001) was observed in a fair condition during reporting period, with corresponding photos presented in **Appendix 3**. The protection zone of H0001 has been expanded due to additional individuals were observed. Landscape
