**ENVIRONMENTAL TEAM FOR
RELOCATION OF SHA TIN SEWAGE TREATMENT
WORKS TO CAVERNS – SITE PREPARATION
AND ACCESS TUNNEL CONSTRUCTION**

UNDER ENVIRONMENTAL PERMIT NO. EP-533/2017

**MONTHLY ENVIRONMENTAL MONITORING & AUDIT
REPORT**

SEPTEMBER 2020

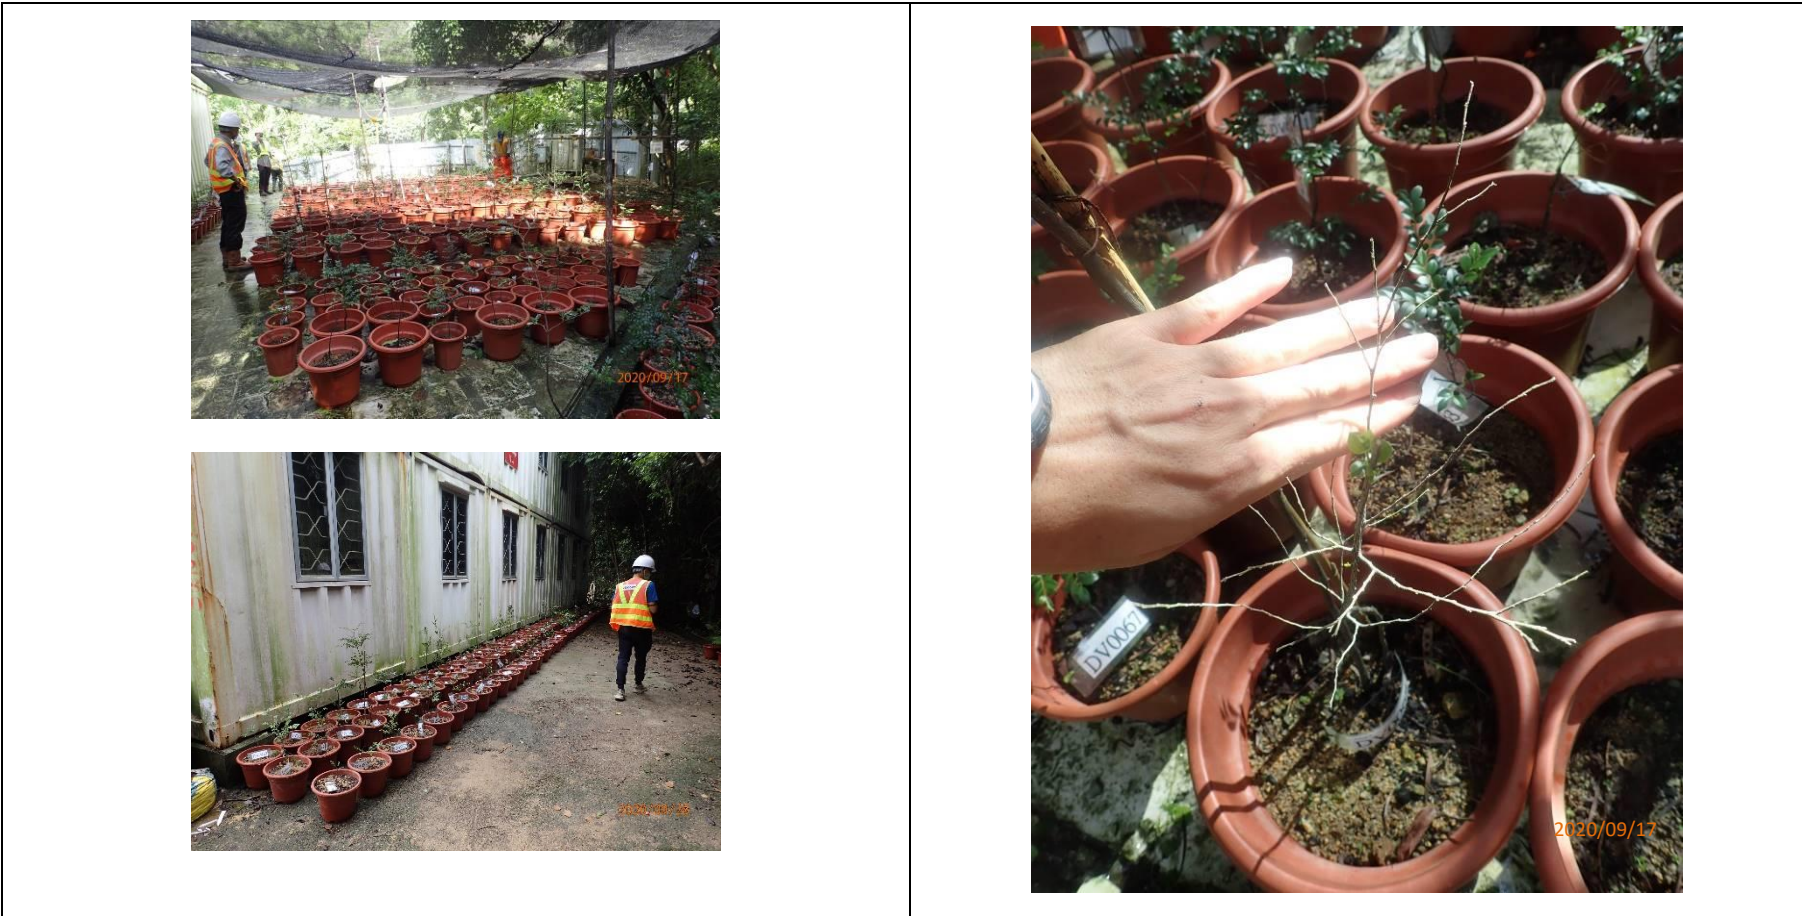
Plate 1. The 3 batches of *Diospyros vaccinioides* transplanted from Site 1 and 2; stored by Landscape Specialist Contractor at the on-site nursery (left). New buds have been observed in some transplanted individuals (right).

According to environmental condition and location of the receptor sites/ nursery, watering frequency was recommended in daily practice for at least the first 3 months as the transplant time is in summer months with strong sunlight and high temperature; except the days with fog and rain. Water frequency may be reduced based on the plant condition after monitoring in the first 3 months.

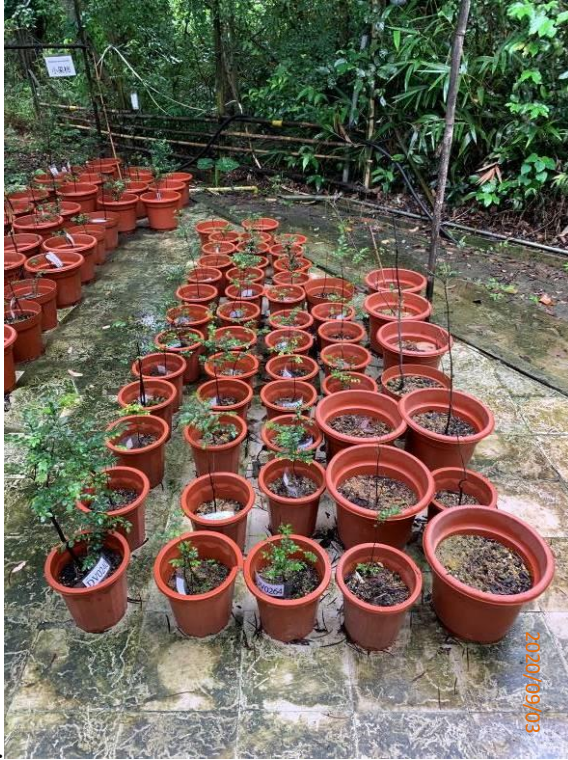
Plant conditions of 1st batch DV0229-DV0268, 2nd batch DV0001-DV0228 and 3rd batch DV0269-DV0500 were listed in **Table 2a, 2b, 2c** and illustrated in **Appendix 1**. Some seedlings were generally tiny (about 10cm in height) aiming at smaller root zone and better survival. However, some of them have yet developed sufficient leaves. Sign of leaf drop and dehydration has been observed, despite provision of shelter and irrigation (**Plate 1**). Although tiny new branch or leaf buds were observed, seedlings may struggle for survival against environmental stress.

Post-transplantation monitoring at temporary nursery on 3, 17 & 28 September 2020

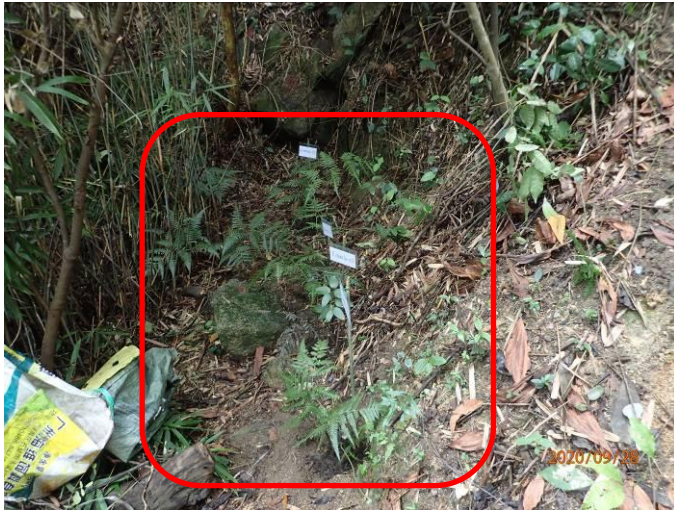
For E0001a-1 to E0001a-17, E0002 and E0003, plant conditions were listed in **Table 3**, and corresponding photographic records were shown in **Appendix 2**. Despite root balls were maintained intact as far as possible, transplanted plants need time to grow into new soil of the receptor site. Therefore, sign of dehydration, leaf yellowing/ wilting, or even die-off were expected.

Post-transplantation monitoring at receptor site on 28 September 2020

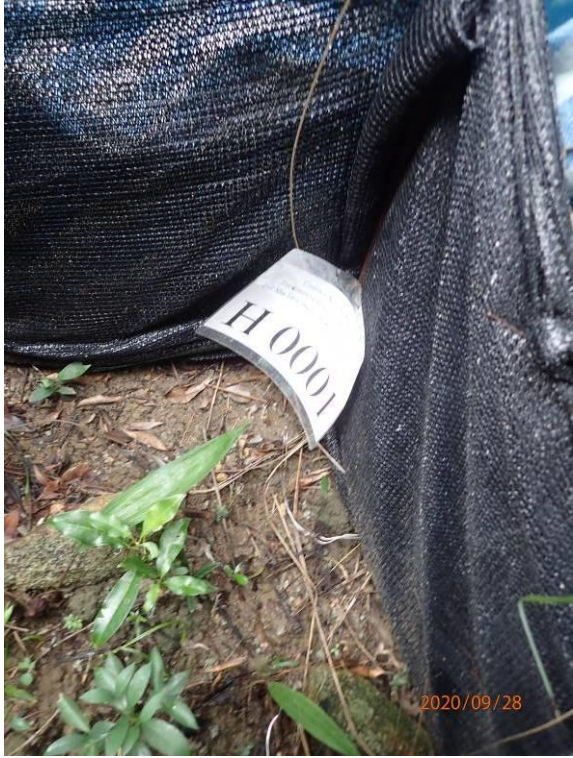
The patch of retained *Ania hongkongensis* (named as H0001) was observed in a fair condition during reporting period, with corresponding photos presented in **Appendix 3**. The protection zone of H0001 has been expanded due to additional individuals were observed. Landscape Contractor was reminded to carry out regular watering to the transplanted H0002.

Bi-weekly ecological monitoring at Site 1 on 17 & 28 September 2020

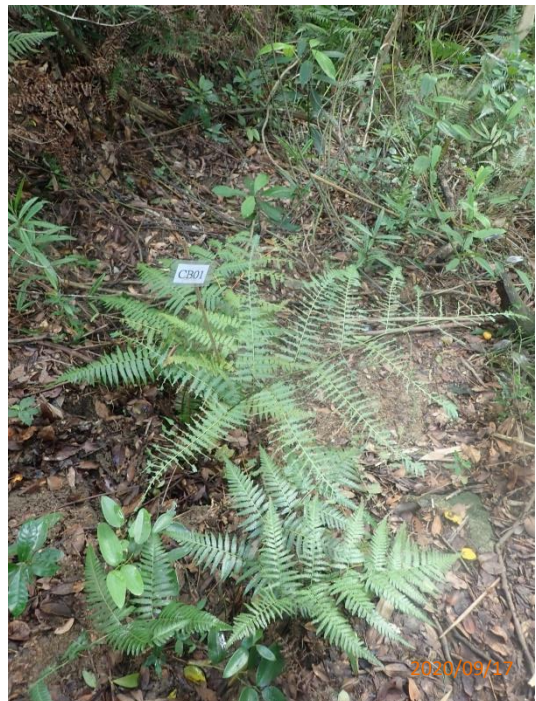
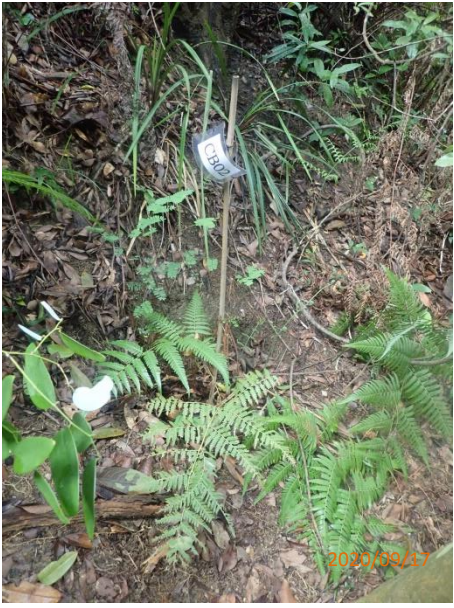
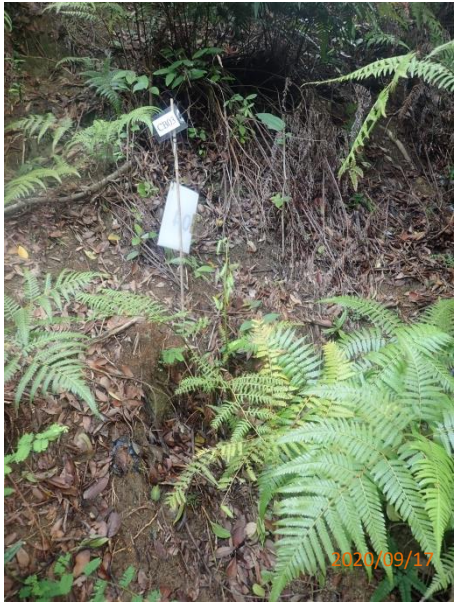
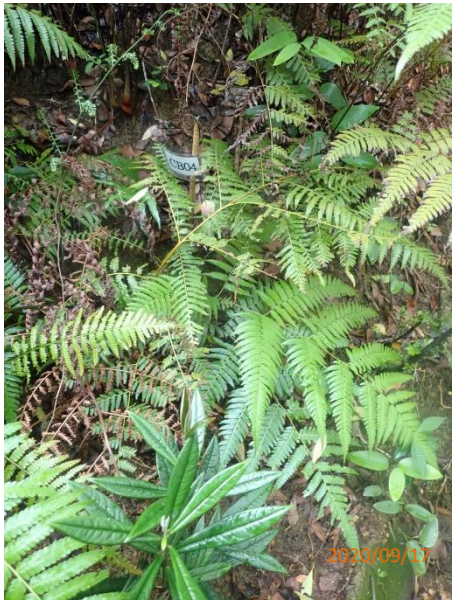
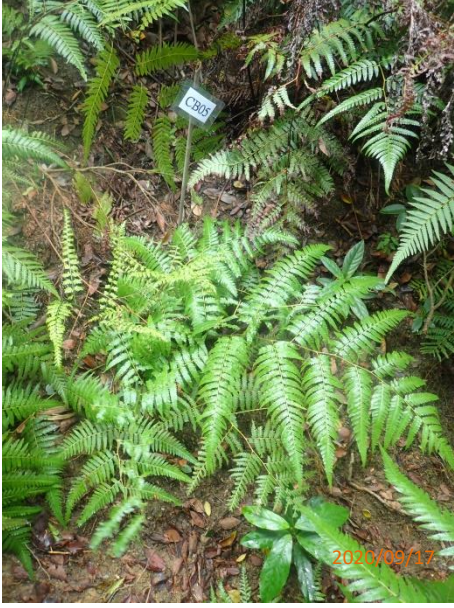
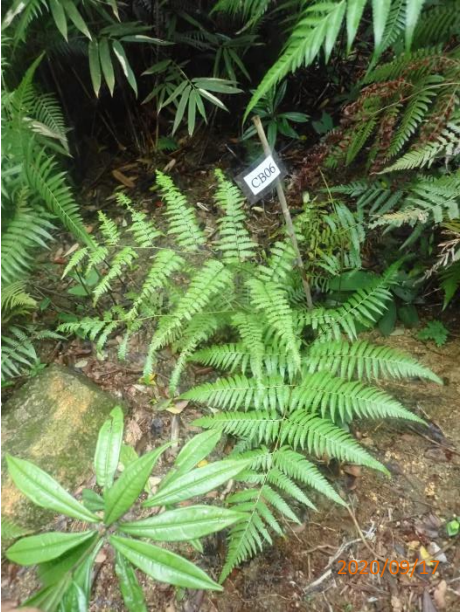
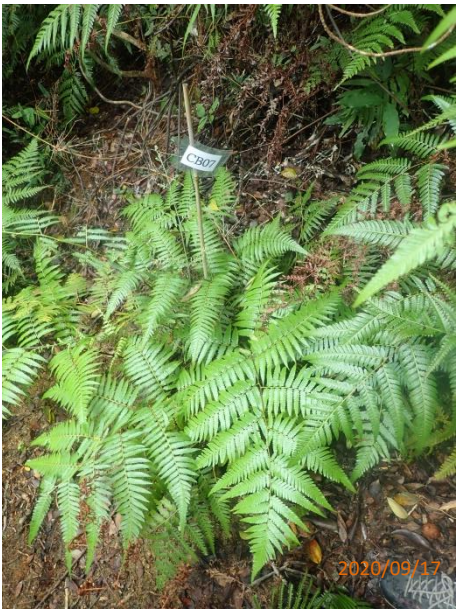
In response to the observed insect damage observed on E0004, appropriate horticultural treatment of spraying soap water (bio-degradable soap mixed with hot water in 1:60-70 ratio and cool down before spraying) once per week for 3-4 cycles with weekly monitoring is suggested to carry out. This help to access if the insect damage stop spreading to other *Cibotium barometz* individuals in vicinity.
