**ENVIRONMENTAL TEAM FOR
RELOCATION OF SHA TIN SEWAGE TREATMENT
WORKS TO CAVERNS – SITE PREPARATION
AND ACCESS TUNNEL CONSTRUCTION**

UNDER ENVIRONMENTAL PERMIT NO. EP-533/2017

**MONTHLY ENVIRONMENTAL MONITORING & AUDIT
REPORT**

OCTOBER 2020

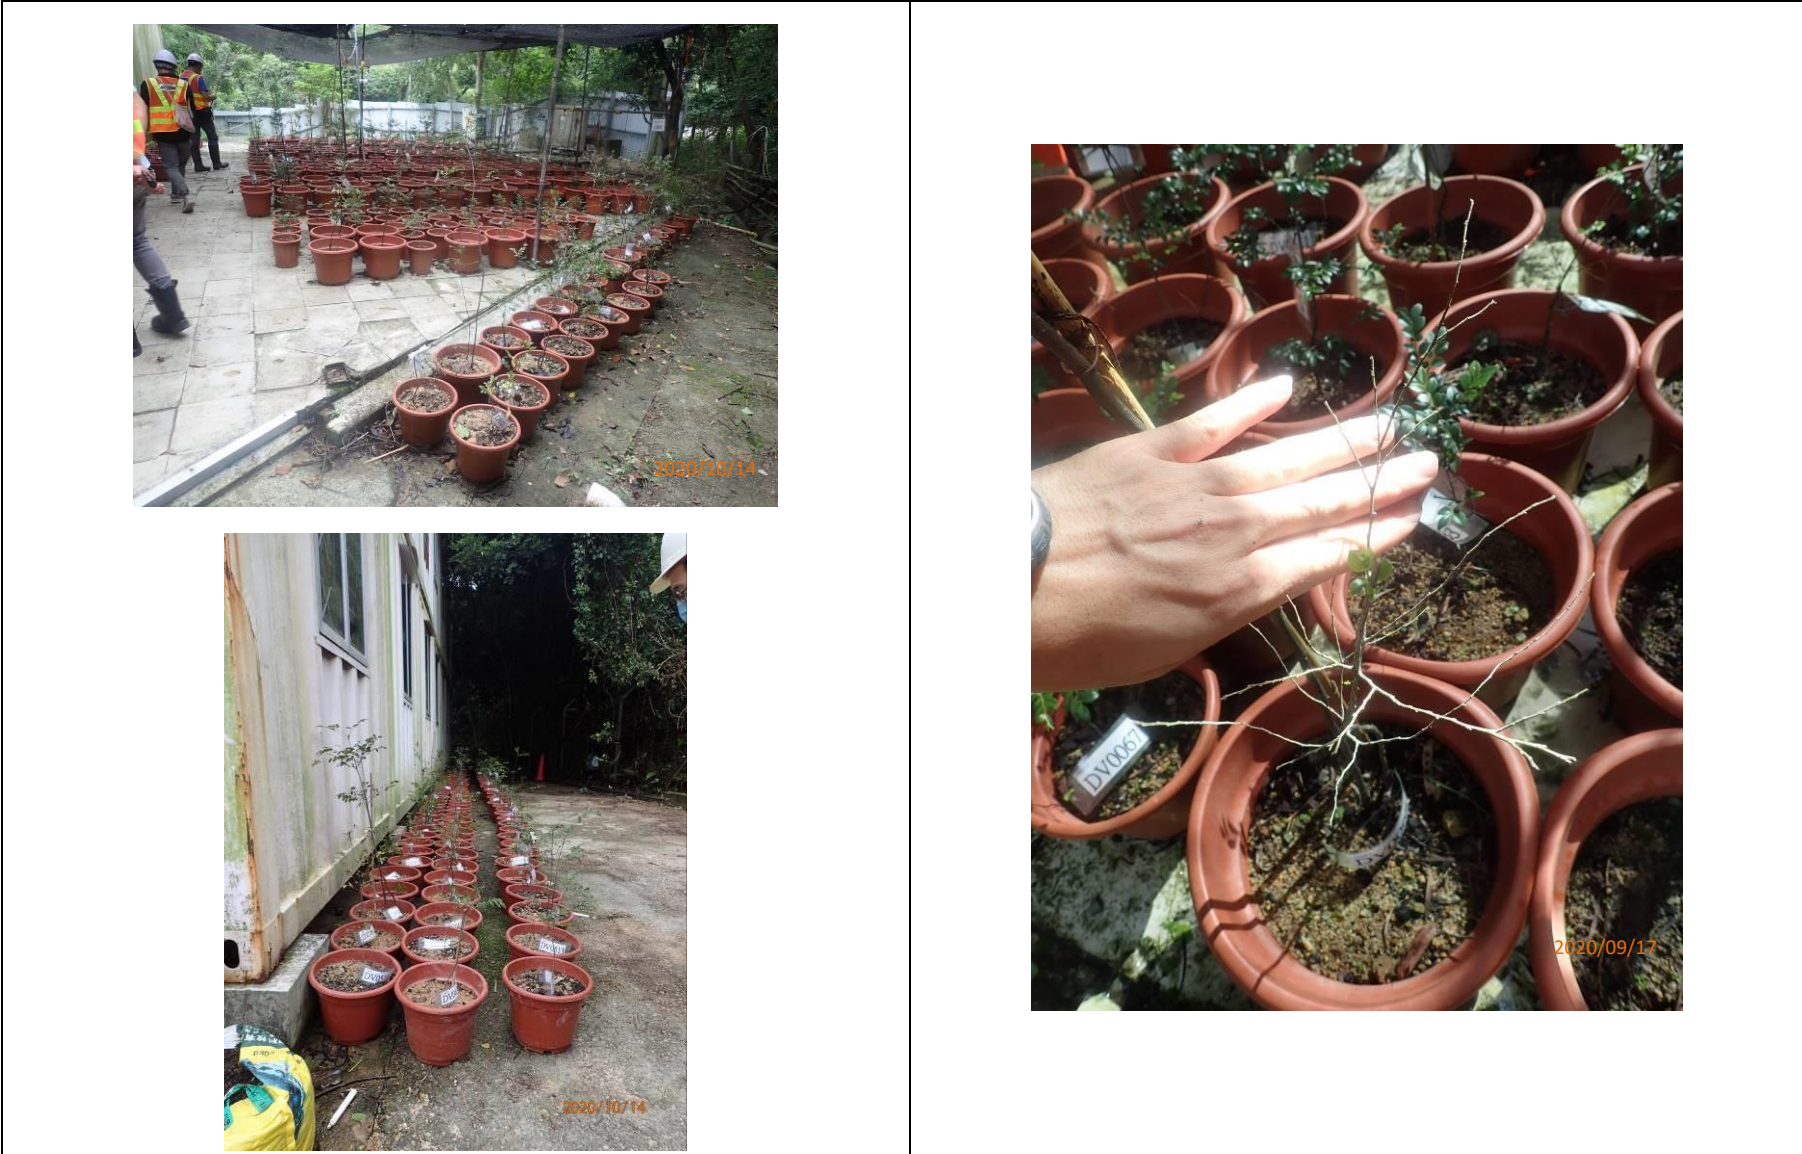
Plant conditions of 1st batch DV0229-DV0268, 2nd batch DV0001-DV0228 and 3rd batch DV0269-DV0500 were listed in **Table 2a, 2b, 2c** and illustrated in **Appendix 1**. Some seedlings were generally tiny (about 10cm in height) aiming at smaller root zone and better survival. However, some of them have yet developed sufficient leaves. Sign of leaf drop and dehydration has been observed, despite provision of shelter and irrigation (**Plate 1**). Although tiny new branch or leaf buds were observed, seedlings may struggle for survival against environmental stress.

Plate 1. The 3 batches of *Diospyros vaccinioides* transplanted from Site 1 and 2; stored by Landscape Specialist Contractor at the on-site nursery (left). New buds have been observed in some transplanted individuals (right).

According to environmental condition and location of the receptor sites/ nursery, watering frequency was recommended in daily practice for at least the first 3 months as the transplant time is in summer months with strong sunlight and high temperature; except the days with fog and rain. Water frequency may be reduced based on the plant condition after monitoring in the first 3 months.

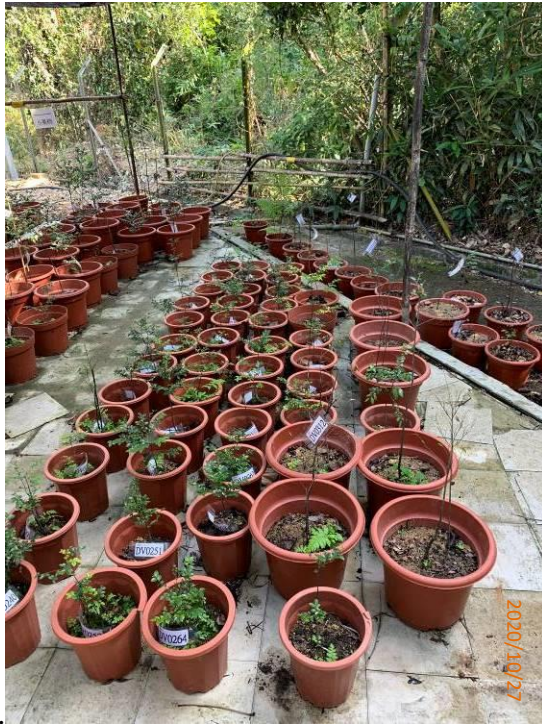
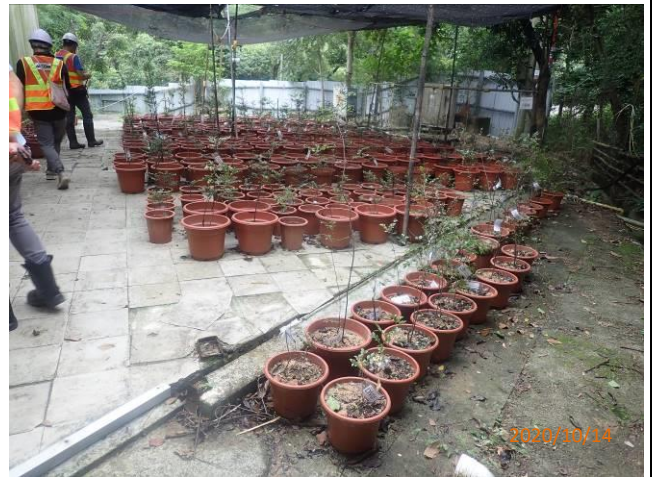
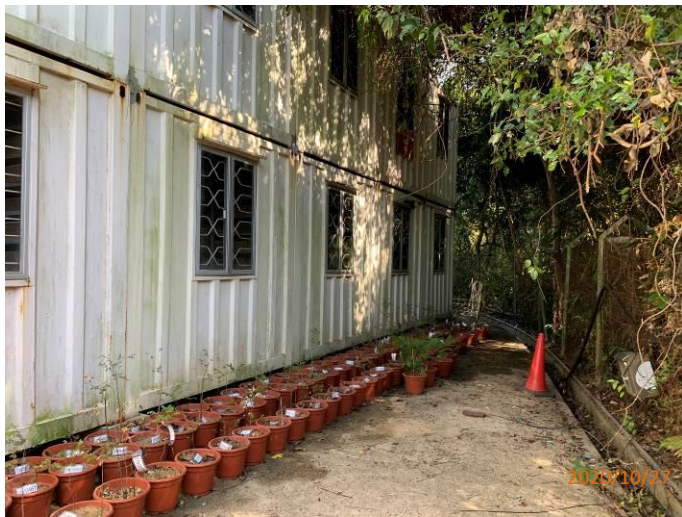
Post-transplantation monitoring at temporary nursery on 14 & 27 October 2020

1st Batch of *Diospyros vaccinioides*

2nd batch of *Diospyros vaccinioides*

3rd batch of *Diospyros vaccinioides*

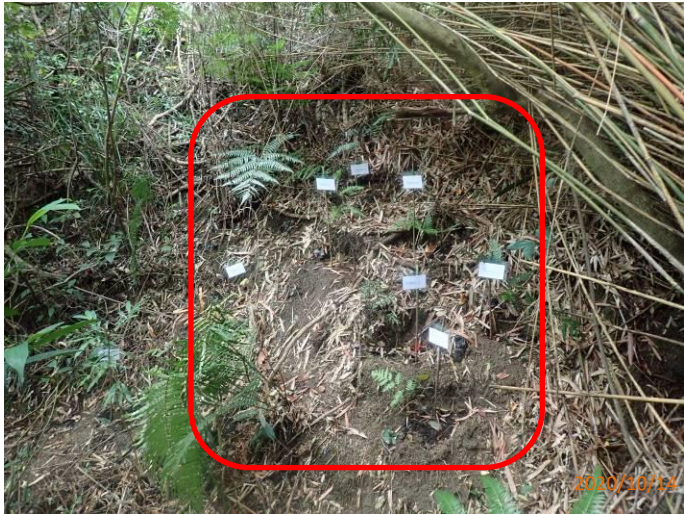
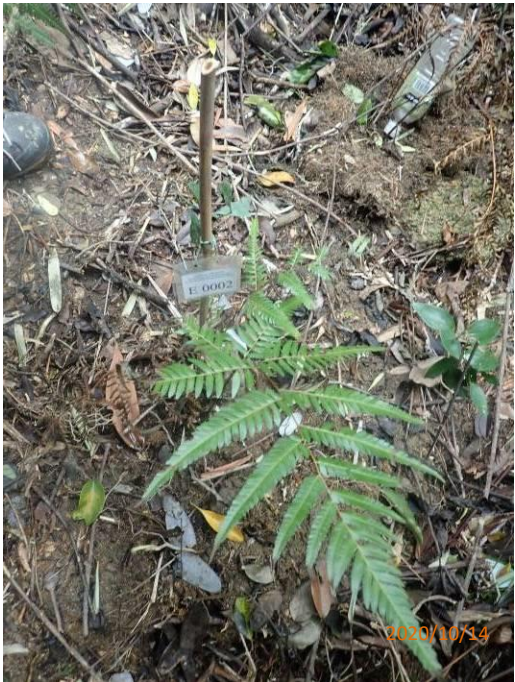
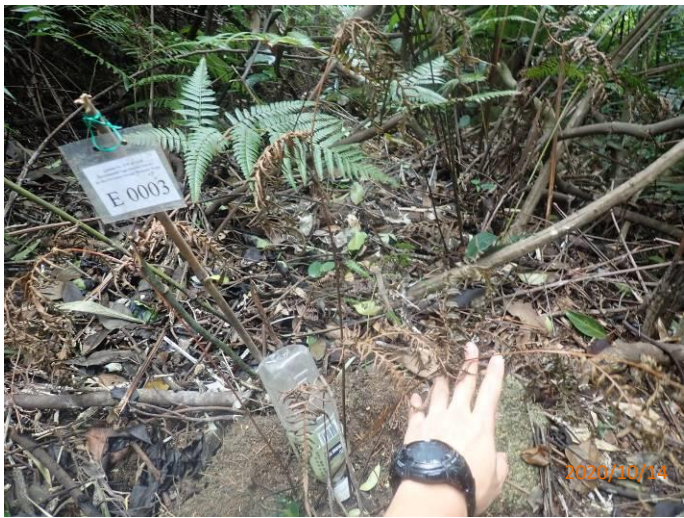
For E0001a-1 to E0001a-17, E0002 and E0003, plant conditions were listed in **Table 3**, and corresponding photographic records were shown in **Appendix 2**. Despite root balls were maintained intact as far as possible, transplanted plants need time to grow into new soil of the receptor site. Therefore, sign of dehydration, leaf yellowing/ wilting, or even die-off were expected.

Post-transplantation monitoring at receptor site on 14 October 2020

E0001a-1 to E0001a-17

E0002

E0003

In contrast, the Landscape Contractor was recommended to check all transplanted plants after heavy rains/ typhoon under safe condition, in order to carry out any stabilization/ maintenance work. Blocked drainage shall be cleared; excessive water shall be pumped or diverged from nursery ground; saturated soil shall be aerated.

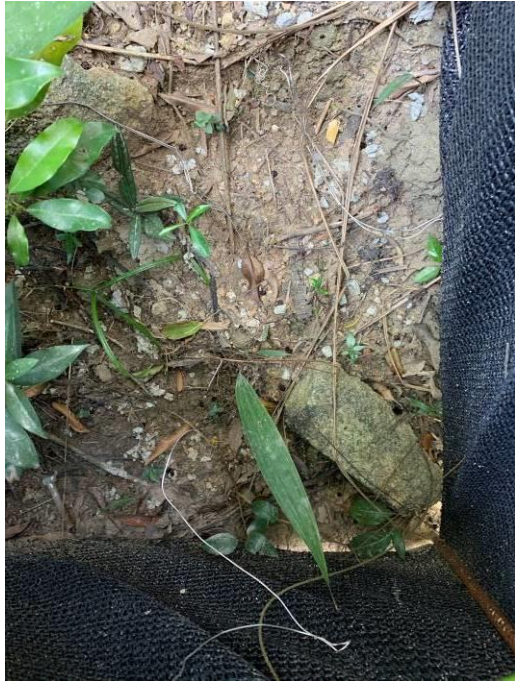
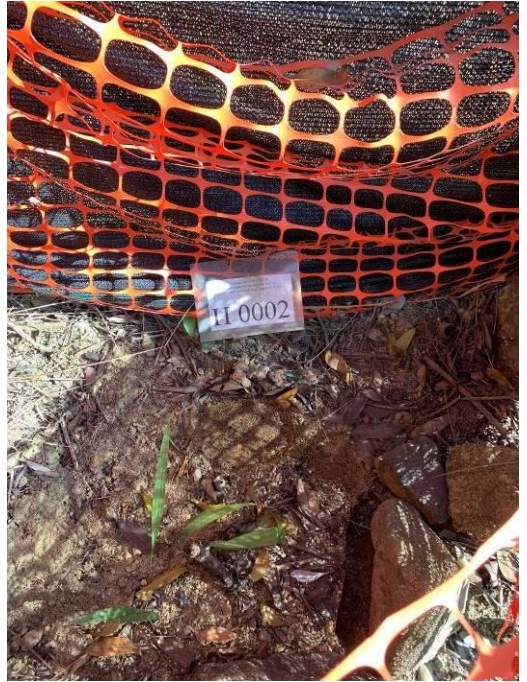
The patch of retained *Ania hongkongensis* (named as H0001) was observed in a fair condition during reporting period, with corresponding photos presented in **Appendix 3**. The protection zone of H0001 has been expanded due to additional individuals were observed. Landscape Contractor was reminded to carry out regular watering to the transplanted H0002.

H0001

H0002

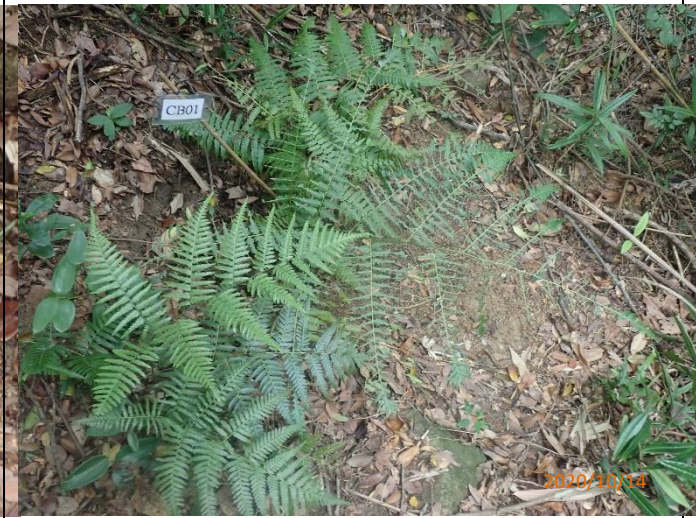
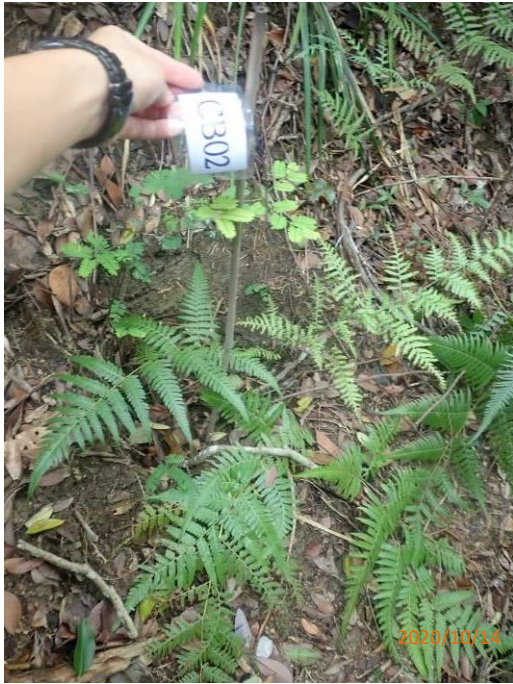
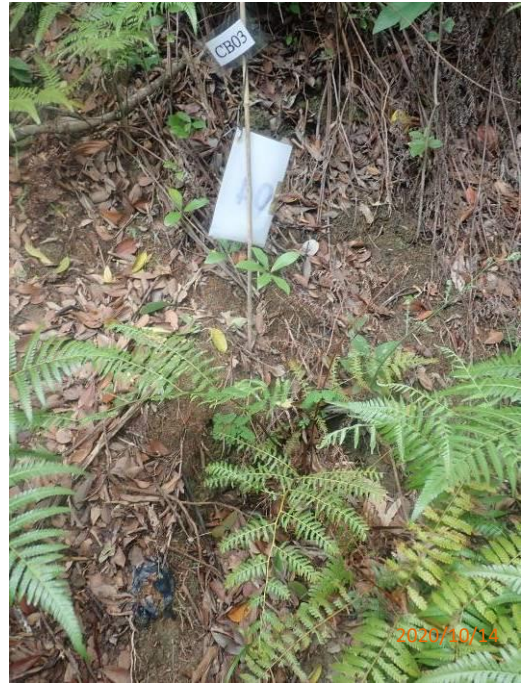
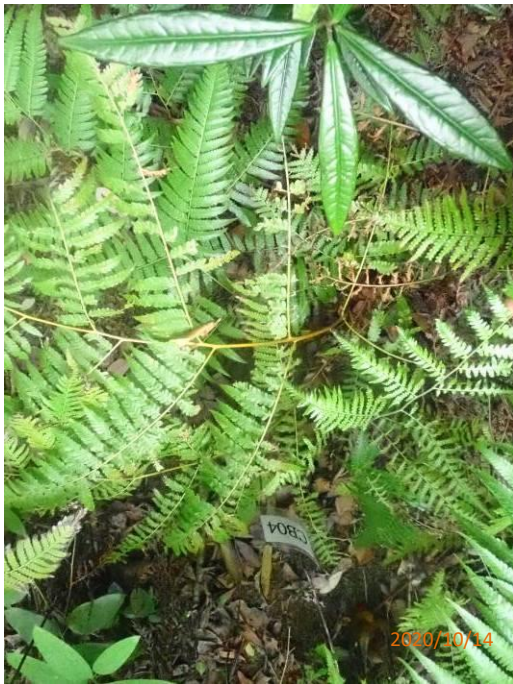
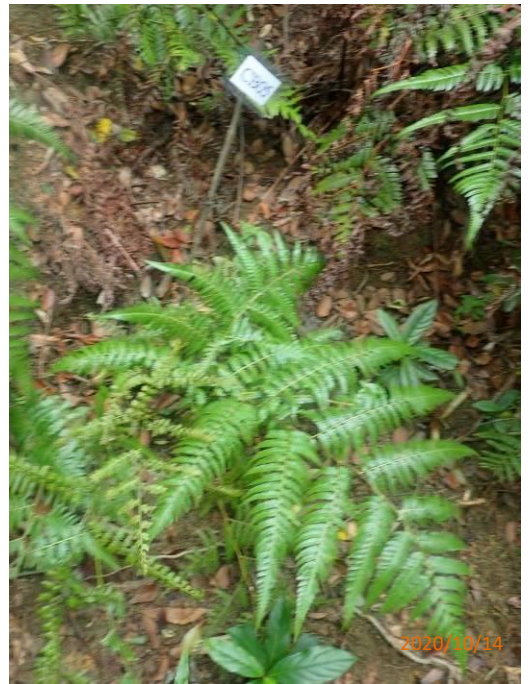
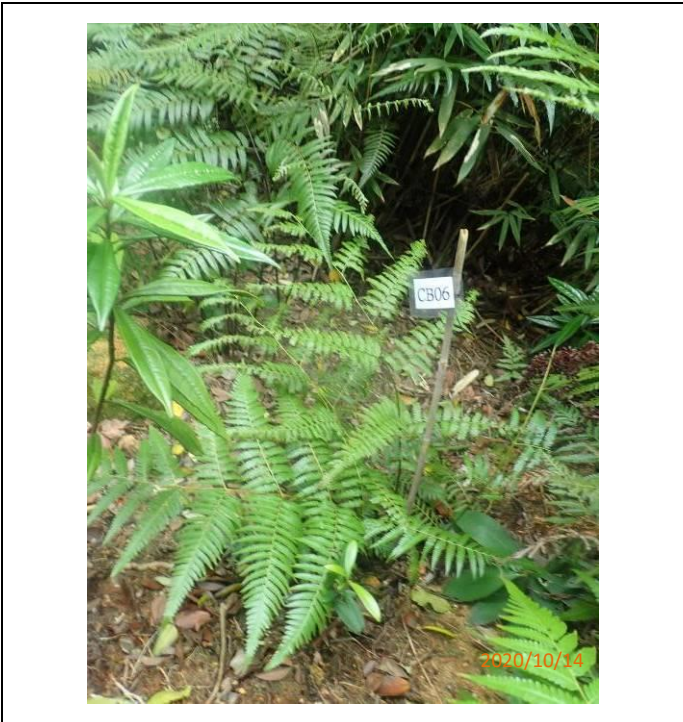
E0004-1

E0004-2

E0004-3

E0004-4

E0004-5

E0004-6

In response to the observed insect damage observed on E0004, appropriate horticultural treatment of spraying soap water (bio-degradable soap mixed with hot water in 1:60-70 ratio and cool down before spraying) once per week for 3-4 cycles with weekly monitoring is suggested to carry out. This help to access if the insect damage stop spreading to other *Cibotium barometz* individuals in vicinity.
