**CONTRACT NO. SPW 25/2018**

**ENVIRONMENTAL TEAM FOR  
RELOCATION OF SHA TIN SEWAGE TREATMENT  
WORKS TO CAVERNS – SITE PREPARATION  
AND ACCESS TUNNEL CONSTRUCTION**

**MONTHLY ENVIRONMENTAL MONITORING & AUDIT  
REPORT**

**NOVEMBER 2020**

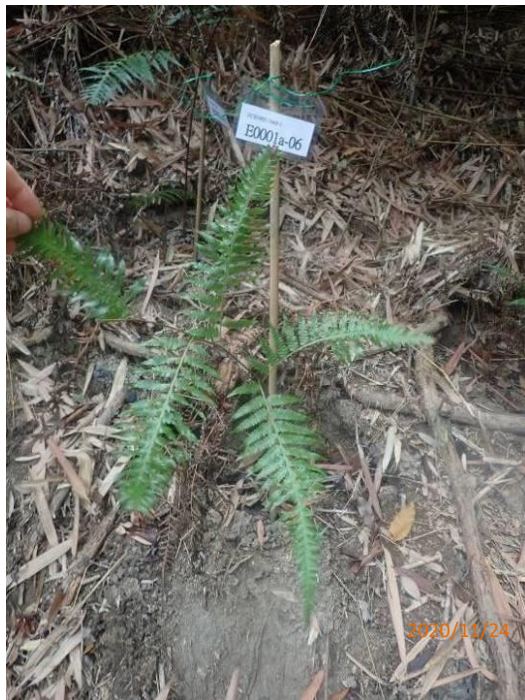
E0001a-06

For E0001a-1 to E0001a-17, E0002 and E0003, plant conditions were listed in **Table 3**, and corresponding photographic records were shown in **Appendix 2**. Despite root balls were maintained intact as far as possible, transplanted plants need time to grow into new soil of the receptor site. Therefore, sign of dehydration, leaf yellowing/ wilting, or even die-off were expected.

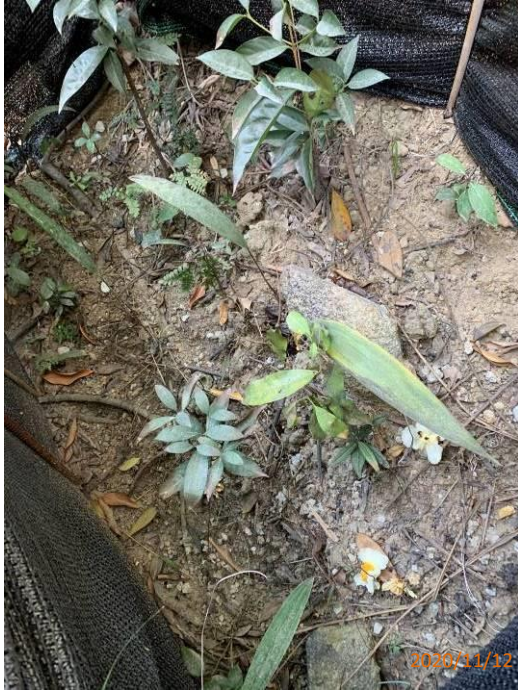
The patch of retained *Ania hongkongensis* (named as H0001) was observed in a fair condition during reporting period, with corresponding photos presented in **Appendix 3**. The protection zone of H0001 has been expanded due to additional individuals were observed. Landscape Contractor was reminded to carry out regular watering to the transplanted H0002.
