**ENVIRONMENTAL TEAM FOR
RELOCATION OF SHA TIN SEWAGE TREATMENT
WORKS TO CAVERNS – SITE PREPARATION
AND ACCESS TUNNEL CONSTRUCTION**

UNDER ENVIRONMENTAL PERMIT NO. EP-533/2017

**MONTHLY ENVIRONMENTAL MONITORING & AUDIT
REPORT**

DECEMBER 2020

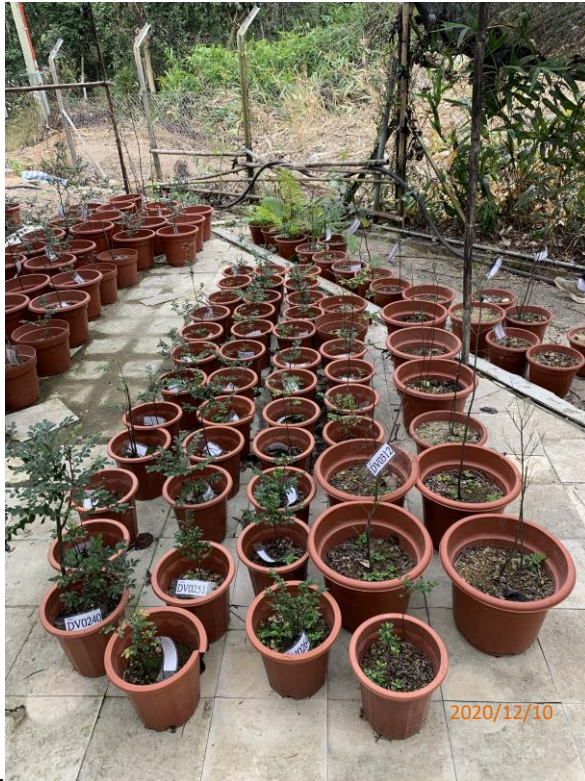
1st Batch of *Diospyros vaccinioides*

Plant conditions of 1st batch, 2nd batch, 3rd batch and 4th batch were listed in **Table 2a, 2b, 2c, 2d** and illustrated in **Appendix 1**. Some seedlings were generally tiny (about 10cm in height) aiming at smaller root zone and better survival. However, some of them have yet developed sufficient leaves. Sign of leaf drop and dehydration has been observed, despite provision of shelter and irrigation (**Plate 1**). Although tiny new branch or leaf buds were observed, seedlings may struggle for survival against environmental stress.

Post-transplantation monitoring at temporary nursery on 10 & 22 December 2020

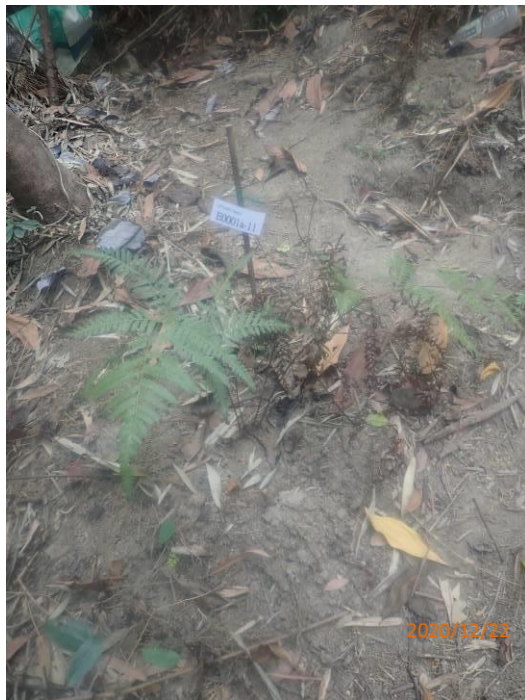
E0001a-11

For E0001a-1 to E0001a-17, E0002 and E0003, plant conditions were listed in **Table 3**, and corresponding photographic records were shown in **Appendix 2**. Despite root balls were maintained intact as far as possible, transplanted plants need time to grow into new soil of the receptor site. Therefore, sign of dehydration, leaf yellowing/ wilting, or even die-off were expected.

Post-transplantation monitoring at receptor site on 22 December 2020

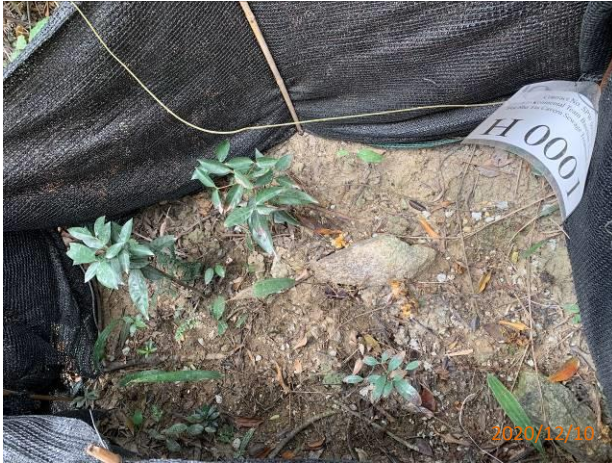
The patch of retained *Ania hongkongensis* (named as H0001) was observed in a fair condition during reporting period, with corresponding photos presented in **Appendix 3**. The protection zone of H0001 has been expanded due to additional individuals were observed. Landscape Contractor was reminded to carry out regular watering to the transplanted H0002.

Bi-weekly ecological monitoring at Site 1 on 10 & 22 December 2020
