**ENVIRONMENTAL TEAM FOR  
RELOCATION OF SHA TIN SEWAGE TREATMENT  
WORKS TO CAVERNS – SITE PREPARATION  
AND ACCESS TUNNEL CONSTRUCTION**

**UNDER ENVIRONMENTAL PERMIT NO. EP-533/2017**

**MONTHLY ENVIRONMENTAL MONITORING & AUDIT  
REPORT**

**JANUARY 2021**

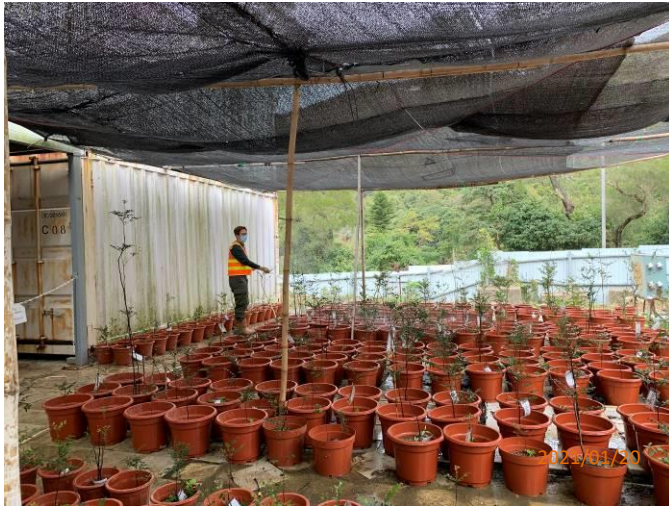
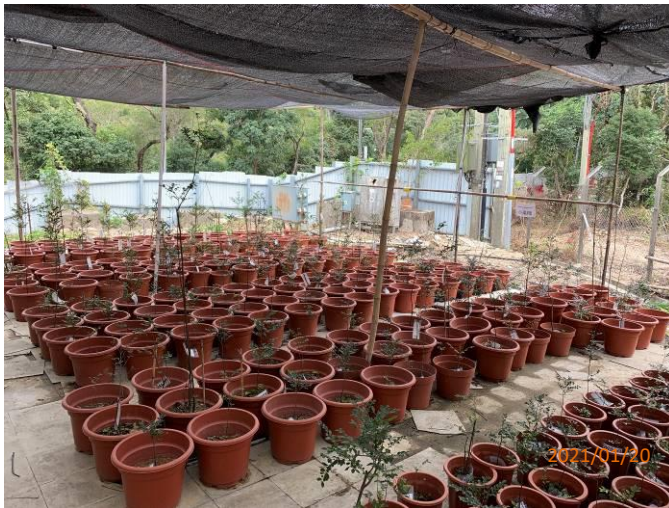
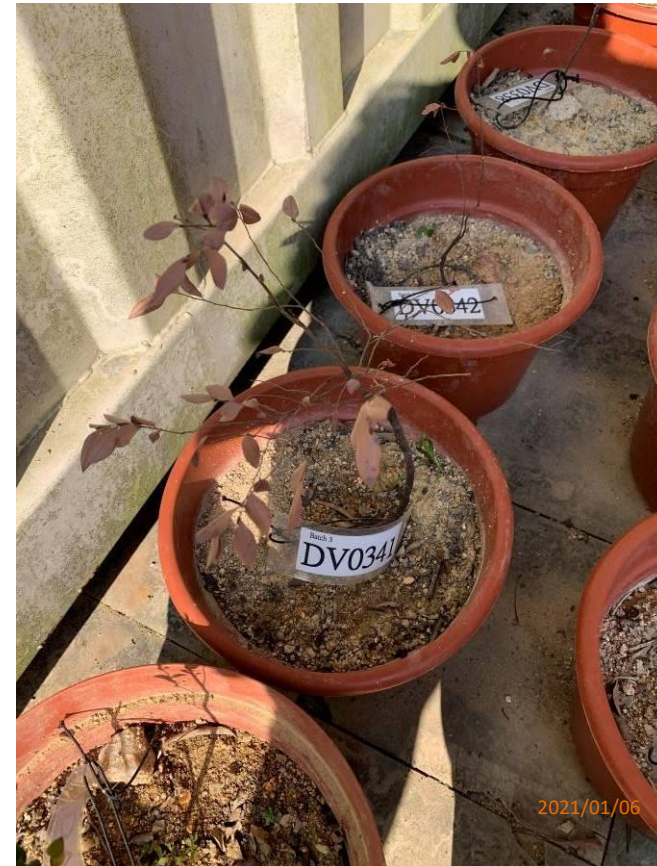
**Plate 1.** The 4 batches of *Diospyros vaccinioides* transplanted from Site 1 and 2; stored by Landscape Specialist Contractor at the on-site nursery (left). Wilting have been observed in some transplanted individuals (right).

Plant conditions of 1<sup>st</sup> batch, 2<sup>nd</sup> batch, 3<sup>rd</sup> batch and 4<sup>th</sup> batch were listed in **Table 2a, 2b, 2c, 2d** and illustrated in **Appendix 1**. Some seedlings were generally tiny (about 10cm in height) aiming at smaller root zone and better survival. However, some of them have yet developed sufficient leaves. Sign of leaf drop and dehydration has been observed, despite provision of shelter and irrigation (**Plate 1**). Although tiny new branch or leaf buds were observed, seedlings may struggle for survival against environmental stress.

According to environmental condition and location of the receptor sites/ nursery, watering frequency was recommended in daily practice for at least the first 3 months as the transplant time is in summer months with strong sunlight and high temperature; except the days with fog and rain. Water frequency may be reduced based on the plant condition after monitoring in the first 3 months.

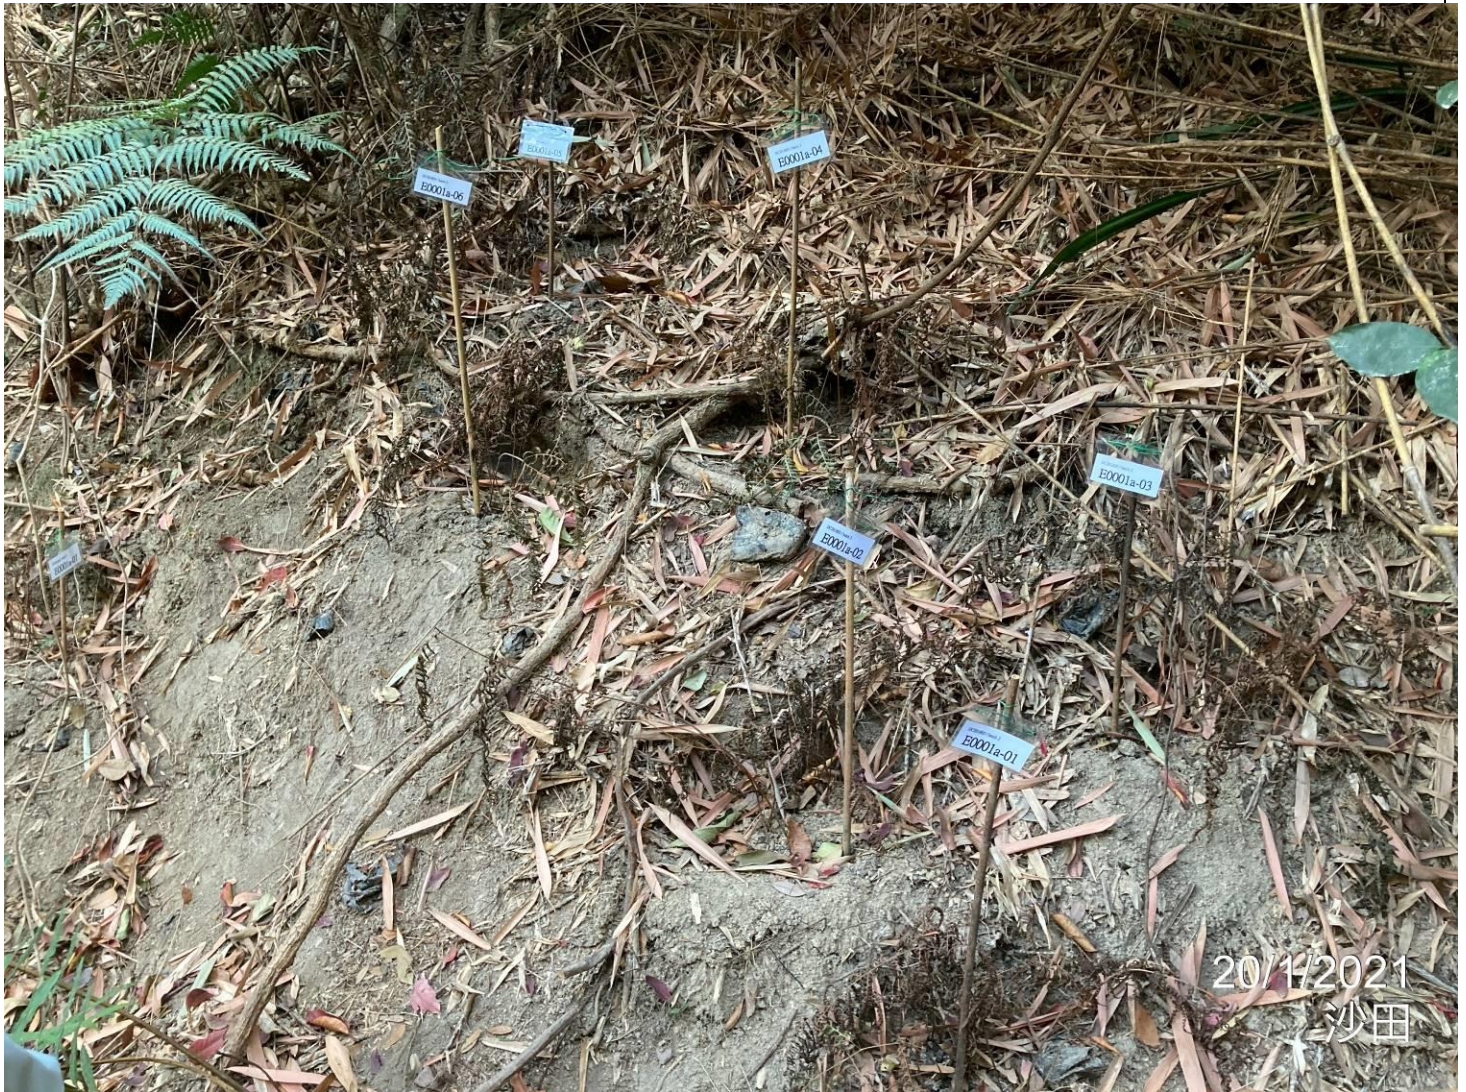
E0001a-01

For E0001a-1 to E0001a-17, E0002 and E0003, plant conditions were listed in **Table 3**, and corresponding photographic records were shown in **Appendix 2**. Despite root balls were maintained intact as far as possible, sign of dehydration, leaf yellowing/ wilting, or even die-off were observed due to low air humidity and soil moisture in the reporting month.

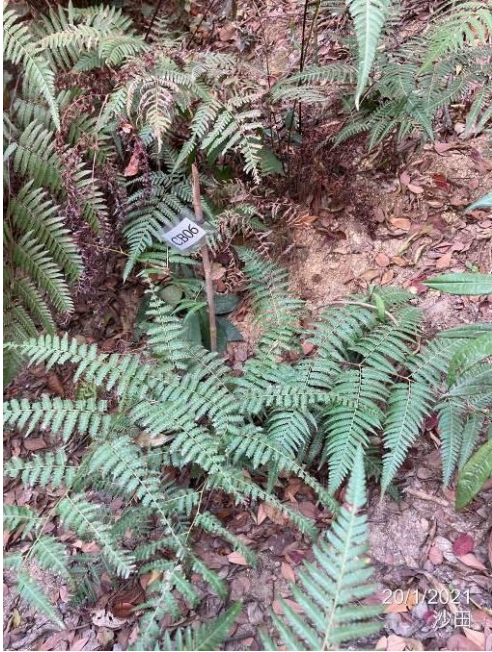
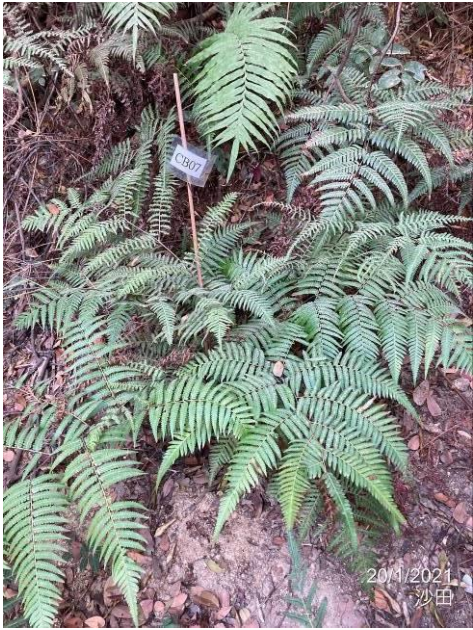
E0004-6 renamed as CB06	E0004-7 renamed as CB07

In response to the observed insect damage observed on E0004, appropriate horticultural treatment of spraying soap water (bio-degradable soap mixed with hot water in 1:60-70 ratio and cool down before spraying) once per week for 3-4 cycles with weekly monitoring is suggested to carry out. This help to access if the insect damage stop spreading to other *Cibotium barometz* individuals in vicinity.
