**ENVIRONMENTAL TEAM FOR
RELOCATION OF SHA TIN SEWAGE TREATMENT
WORKS TO CAVERNS – SITE PREPARATION
AND ACCESS TUNNEL CONSTRUCTION**

**MONTHLY ENVIRONMENTAL MONITORING & AUDIT
REPORT**

FEBRUARY 2021

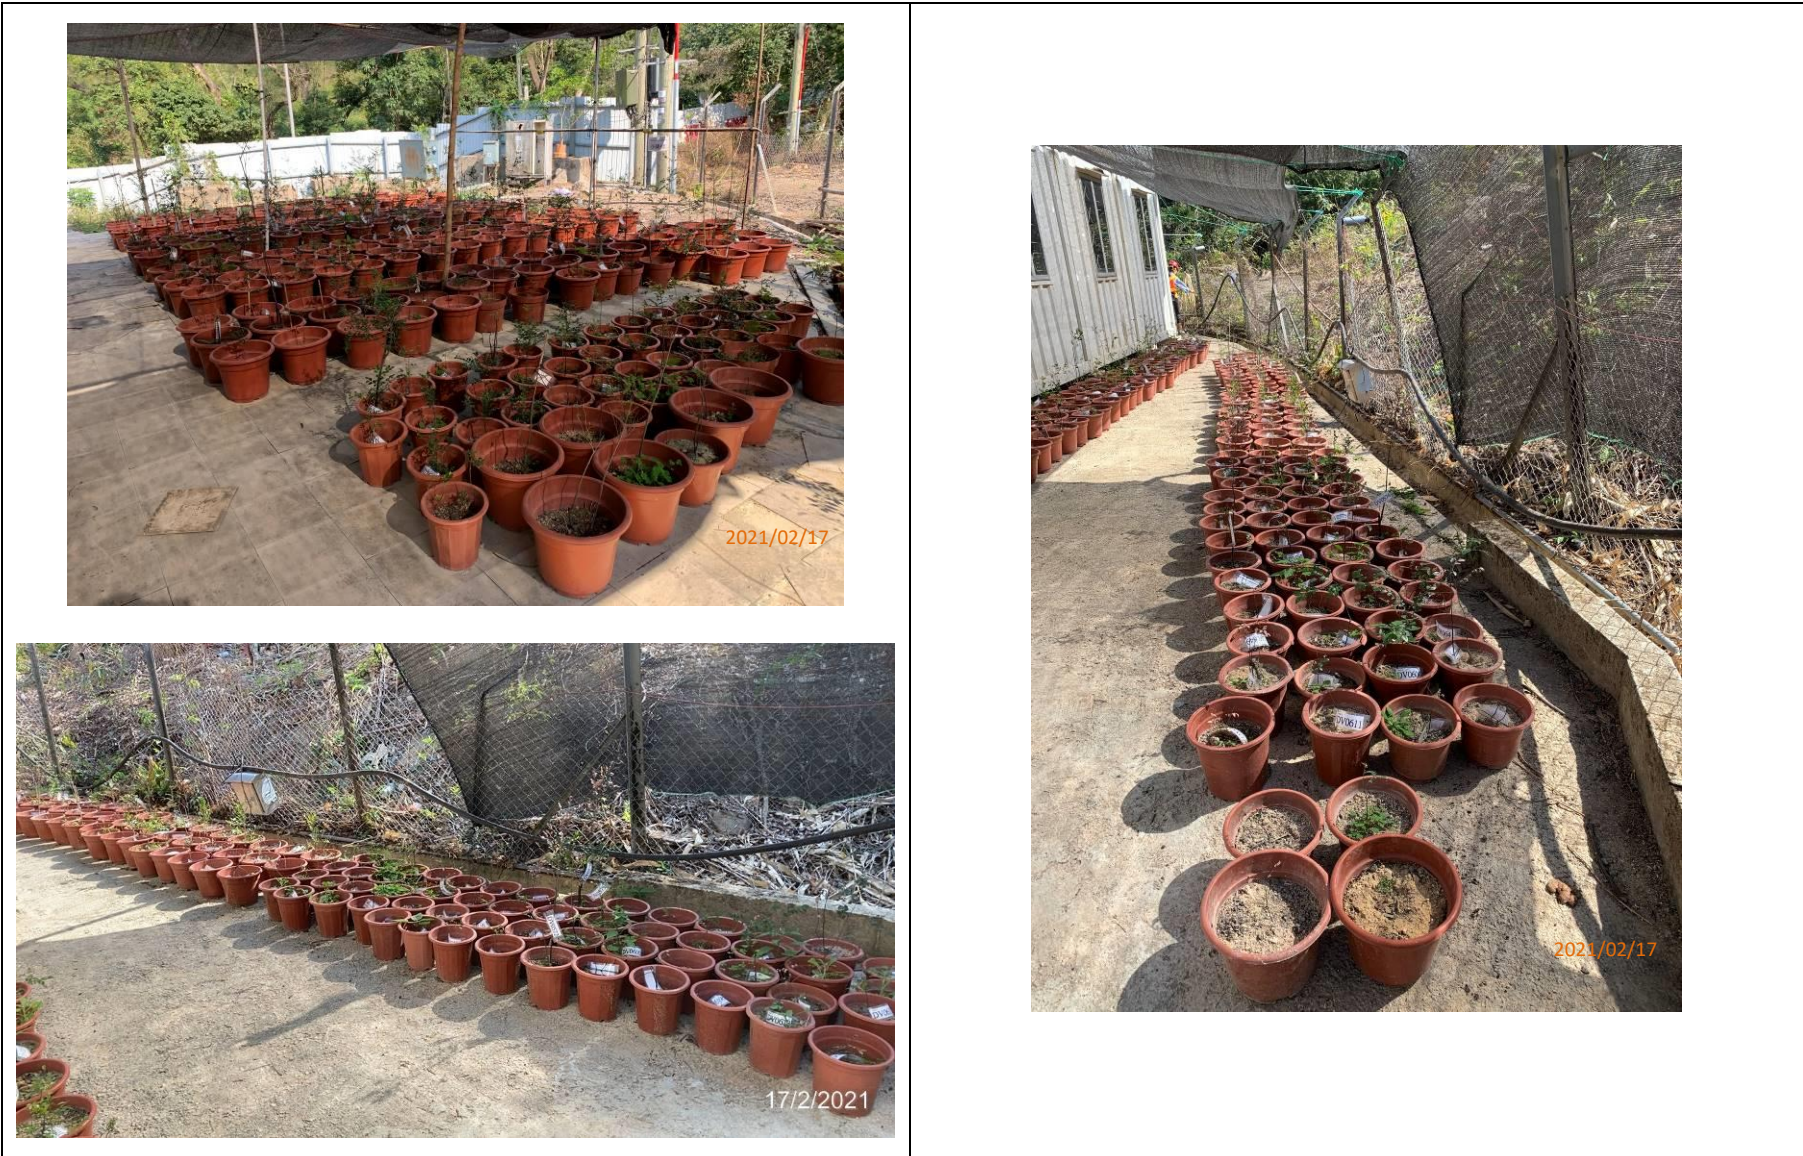
Plate 1. The 4 batches of *Diospyros vaccinioides* transplanted from Site 1 and 2; stored by Landscape Specialist Contractor at the on-site nursery (left). Wilting have been observed in some transplanted individuals (right).

Plant conditions of 1st batch, 2nd batch, 3rd batch and 4th batch were listed in **Table 2a, 2b, 2c, 2d** and illustrated in **Appendix 1**. Some seedlings were generally tiny (about 10cm in height) aiming at smaller root zone and better survival. However, some of them have yet developed sufficient leaves. Sign of leaf drop and dehydration has been observed, despite provision of shelter and irrigation (**Plate 1**). Although tiny new branch or leaf buds were observed, seedlings may struggle for survival against environmental stress.

According to environmental condition and location of the receptor sites/ nursery, watering frequency was recommended in daily practice for at least the first 3 months as the transplant time is in summer months with strong sunlight and high temperature; except the days with fog and rain. Water frequency may be reduced based on the plant condition after monitoring in the first 3 months.

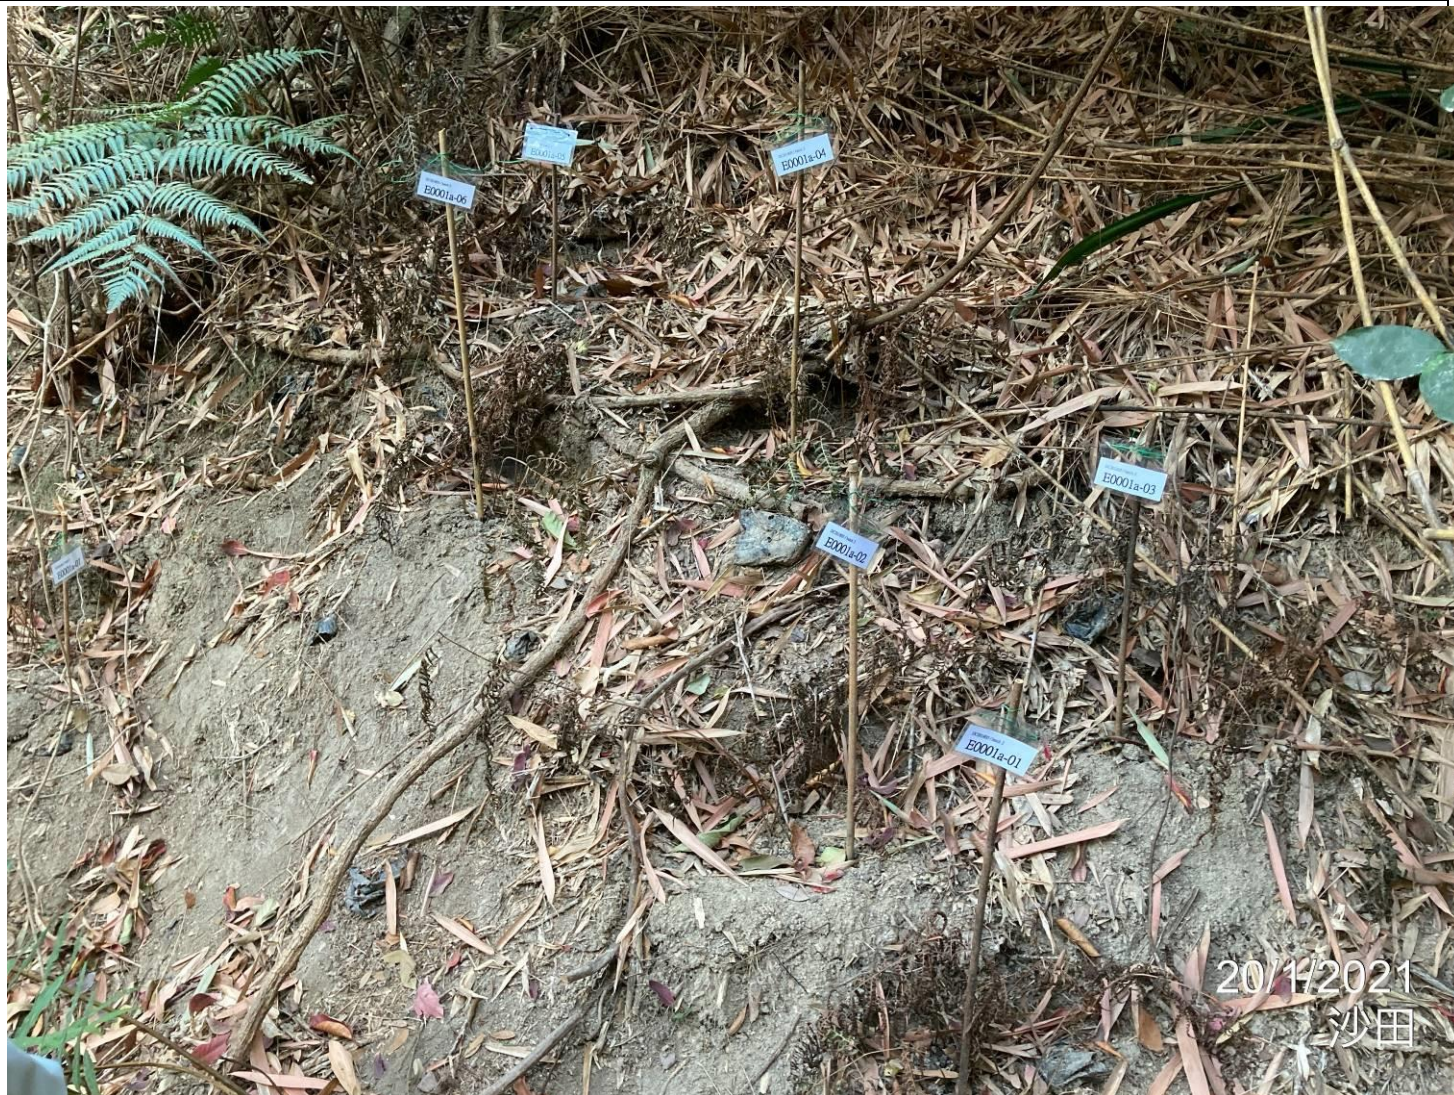
- E0001a-01
- E0001a-02
- E0001a-03
- E0001a-04
- E0001a-05
- E0001a-06

Post-transplantation monitoring at receptor site on 20 January 2021

Monitoring for 19 nos. of *Cibotium barometz* (E0001a-1 to E0001a-17, E0002 and E0003) were conducted on 20 January 2021 at a quarterly basis and the coming monitoring will be carried out in April 2021. Plant conditions were listed in **Table 3**, and corresponding photographic records were shown in **Appendix 2**.

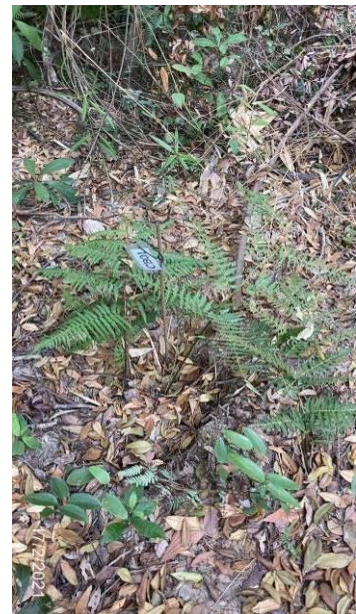
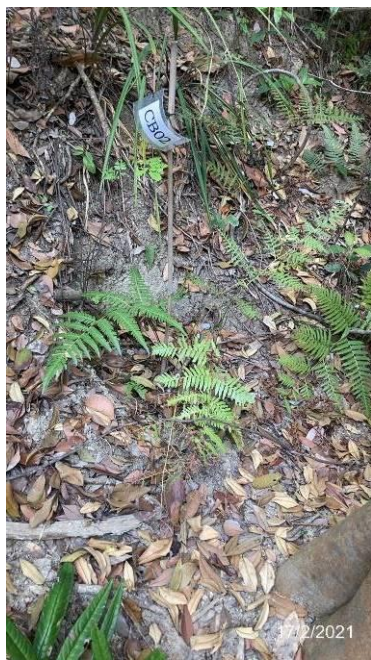
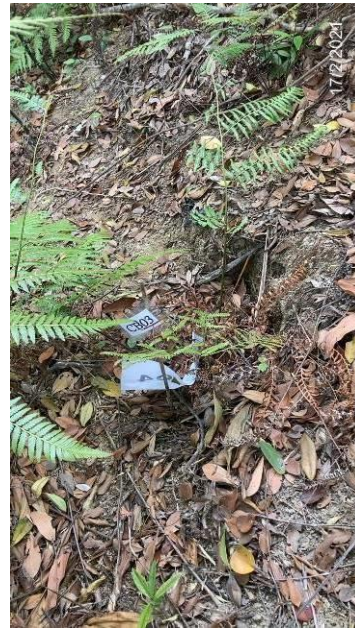
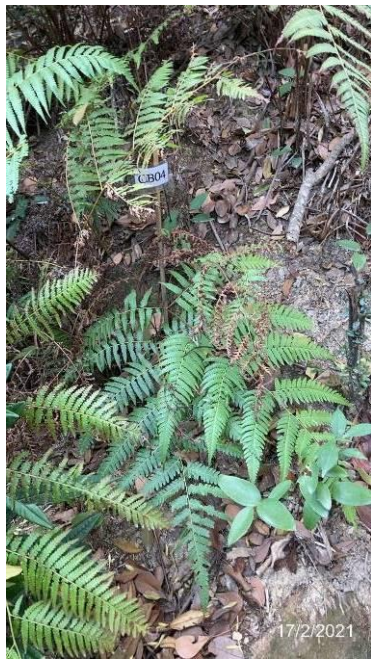
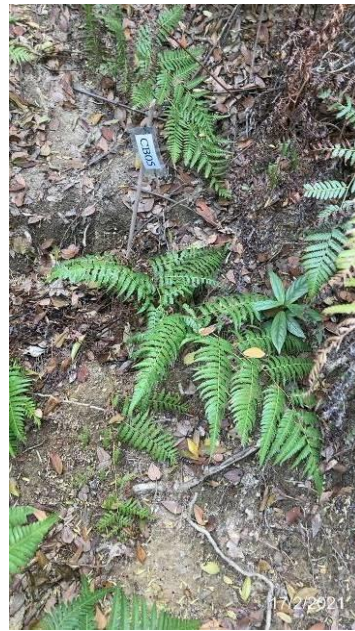
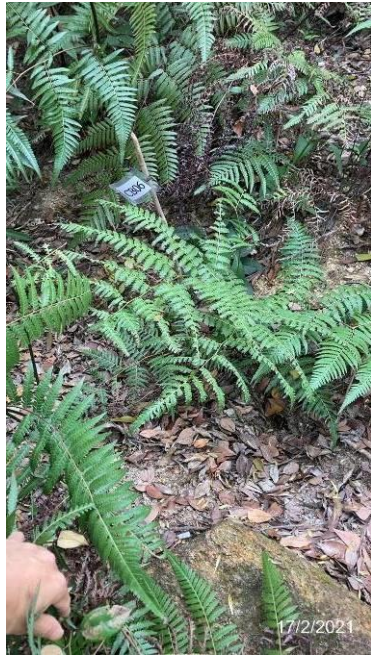
E0004-1 renamed as CB01

E0004-2 renamed as CB02

E0004-3 renamed as CB03

E0004-4 renamed as CB04

E0004-5 renamed as CB05

In response to the observed insect damage observed on E0004, appropriate horticultural treatment of spraying soap water (bio-degradable soap mixed with hot water in 1:60-70 ratio and cool down before spraying) once per week for 3-4 cycles with weekly monitoring is suggested to carry out. This help to access if the insect damage stop spreading to other *Cibotium barometz* individuals in vicinity.
