**ENVIRONMENTAL TEAM FOR
RELOCATION OF SHA TIN SEWAGE TREATMENT
WORKS TO CAVERNS – SITE PREPARATION
AND ACCESS TUNNEL CONSTRUCTION**

**MONTHLY ENVIRONMENTAL MONITORING & AUDIT
REPORT**

MARCH 2021

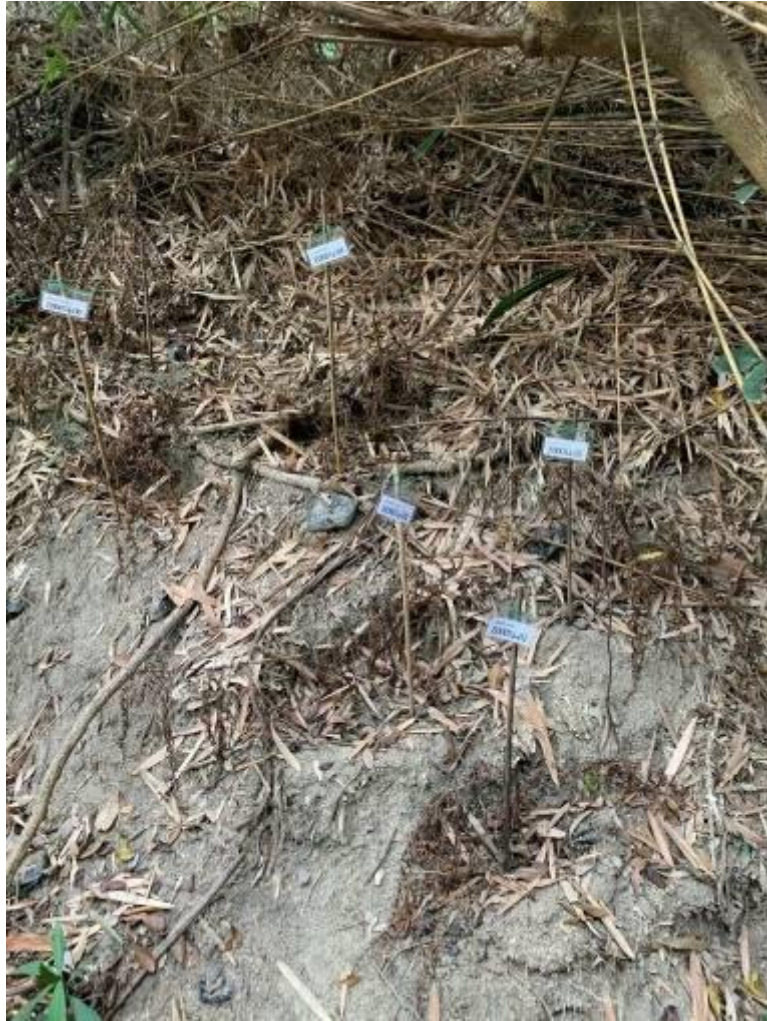
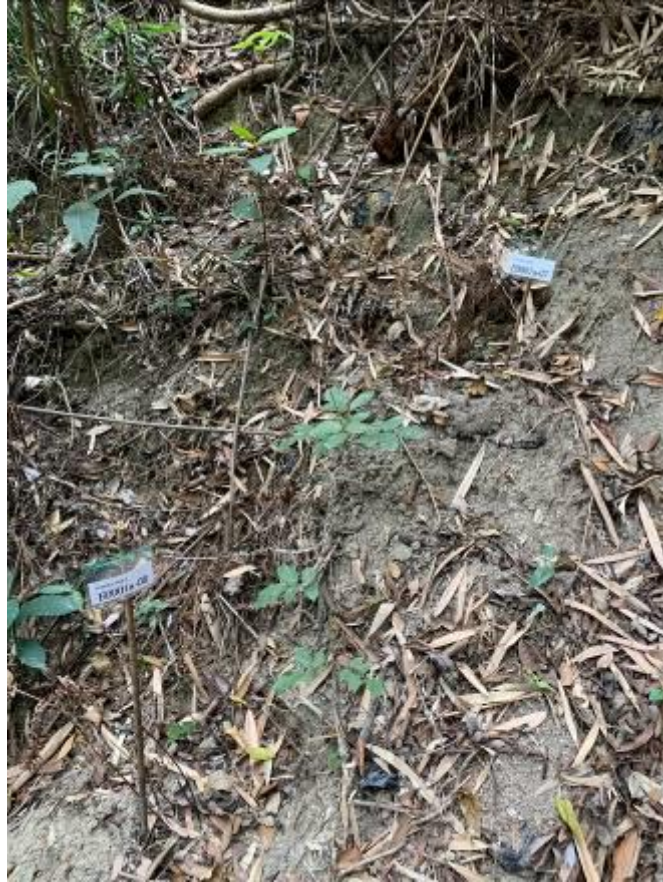
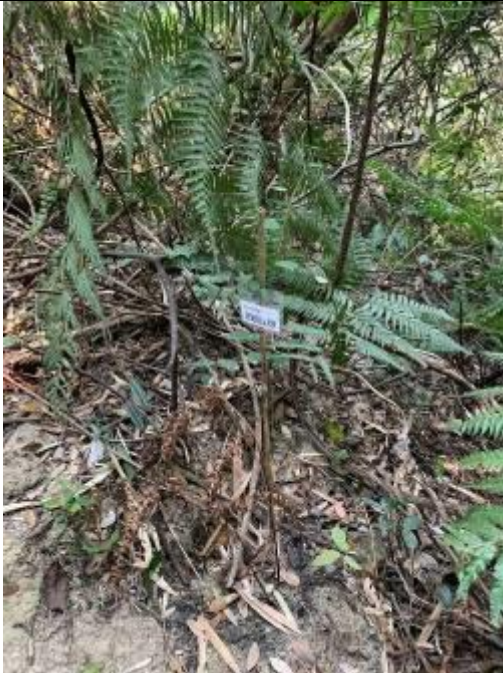
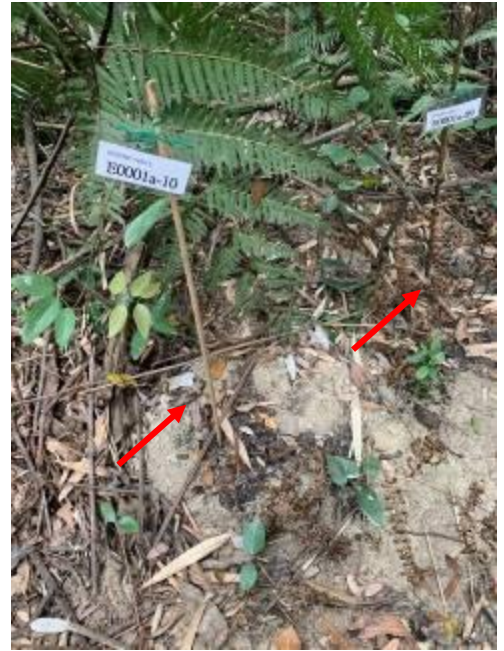
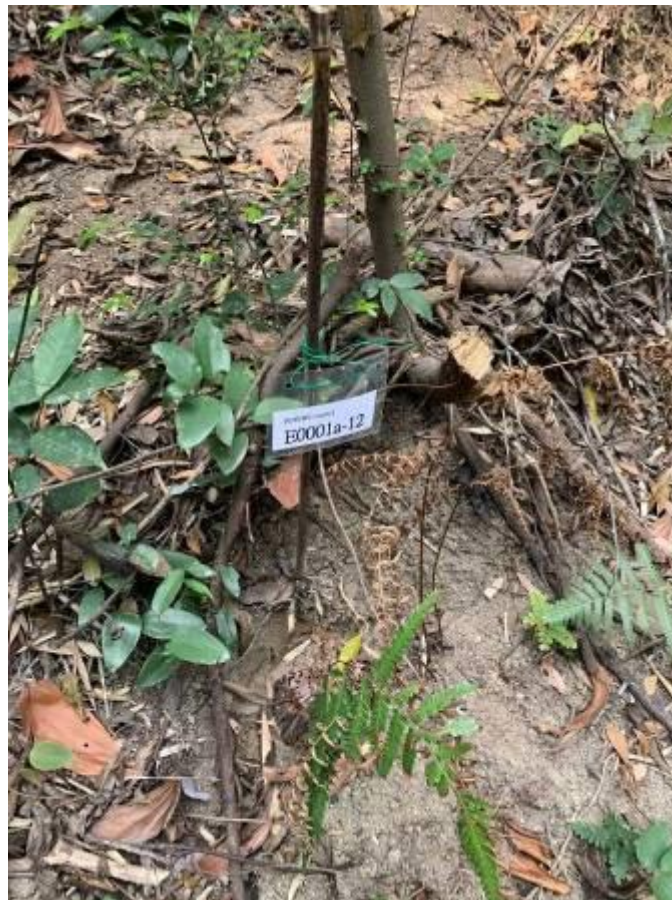
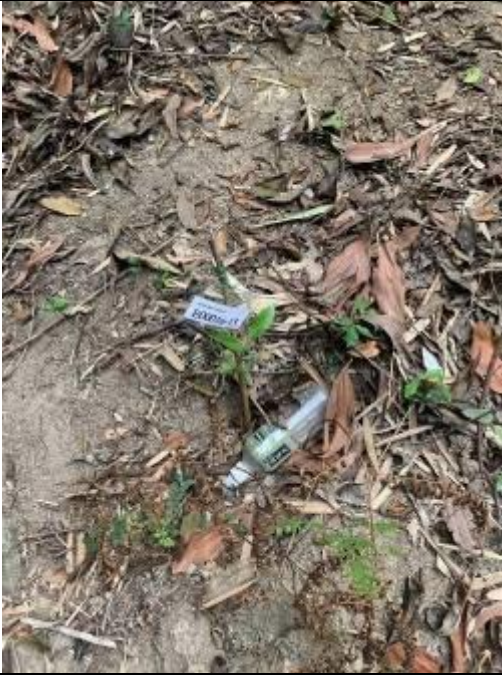
Monitoring for 19 nos. of *Cibotium barometz* (E0001a-1 to E0001a-17, E0002 and E0003) and were conducted on 17 March 2021 at a quarterly basis and the coming monitoring will be carried out in June 2021. Plant conditions were listed in **Table 3**, and corresponding photographic records were shown in **Appendix 2**.

Date of monitoring	No.	Form	Health condition	Structural condition	Amenity value	Remarks
17-Mar-20	E0001a-1	Poor	Poor	Poor	Poor	
	E0001a-2	Poor	Poor	Poor	Poor	
	E0001a-3	Poor	Poor	Poor	Poor	
	E0001a-4	Poor	Poor	Poor	Poor	
	E0001a-5	Poor	Poor	Poor	Poor	
	E0001a-6	Poor	Poor	Poor	Poor	
	E0001a-7	Poor	Poor	Poor	Poor	
	E0001a-8	Poor	Poor	Poor	Poor	
	E0001a-9	Poor	Poor	Poor	Poor	
	E0001a-10	Poor	Poor	Poor	Poor	
	E0001a-11	Poor	Poor	Poor	Poor	
	E0001a-12	Poor	Poor	Poor	Poor	
	E0001a-13	Poor	Poor	Poor	Poor	
	E0001a-14	Poor	Poor	Poor	Poor	
	E0001a-15	Poor	Poor	Poor	Poor	
	E0001a-16	Poor	Poor	Poor	Poor	
	E0002-01	Poor	Poor	Poor	Poor	
	E0002-02	Poor	Poor	Poor	Poor	
	E0003	Poor	Poor	Poor	Poor

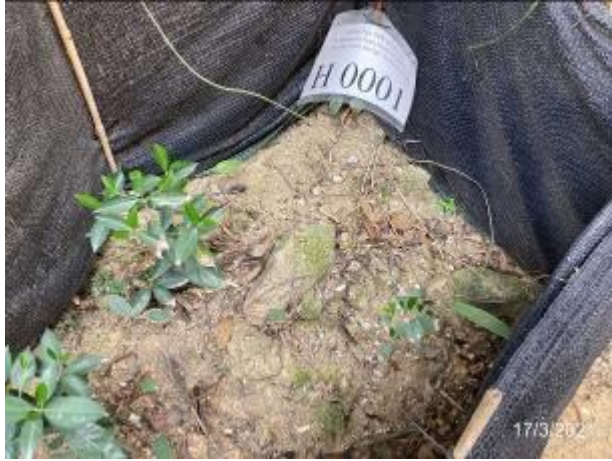
The patch of retained *Ania hongkongensis* (named as H0001) was observed in a fair condition during reporting period, with corresponding photos presented in **Appendix 3**. The protection zone of H0001 has been expanded due to additional individuals were observed. Landscape Contractor was reminded to carry out regular watering to the transplanted H0002.
