**ENVIRONMENTAL TEAM FOR
RELOCATION OF SHA TIN SEWAGE TREATMENT
WORKS TO CAVERNS – SITE PREPARATION
AND ACCESS TUNNEL CONSTRUCTION**

UNDER ENVIRONMENTAL PERMIT NO. EP-533/2017

**MONTHLY ENVIRONMENTAL MONITORING & AUDIT
REPORT**

APRIL 2021

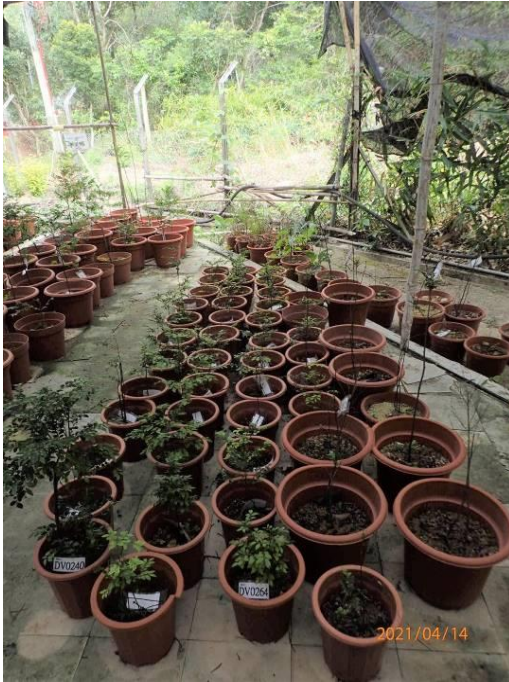
1st Batch of *Diospyros vaccinioides*

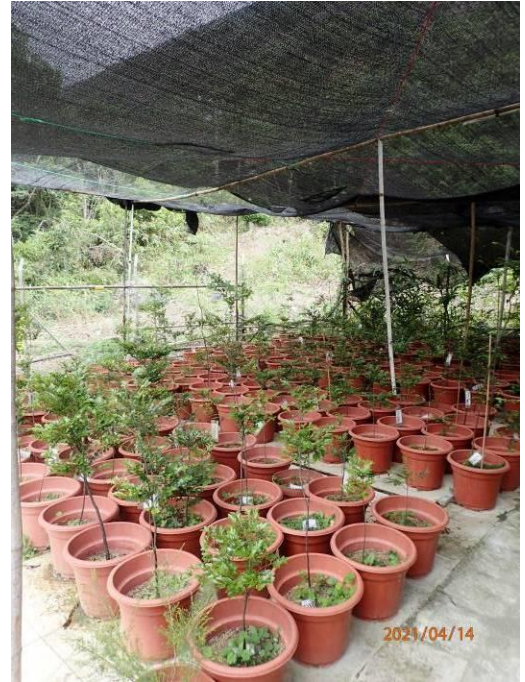
2nd batch of *Diospyros vaccinioides*

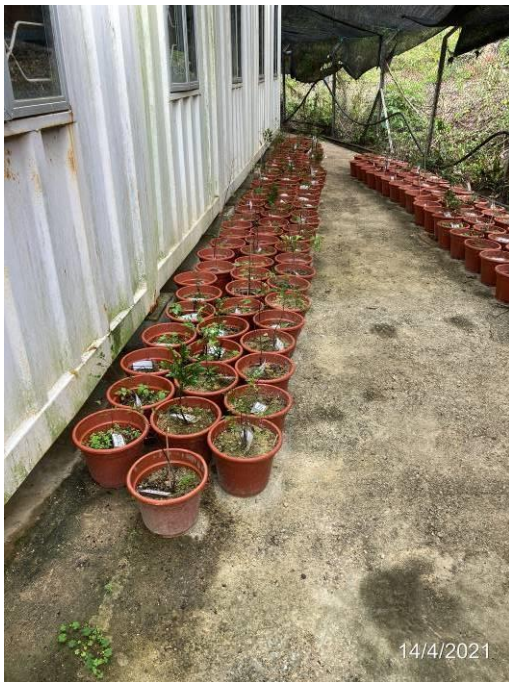
Date of monitoring	No.	Form	Health condition	Structural condition	Amenity value	Remarks
14 and 27 Apr 2021	DV0269	Fair	Fair	Fair	Fair	Leaf dropped
	DV0270	Fair	Fair	Fair	Fair	Leaf dropped
	DV0271	Fair	Fair	Fair	Fair	Leaf dropped
	DV0272	Fair	Fair	Fair	Fair	
	DV0273	Fair	Fair	Fair	Fair	Leaf dropped
	DV0276	Fair	Fair	Fair	Fair	Leaf dropped
	DV0278	Fair	Fair	Fair	Fair	
	DV0279	Fair	Fair	Fair	Fair	Leaf dropped
	DV0280	Fair	Fair	Fair	Fair	Leaf dropped
	DV0281	Fair	Fair	Fair	Fair	
	DV0283	Fair	Fair	Fair	Fair	
	DV0284	Fair	Fair	Fair	Fair	
	DV0285	Fair	Fair	Fair	Fair	
	DV0286	Fair	Fair	Fair	Fair	
	DV0287	Fair	Fair	Fair	Fair	
	DV0291	Fair	Fair	Fair	Fair	Leaf dropped
	DV0292	Fair	Fair	Fair	Fair	
	DV0293	Fair	Fair	Fair	Fair	
	DV0295	Fair	Fair	Fair	Fair	Leaf dropped
	DV0298	Fair	Fair	Fair	Fair	
	DV0299	Fair	Fair	Fair	Fair	Leaf dropped
	DV0300	Fair	Fair	Fair	Fair	Leaf dropped
	DV0301	Fair	Fair	Fair	Fair	
	DV0302	Fair	Fair	Fair	Fair	Leaf dropped

3rd batch of *Diospyros vaccinioides*

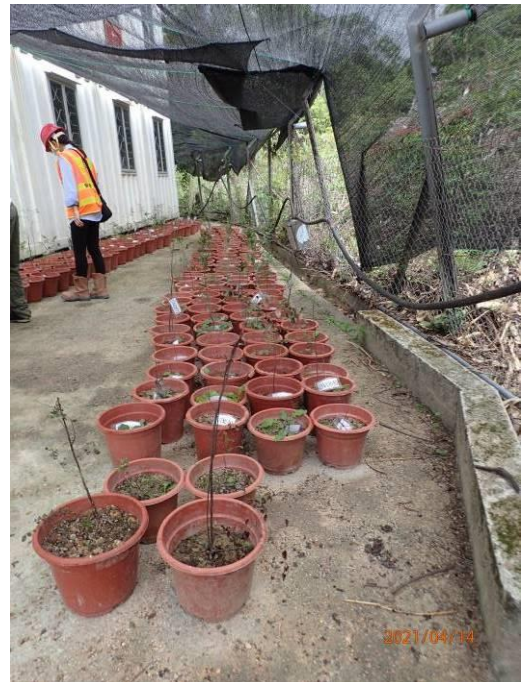
Date of monitoring	No.	Form	Health condition	Structural condition	Amenity value	Remarks
14 and 27 Apr 2021	DV0571	Fair	Fair	Fair	Fair	
	DV0572	Fair	Fair	Fair	Fair	Leaf dropped
	DV0573	Fair	Fair	Fair	Fair	Leaf dropped
	DV0574	Fair	Fair	Fair	Fair	Leaf dropped
	DV0575	Fair	Fair	Fair	Fair	
	DV0584	Fair	Fair	Fair	Fair	
	DV0585	Fair	Fair	Fair	Fair	Leaf dropped
	DV0589	Fair	Fair	Fair	Fair	
	DV0590	Fair	Fair	Fair	Fair	
	DV0594	Fair	Fair	Fair	Fair	Leaf dropped
	DV0596	Fair	Fair	Fair	Fair	Leaf dropped
	DV0597	Fair	Fair	Fair	Fair	
	DV0599	Fair	Fair	Fair	Fair	
	DV0600	Fair	Fair	Fair	Fair	
	DV0601	Fair	Fair	Fair	Fair	
	DV0602	Fair	Fair	Fair	Fair	
	DV0603	Fair	Fair	Fair	Fair	
	DV0604	Fair	Fair	Fair	Fair	
	DV0605	Fair	Fair	Fair	Fair	
	DV0606	Fair	Fair	Fair	Fair	
	DV0607	Fair	Fair	Fair	Fair	
	DV0608	Fair	Fair	Fair	Fair	
	DV0609	Fair	Fair	Fair	Fair	
	DV0614	Fair	Fair	Fair	Fair	Leaf dropped
	DV0615	Fair	Fair	Fair	Fair	
	DV0616	Fair	Fair	Fair	Fair

4th batch of *Diospyros vaccinioides*

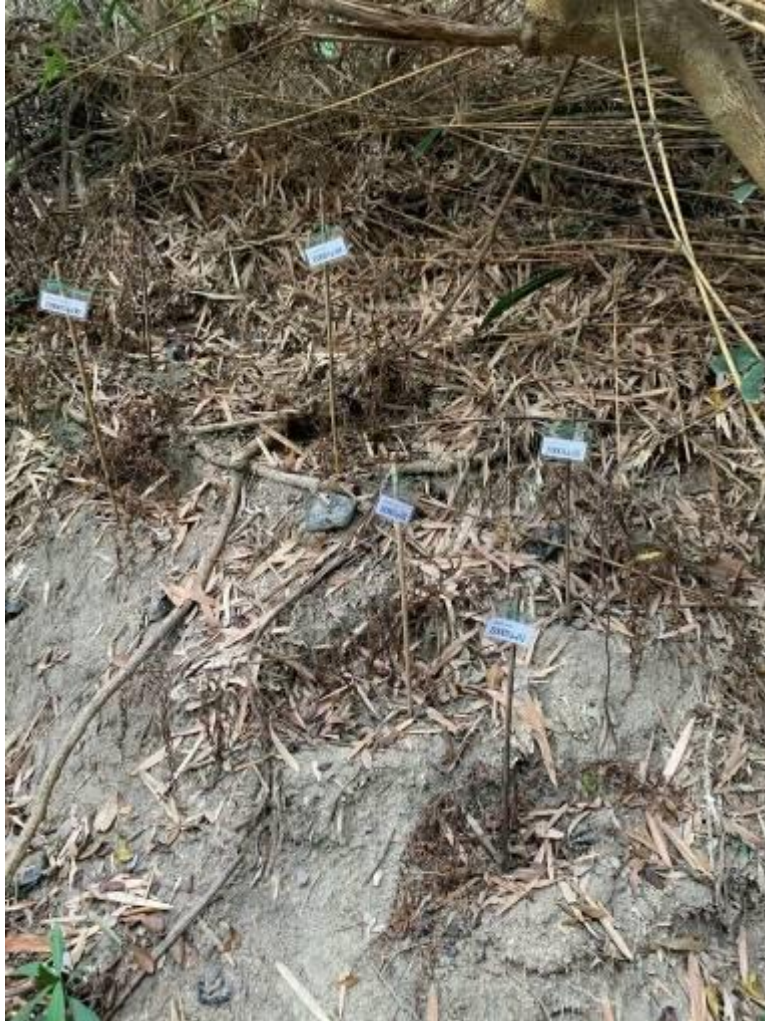
E0001a-01

Date of monitoring	No.	Form	Health condition	Structural condition	Amenity value	Remarks
17-Mar-20	E0001a-1	Poor	Poor	Poor	Poor	
	E0001a-2	Poor	Poor	Poor	Poor	
	E0001a-3	Poor	Poor	Poor	Poor	
	E0001a-4	Poor	Poor	Poor	Poor	
	E0001a-5	Poor	Poor	Poor	Poor	
	E0001a-6	Poor	Poor	Poor	Poor	
	E0001a-7	Poor	Poor	Poor	Poor	
	E0001a-8	Poor	Poor	Poor	Poor	
	E0001a-9	Poor	Poor	Poor	Poor	
	E0001a-10	Poor	Poor	Poor	Poor	
	E0001a-11	Poor	Poor	Poor	Poor	
	E0001a-12	Poor	Poor	Poor	Poor	
	E0001a-13	Poor	Poor	Poor	Poor	
	E0001a-14	Poor	Poor	Poor	Poor	
	E0001a-15	Poor	Poor	Poor	Poor	
	E0001a-16	Poor	Poor	Poor	Poor	
	E0002-01	Poor	Poor	Poor	Poor	
	E0002-02	Poor	Poor	Poor	Poor	
	E0003	Poor	Poor	Poor	Poor

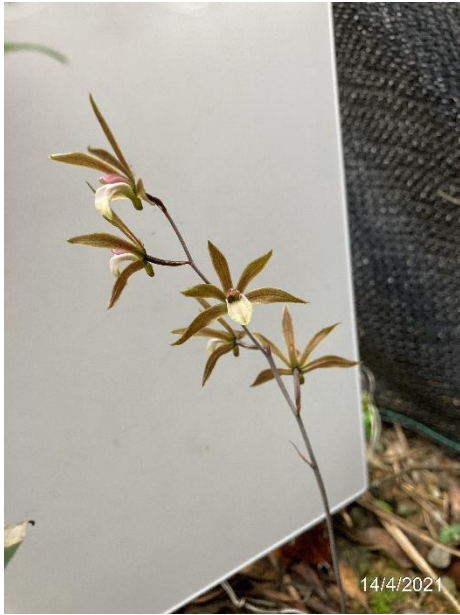
The patch of retained *Ania hongkongensis* (named as H0001) was observed in a fair condition during reporting period, with corresponding photos presented in **Appendix 3**. The protection zone of H0001 has been expanded due to additional individuals were observed. Landscape Contractor was reminded to carry out regular watering to the transplanted H0002.
