**ENVIRONMENTAL TEAM FOR
RELOCATION OF SHA TIN SEWAGE TREATMENT
WORKS TO CAVERNS – SITE PREPARATION
AND ACCESS TUNNEL CONSTRUCTION**

UNDER ENVIRONMENTAL PERMIT NO. EP-533/2017

**MONTHLY ENVIRONMENTAL MONITORING & AUDIT
REPORT**

JULY 2021

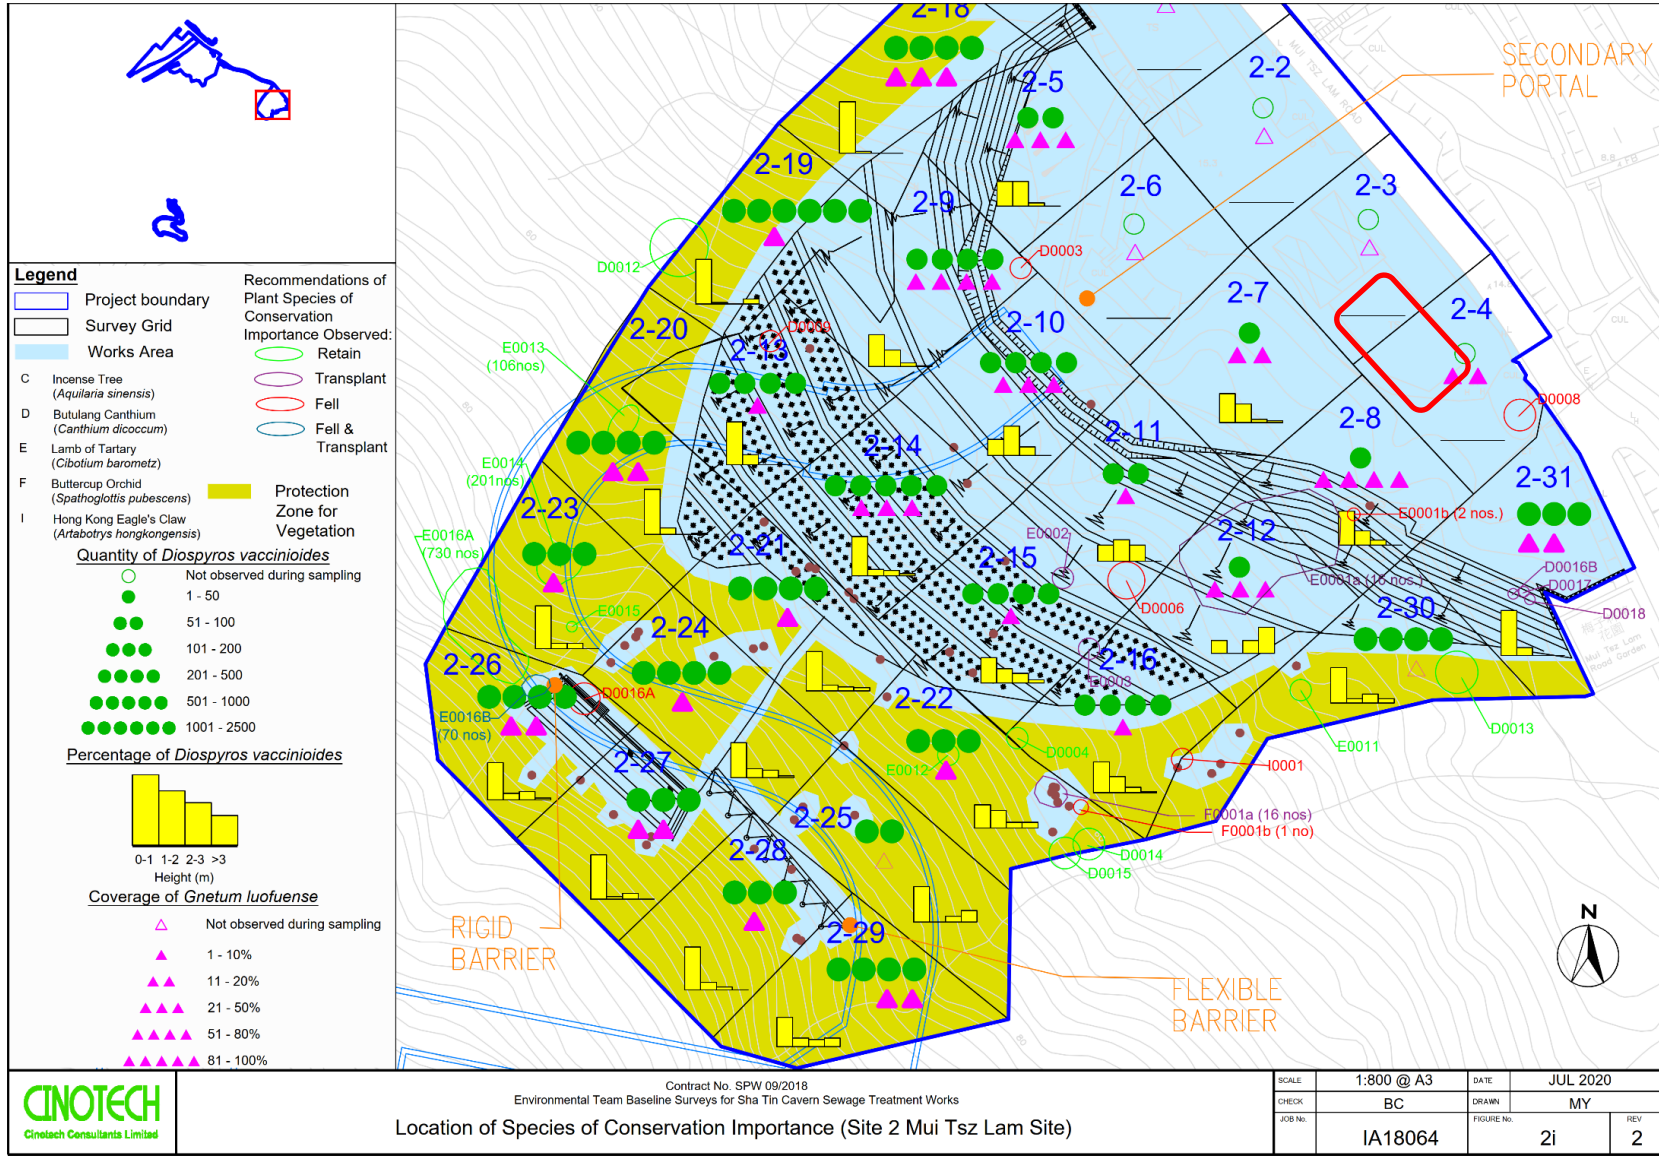
Figure 2. Original location of DV0269-DV0500 (3rd batch) and DV0501-DV0550 (4th batch) at Site 2. Previous nursery site highlighted in red frame for DV0229-DV0268 (1st batch), DV0001-DV0228 (2nd batch), DV0269-DV0500 (3rd batch) and DV0501-DV0550 (4th batch) at Site 2.

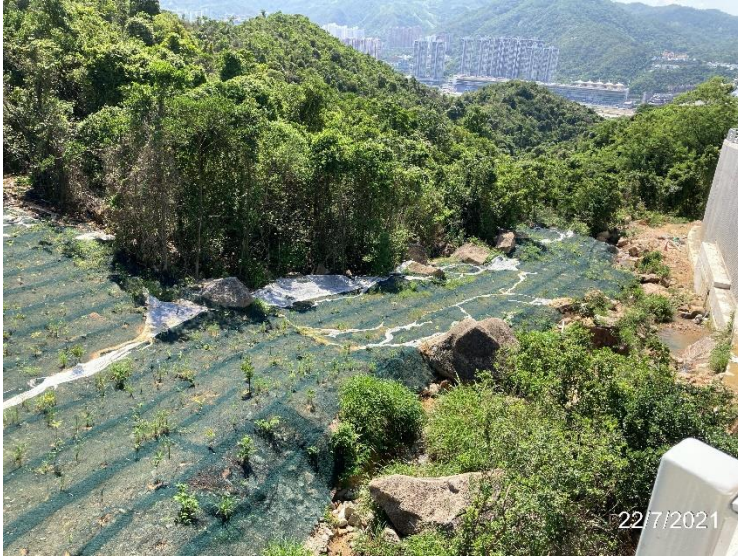
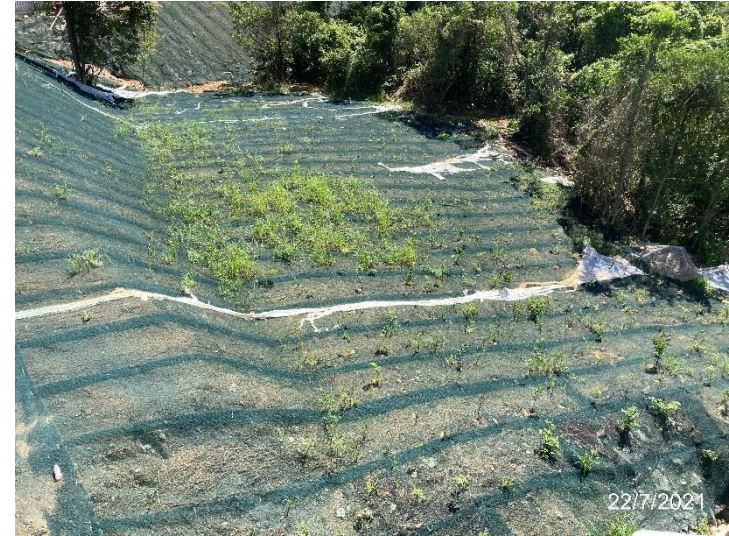
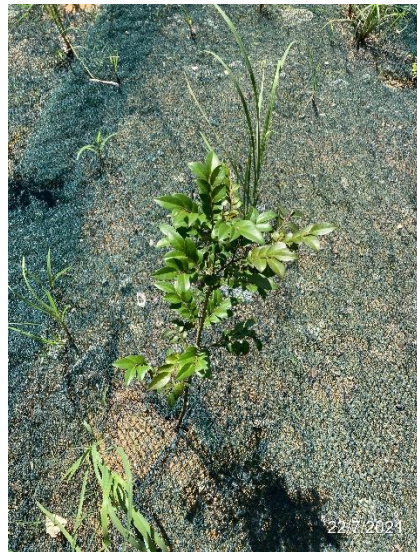
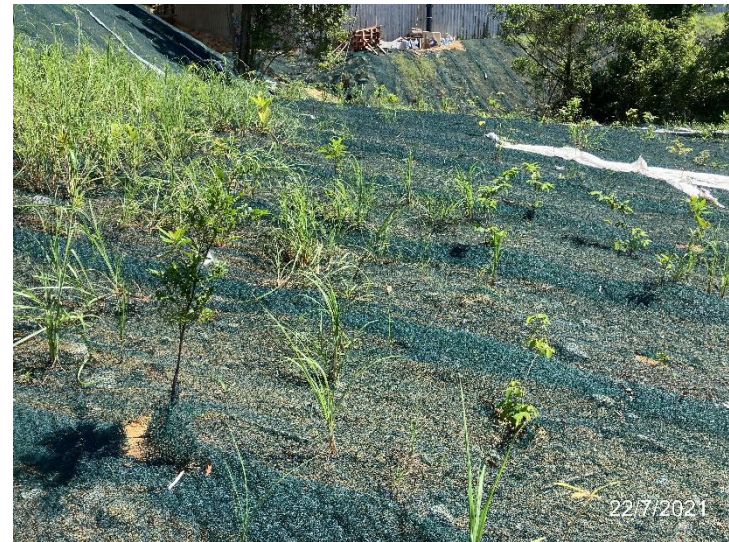
Photographic records of 1st batch, 2nd batch, 3rd batch and 4th batch of *Diospyros vaccinioides* at the receptor site are presented in **Appendix 1**. Some seedlings were generally tiny (about 10cm in height) aiming at smaller root zone and better survival. However, some of them have yet developed sufficient leaves. Sign of leaf drop and dehydration has been observed, despite provision of shelter and irrigation. Although tiny new branch or leaf buds were observed, seedlings may struggle for survival against environmental stress.

Post-transplantation monitoring at receptor site at RMZ1 down hill side on 6 and 22 July 2021

According to environmental condition and location of the receptor sites/ nursery, watering frequency was recommended in daily practice for at least the first 3 months as the transplant time is in summer months with strong sunlight and high temperature; except the days with fog and rain. Water frequency may be reduced based on the plant condition after monitoring in the first 3 months.

In contrast, the Landscape Contractor was recommended to check all transplanted plants after heavy rains/ typhoon under safe condition, in order to carry out any stabilization/ maintenance work. Blocked drainage shall be cleared; excessive water shall be pumped or diverged from nursery ground; saturated soil shall be aerated.

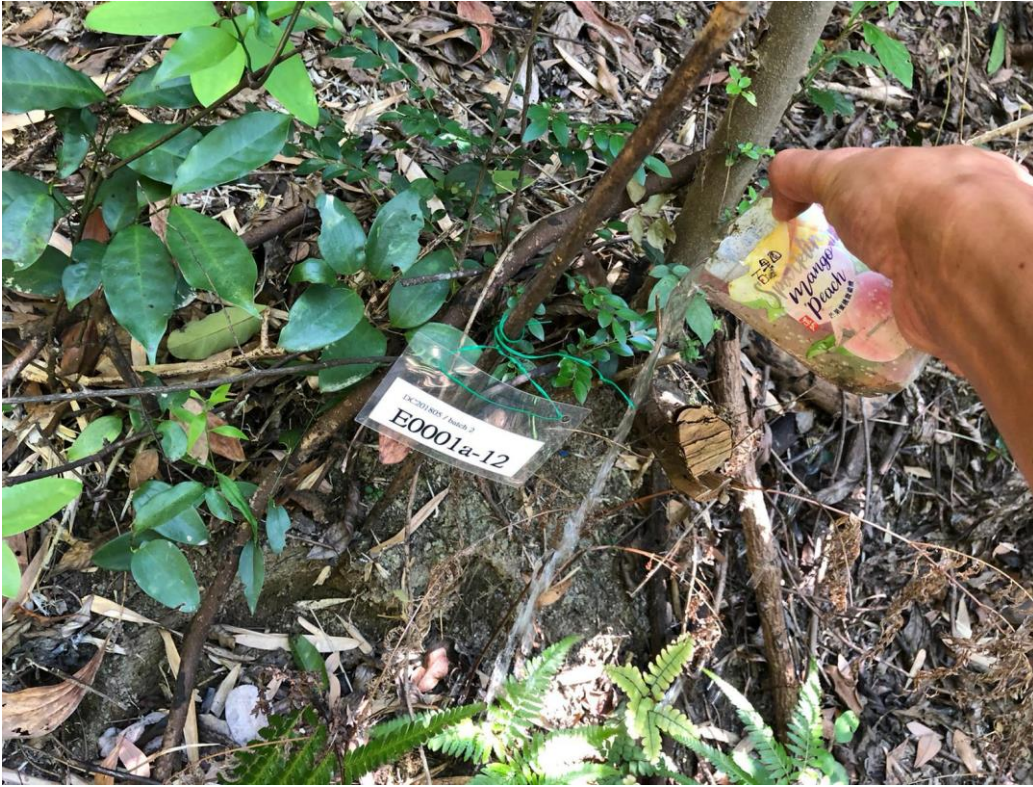
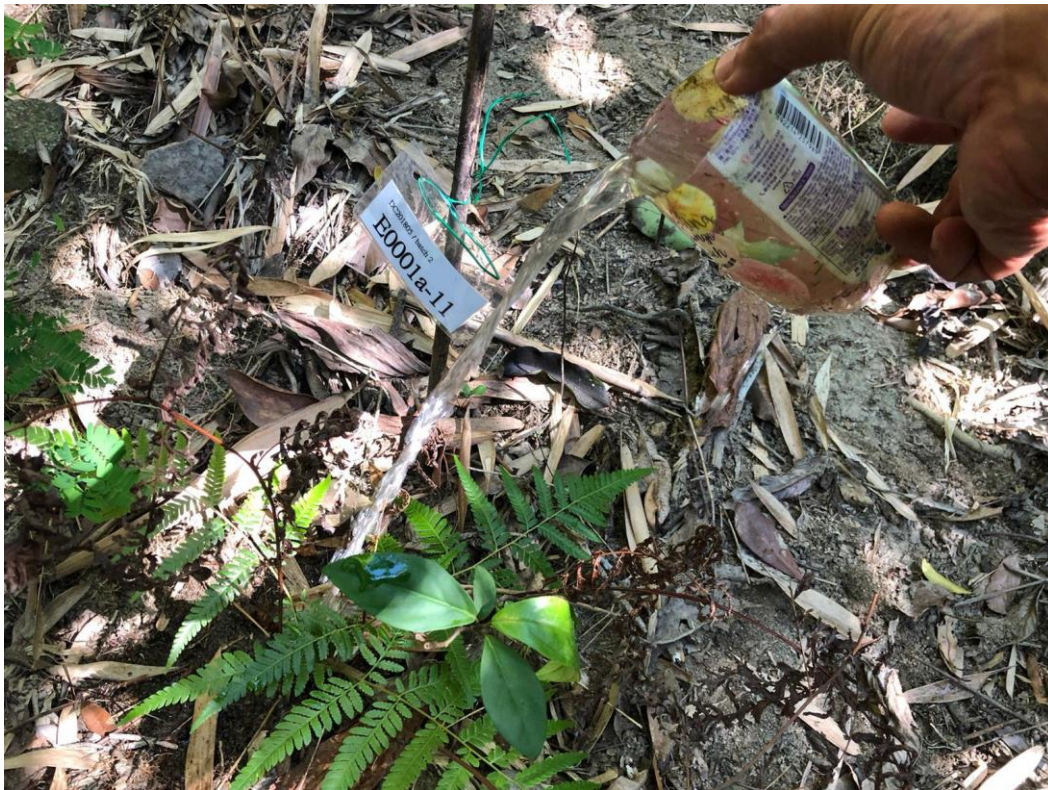
Monitoring for 19 nos. of *Cibotium barometz* (E0001a-1 to E0001a-16, E0002-01, E0002-02 and E0003) were conducted on 22 June 2021 at a quarterly basis and the coming monitoring will be carried out in September 2021. Plant conditions were listed in **Table 2**, and corresponding photographic records were shown in **Appendix 2**.

Post-transplantation monitoring at receptor site on June 2021

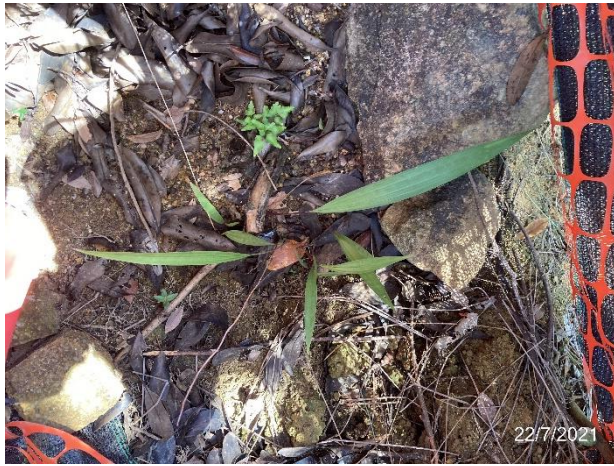
The patch of retained *Ania hongkongensis* (named as H0001) was observed in a fair condition during reporting period, with corresponding photos presented in **Appendix 3**. The protection zone of H0001 has been expanded due to additional individuals were observed. Landscape Contractor was reminded to carry out regular watering to the transplanted H0002.

Bi-weekly ecological monitoring at Site 1 on 6 and 22 July 2021
