**CONTRACT NO. STW 01/2021**

**ENVIRONMENTAL TEAM FOR  
RELOCATION OF SHA TIN SEWAGE TREATMENT  
WORKS TO CAVERNS – SITE PREPARATION  
AND ACCESS TUNNEL CONSTRUCTION**

**MONTHLY ENVIRONMENTAL MONITORING & AUDIT  
REPORT**

**SEPTEMBER 2021**

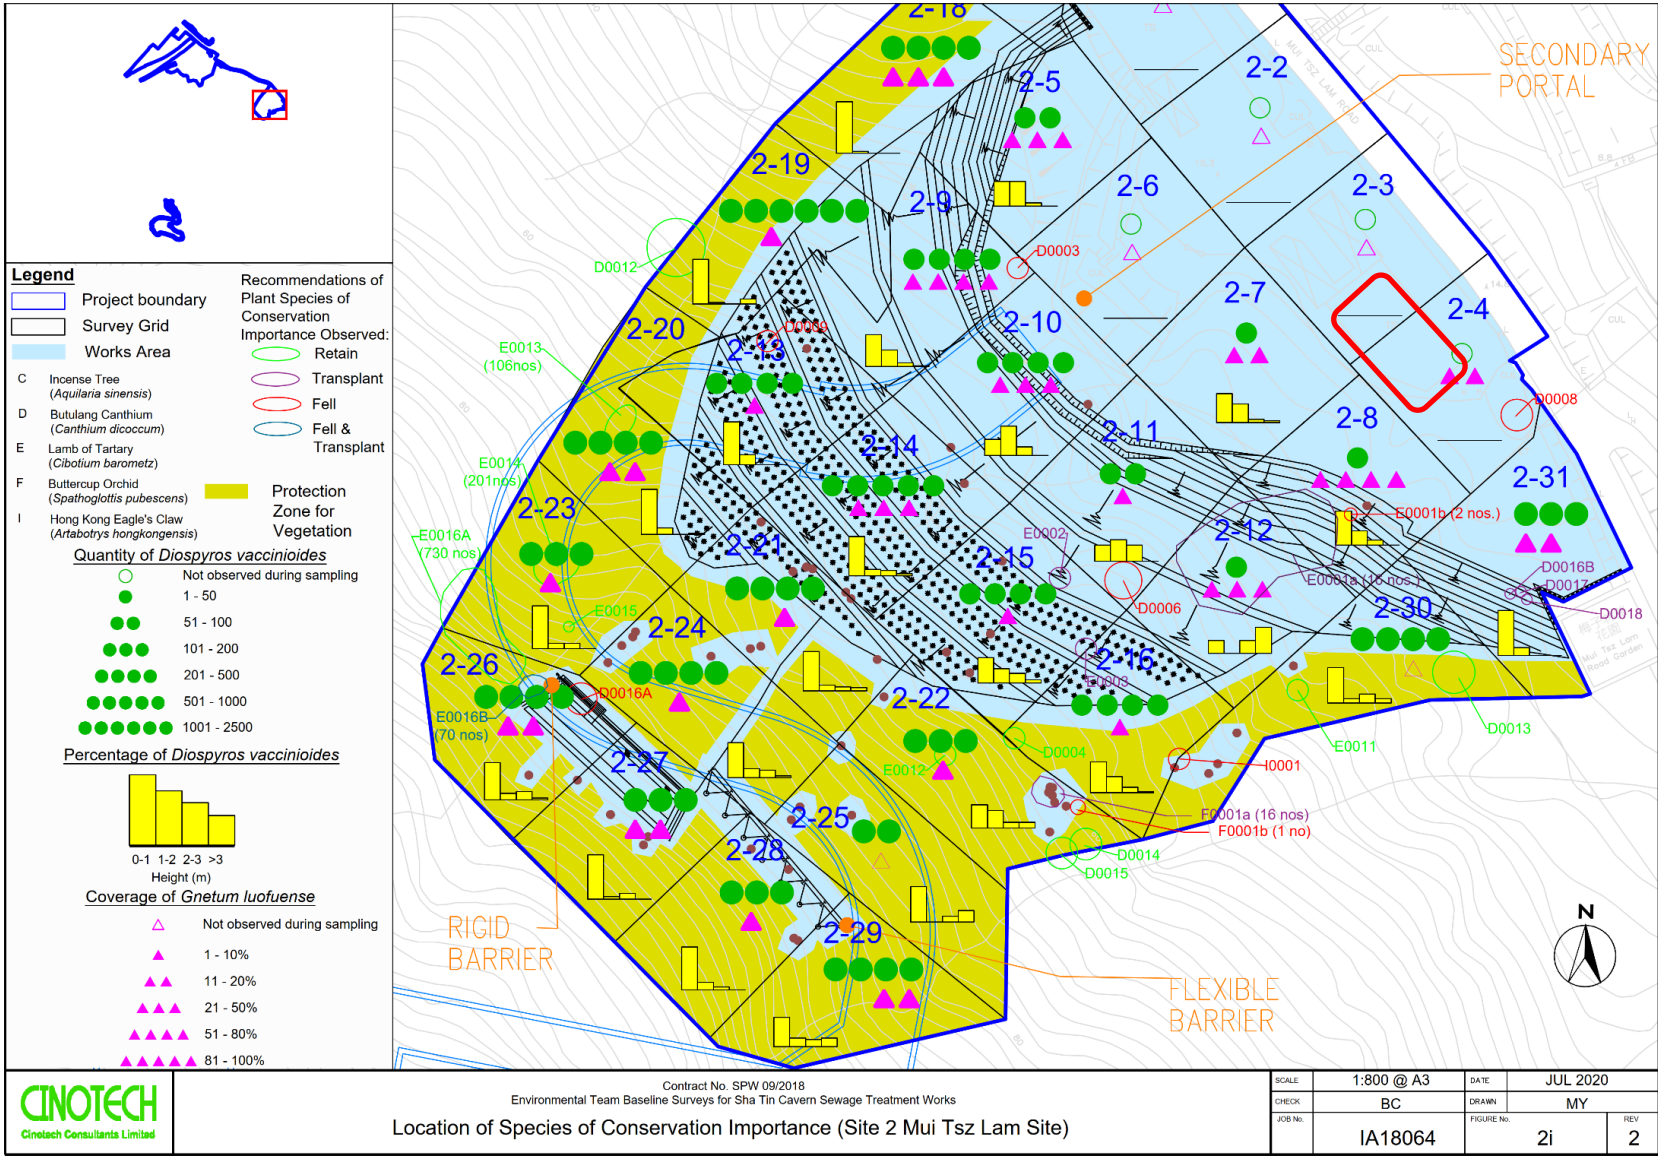
**Figure 2.** Original location of DV0269-DV0500 (3<sup>rd</sup> batch) and DV0501-DV0550 (4<sup>th</sup> batch) at Site 2. Nursery site highlighted in red frame for DV0229-DV0268 (1<sup>st</sup> batch), DV0001-DV0228 (2<sup>nd</sup> batch), DV0269-DV0500 (3<sup>rd</sup> batch) and DV0501-DV0550 (4<sup>th</sup> batch) at Site 2.

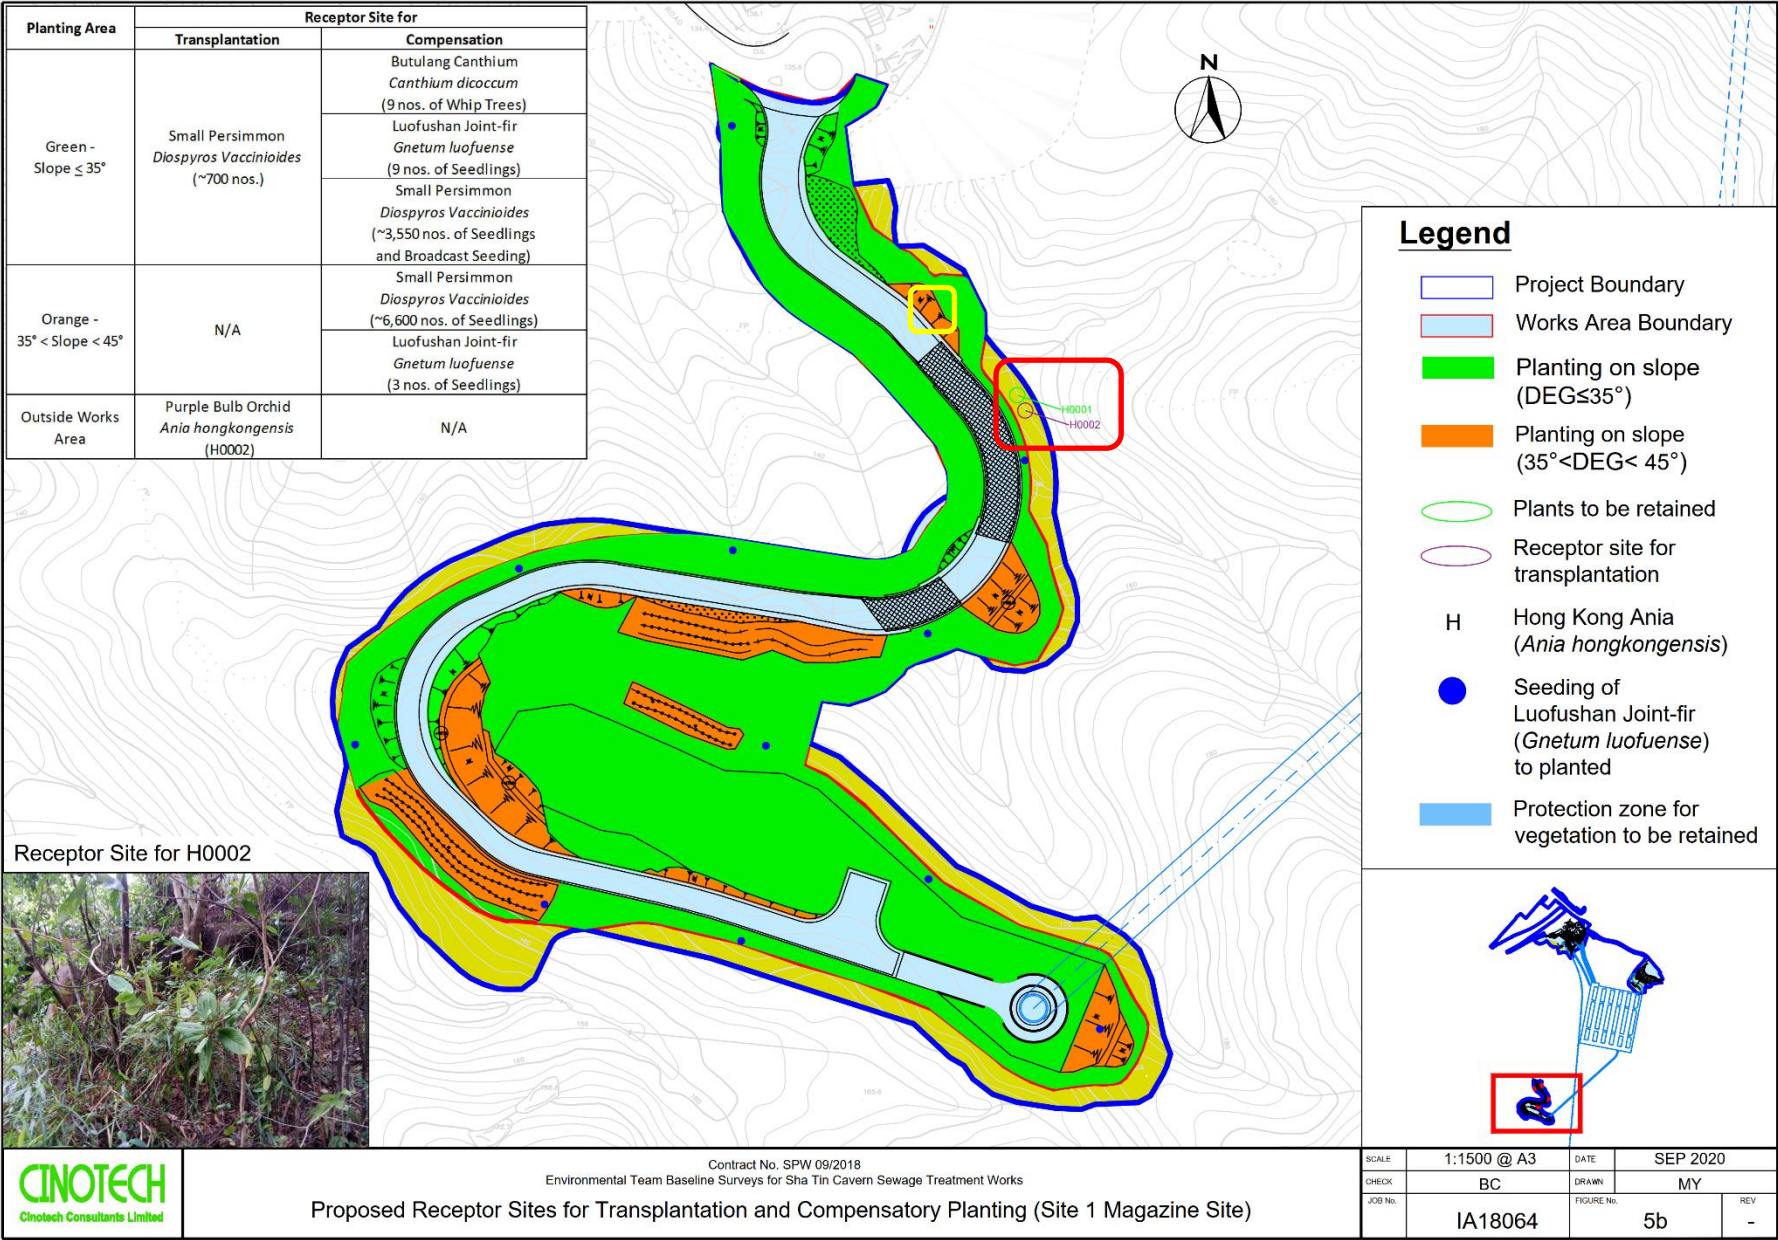
Figure 3. Original location of H0002 highlighted in yellow frame and its receptor site highlighted in red frame.

zone of H0001 has been expanded due to additional individuals were observed. Landscape Contractor was reminded to carry out regular watering to the transplanted H0002.

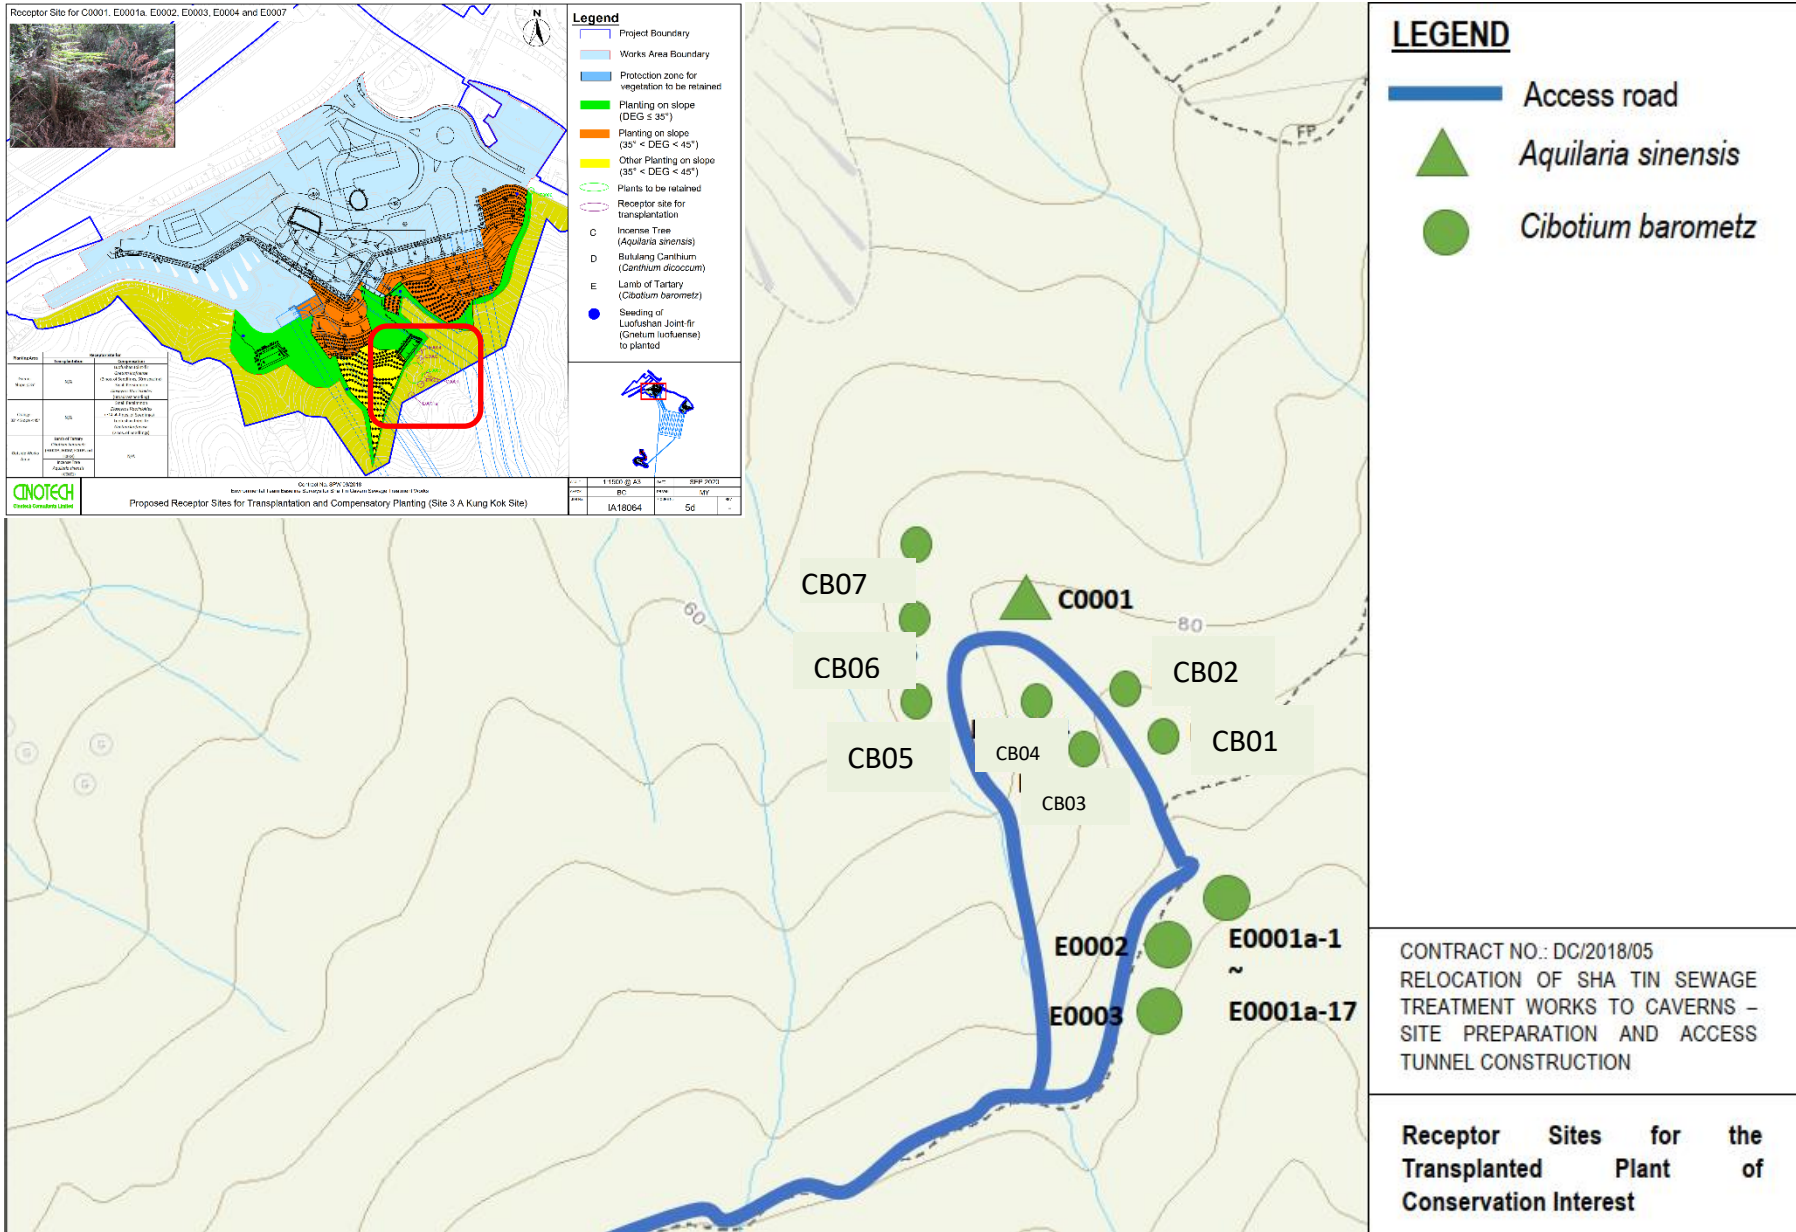
Figure 4. Receptor site for C0001 and E0001a-E0004, the area highlighted in red frame is enlarged.

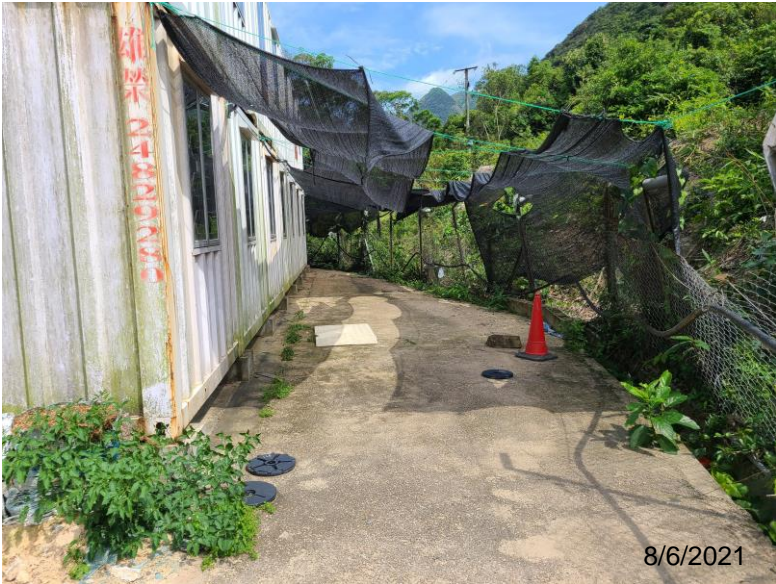
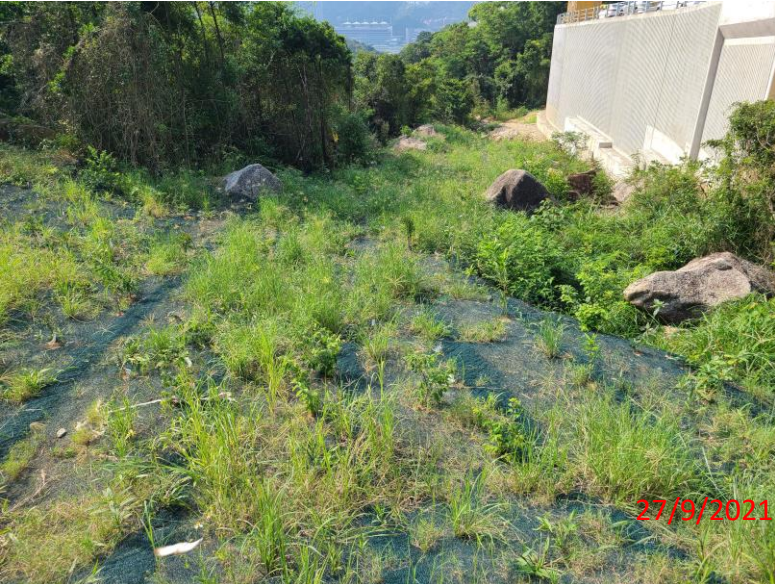
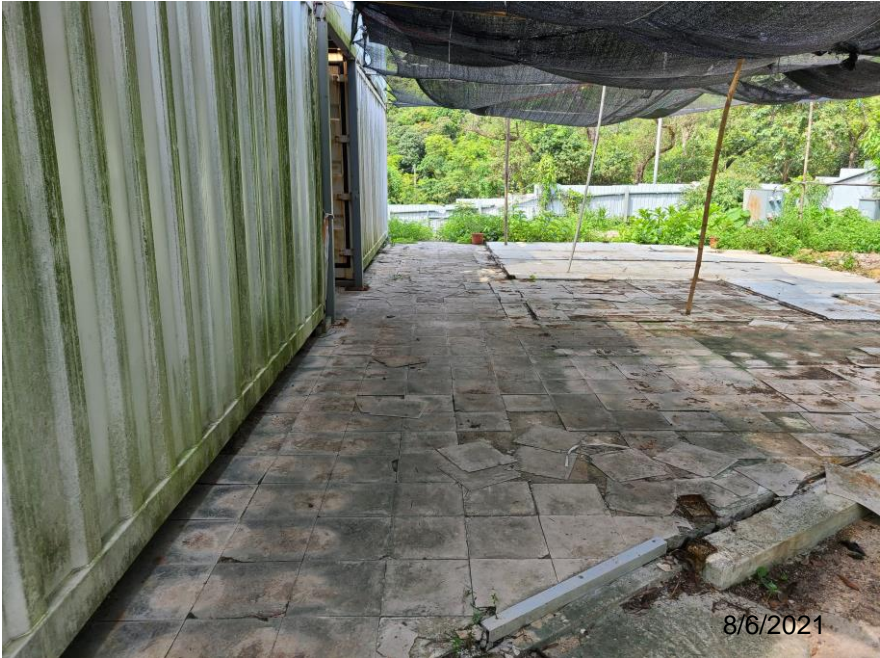
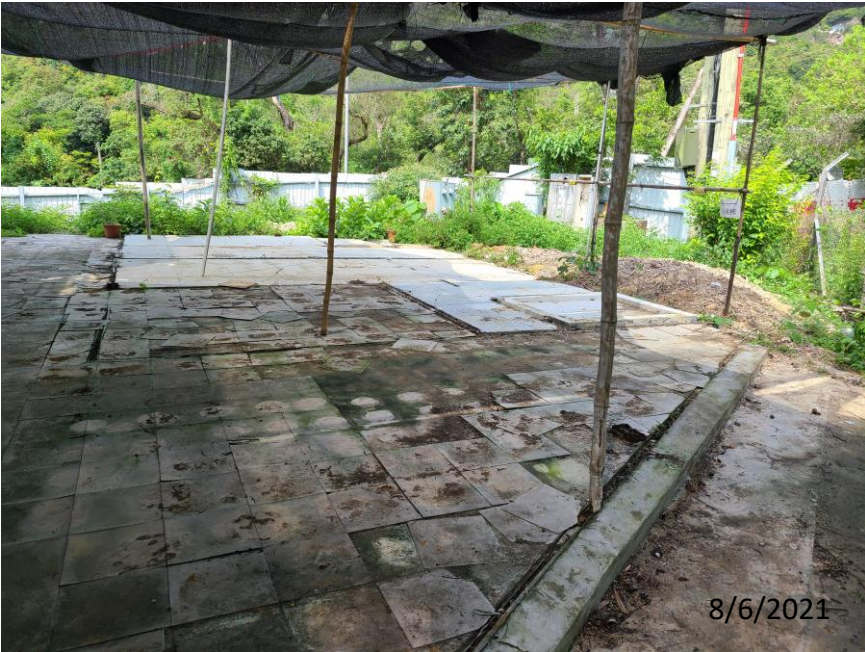
*Plate 1.* The 4 batches of *Diospyros vaccinioides* at the on-site nursery were transplanted to receptor site on 11<sup>st</sup> and 21<sup>st</sup> May 2021

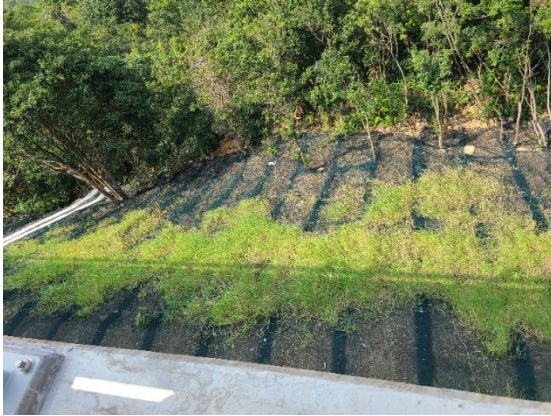
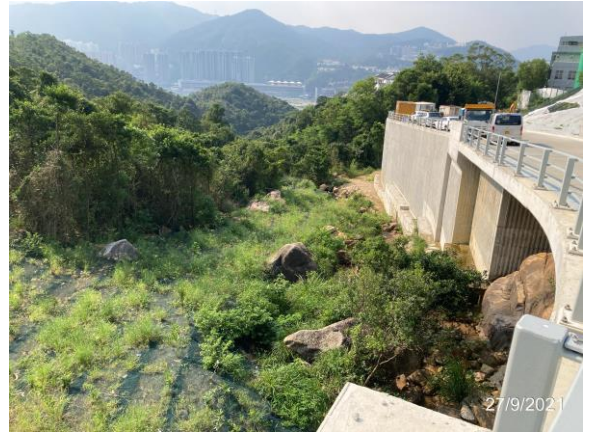
The 20 nos. of *Diospyros vaccinioides* (Name as DV 0531-DV0550), Sign of leaf drop and dehydration has been observed. Plant conditions of *Diospyros vaccinioides* at the receptor site were listed in **Table 4** and illustrated in **Appendix 1**.

Post-transplantation monitoring at receptor site on 17 and 27 Sept 2021

Receptor site of *Diospyros vaccinioides*

According to environmental condition and location of the receptor sites/ nursery, watering frequency was recommended in daily practice for at least the first 3 months as the transplant time is in summer months with strong sunlight and high temperature; except the days with fog and rain. Water frequency may be reduced based on the plant condition after monitoring in the first 3 months.

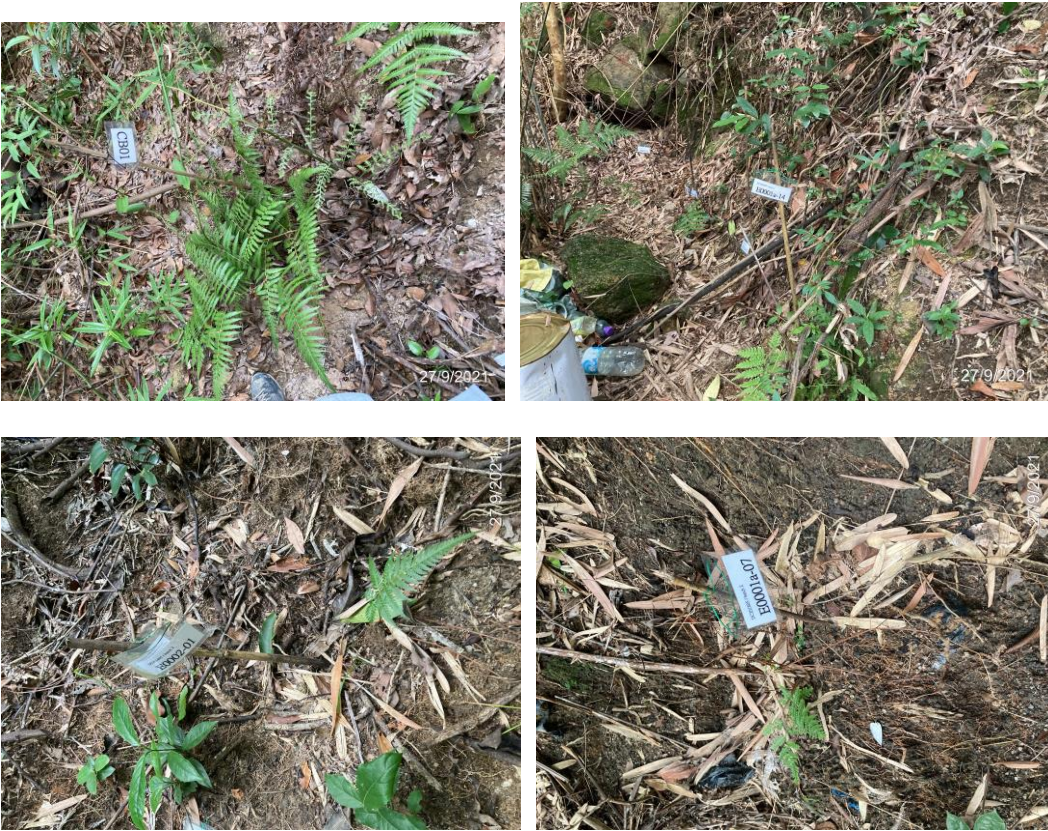
Monitoring for 19 nos. of *Cibotium barometz* (E0001a-1 to E0001a-16, E0002-01, E0002-02 and E0003) were conducted on 17 and 27 Sept 2021 at a quarterly basis and completed establishment period on Sept 2021. A total of 17 nos. of *Cibotium barometz* were retained at receptor site, while 2 nos of *Cibotium barometz* were found in poor condition (**E0007 and E0015**) (**Figure 4**). Regular monitoring is not recommended after establishment period expect replacement planting if found dead (subject to agreement with AFCD). Plant conditions were listed in **Table 2**, and corresponding photographic records were shown in **Appendix 2**.

Post-transplantation monitoring at receptor site on 27 September 2021

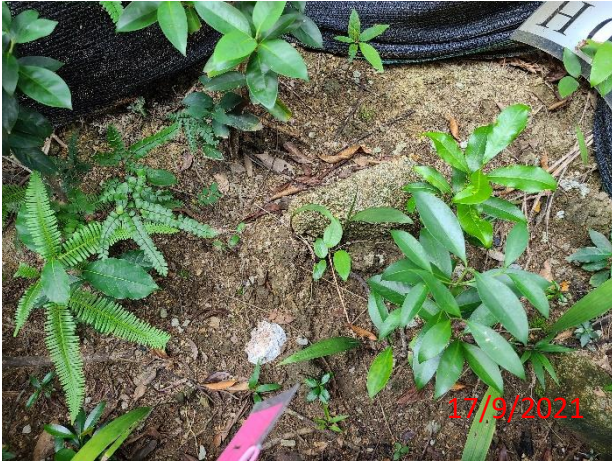
H0001

The patch of retained *Ania hongkongensis* (named as H0001) was observed in a fair condition during reporting period, with corresponding photos presented in **Appendix 3**. The protection

Bi-weekly ecological monitoring at Site 1 on 17 and 27 Sept 2021
