**ENVIRONMENTAL TEAM FOR  
RELOCATION OF SHA TIN SEWAGE TREATMENT  
WORKS TO CAVERNS**

**UNDER ENVIRONMENTAL PERMIT NO. EP-533/2017**

**MONTHLY ENVIRONMENTAL MONITORING & AUDIT  
REPORT**

**MAY 2022**

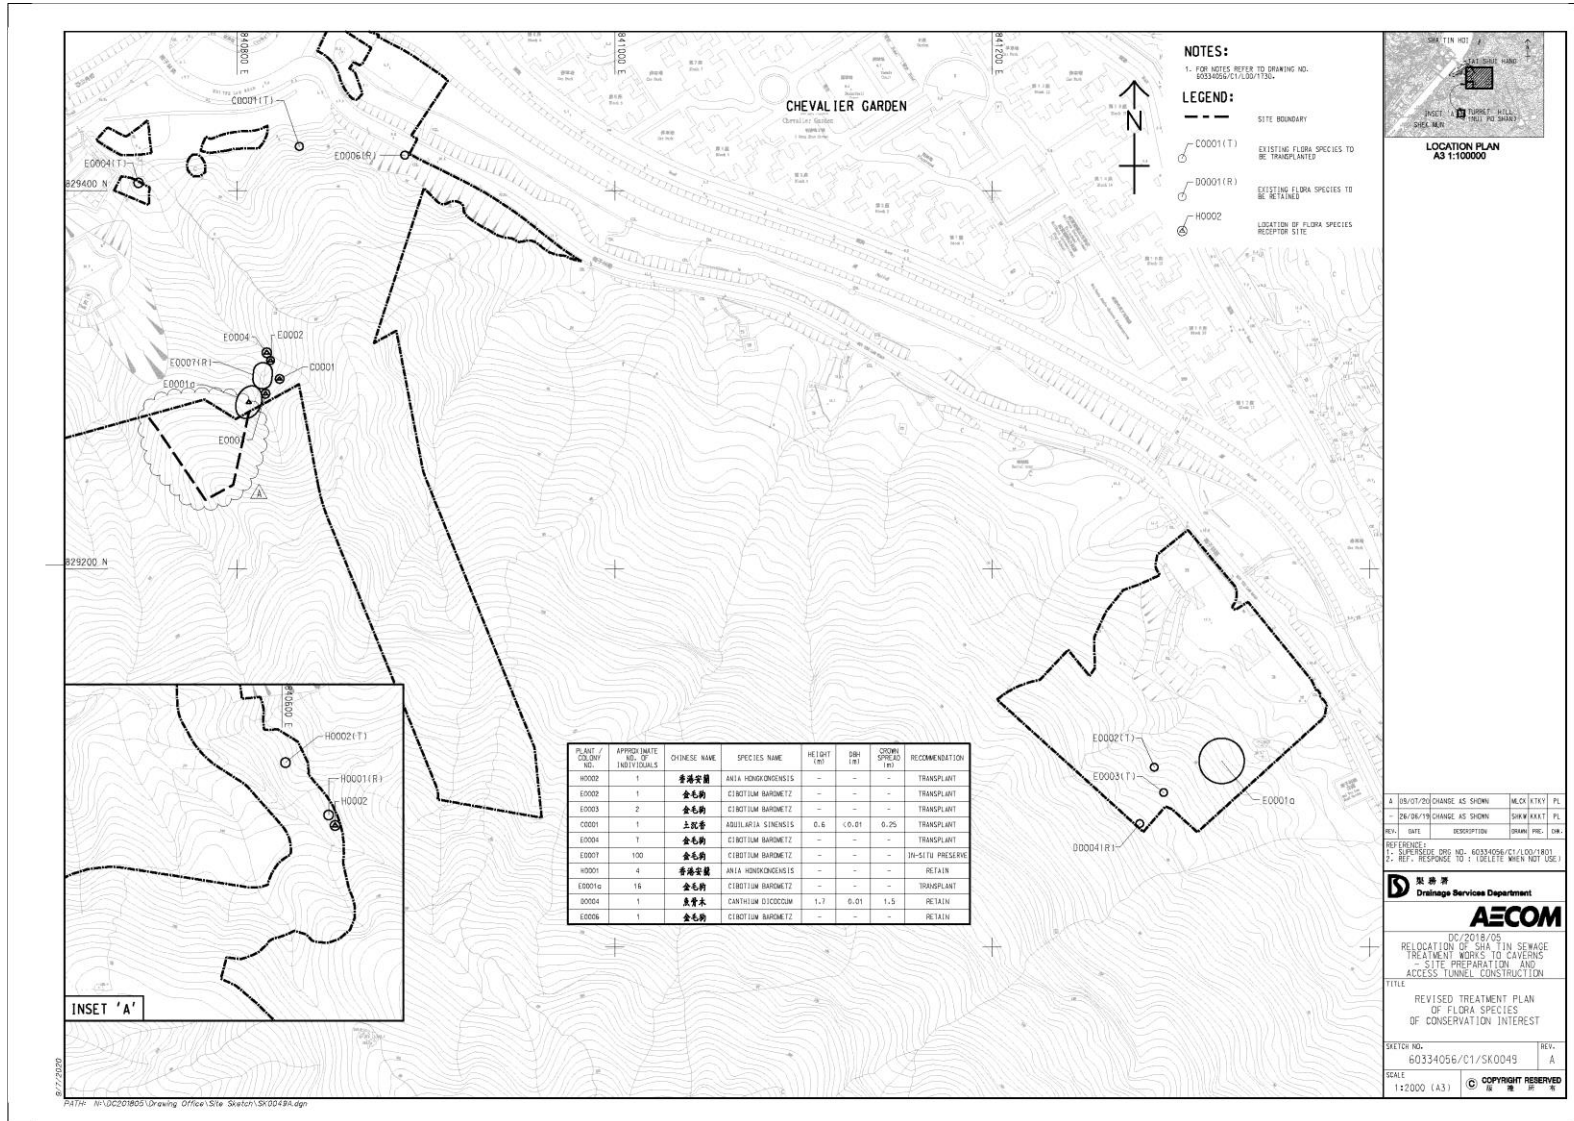
Figure 3. Original location of species of conservation Importance frame and its receptor site.

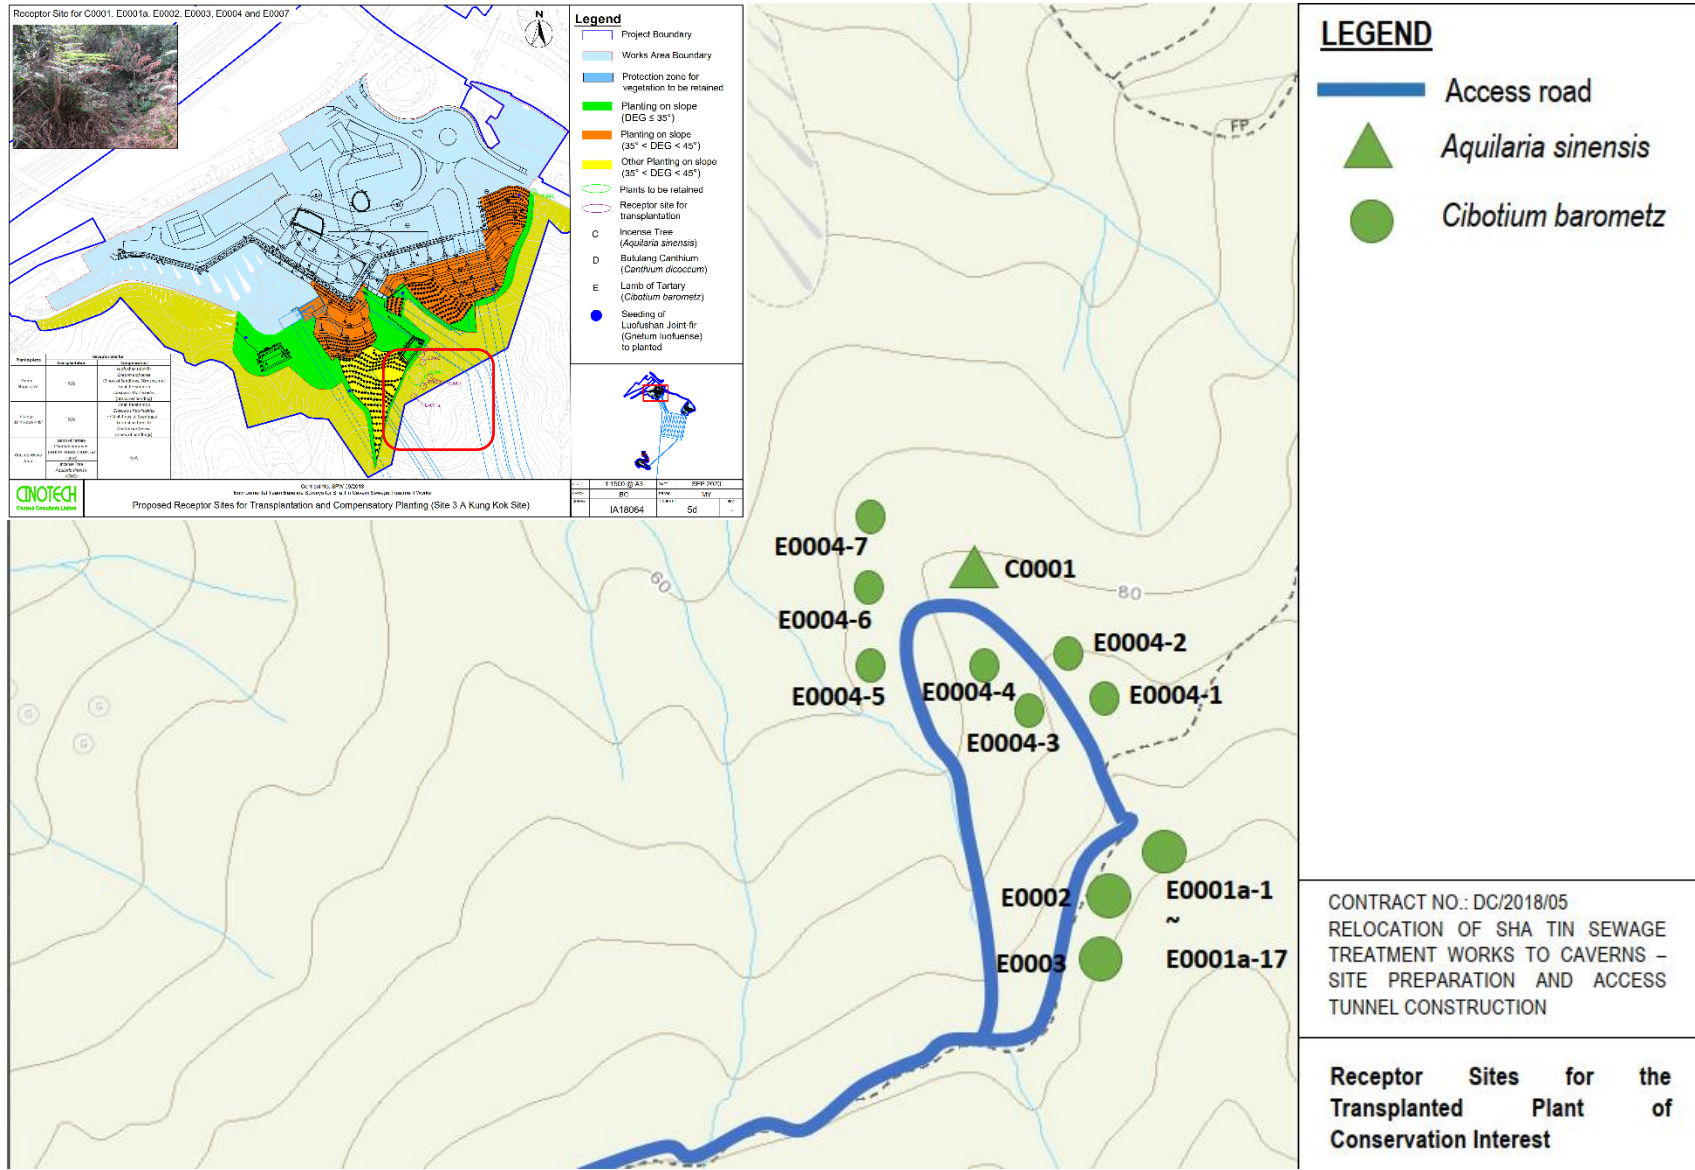
Figure 4. Receptor site for C0001 and E0001a-E0004, the area highlighted in red frame is enlarged.

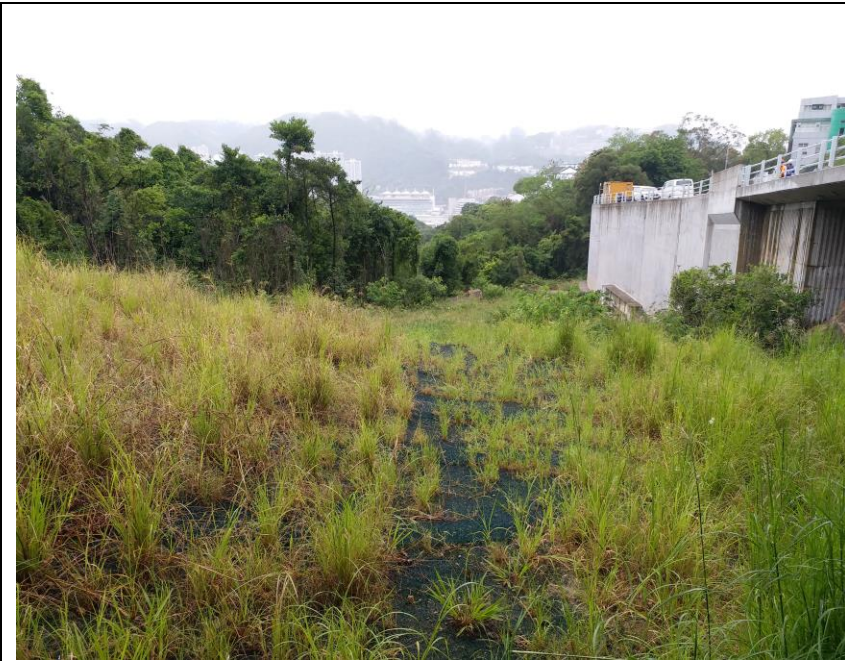
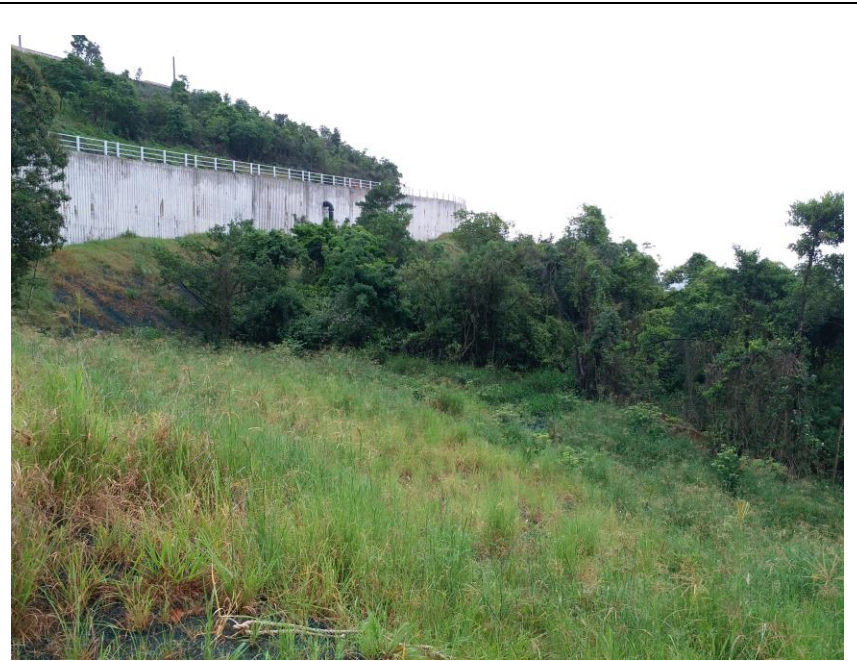
- 2.1.7. The monthly monitoring for the on-going for Post-transplantation were conducted on 24 May 2022.
- 2.1.8. As frequent rain and overgrowth of grass (>1m at same area) make the planted *Diospyros vaccinioides* difficult to detect, even tagged. Weeding or grass cutting is required before a full set of planted *Diospyros vaccinioides* (ADV 00001-ADV 0530) can be observed. Therefore, monitoring results of DV00001-DV0530 will be detailed in June 2022 monitoring report.

Post-transplantation monitoring at receptor site on 24 May 2022.

Receptor site of *Diospyros vaccinioides*

- 2.1.9. According to environmental condition and location of the receptor sites/ nursery, watering frequency was recommended in daily practice for at least the first 3 months as the transplant time is in summer months with strong sunlight and high temperature; except the days with fog and rain. Water frequency may be reduced based on the plant condition after monitoring in the first 3 months.

- 2.1.10. In contrast, the Landscape Contractor was recommended to check all transplanted plants after heavy rains/ typhoon under safe condition, in order to carry out any stabilization/ maintenance work. Blocked drainage shall be cleared; excessive water shall be pumped or diverged from nursery ground; saturated soil shall be aerated.

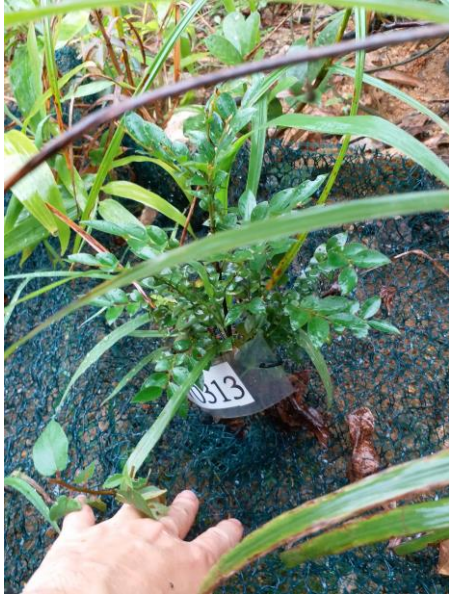
Photographic records of post-transplantation monitoring on plants of conservation importance transplanted at receptor site on 24 May 2022.

<p>Photo record of <i>Diospyros vaccinioides</i></p>	<p>Photo record of <i>Diospyros vaccinioides</i></p>

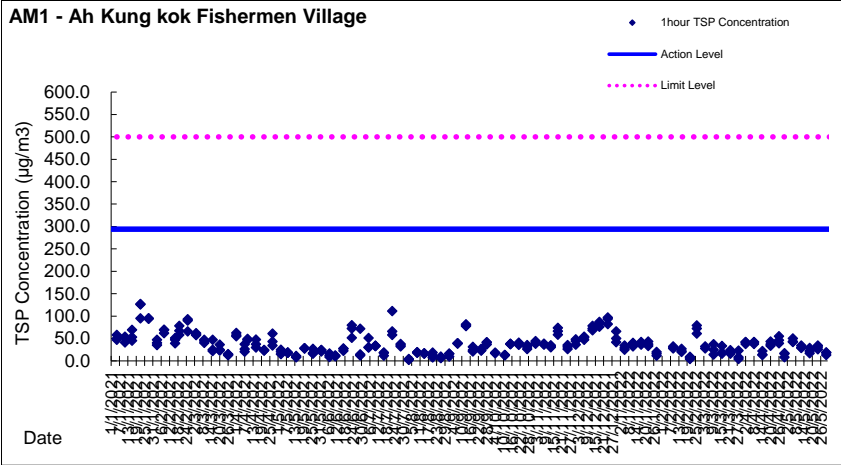
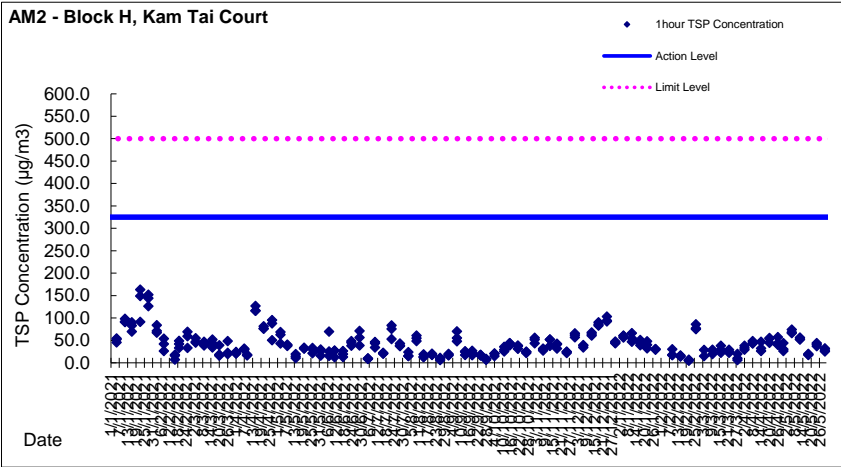
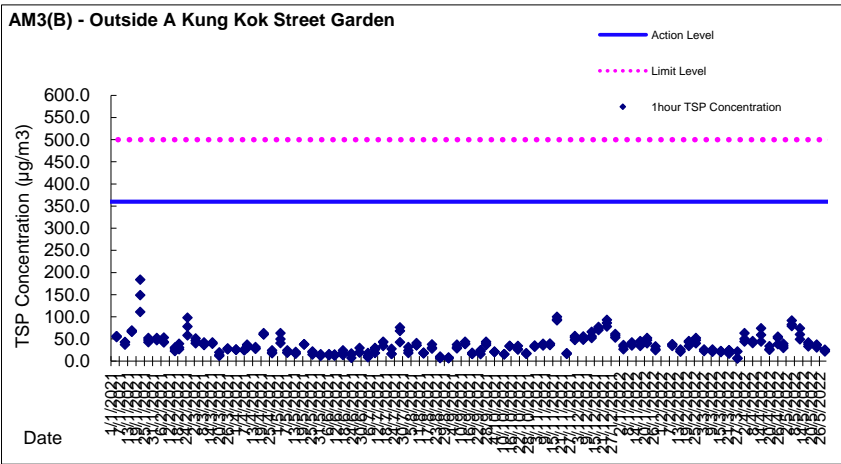
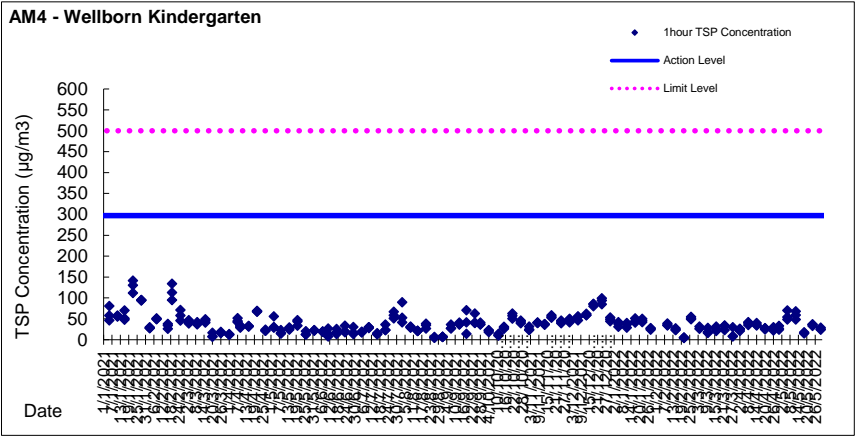
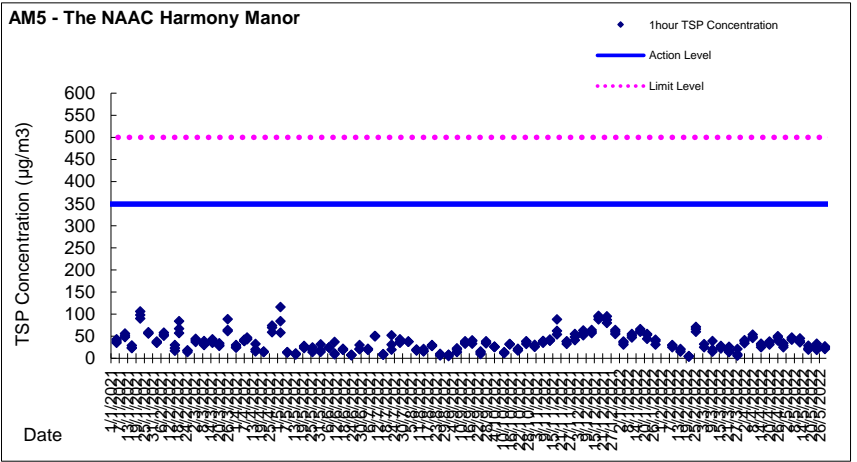
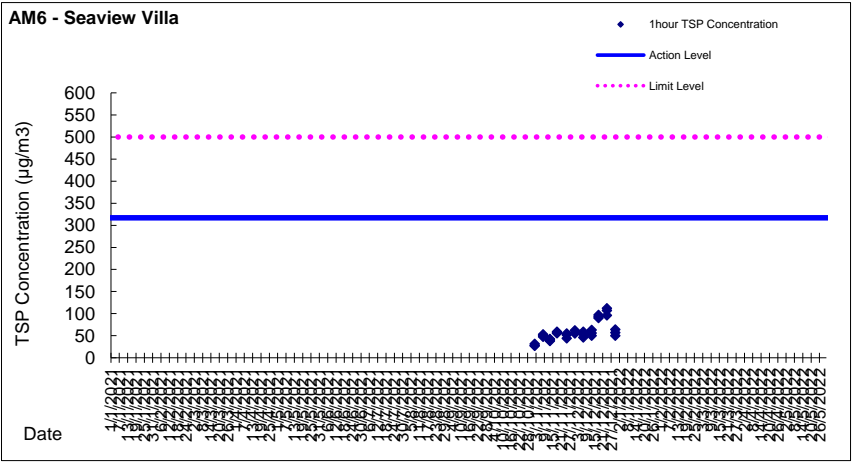
**Graphic Presentation of TSP Result**

Date	Weather Condition	Time	Mass Concentration ( $\mu\text{g}/\text{m}^3$ )
6-May-22	Fine	8:15	47
6-May-22	Fine	9:16	44
6-May-22	Fine	10:17	42
12-May-22	Fine	8:10	36
12-May-22	Fine	9:11	39
12-May-22	Fine	10:12	45
18-May-22	Cloudy	8:13	20
18-May-22	Cloudy	9:14	28
18-May-22	Cloudy	10:15	23
24-May-22	Cloudy	8:05	19
24-May-22	Cloudy	9:06	25
24-May-22	Cloudy	10:07	33
30-May-22	Cloudy	8:10	21
30-May-22	Cloudy	9:11	27
30-May-22	Cloudy	10:12	24

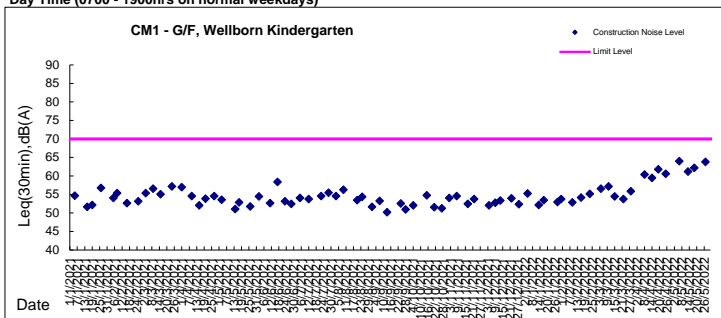
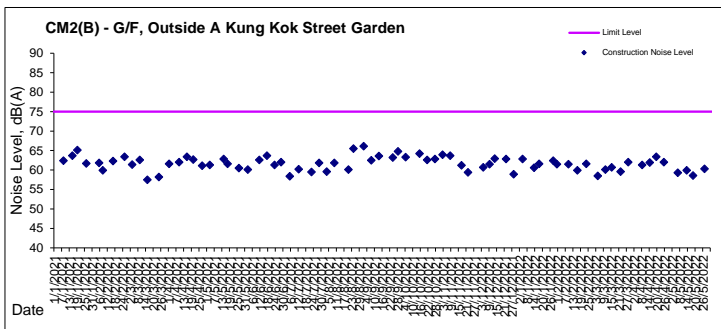
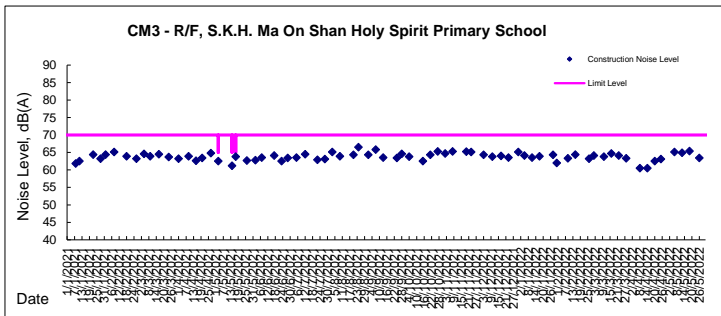
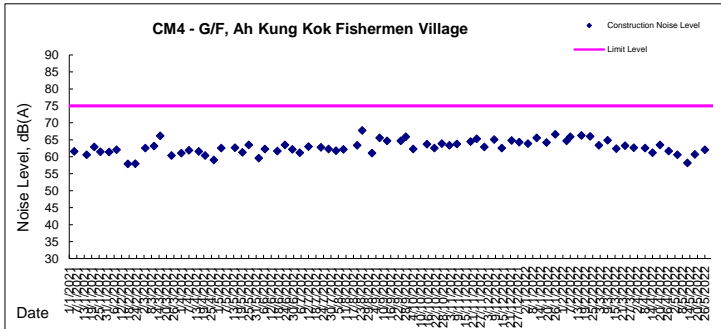
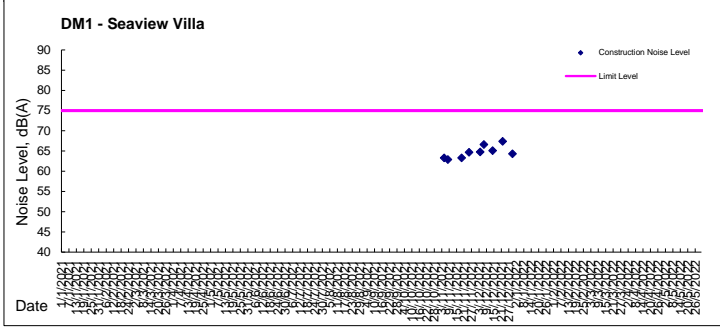
**Graphic Presentation of Noise Monitoring Result**

- xiv. Based on review on noise monitoring data, no exceedances were recorded at the noise monitoring stations CM1 - G/F, Wellborn Kindergarten and CM2(B) - G/F, Outside A Kung Kok Street Garden (located within the Chevalier Garden) during the scheduled Leq30 min noise monitoring in April 2022. ET conducted regular noise monitoring on 6 May 2022, no exceedances were recorded at the noise monitoring stations CM1 - G/F, Wellborn Kindergarten and CM2(B) - G/F, Outside A Kung Kok Street Garden. Site inspection was conducted on 5 & 12 May 2022, it is observed that rock-breaking was conducted at the construction site of Portion 10. Ad-hoc noise monitoring at CM1 - G/F, Wellborn Kindergarten and CM2(B) - G/F, Outside A Kung Kok Street Garden on 13 May 2022, no exceedances were recorded.

**Day Time (0700 - 1900hrs on normal weekdays)**

- xviii. The Contractor is recommend to review the construction operation to erect the temporary noise barriers, if feasible and ensure all idled PME are shut down to minimize potential noise emanation at the concerned works area to avoid potential nuisance.

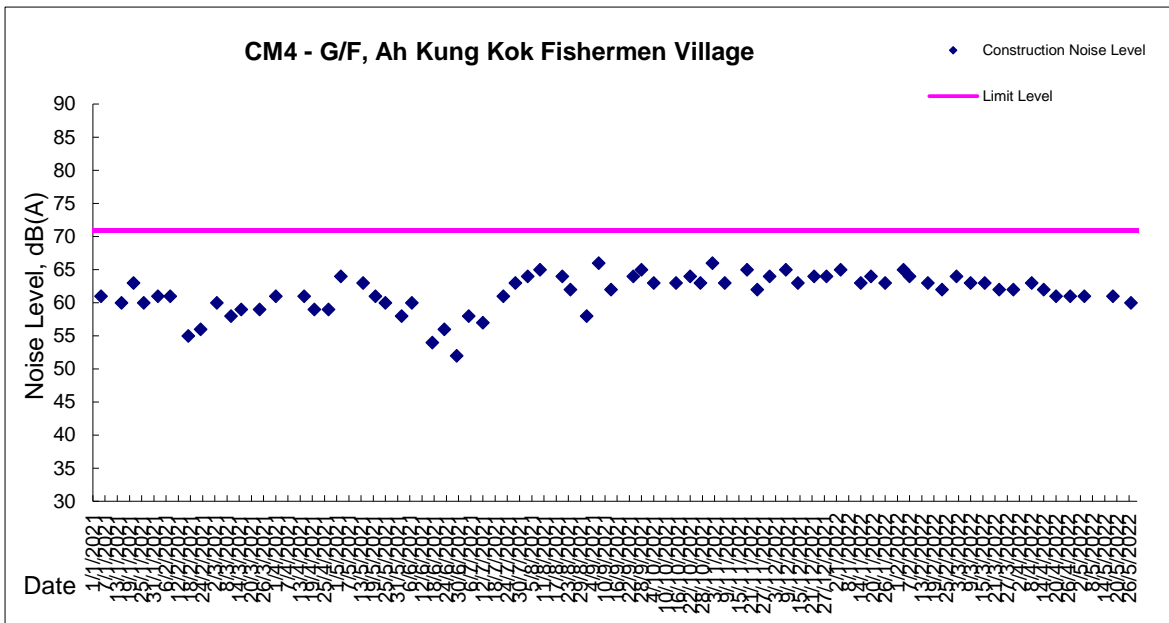
**Graphic Presentation of Noise Monitoring Result**  
**Evening Time (1900 - 2300hrs on normal weekdays)**

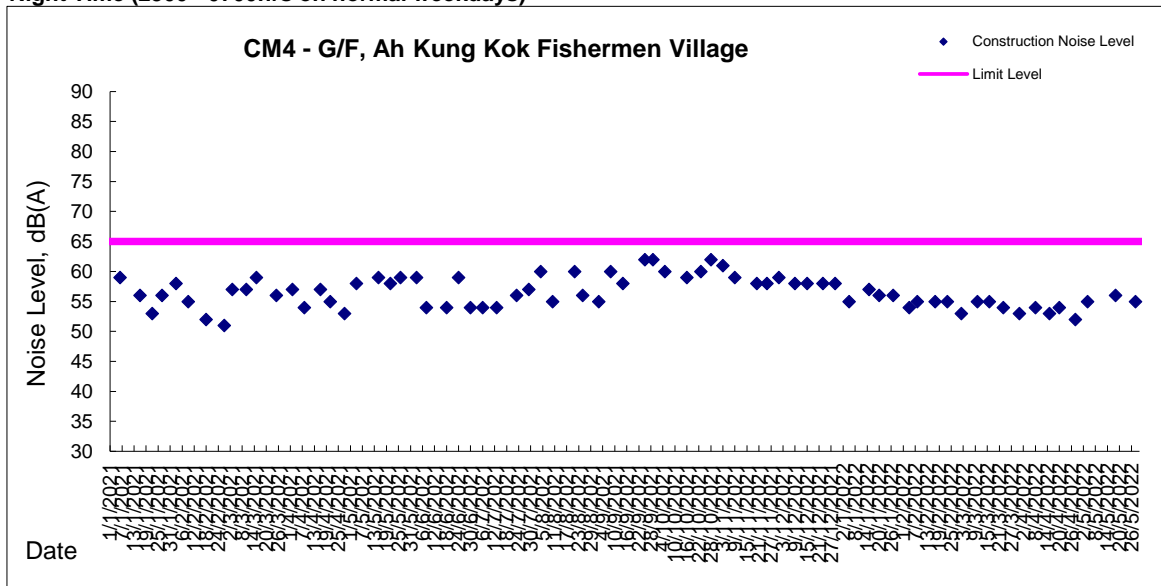
**Graphic Presentation of Noise Monitoring Result**  
**Night Time (2300 - 0700hrs on normal weekdays)**
