**ENVIRONMENTAL TEAM FOR  
RELOCATION OF SHA TIN SEWAGE TREATMENT  
WORKS TO CAVERNS**

**MONTHLY ENVIRONMENTAL MONITORING & AUDIT  
REPORT**

**JUNE 2022**

**Re: Contract No. DC/2020/05**  
**Relocation of Sha Tin Sewage Treatment Works to Cavern – Main Caverns**  
**Construction**  
**Verification of EM&A Monthly Report (June2022)**

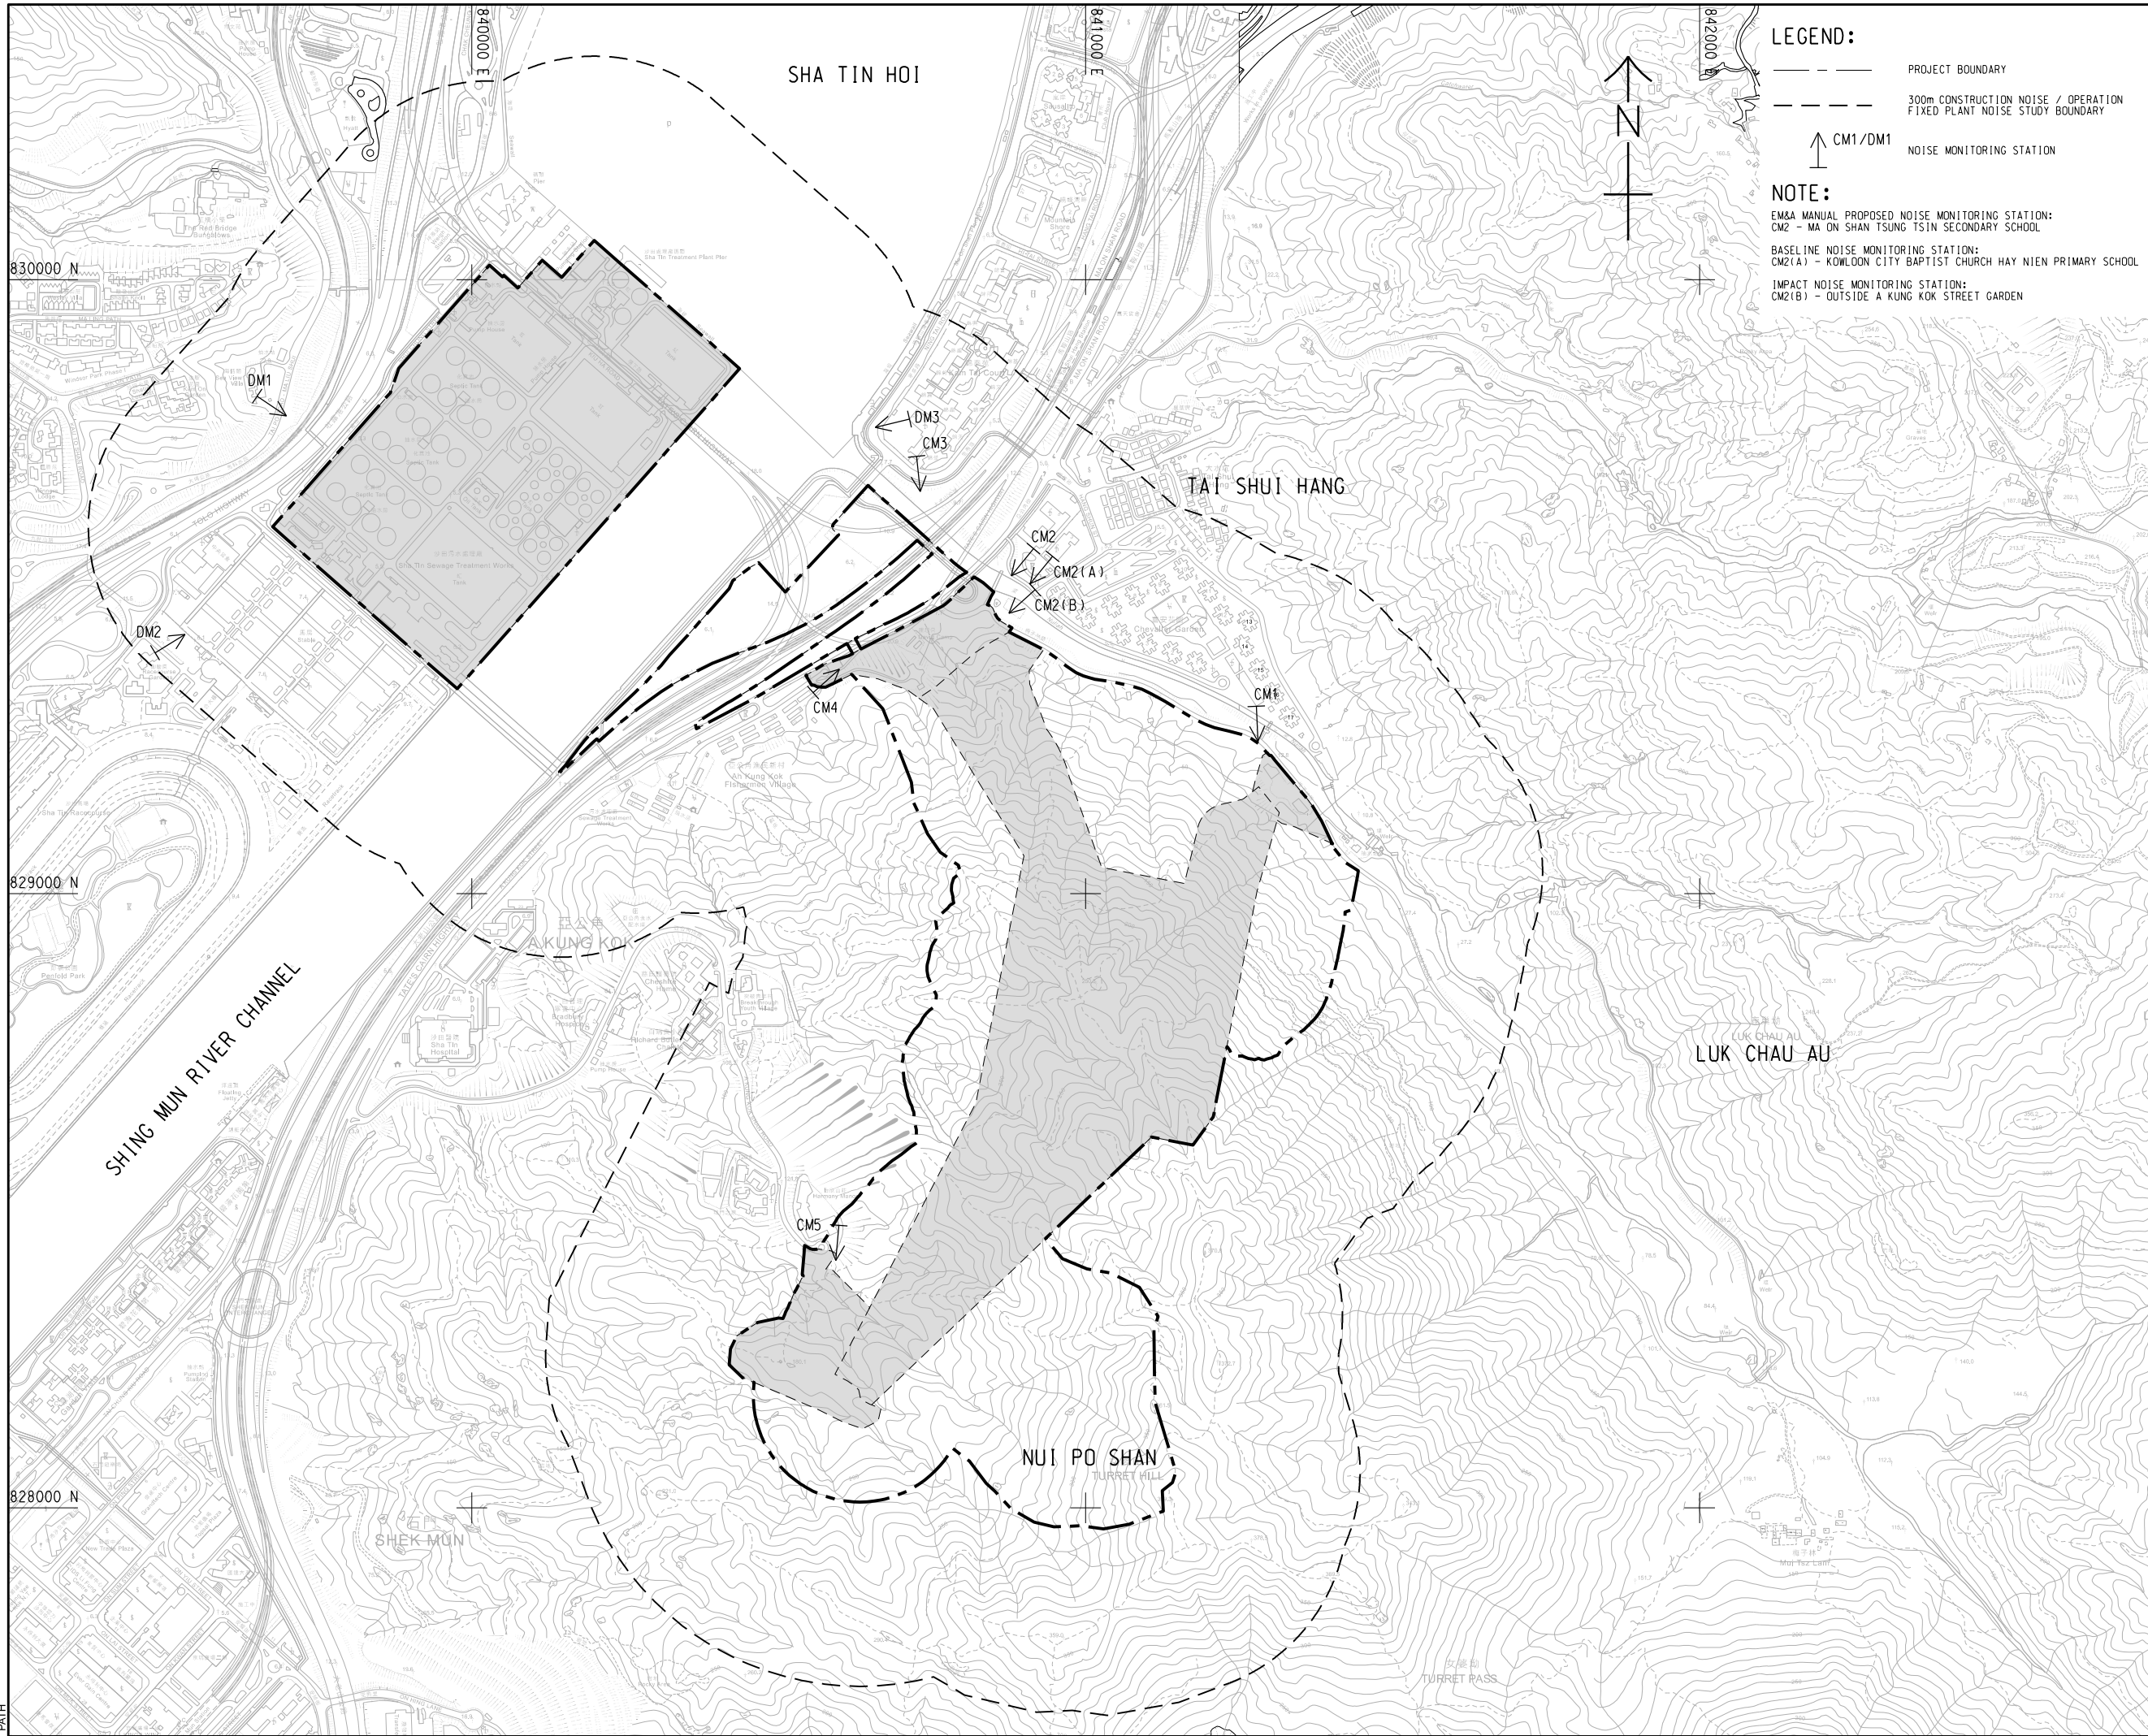
**LEGEND:**  
 - - - - - PROJECT BOUNDARY  
 . . . . . 300m CONSTRUCTION NOISE / OPERATION FIXED PLANT NOISE STUDY BOUNDARY  
 ↑ CM1/DM1 NOISE MONITORING STATION

**NOTE:**  
 EM&A MANUAL PROPOSED NOISE MONITORING STATION:  
 CM2 - MA ON SHAN TSUNG TSIN SECONDARY SCHOOL  
 BASELINE NOISE MONITORING STATION:  
 CM2(A) - KOWLOON CITY BAPTIST CHURCH HAY NIEN PRIMARY SCHOOL  
 IMPACT NOISE MONITORING STATION:  
 CM2(B) - OUTSIDE A KUNG KOK STREET GARDEN

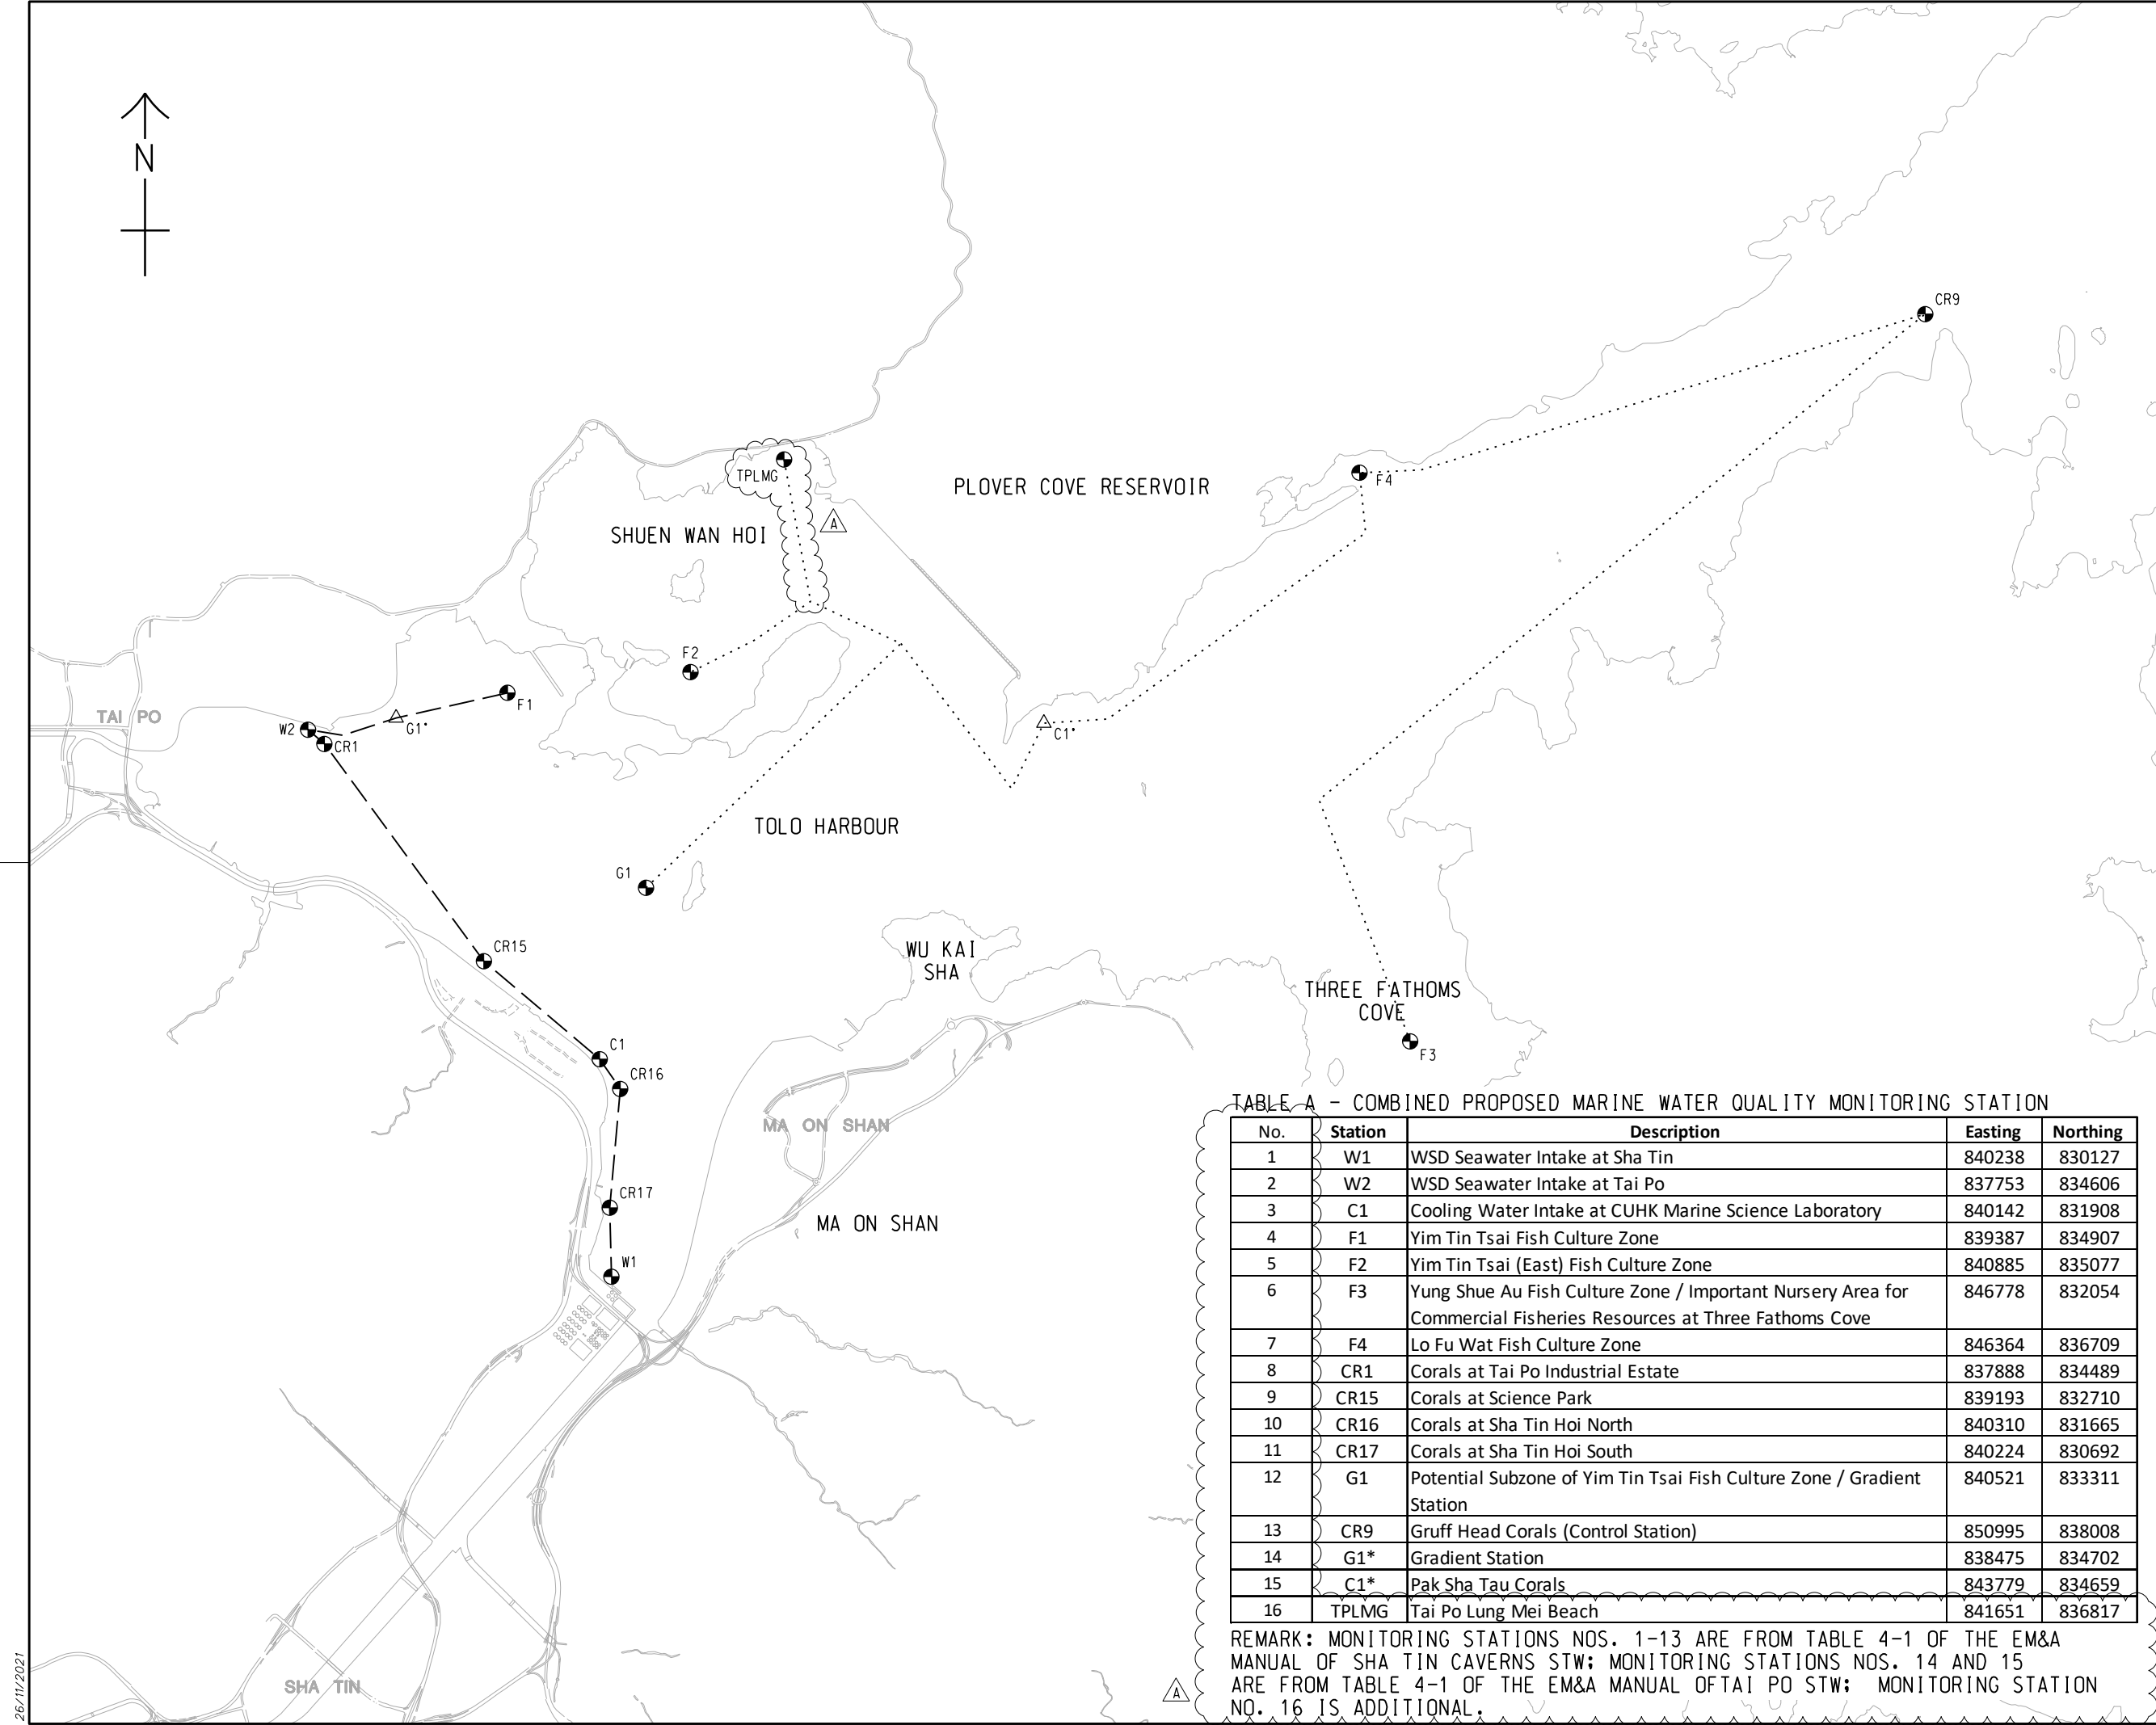
- MARINE WATER SAMPLING ROUTE (1)
- - - MARINE WATER SAMPLING ROUTE (2)
- W1 MARINE WATER QUALITY MONITORING STATIONS
- ▲ C1\* ADDITIONAL MARINE WATER QUALITY MONITORING STATIONS

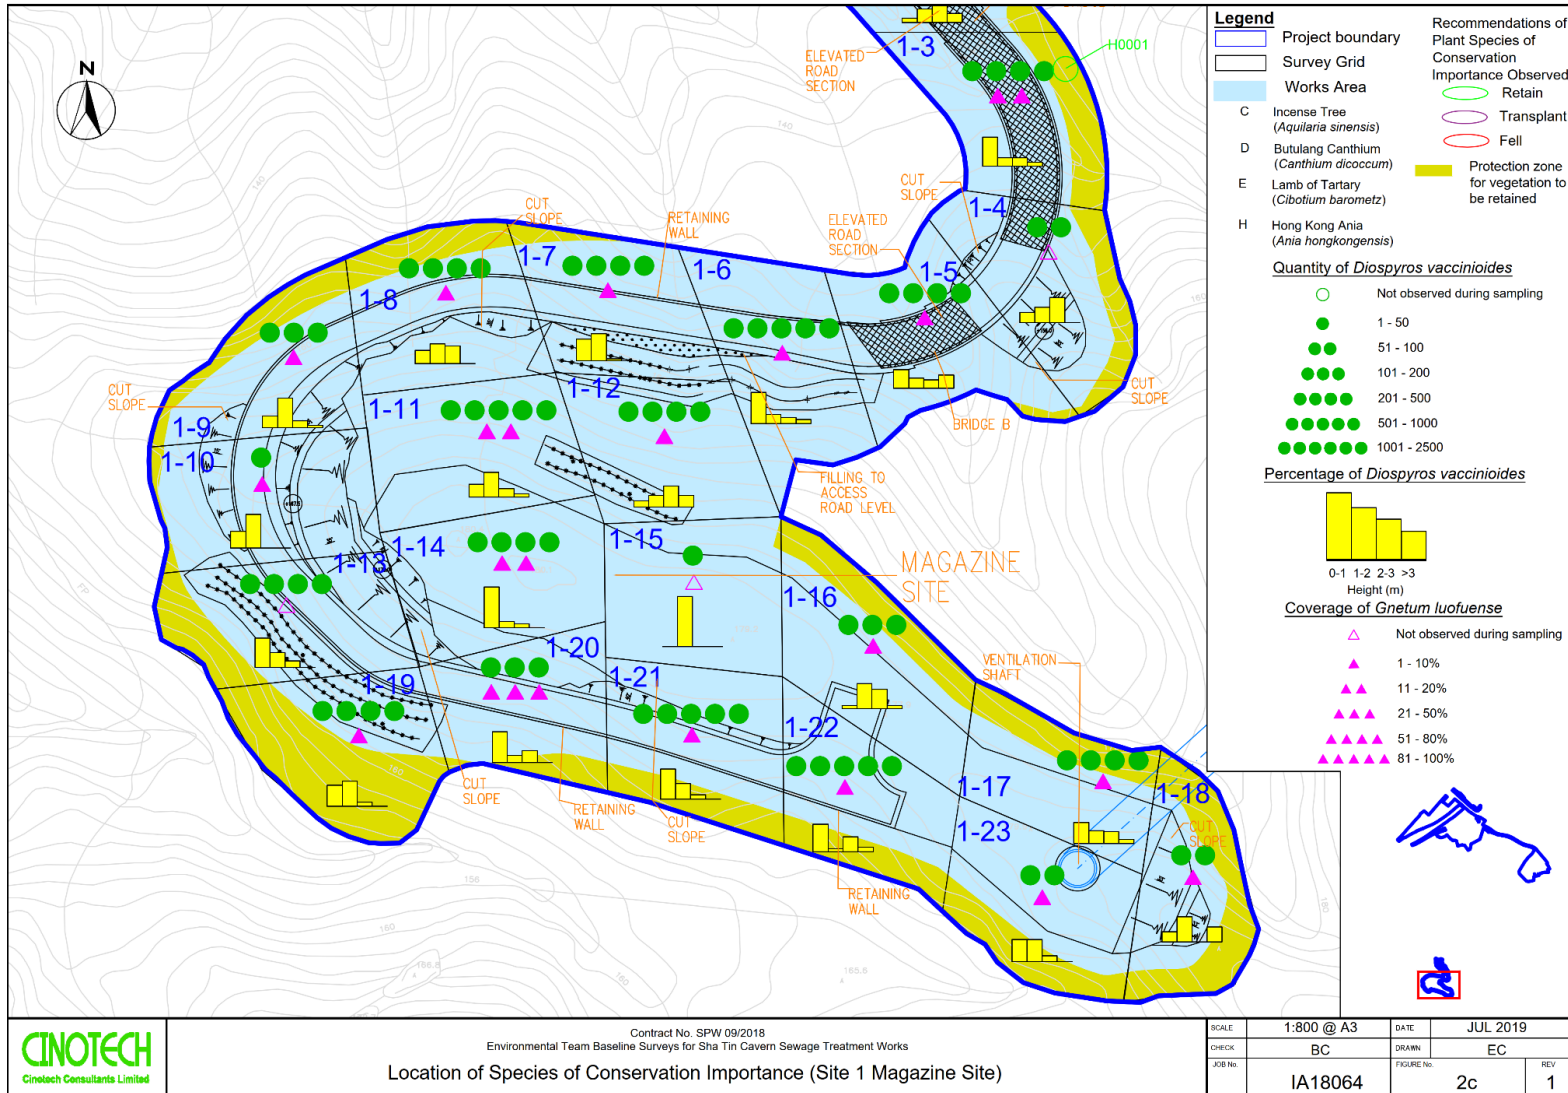
**Figure 1 Original location of DV0229-DV0268 and DV0001-DV0228 at Site 1.**

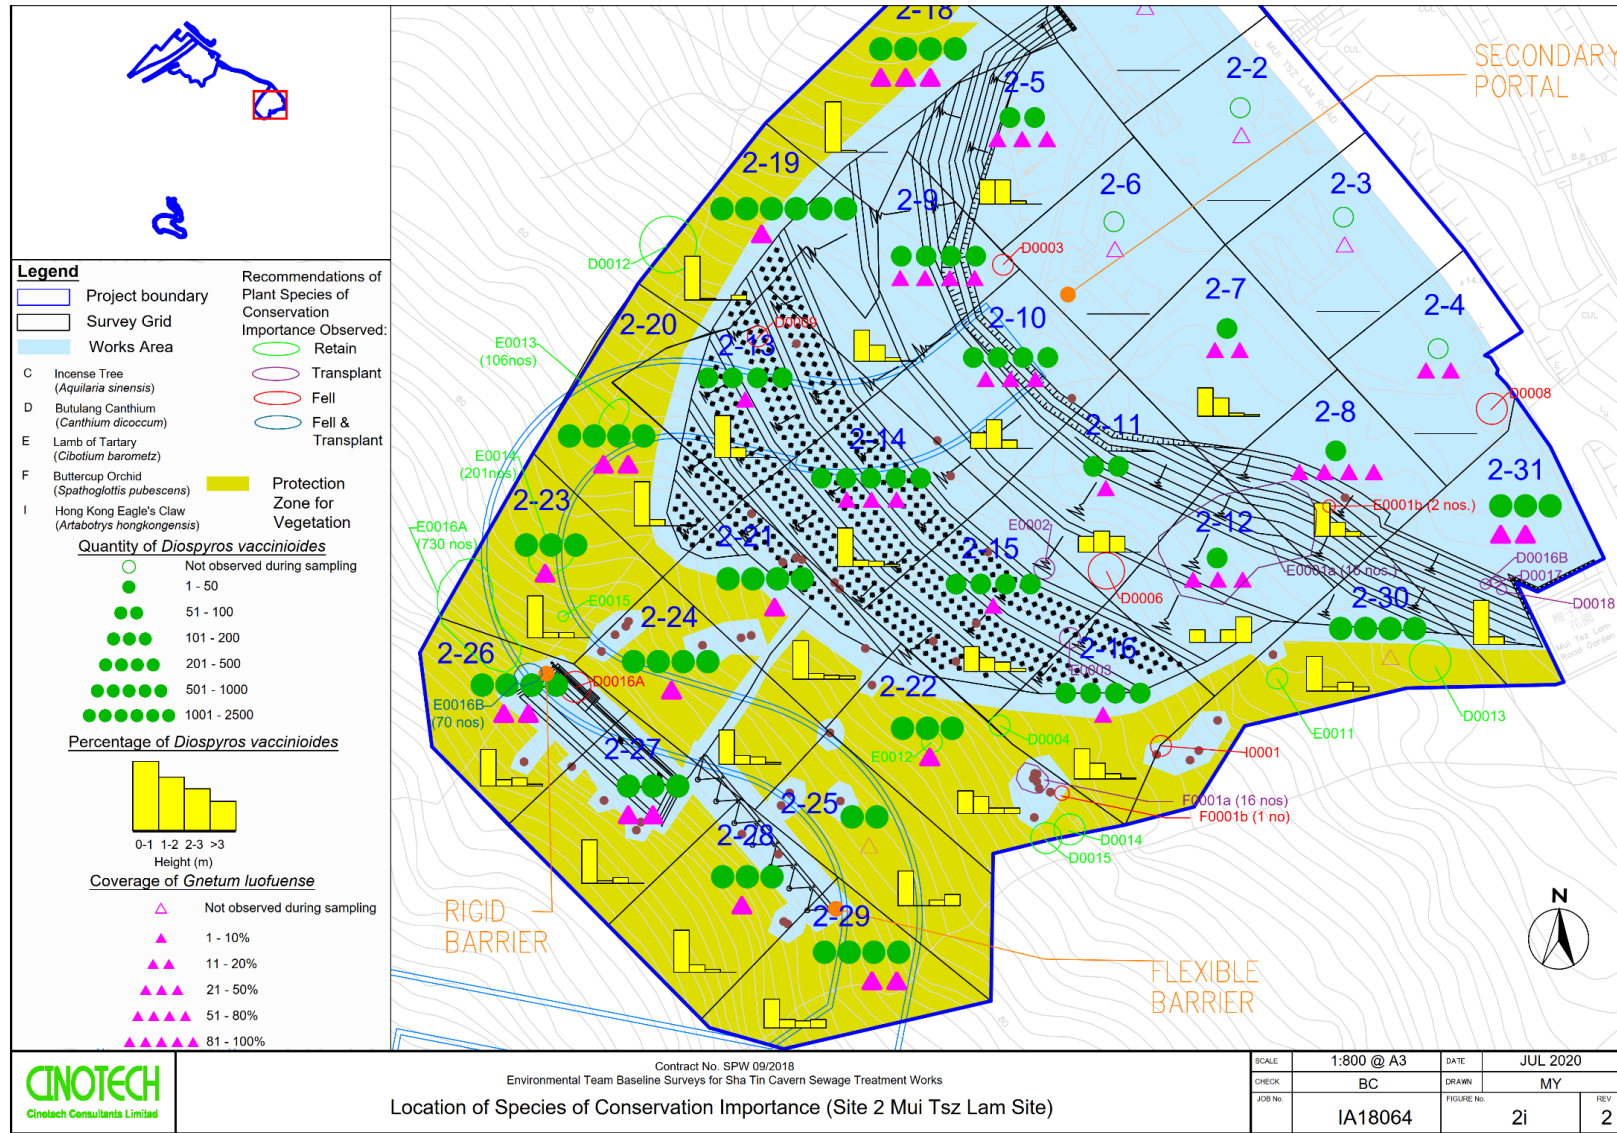
**Figure 2. Original location of DV0269-DV0500 and DV0501-DV0550 at Site 2. Nursery site highlighted in red frame for DV0229-DV0268, DV0001-DV0228, DV0269-DV0500 and DV0501-DV0550 at Site 2.**

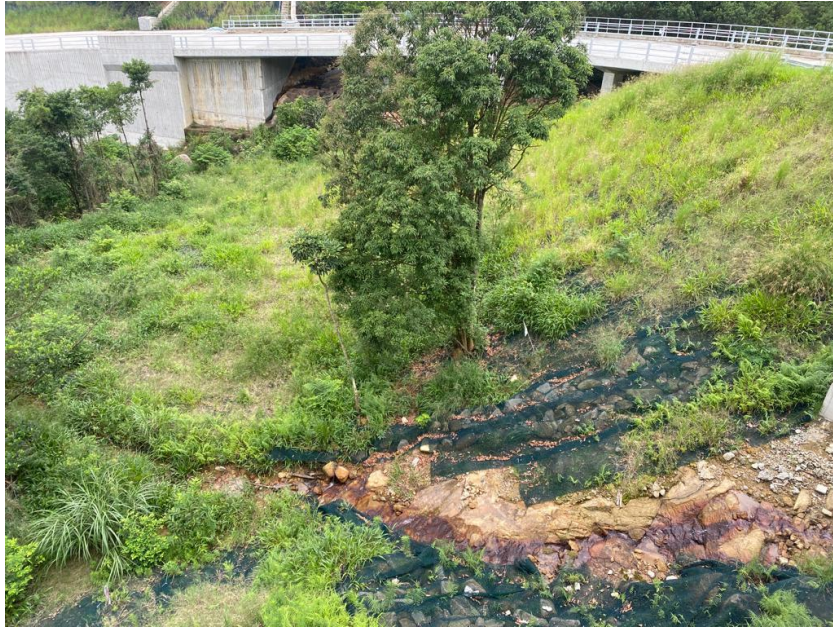
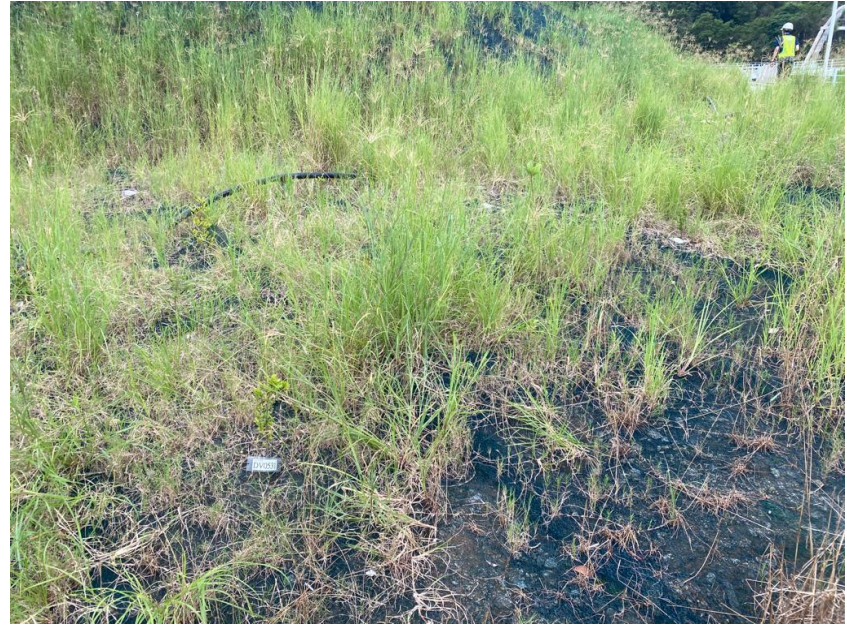
Post-transplantation monitoring at receptor site on 21 June 2022.

Receptor site of *Diospyros vaccinioides*

- 2.1.9. According to environmental condition and location of the receptor sites/ nursery, watering frequency was recommended in daily practice for at least the first 3 months as the transplant time is in summer months with strong sunlight and high temperature; except the days with fog and rain. Water frequency may be reduced based on the plant condition after monitoring in the first 3 months.

- 2.1.10. In contrast, the Landscape Contractor was recommended to check all transplanted plants after heavy rains/ typhoon under safe condition, in order to carry out any stabilization/ maintenance work. Blocked drainage shall be cleared; excessive water shall be pumped or diverged from nursery ground; saturated soil shall be aerated.

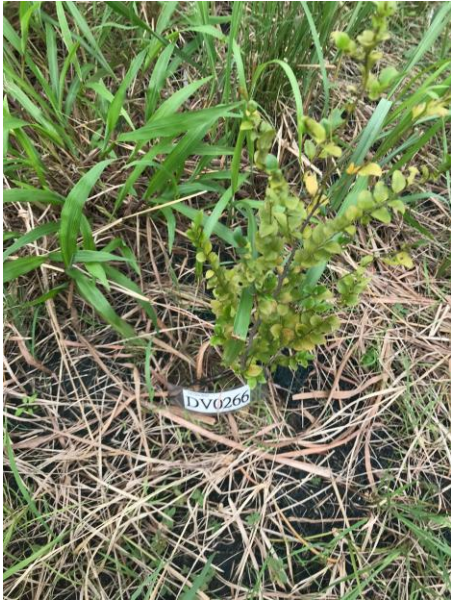
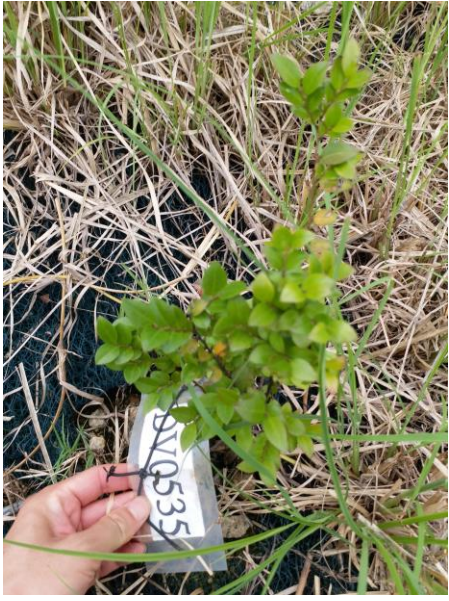
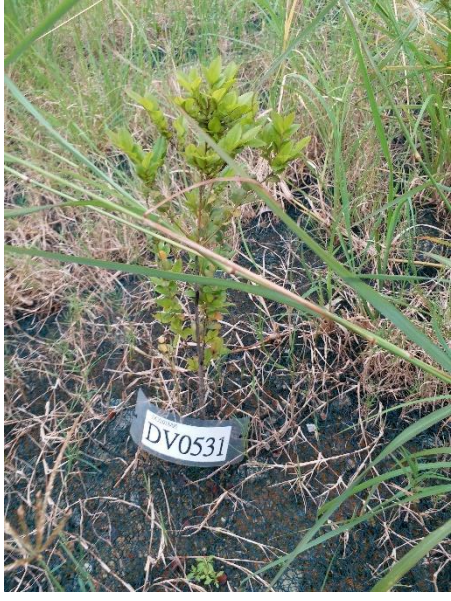
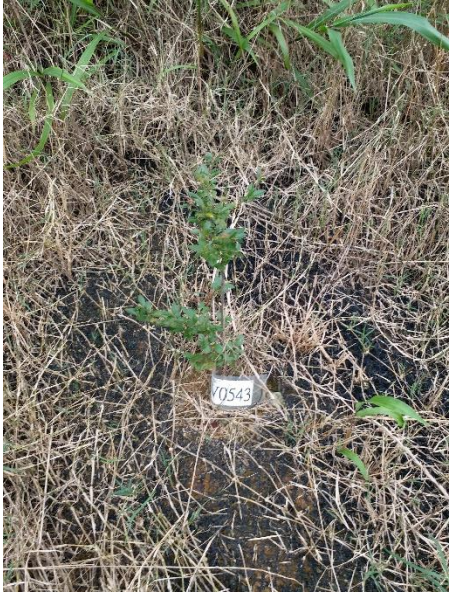
Photographic records of post-transplantation monitoring on plants of conservation importance transplanted at receptor site on 21 June 2022.

<p>Photo record of <i>Diospyros vaccinioides</i></p>	<p>Photo record of <i>Diospyros vaccinioides</i></p>

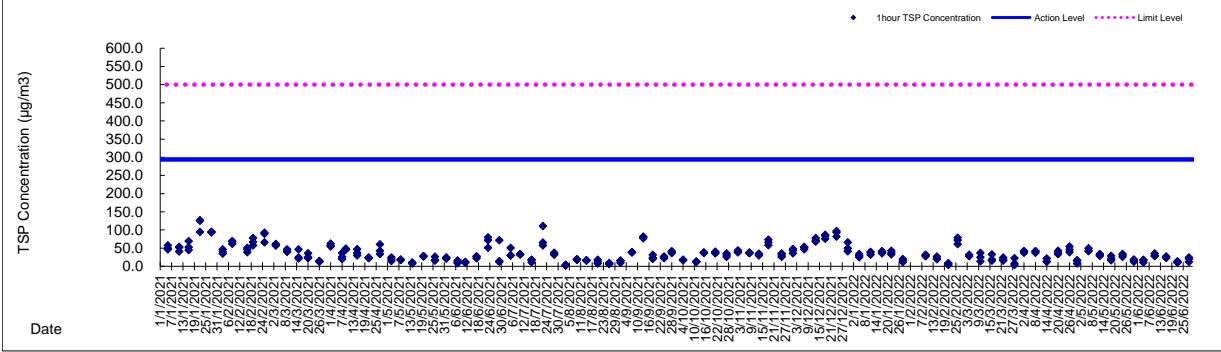
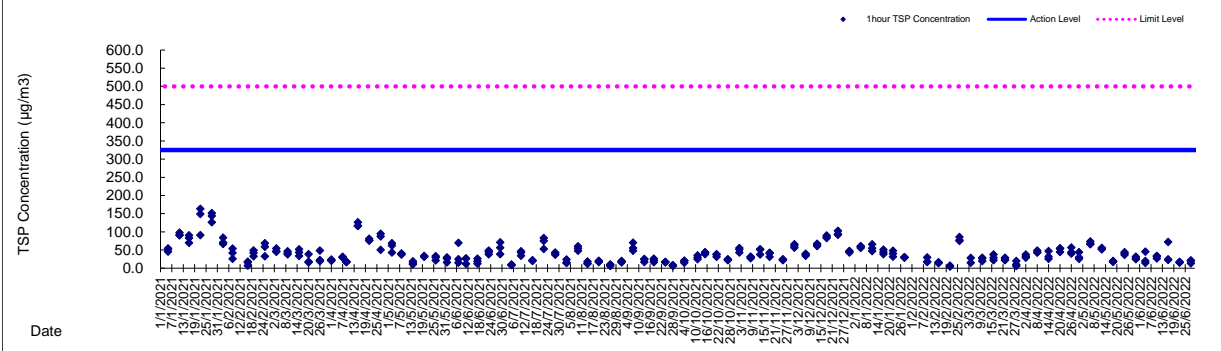
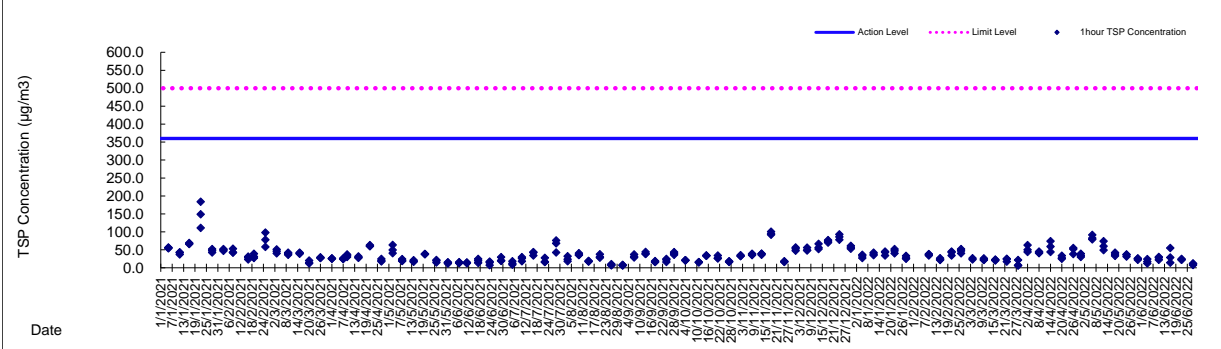
Graphic Presentation of TSP Result

AM1 - Ah Kung kok Fishermen Village

AM2 - Block H, Kam Tai Court

AM3(B) - Outside A Kung Kok Street Garden

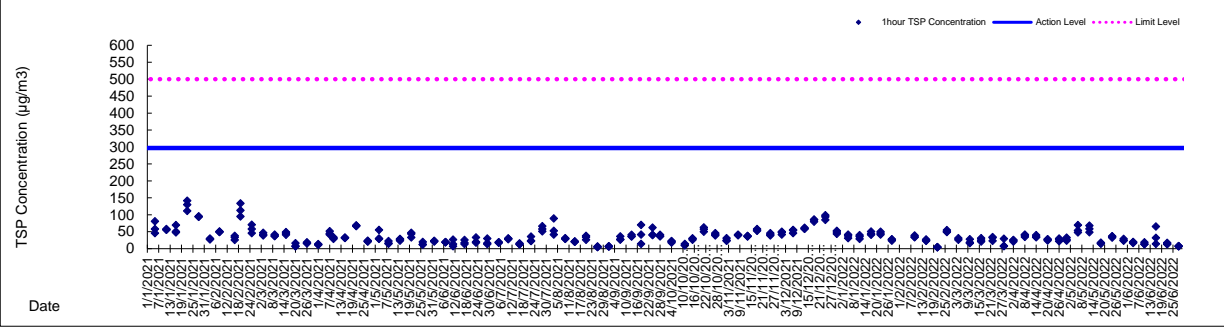
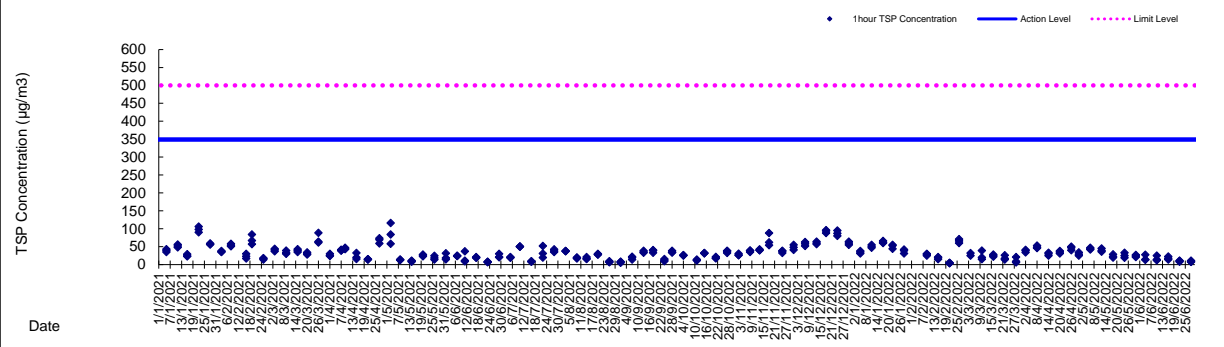
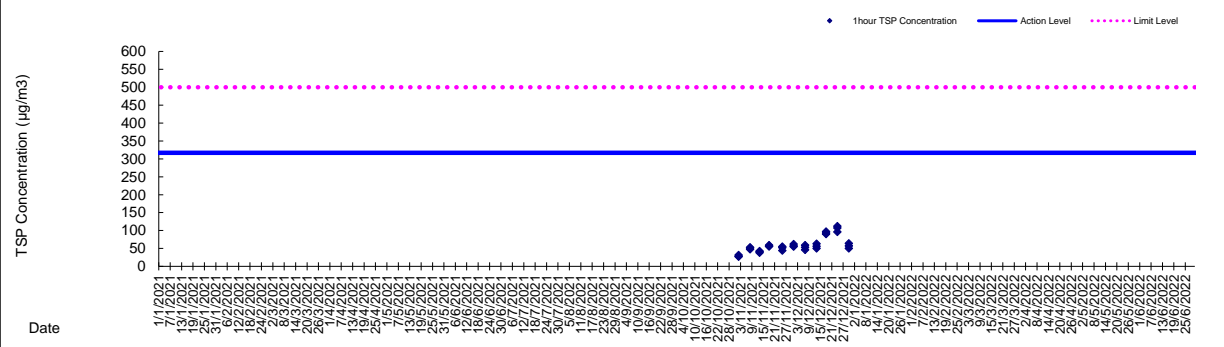
Graphic Presentation of TSP Result

AM4 - Wellborn Kindergarten

AM5 - The NAAC Harmony Manor

AM6 - Seaview Villa

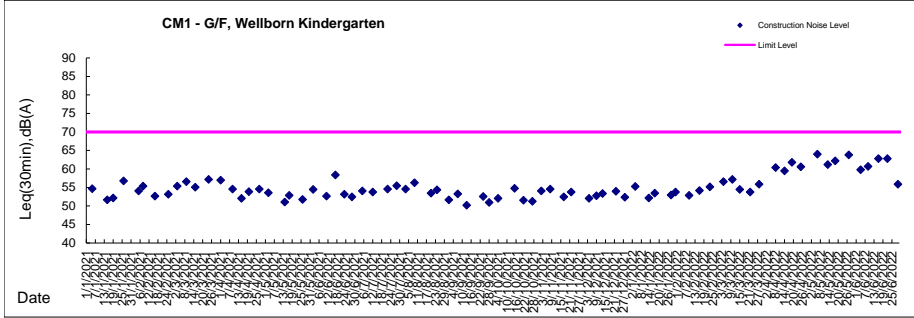
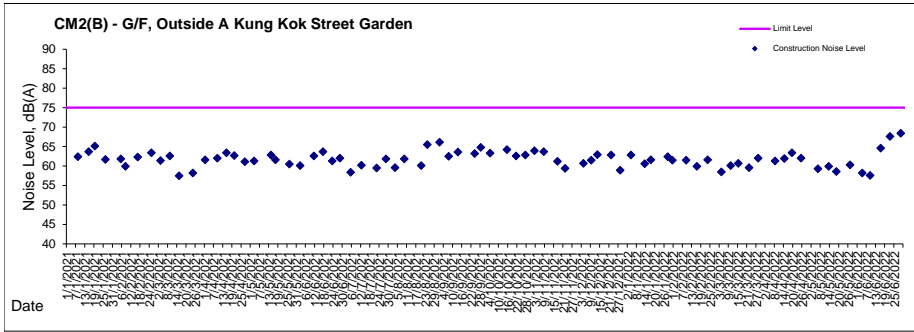
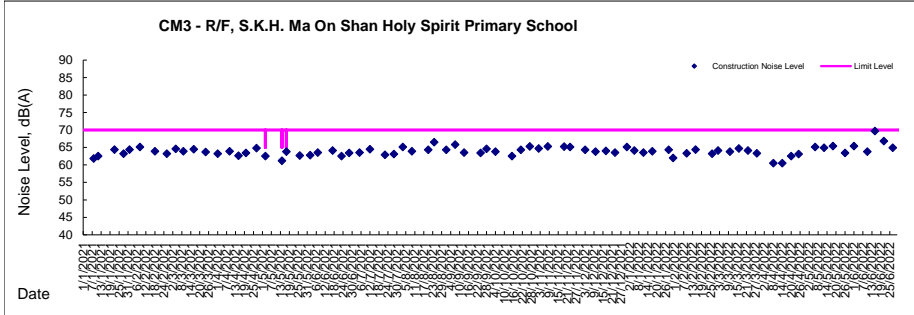
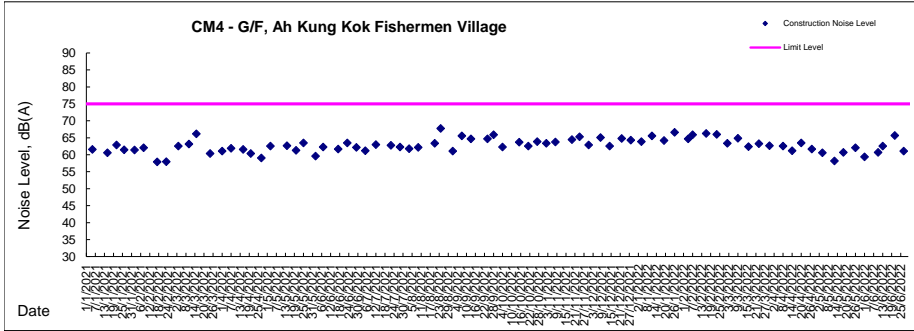
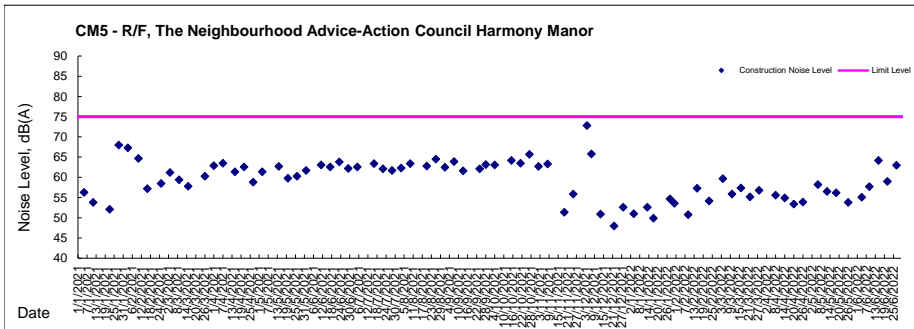
**Graphic Presentation of Noise Monitoring Result**

Day Time (0700 - 1900hrs on normal weekdays)

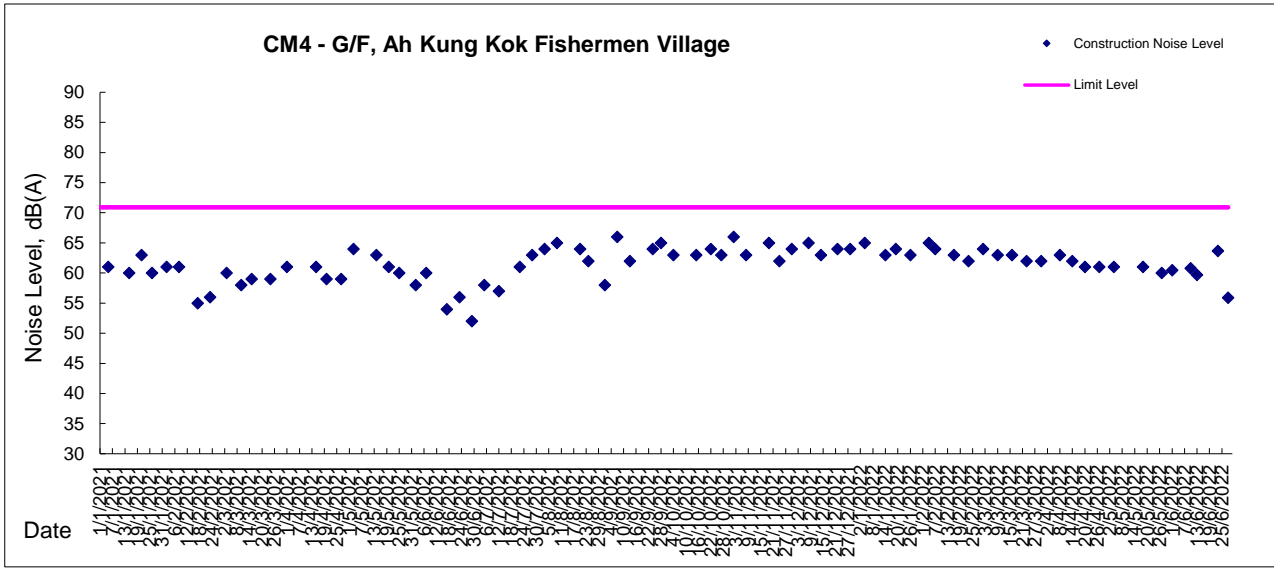
**Graphic Presentation of Noise Monitoring Result**  
**Evening Time (1900 - 2300hrs on normal weekdays)**

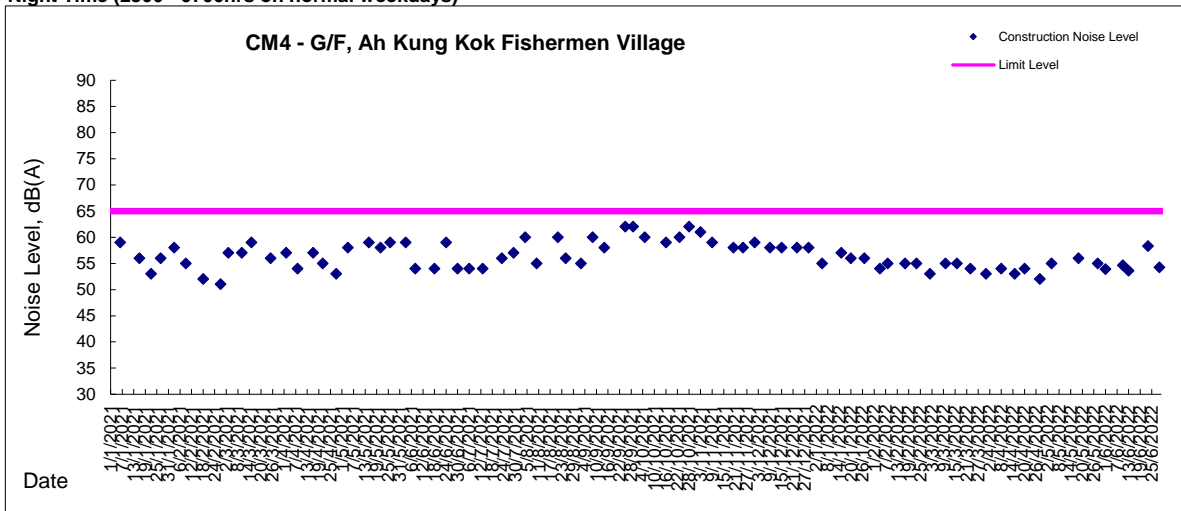
**Graphic Presentation of Noise Monitoring Result**  
**Night Time (2300 - 0700hrs on normal weekdays)**
