**Agreement No. CE 30/2018 (EP)  
Environmental Team for Kai Tak Sports Park –  
Design and Construction**

Monthly EM&A Report for September 2019

October 2019

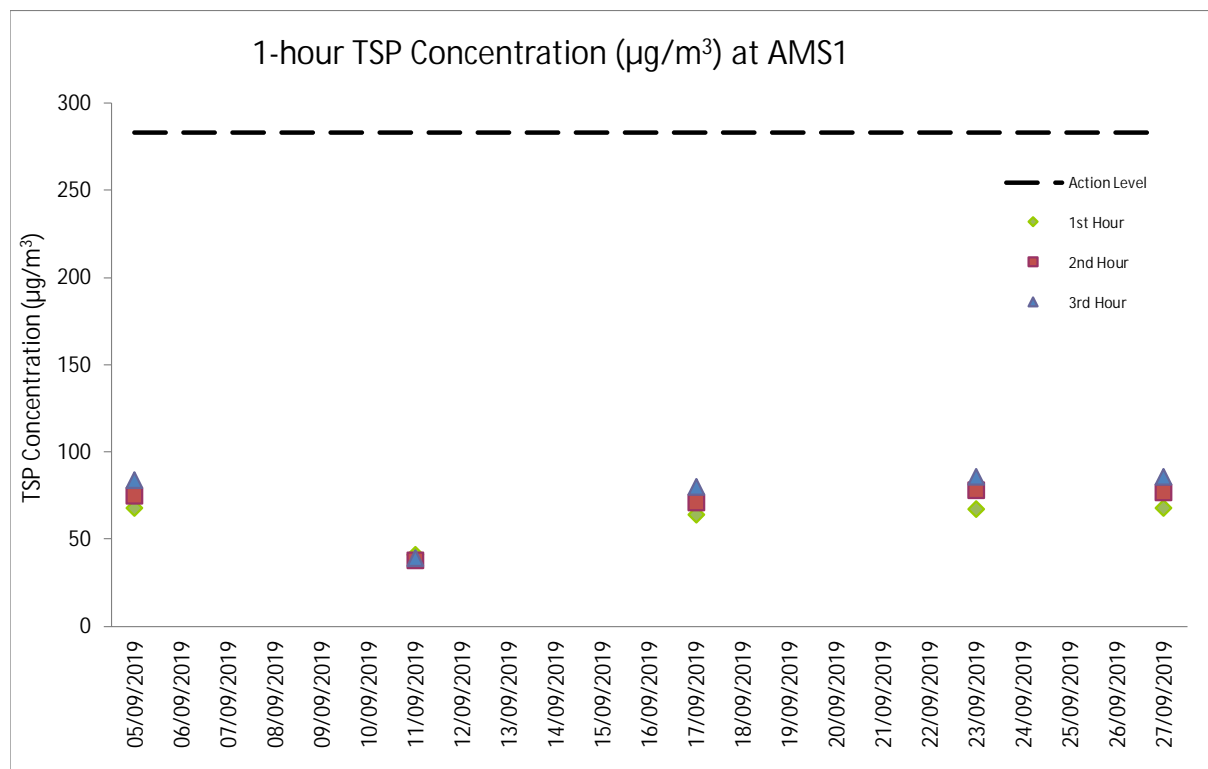
## Graphical Presentation for 1-hour TSP Monitoring at AMS1

Date	Start Time	Finish Time	Weather	Wind Speed (m/s)	Wind Direction (deg)	1-hour TSP ( $\mu\text{g}/\text{m}^3$ )
05-Sep-19	8:47	9:47	Sunny	2.7	30	68
05-Sep-19	9:47	10:47	Sunny	2.9	73	75
05-Sep-19	10:47	11:47	Sunny	3.4	131	84
11-Sep-19	8:58	9:58	Sunny	1.7	112	41
11-Sep-19	9:58	10:58	Sunny	2.3	65	38
11-Sep-19	10:58	11:58	Sunny	3.7	139	39
17-Sep-19	9:00	10:00	Fine	5.8	104	64
17-Sep-19	10:00	11:00	Fine	2.3	53	71
17-Sep-19	11:00	12:00	Fine	3.8	108	80
23-Sep-19	8:36	9:36	Sunny	2.0	8	67
23-Sep-19	9:36	10:36	Sunny	3.0	54	78
23-Sep-19	10:36	11:36	Sunny	4.2	31	86
27-Sep-19	9:15	10:15	Sunny	1.3	328	68
27-Sep-19	10:15	11:15	Sunny	1.2	10	77
27-Sep-19	11:15	12:15	Sunny	0.8	327	86

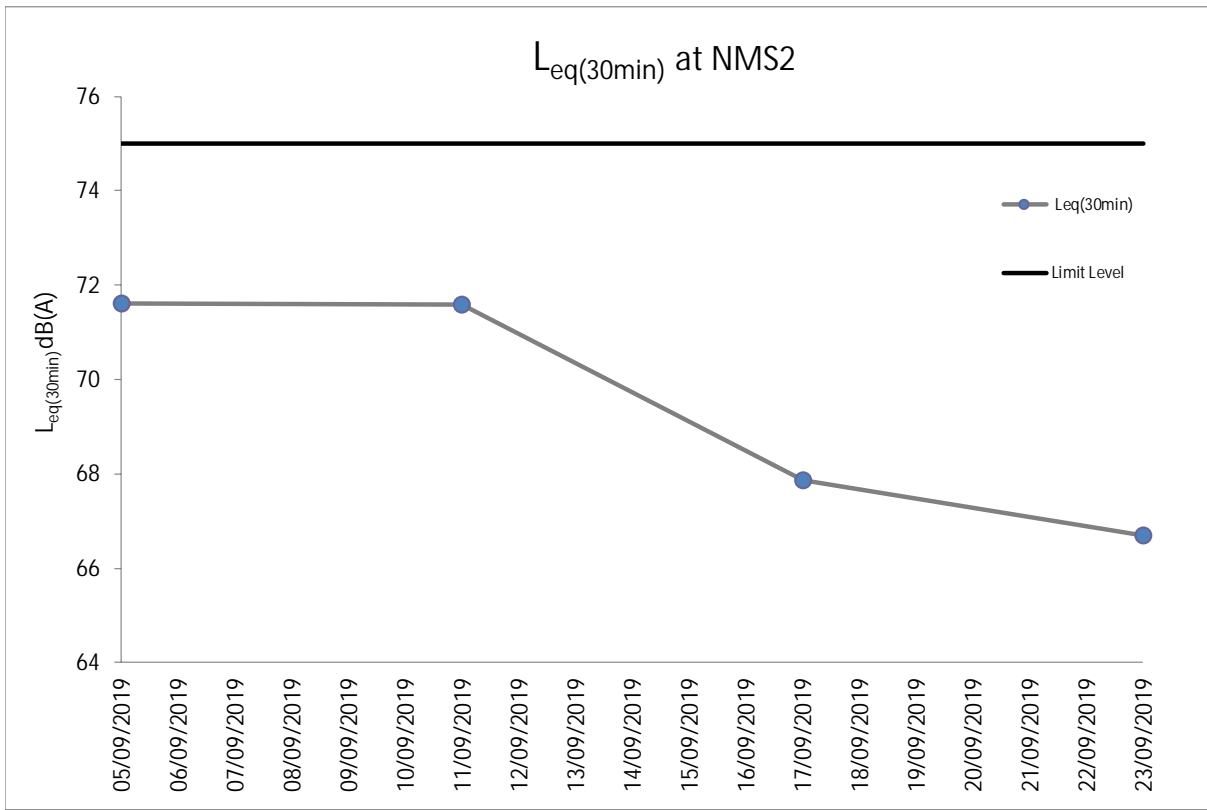
### Graphical Presentation for Noise Monitoring at NMS2

Date	Time	Weather	L <sub>eq(5min)</sub>	L <sub>10</sub>	L <sub>90</sub>	Measured L <sub>eq(30min)</sub>
05-Sep-19	08:51	Sunny	71.1	73.4	64.1	71.6
05-Sep-19	08:56	Sunny	72.1	74.0	65.7	
05-Sep-19	09:01	Sunny	70.9	72.9	64.0	
05-Sep-19	09:06	Sunny	71.1	73.6	64.7	
05-Sep-19	09:11	Sunny	72.2	74.3	65.2	
05-Sep-19	09:16	Sunny	72.1	74.5	65.6	
11-Sep-19	09:00	Sunny	70.1	72.7	64.9	71.6
11-Sep-19	09:05	Sunny	71.2	73.9	65.7	
11-Sep-19	09:10	Sunny	71.9	73.7	65.8	
11-Sep-19	09:15	Sunny	72.4	74.4	64.7	
11-Sep-19	09:20	Sunny	70.6	73.0	64.5	
11-Sep-19	09:25	Sunny	72.7	74.9	65.8	
17-Sep-19	08:16	Fine	67.9	70.1	64.1	67.9
17-Sep-19	08:21	Fine	66.9	69.4	63.4	
17-Sep-19	08:26	Fine	68.2	71.5	65.2	
17-Sep-19	08:31	Fine	68.0	71.5	65.7	
17-Sep-19	08:36	Fine	67.7	70.6	64.2	
17-Sep-19	08:41	Fine	68.4	71.6	65.0	
23-Sep-19	07:54	Sunny	65.8	67.4	62.1	66.7
23-Sep-19	07:59	Sunny	65.9	68.0	62.4	
23-Sep-19	08:04	Sunny	66.2	68.4	63.1	
23-Sep-19	08:09	Sunny	67.1	69.0	63.9

23-Sep-19	08:14	Sunny	66.9	68.7	63.4	
23-Sep-19	08:19	Sunny	67.9	69.4	64.0
