**Agreement No. CE 30/2018 (EP)
Environmental Team for Kai Tak Sports Park –
Design and Construction**

Monthly EM&A Report for February 2021

March 2021

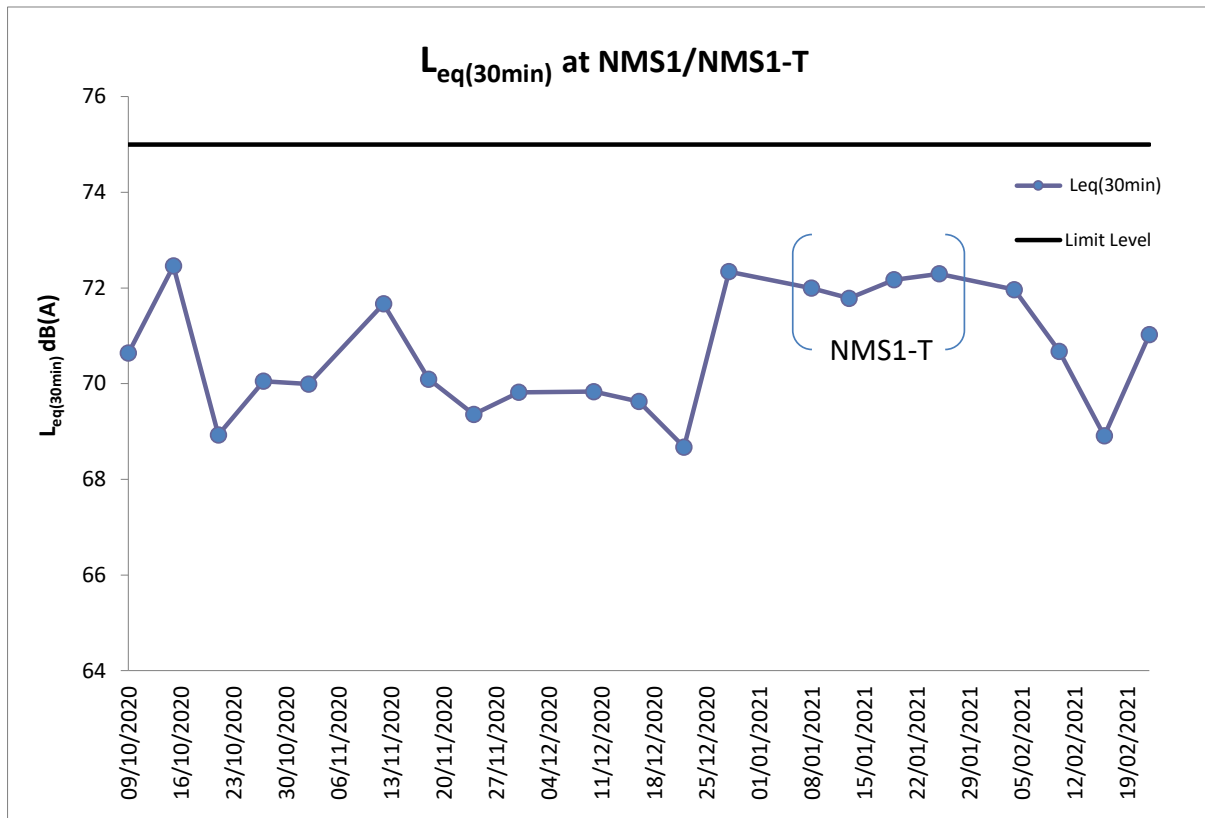
Graphical Presentation for Noise Monitoring at NMS1/NMS1-T*

* Monitoring station NMS1 was temporary suspended from 4 January 2021 to 25 January 2021, due to a case of COVID-19 diagnosed at the Hong Kong Society for the Blind Workshop. Temporary noise monitoring station, NMS1-T was used to conduct noise monitoring on 8, 13, 19 and 25 January 2021. Details of temporary alternative monitoring locations are presented in Temporary Alternative Proposal for Monitoring Station as proposed by ET and agreed by IEC dated 6 January 2021.

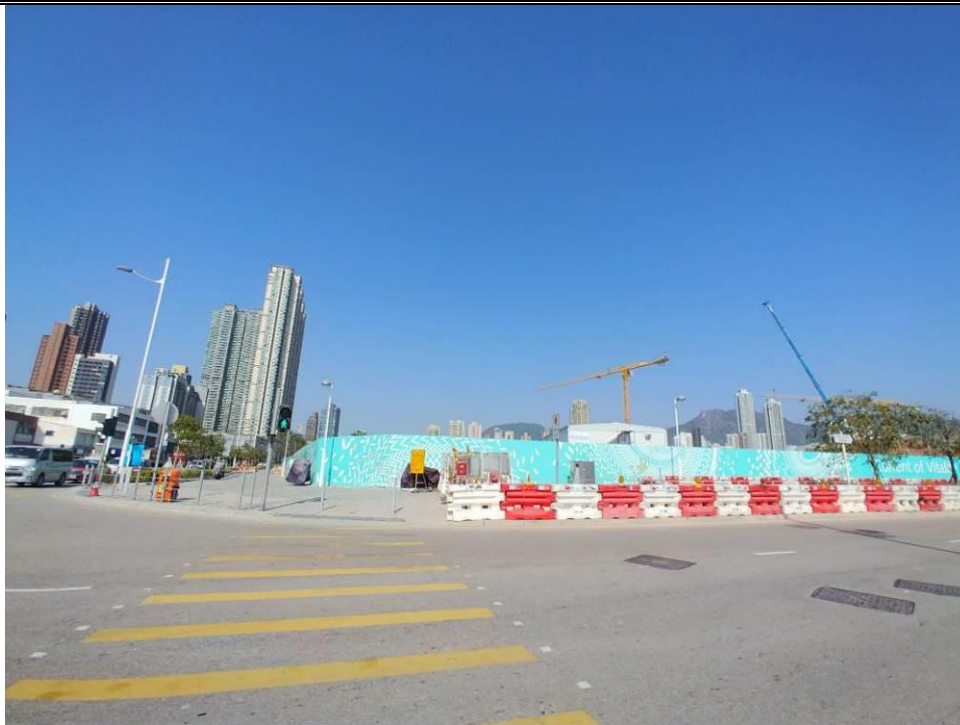
Photo 1a: Road condition at Shing Kai Road (Kowloon Bay direction) near Sung Wong Toi Road (3 February 2021)

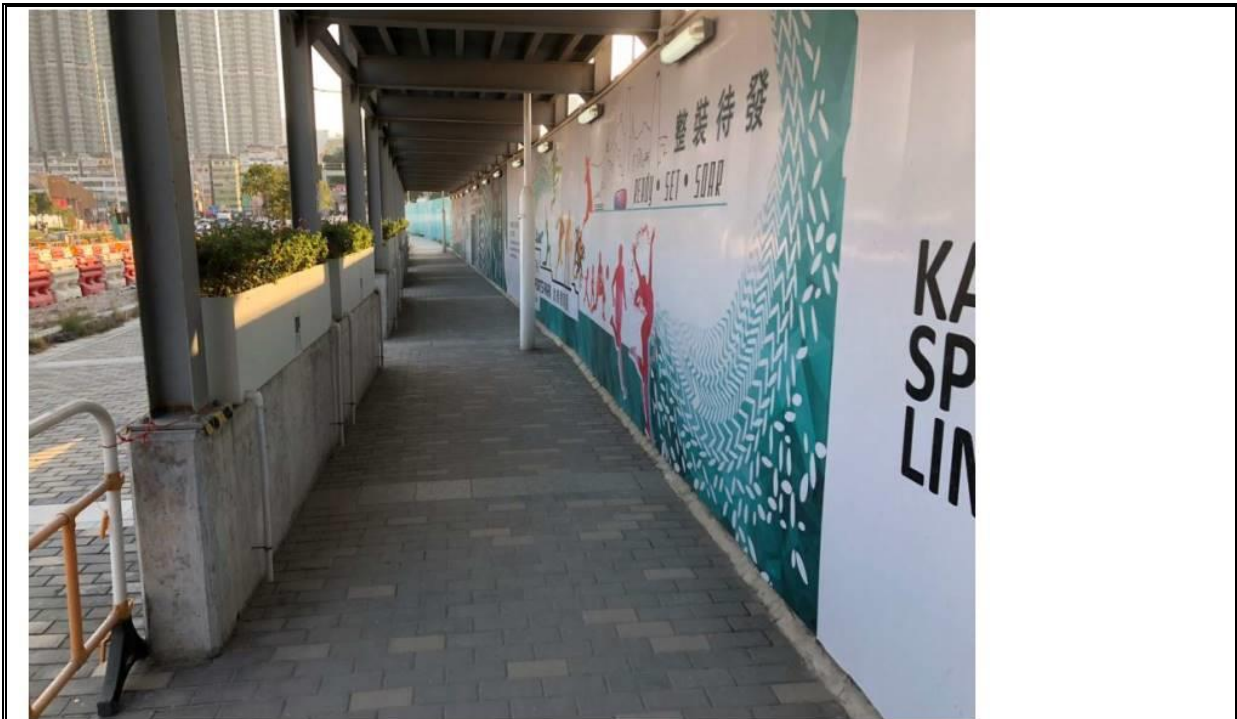
Photo 2: KTSP Site Boundary near Shing Kai Road (Kowloon Bay direction) (3 February 2021)

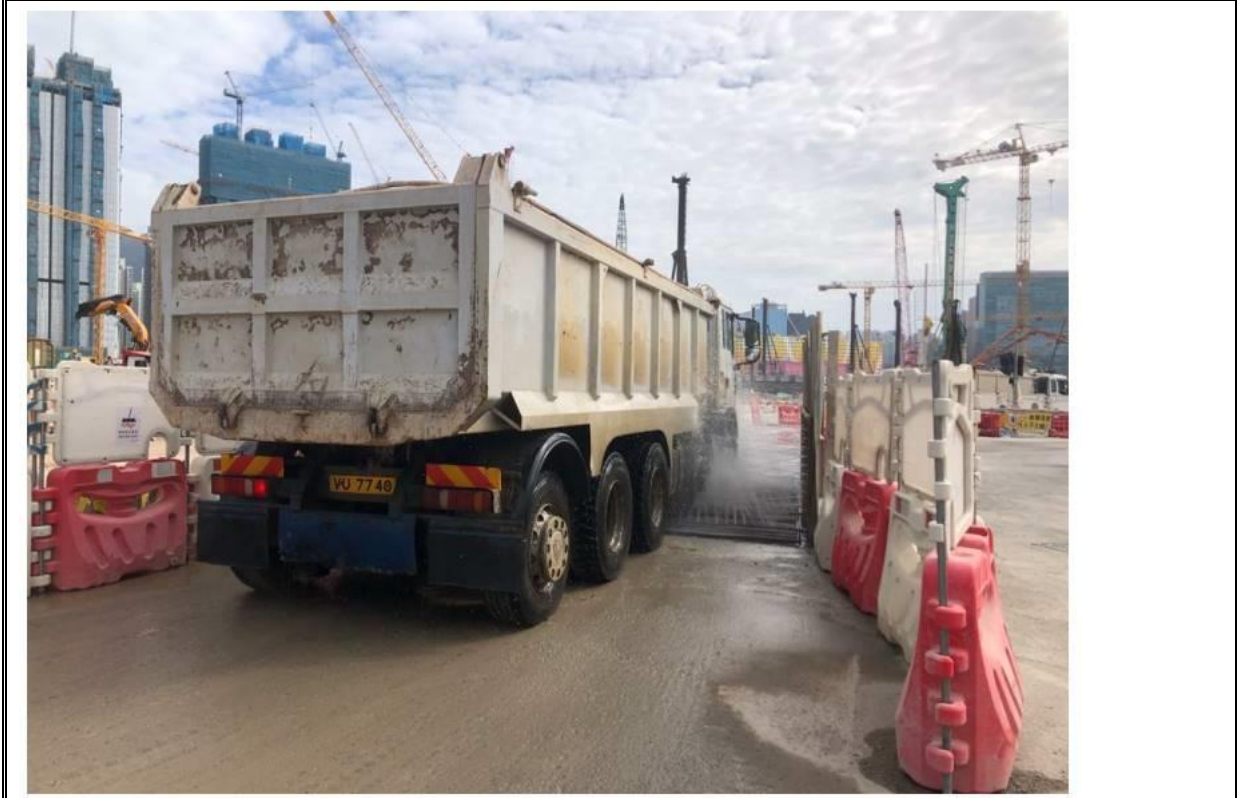
Photo 3: Wheel washing facility has been installed and implemented at all site exits.

RECOMMENDATIONS / MITIGATION MEASURES / ACTIONS			
Environmental mitigation measures have been maintained as follow:			
<ol style="list-style-type: none"> 1. Wheel washing facilities have been installed and implemented at all site exits. (Photo 3) 2. Water spraying by water truck has been suspended in front of North 1 Gate.(Photo 4) 			
Prepared by:	Sunny Chan	Title:	Environmental Team Leader
Signature:

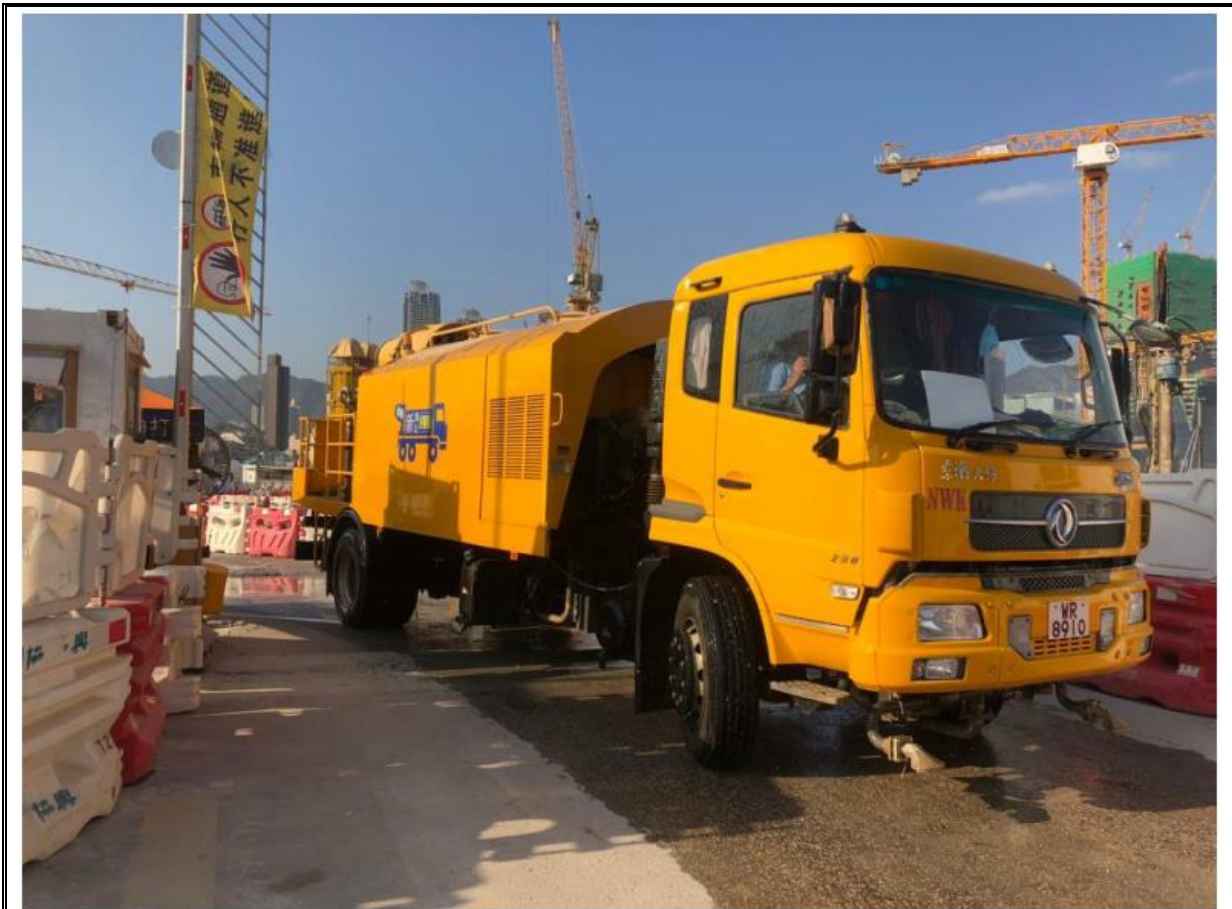
Photo 4: Water spraying by water truck has been suspended in front of North 1 Gate.
